Rail Accident Investigation Branch

Rail Accident Report

**Collision at Black Horse Drove Crossing, near
Littleport, Cambridgeshire
19 October 2005.**

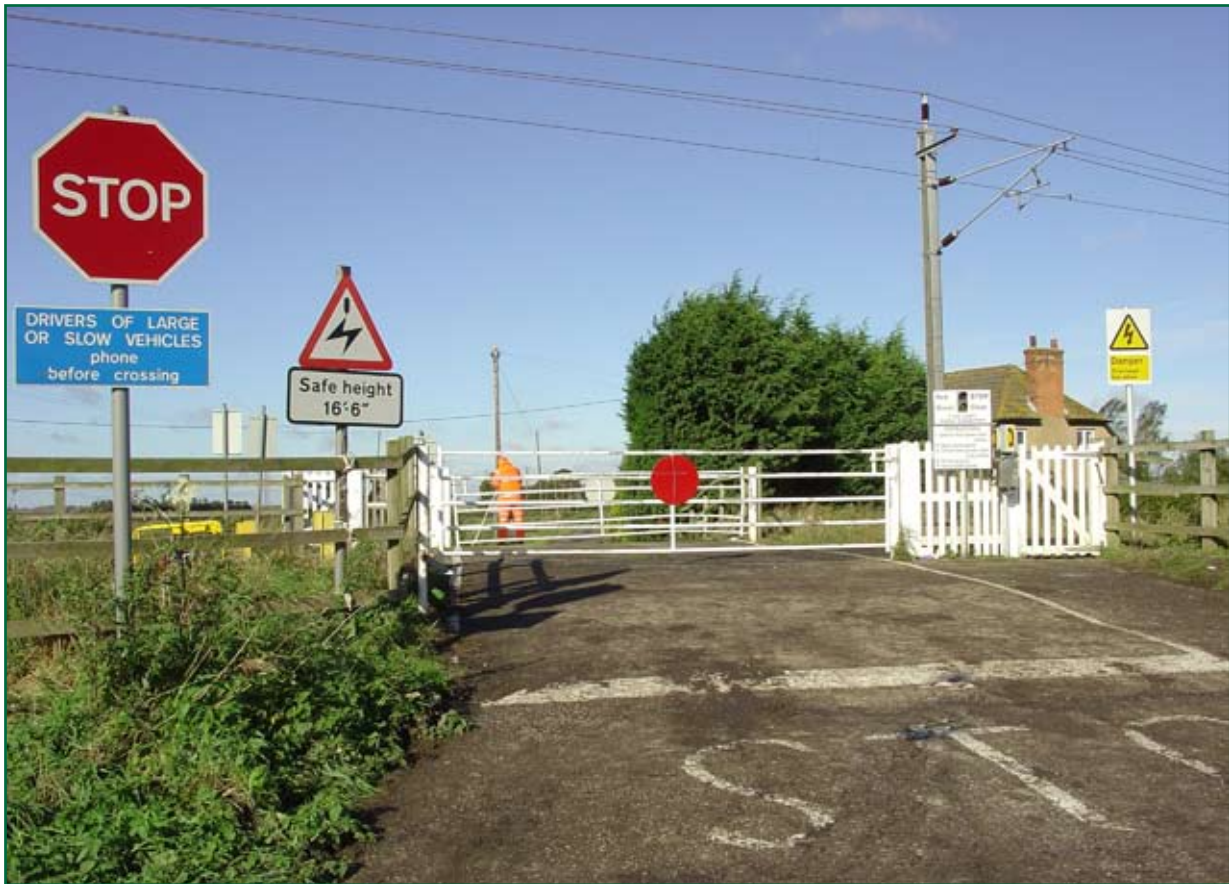
Figure 4: View of crossing approach from East side showing the stop line and gate line

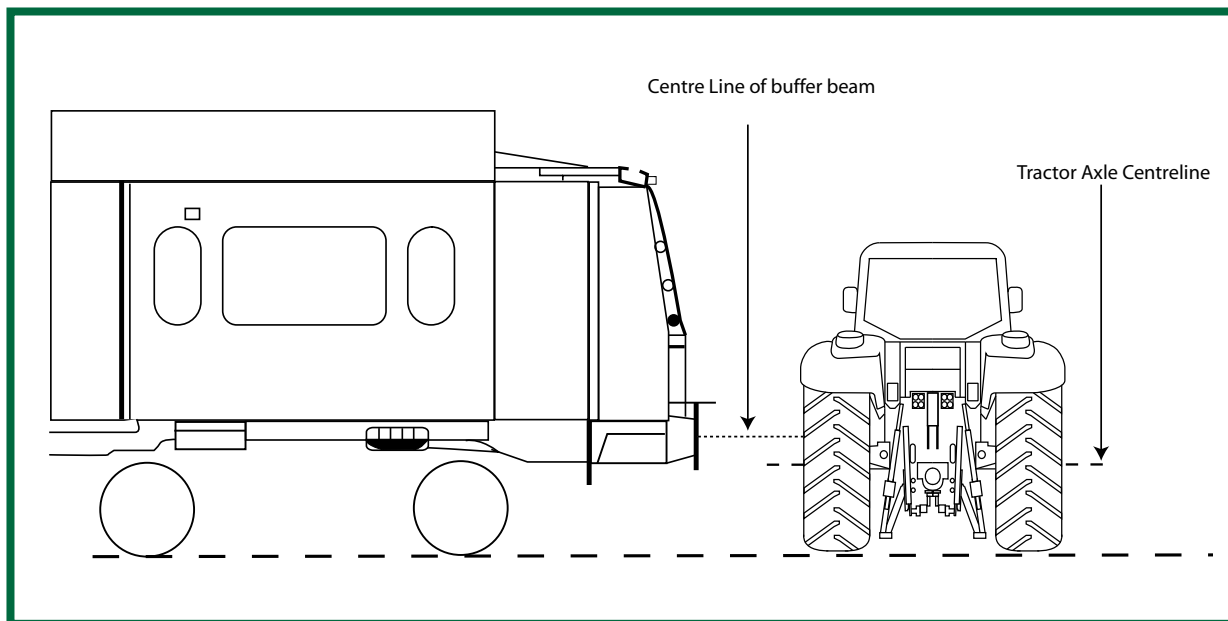
- 50 The relative orientation of the train and tractor are shown in Figures 6 and 7 in plan and elevation respectively. Figure 7 shows how the rear axle of the tractor was at the same height as the right side *anticlimber* on the train. This meant that the initial impact force was borne by the train on the members that were designed for this purpose. The skew of the level crossing meant that the initial impact was between the GRP fairing over the right side anticlimber and the back wheel tyre of the tractor. This impact would not have been severe and the anticlimber continued into the main structural core of the tractor, bursting the fuel tank. The main tractor units; chassis, gearbox and back axle, are all aligned at the height of the rear axle and were broken apart by the right side anticlimber.

Figure 7: Position of tractor and train just prior to impact (elevation)

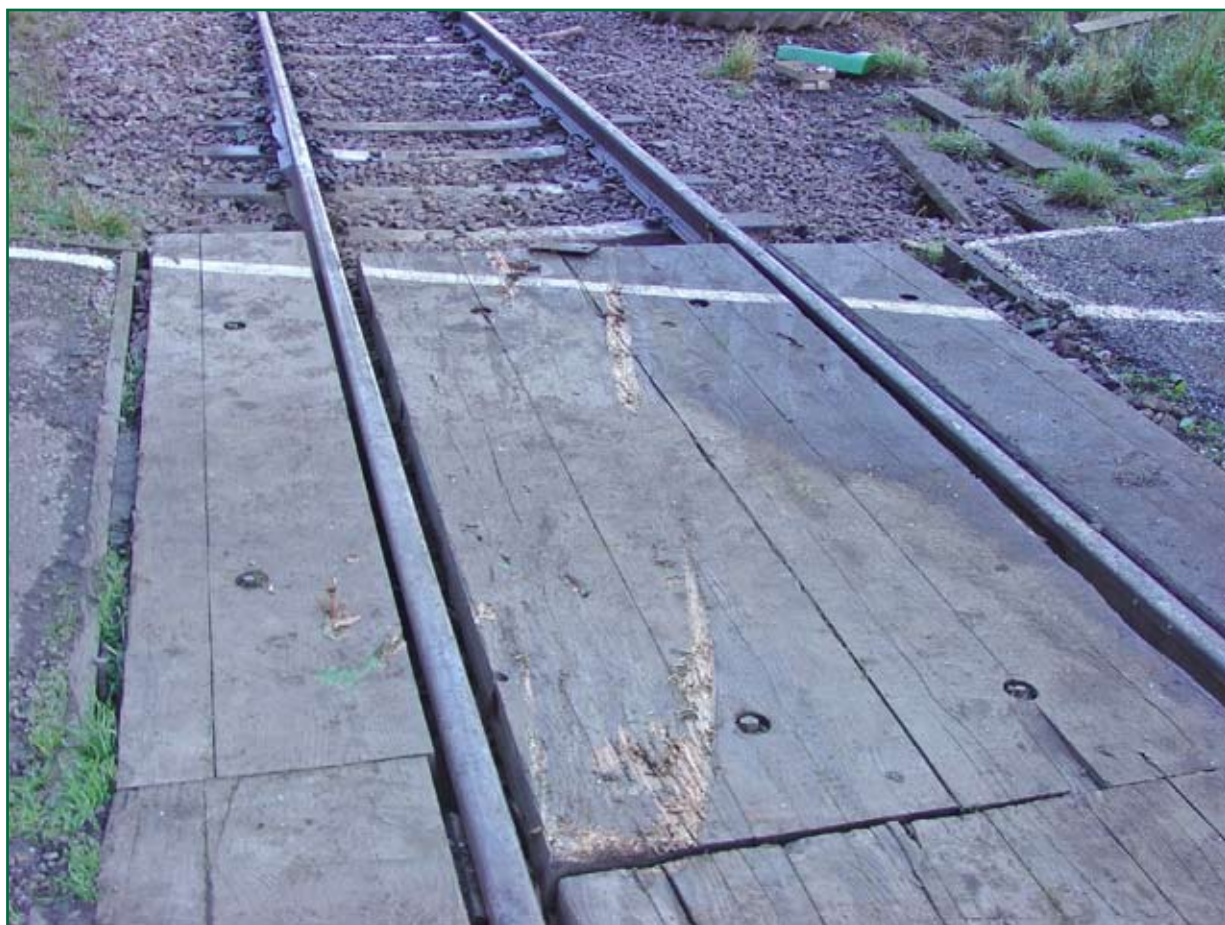
- 51 The impact pushed the tractor over raising the left side front wheel so that its axle end impacted with the train's left side anticlimber. The front axle was then wedged between the anticlimber and the timber surface of the crossing. The train pushed the axle across the timber surface leaving score marks (Figure 8) before the axle was thrown clear with the rest of the debris as the tractor broke up.

Figure 8: Gouge marks on crossing surface

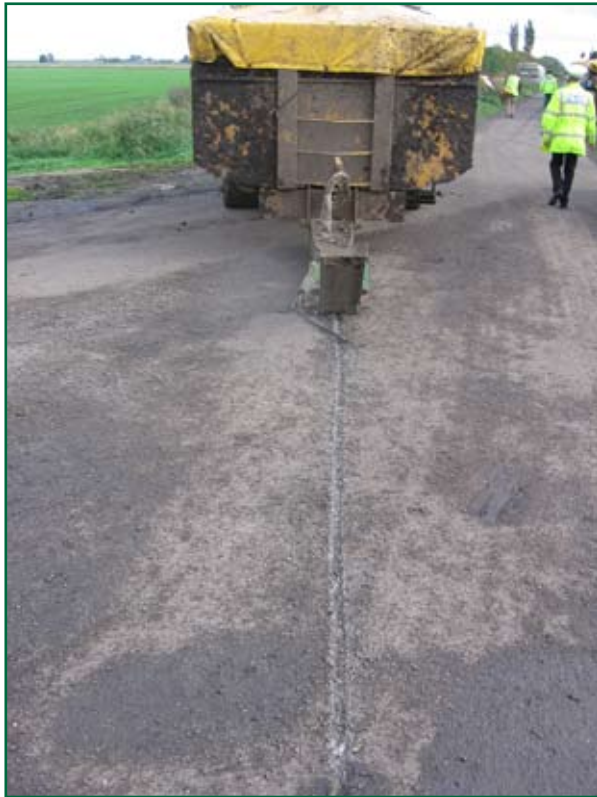
52 Very early on in the collision, the coupling between tractor and trailer was broken though the drawhook connection to the trailer remained intact. The failure occurred where the drawhook assembly attaches to the tractor, this assembly remaining attached to the trailer (Figure 9). The trailer then rolled back down the slope clear of the line.

Figure 9: Trailer with part of the tractor drawbar still attached

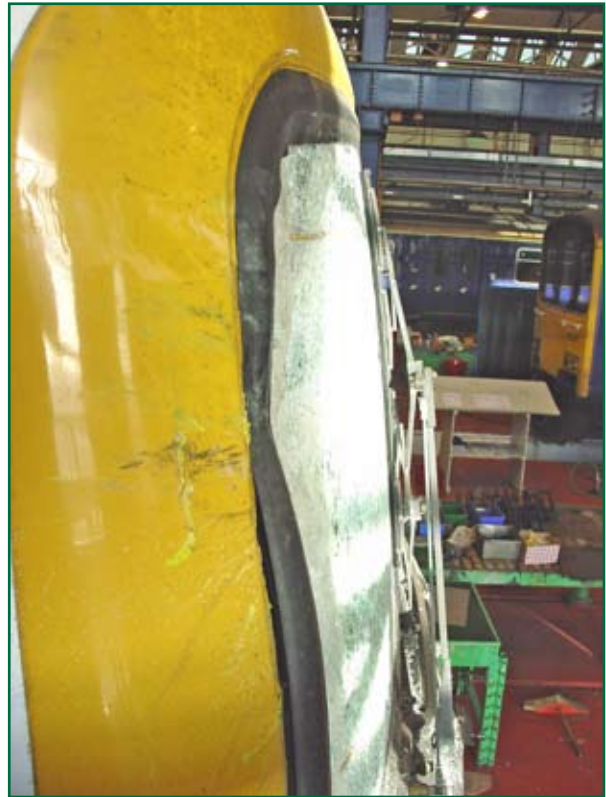
Figure 10: Front of train showing impact marks from tractor cab

53 The top of the tractor cab impacted the GRP fairing of the train cab high up, breaking the train windscreen (Figure 10), though the glass remained in place. The rear section of the tractor was then pushed aside to the right of the train impacting heavily with the train driver's door and breaking the glass, which showered into the train cab.

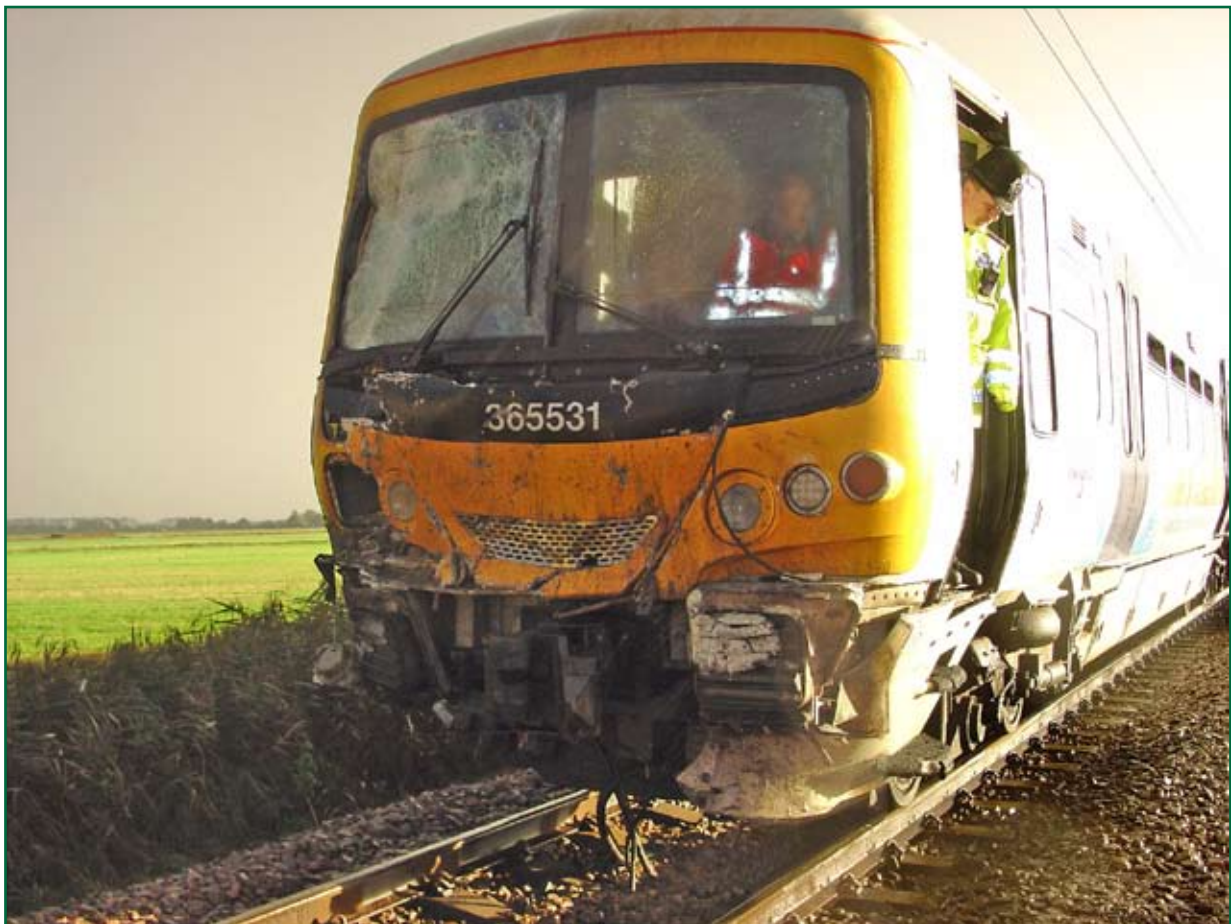
Figure 11: Damage to front of train

- 56 The train front was built to comply with the *crashworthy principles* of GM/RT 2100 and so had anticlimbers in the position where a conventional train has buffers. The offside anticlimber struck the tractor at the front of the rear tyre then impacted on the plastic fuel tank. This caused the diesel fuel from the tractor to be ejected and the spray obscured the train from the view of some witnesses. Despite the presence of 25 kV overhead electrification, this fuel cloud did not ignite.

- 57 The relative height of the train's structural underframe members and the tractor's main masses meant that the centre of gravity of the large parts of the tractor aligned with the axis of the train underframe. The underframe was therefore able to resist the impact loading with the energy absorbing members deforming in the process. If the relative heights of the underframe and tractor were different, the consequences of the accident could have been much more serious for the train driver and passengers as the cab could have been severely damaged or the train derailed.

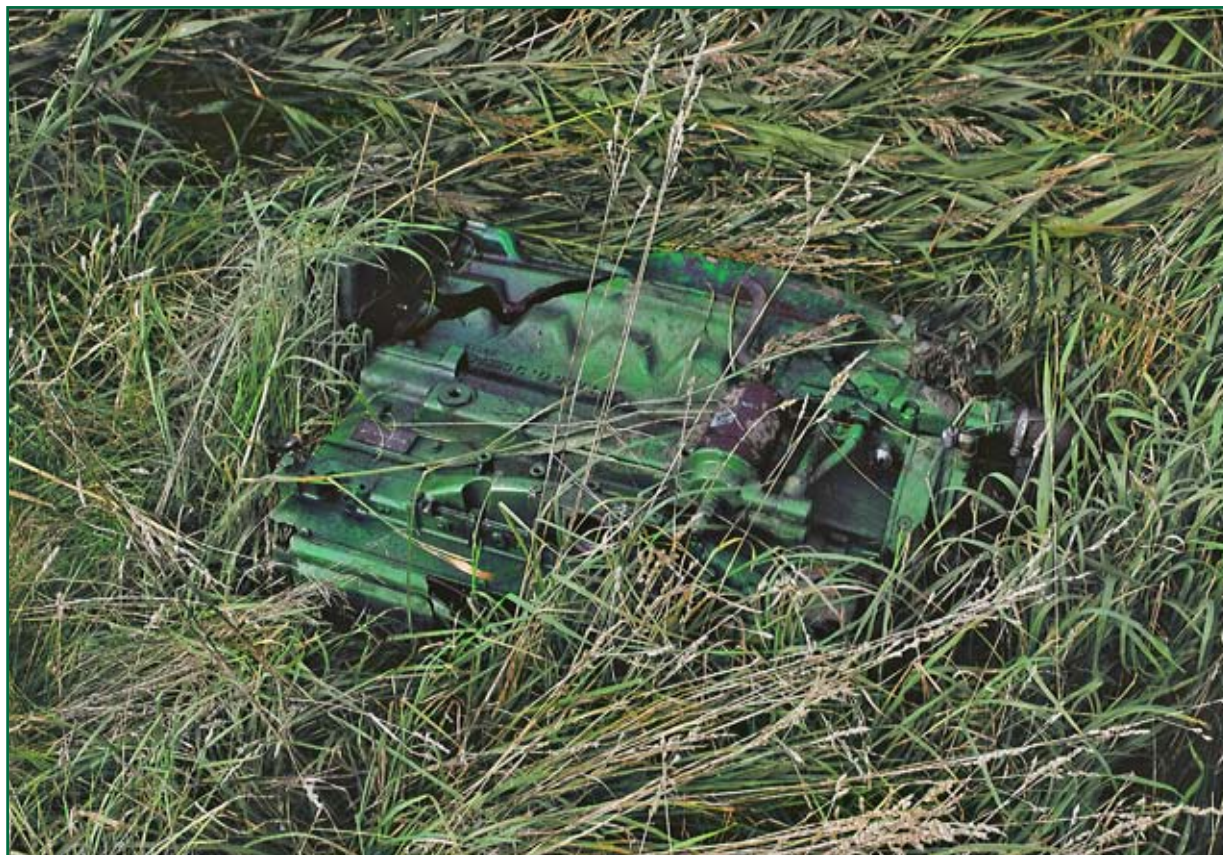
60 The tractor engine was mounted on top of the main chassis member and this raised it above the level of the train's anticlimbers. The engine was struck by the front section of the cab where the two GRP skins are at their maximum separation and the collision imparted a considerable amount of energy to the engine. The engine was thrown a total distance of 171 m, ricocheting off a gate before coming to rest in reeds at the lineside. The engine was almost complete (Figure 12); the weight of a complete engine is 537 kg. The impact pushed the cab front inwards, causing a panel to dislodge from the driver's desk.

Figure 12: Tractor engine

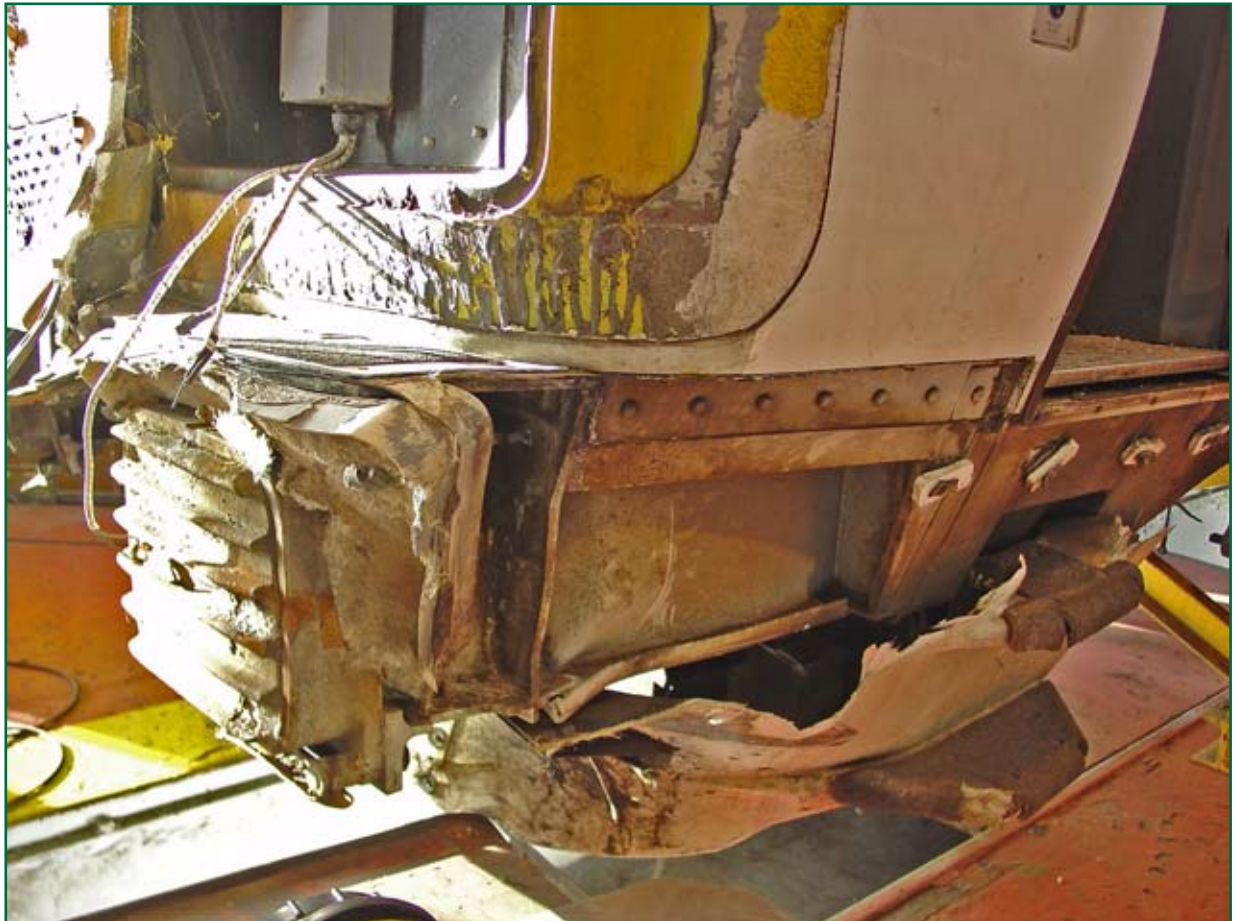
61 The GRP cladding on the lower part of the front of the train was broken up and the electrical connection box at the coupler was destroyed. The anticlimbers suffered heavy impacts and their supporting structure was distorted. This supporting structure consists, in part, of curved plates behind the anticlimbers whose purpose is to absorb energy. These were distorted (Figure 13). The cab structure had shortened such that the left side anticlimber moved back by 22 mm and the right side anticlimber was pushed back a maximum of 382 mm, though it was rotated to the right side. This shortening of the cab structure was evident in the buckling of the floor plate (Figure 14).

Figure 13: Damage at left side of train

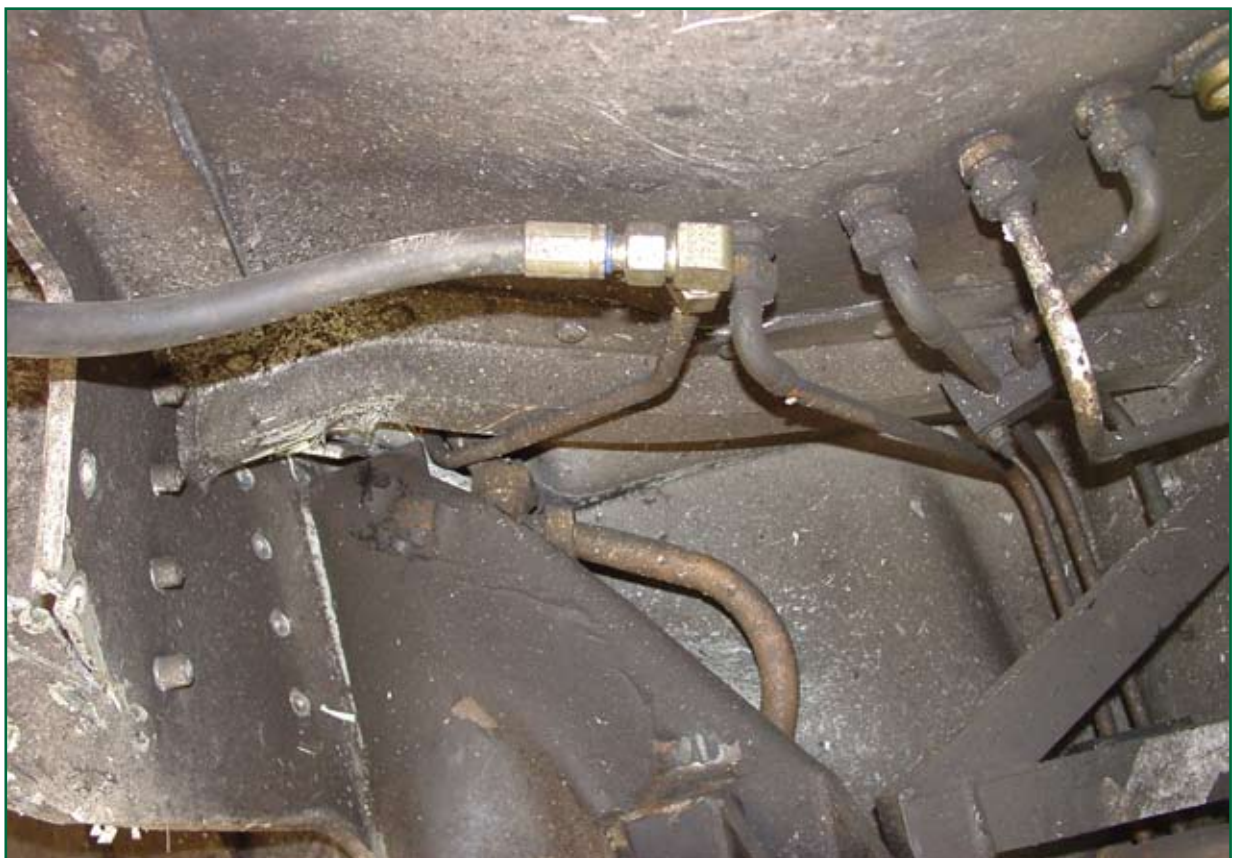
Figure 14: Buckled floor plate beneath train cab

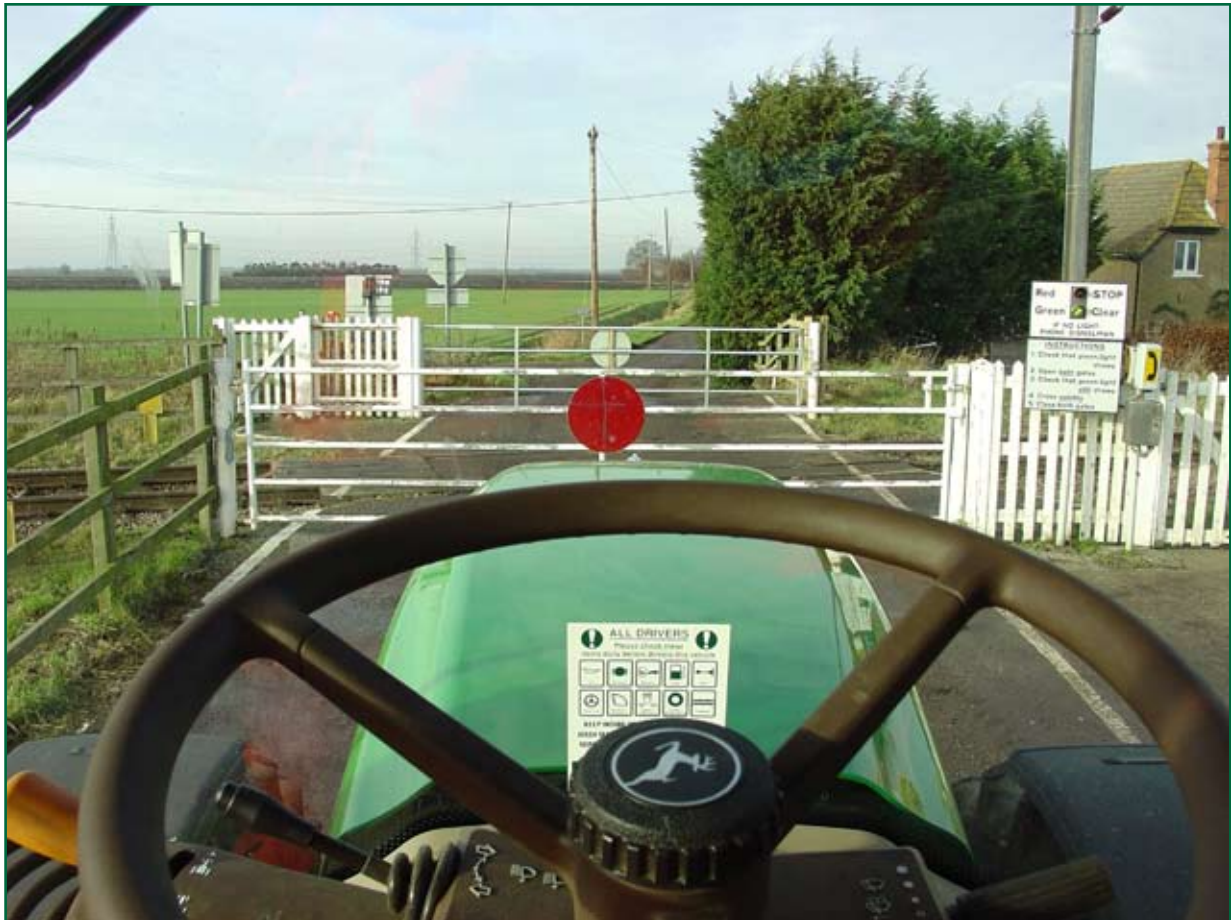
Figure 18: Level crossing from tractor parked on the stop line

119 The conspicuity of the miniature stop lights was considered and assessed by an RAIB Inspector sitting in the cab of the tractor on the stop line. Figure 18 shows the view of the crossing from the tractor cab. The board containing the miniature stop lights can be seen quite clearly, although the lights are not as large as conventional traffic lights. It was concluded that the conspicuity of the lights was not causal.
