Rail Accident Investigation Branch

# Rail Accident Report

## The blowback of a locomotive fire at Grosmont on the North Yorkshire Moors Railway 16 April 2006

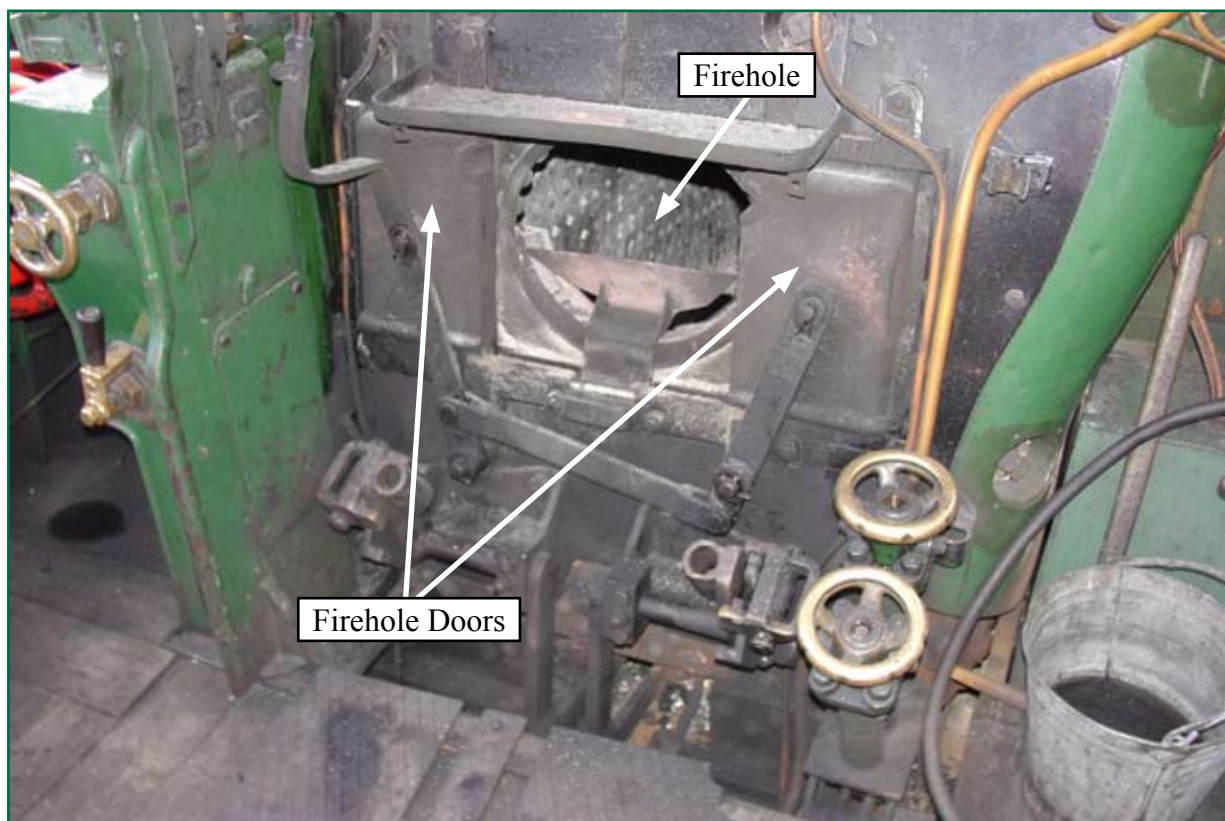
Figure 4: Locomotive 75029 footplate showing the firehole doors open

- 43 The cleaner then saw flames around 2.5 metres long engulfing a considerable area of the footplate in front of the firehole doors. The cleaner shouted a warning to the rest of the crew. The amount of flame and smoke was such as to make it impossible for the fireman to see across the footplate to the driver's side.

- 44 On hearing the warning, the driver turned back towards the footplate and saw the flames. The driver immediately shut the regulator, opened the blower and applied the train brake, the last action causing him to receive a minor burn to his right hand. The flames started to abate and the fireman was then able to kick the firehole doors shut finally stopping the blowback. By the time the train had stopped, the blowback had finished. The firehole doors and driver's controls are pictured in Figures 4 and 5.

- 64 The fireman left the doors open to maximise the secondary air supply and again, given the way the locomotive was being worked, there was nothing unusual or incorrect in this. Texts on firing steam locomotives, including the The British Transport Commission (Railway Division) 'Good Firemanship' booklet, explains that depending on coal type and prevailing condition, the firehole doors may need to be left open to varying degrees.

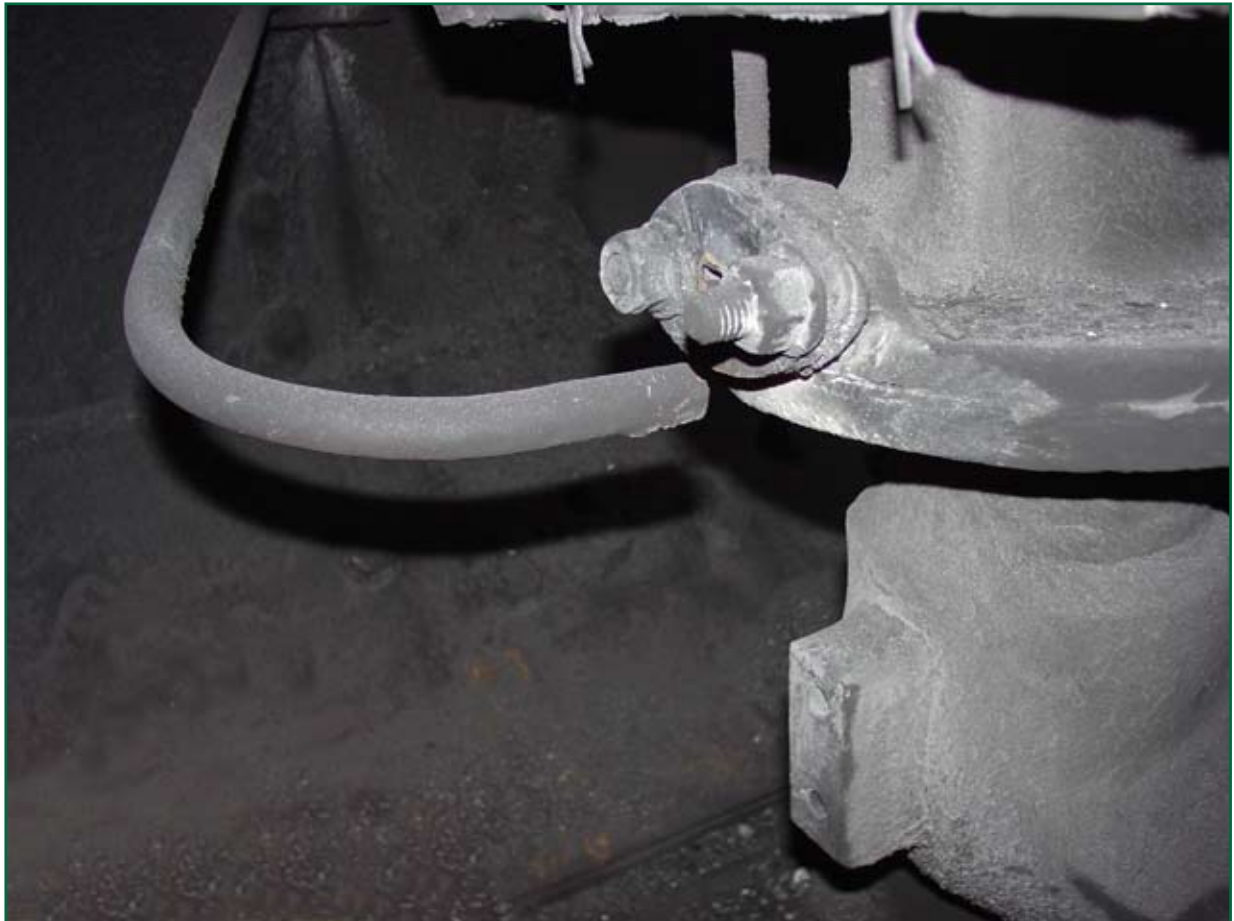
*Figure 7: The fractured rear blower feed pipe in-situ*

- when exhaust steam was vented through the blastpipe during testing, some was seen to leak into the smokebox through the cracks in the concrete;
- the rear blower feed pipe was fractured (see Figure 7), but had only been fractured a relatively short time as evidenced by the bright surface observed on one fractured face on 17 April 2006 that had dulled significantly within ten days of the accident. This was confirmed by metallurgical examination (paragraph 60 refers);

- 68 The rear blower feed pipe was intact, although possibly cracked, when the locomotive left the shed that morning (paragraph 37 refers). Prior to the incident, the blower valve had been slightly open for a considerable time and during the incident opening the blower valve fully helped to reduce the flames. Immediately after the incident, the blower was drawing smoke through the front chimney only, suggesting that the rear blower pipe had fractured before then.

- 69 Calculations show that the steam pressure within the rear blower feed pipe, even if the blower valve was fully open, is insufficient to cause its final ductile overload failure (described in paragraph 60). Calculations also show that once the pipe had failed, it would not have displaced by much, either by the jetting action of leaking steam, when the blower was fully opened, or by the action of its own weight. Thus, any steam coming from the fractured blower pipe would have either been aimed at the flange or close to it. Marks on the flange and the clean fracture surface (see Figure 7) also suggest that steam was jetted in that direction after the pipe fractured. It is thus clear that steam jetting from the rear blower feed pipe would not have been aimed back at the *tubeplate*, which is another possible cause of blowbacks.

- 70 It is therefore concluded that the blower feed pipe most probably finally failed during the incident, as a result of blastpipe movement, at a time when the blower valve was slightly open. Whilst theoretically that may have resulted in a slight increase in smokebox pressure, this would have been negligible compared to the increase in pressure as a result of the blastpipe moving (paragraph 74 refers) and can therefore be discounted as a causal factor. This is further confirmed by the fact that when the blower valve was fully opened, it helped to reduce the blow back, rather than increase it.

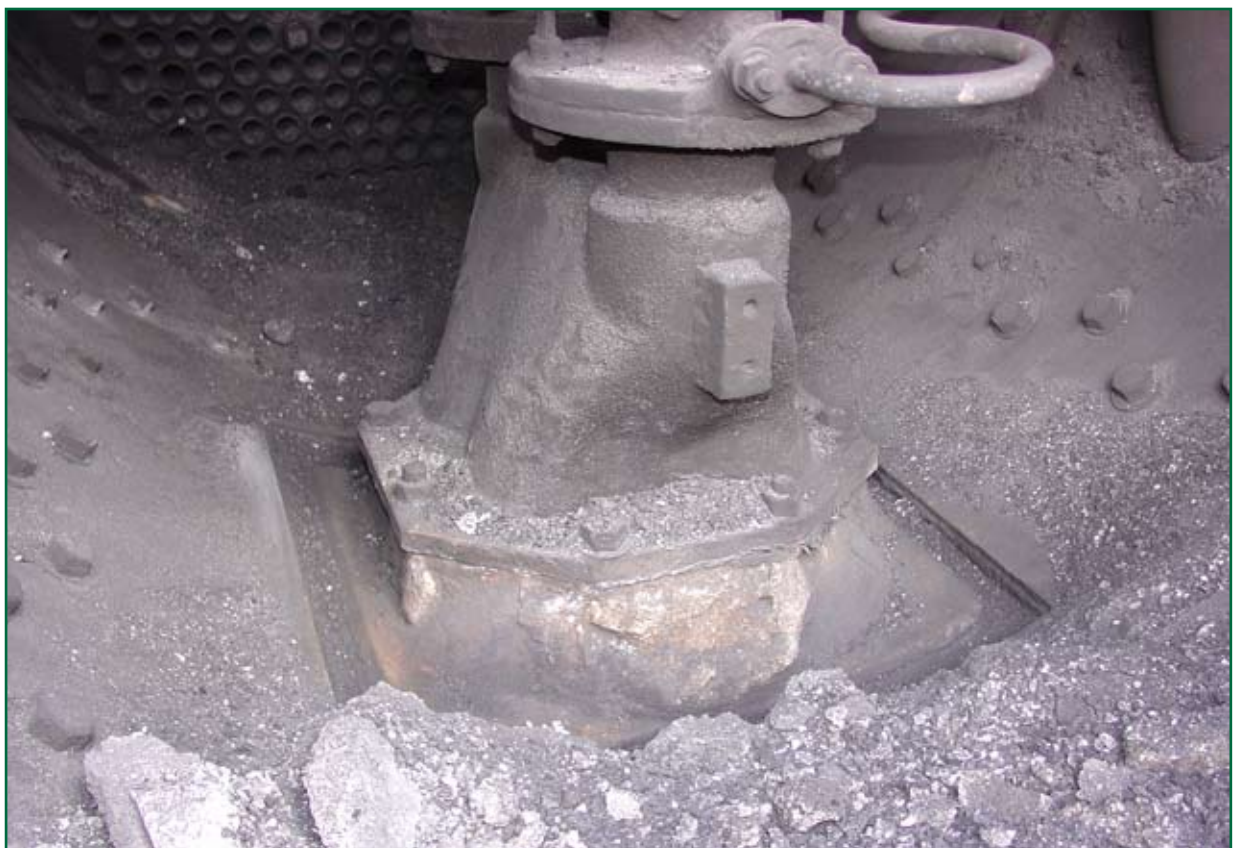
*Figure 8: The blastpipe in-situ*

- 71 After the incident, the blastpipe base was found not secured to the saddle plate and to have moved around 5 mm to the left relative to the direction of travel. Whether this movement was a direct result of the incident, the result of removing the refractory concrete with a bar by NYMR or by post incident vibration cannot be determined. However, what is clear is that the unsecured blastpipe/blastpipe base assembly could move relatively easily.

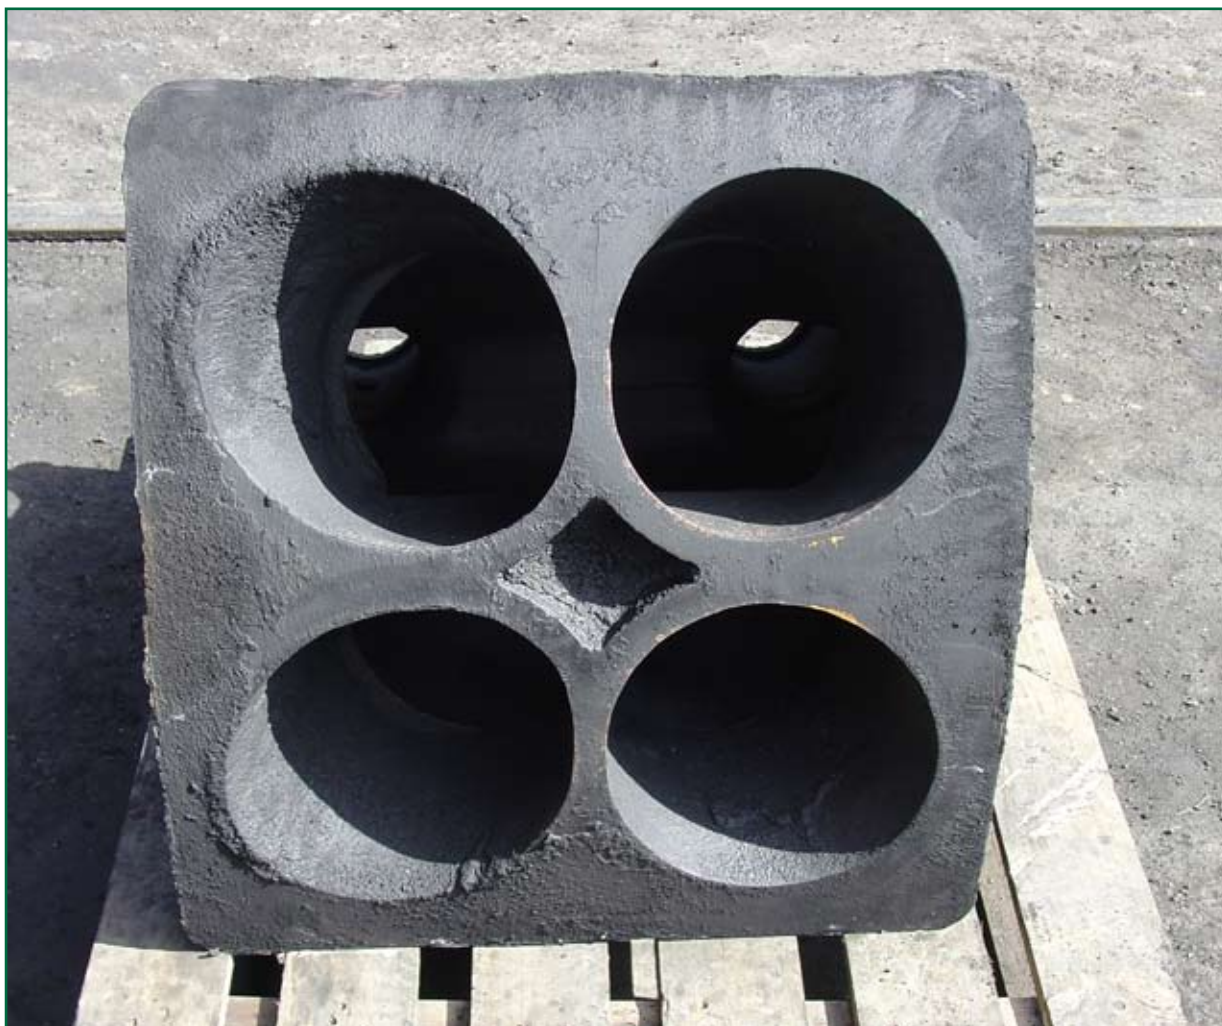
Figure 9: The underside of the blastpipe base

- there was virtually no weld metal remaining between the blastpipe base and saddle plate and the remaining weld had failed (see Figure 9);
- the broken weld between blastpipe base and saddle plate was difficult to see clearly without cleaning the area with a wire brush and washing with solvent;

- the blastpipe was displaced around 5 mm to the left of its built position relative to the direction of travel;
- there were oily streaks on the bottom of the blastpipe base (see Figure 9);

- 76 Metallurgical examination indicated that the blastpipe base/saddle plate weld had failed some considerable time previously and that the blower feed pipe had fatigued rapidly, quite possibly as a consequence of increased movements of an unsecured blastpipe. Further evidence that the blastpipe had been unsecured for some time is provided by the oil streaking on the underside of the blastpipe base, which suggests that oily exhaust steam had been escaping for some time.

- 105 NYMR have repaired locomotive 75029 with weld larger than 5/16 inch (8 mm) and have checked the weld quality with *non-destructive testing* (NDT).

- 1 NYMR and other operators of locomotives with blastpipes or blastpipe bases welded to the saddle plate, should carry out an immediate, where reasonably practicable, and appropriate NDT examination of the blastpipe base/saddle plate weld and, where necessary, make suitable repairs (paragraph 98).

- 4 NYMR and other operators of locomotives fitted with blastpipes or blastpipe bases welded to the saddle plate, should ensure that the maintenance procedures for those locomotives include NDT inspection of the welds at a periodicity determined by assessing the risk of failure prior to the next inspection (paragraph 99).
