Rail Accident Investigation Branch

Rail Accident Report

**Train collision with a road vehicle at Bratts
Blackhouse No 1 User Worked Crossing, near
Sizewell, Suffolk
22 May 2006**

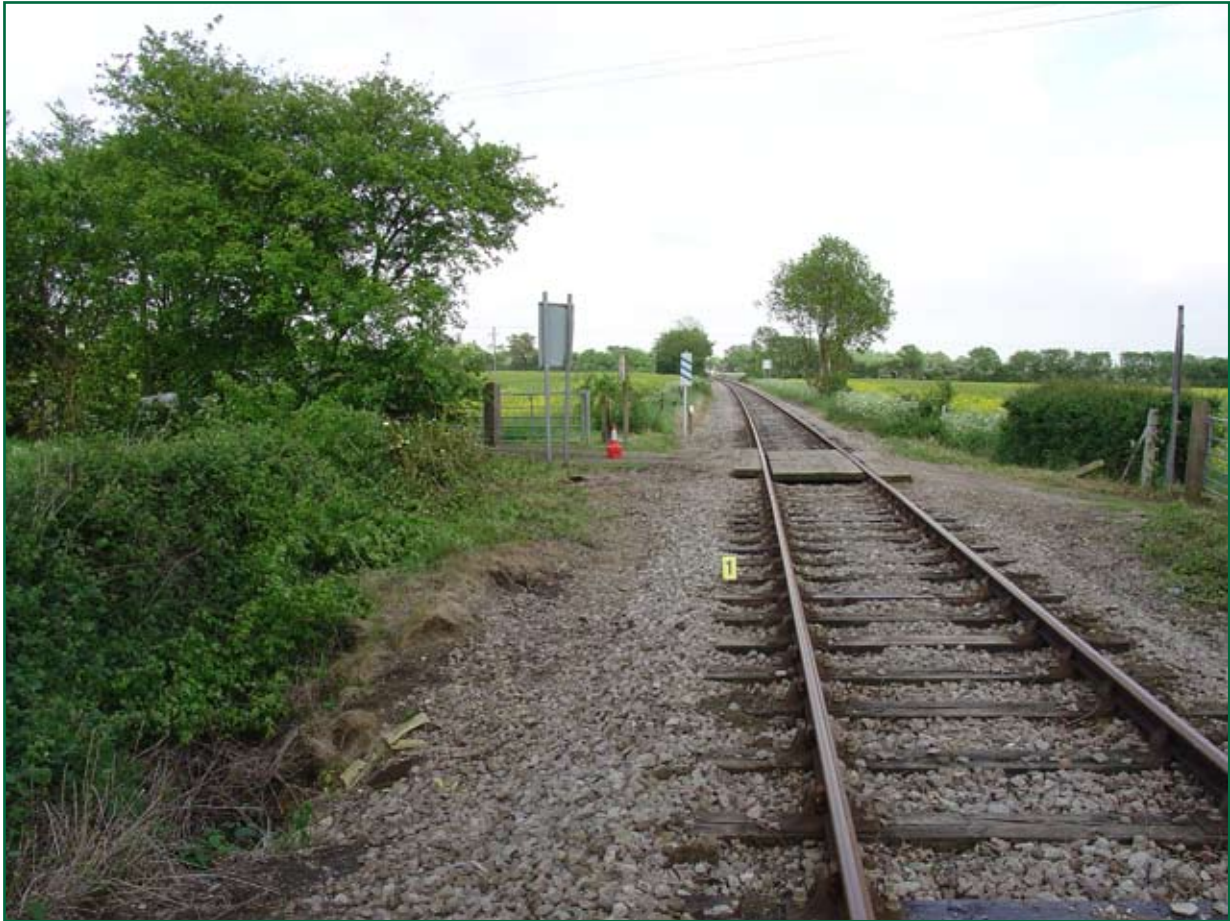
Figure 3: Bratts Blackhouse No 1 UWC as seen by trains travelling from Saxmundham to Sizewell (20 m from crossing). The cone is approximately 3 m from the nearest rail.

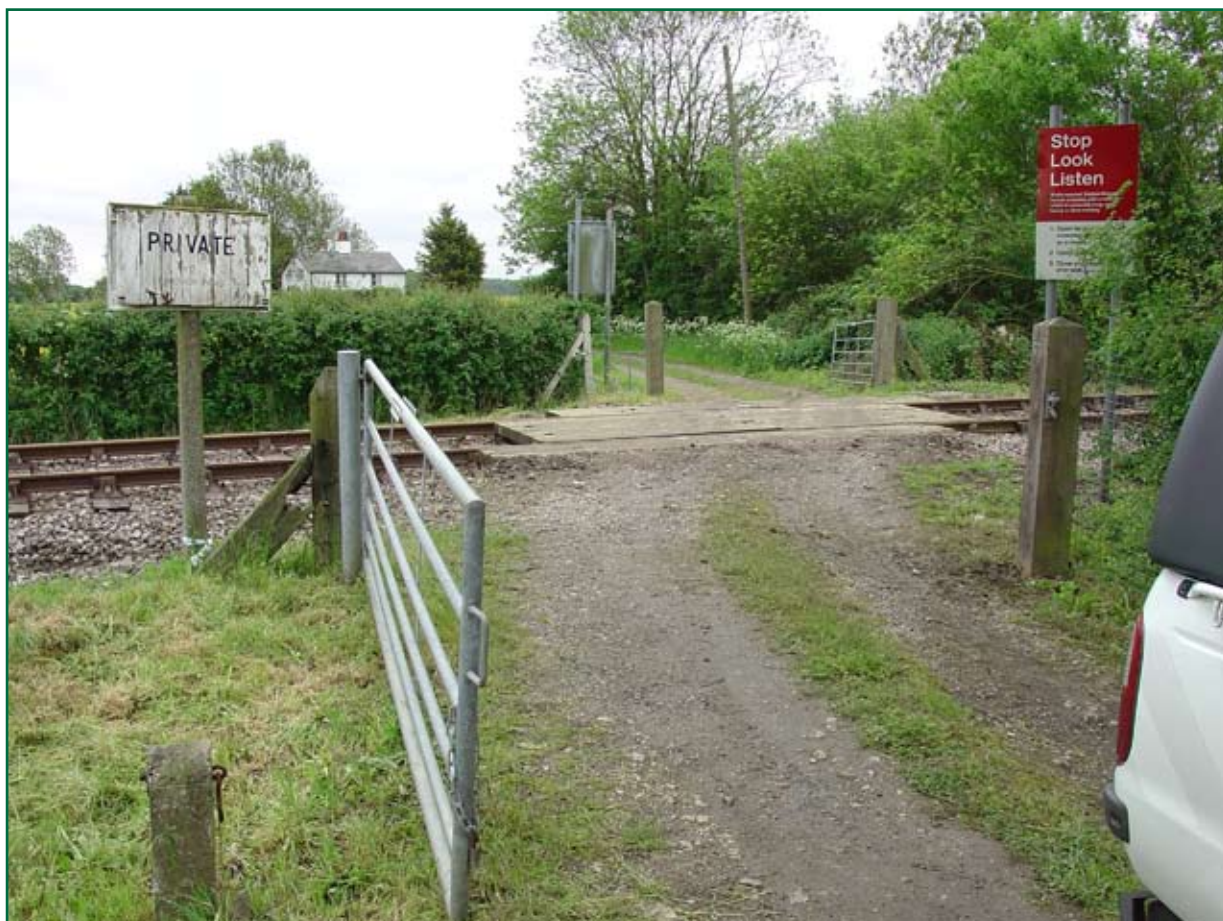
Figure 4: Bratts Blackhouse No 1 UWC as seen from the road track on the north side.

- 22 The crossing has two stop signs, one either side, facing oncoming road traffic. On the approach to the crossing from the north side, the dirt track from the public road is approximately 250 m long with a small chicane in it at 50 m from the crossing gates. The stop sign for users is positioned to the right hand side of the dirt track; the bottom of the sign is 1.5 m above ground level. The view of the sign for oncoming traffic is obscured by vegetation and foliage. There is also a sign marked 'Private' on the left hand side, near to the gate hinge post (see Figure 4).

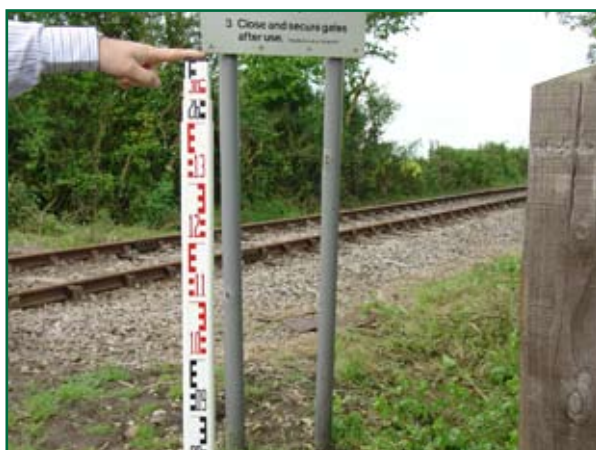
Figure 6: Motorist's view of approaching trains when at decision point

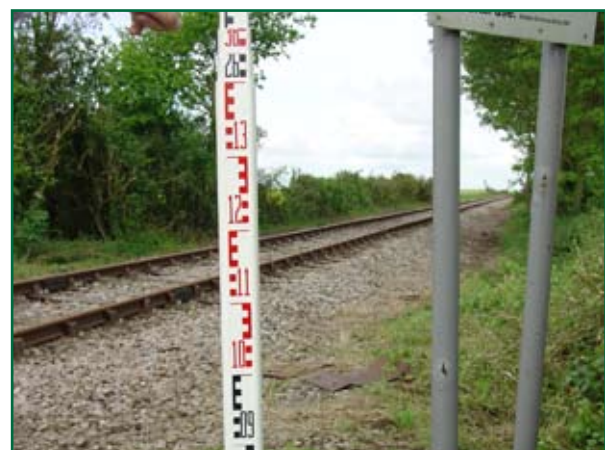
Motorist's view of approaching trains when at final decision point. (Motorist's eye level at 1.2 m)

123 At Bratts Blackhouse No 1 UWC, there was insufficient warning time to cross in safety unless the driver stops (and looks), with the bonnet of his car within 2.5 m of the track, ie at the final decision point. This problem is exacerbated by the inadequate control of vegetation in proximity to sightlines. The sightlines at the decision point (ie the point at which the sign can be read), are too short to provide sufficient warning to cross in safety (Recommendation 4).

104 If the safety of the crossing is reliant on condition (a) above, then there would be benefit in installing a Stop sign or some other marking at the final decision point and modifying the instructions to users. This is consistent with the findings of the recent research into 'Determining the final decision point at UWCs by RSSB in 2004'.

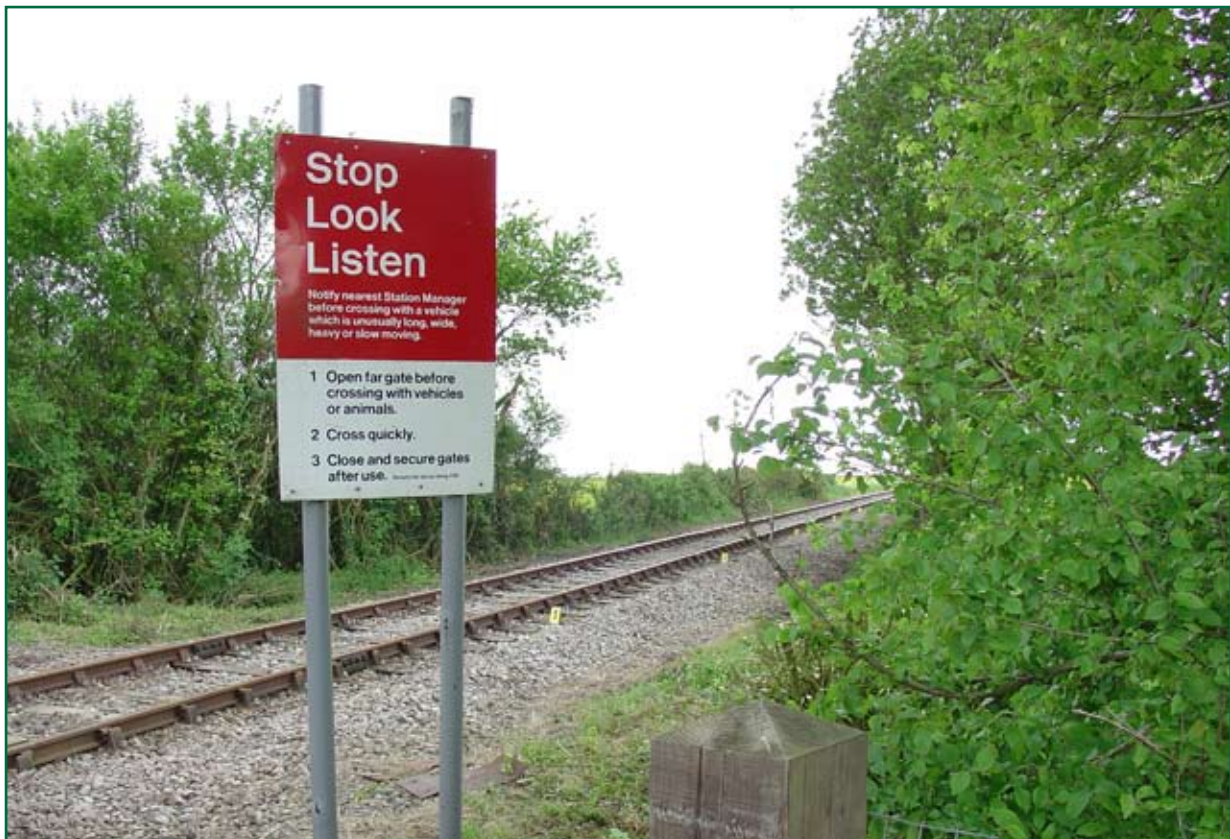
- 108 The wording on the sign at Bratts Blackhouse No 1 UWC is as shown in Figure 7 and is not compliant with The Private Crossings (Signs and Barriers) Regulations 1996 (Diagram 102). The existing sign requests that persons crossing with a vehicle which is unusually long, wide, heavy or slow moving should "notify nearest Station Manager".

- 109 No telephone number is provided on the sign.

Figure 7: Bratts Blackhouse No 1 UWC vehicle and Pedestrian Stop sign

- 6 Network Rail should modify the relevant company standard(s) to require the provision of a telephone number of the signaller on all signs at UWC's and to implement a programme for ensuring compliance (paragraphs 109 and 125).
- 7 Network Rail should ensure that the signaller at Saxmundham is made aware of power and UPS failures that will affect the operation of the voice recorder and other safety related equipment (paragraphs 43 and 127).
- 8 Network Rail should install a sign at all UWCs indicating the name of the crossing to comply with Railway Safety Principles and Guidance, Section 2 part E, paragraph 287 (paragraphs 42 and 126).
