Rail Accident Investigation Branch

Rail Accident Report

**Detachment of containers from freight wagons
near Cheddington and Hardendale
1 March 2008**

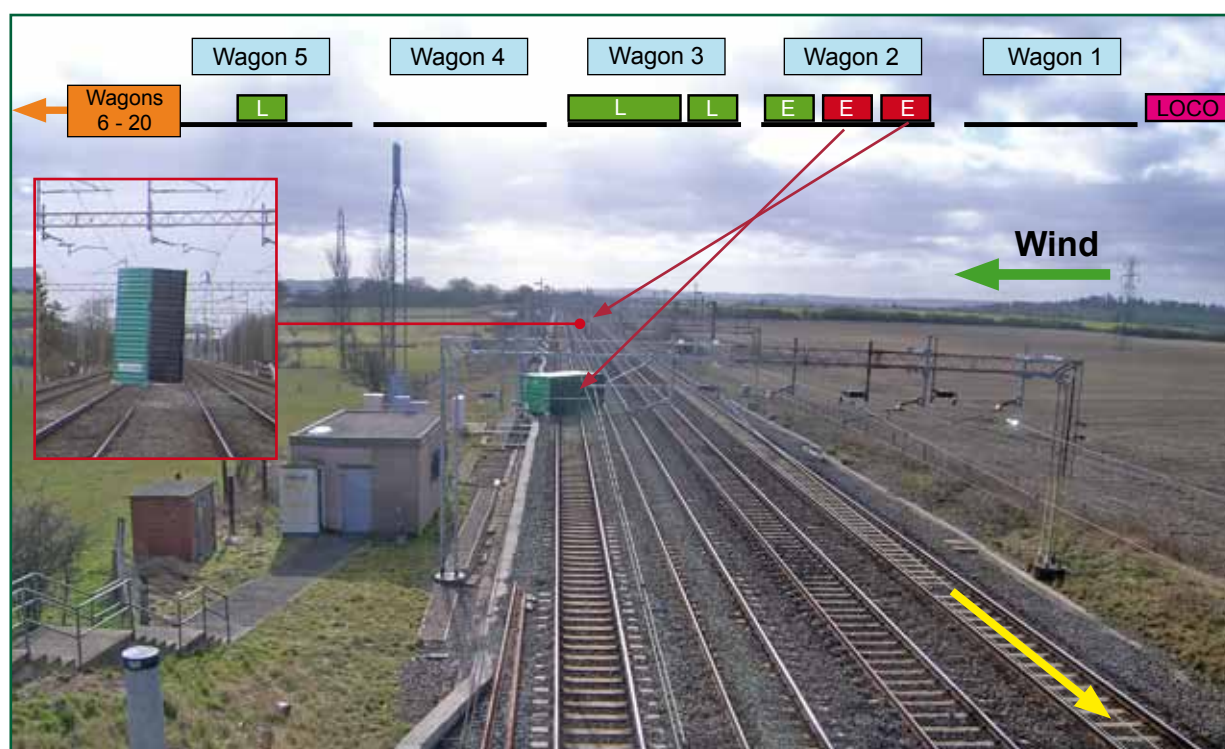
- 28 The site of the first incident was on a section of straight track on the WCML between the stations at Cheddington (36 miles 8 chains) and Leighton Buzzard (40 miles 14 chains) (Figure 1). The railway here consists of four running lines aligned in a generally north-south direction. From west to east these lines are the Down Fast, Up Fast, Down Slow and Up Slow. The first detached container was found on the Up Fast line at 36 miles 74 chains and the second container was found on the Up Slow line approximately 1.4 miles (2.2 km) further north at 38 miles 27 chains. Figure 3 shows a general view of the track, the detached containers and their original positions on train 4E90.

Figure 3: Detached containers near Cheddington and their original location on train 4E90

- 57 Among the containers that remained on train 4E90, the trailing 20 ft container on the second wagon had a gash in the upper half of its right-hand side over most of its length. The trailing 40 ft container on the third wagon also had a smaller gash to its right-hand side. There was no significant damage to any of the wagons on train 4E90.

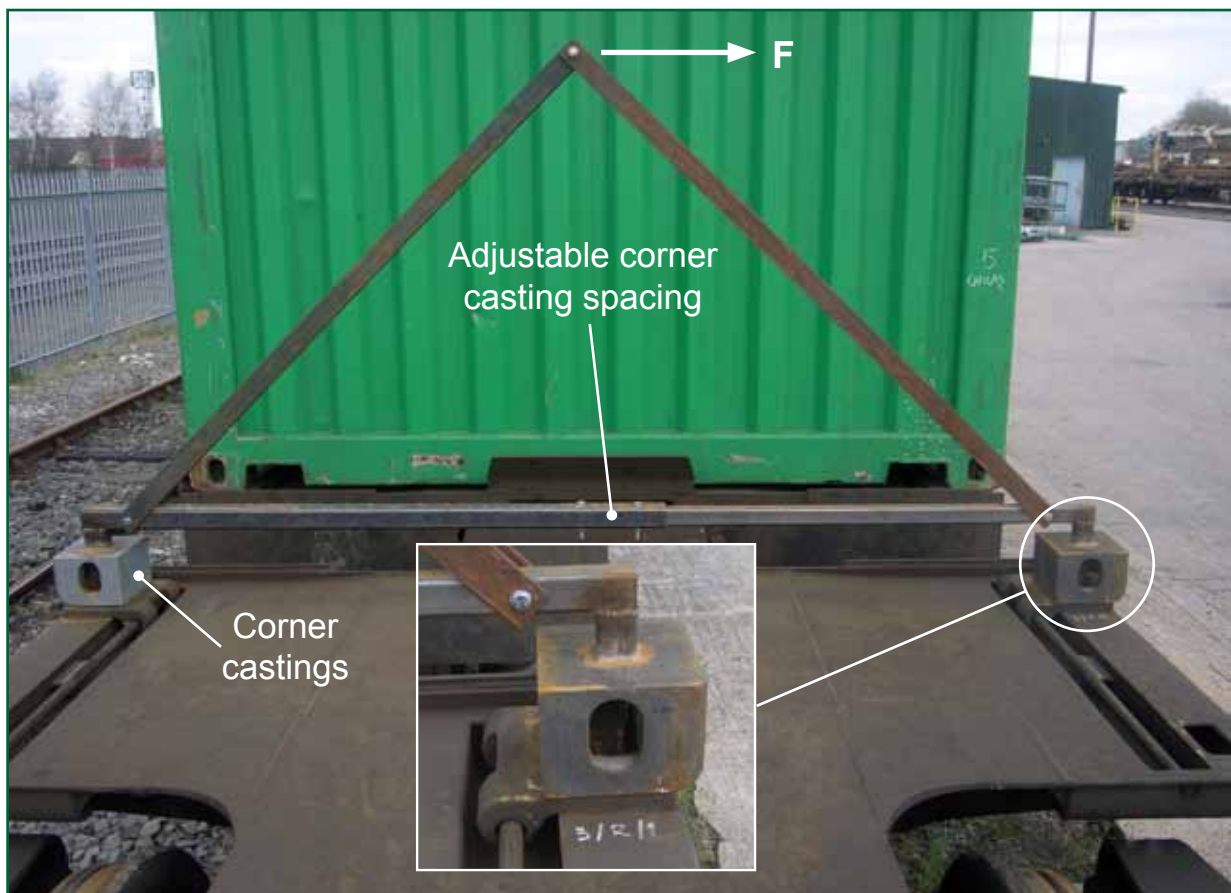
120 Tests were carried out on wagon 643003 (from Cheddington) to check the functionality of the spigots. A test rig, developed by Fastline for this purpose, was used for the tests. It comprises a full size container corner casting at each end of an adjustable A-frame as shown in Figure 11. It can be used to simulate the effects of wind loading on a container by manually applying a horizontal force at the apex of the A frame. If the frame is not restrained by the spigots when loaded at the apex, this indicates that a full size container will not be restrained.

Figure 11: A-frame used to test container overturning on Fastline FEA-B

- Fixed spigots (Figure 12) which are compliant with UIC 571-4 provide overturning restraint, those that are not compliant do not provide reliable restraint.
- Fold-down spigots with inboard hinges, as fitted to the FEA-B wagons do not offer any overturning restraint, even if the spacings are complaint, because the spigot rotation follows the rotation of the overturning container on the windward side.
- Fold-down spigots with outboard hinges (Figure 13), as fitted to most wagons with UIC spigots, may not reliably restrain overturning containers if there is sufficient play in the hinges to allow them to initially rotate inwards, pivoting about the inboard edge as shown in Figure 14. During testing, inward rotations of up to 4.5 degrees were measured; the maximum specified in the UIC 571-4 is 2 degrees.
