# Rail Accident Report

## Road-rail vehicle runaway incidents at Brentwood, Essex and at Birmingham Snow Hill 4 November & 31 October 2007

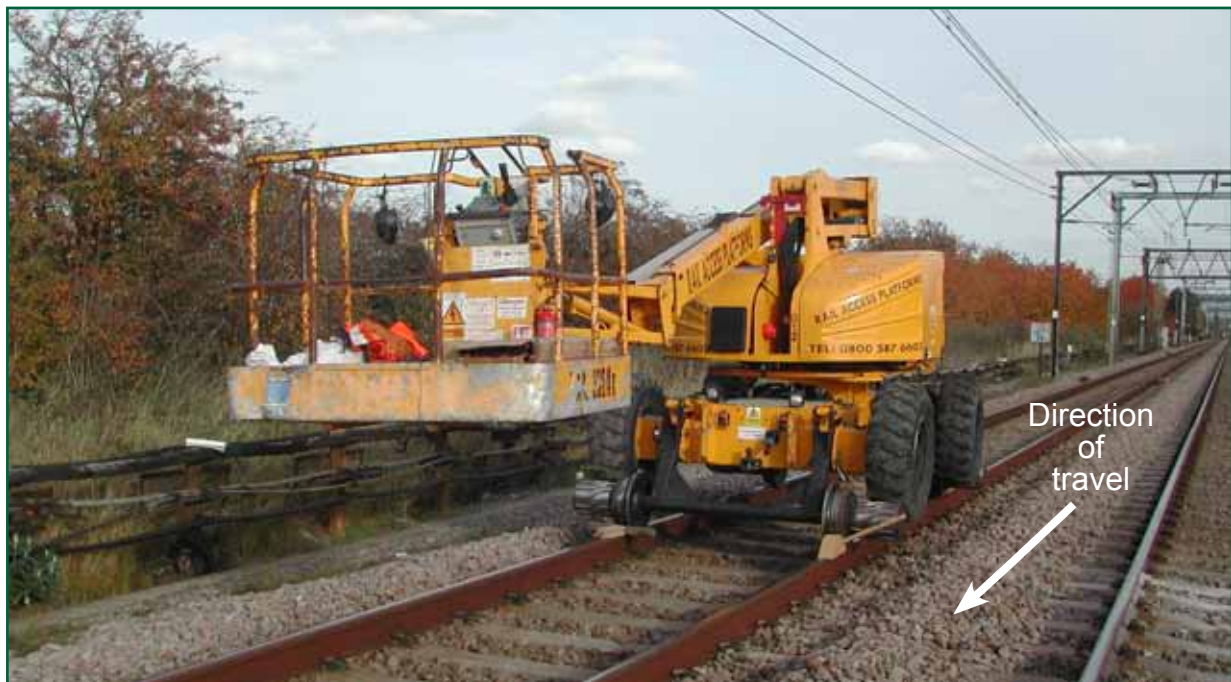
Figure 3: The Basket 14 RRV stopped west of Romford station after the runaway

- 22 The machine ran for a total of seven miles - three miles of which were outside the possession arranged for the renewal work - until staff, from the Romford OLE maintenance depot, stopped it west of Romford station (12 miles 30 chains), Figure 3. There was no material damage.

- 23 The machine had started to slow down as it passed Harold Wood station (14 miles 76 chains), and the operator jumped clear as it left the possession on its approach to Gidea Park station (13 miles 41 chains). He sustained injuries requiring hospital treatment, but he was not detained overnight.

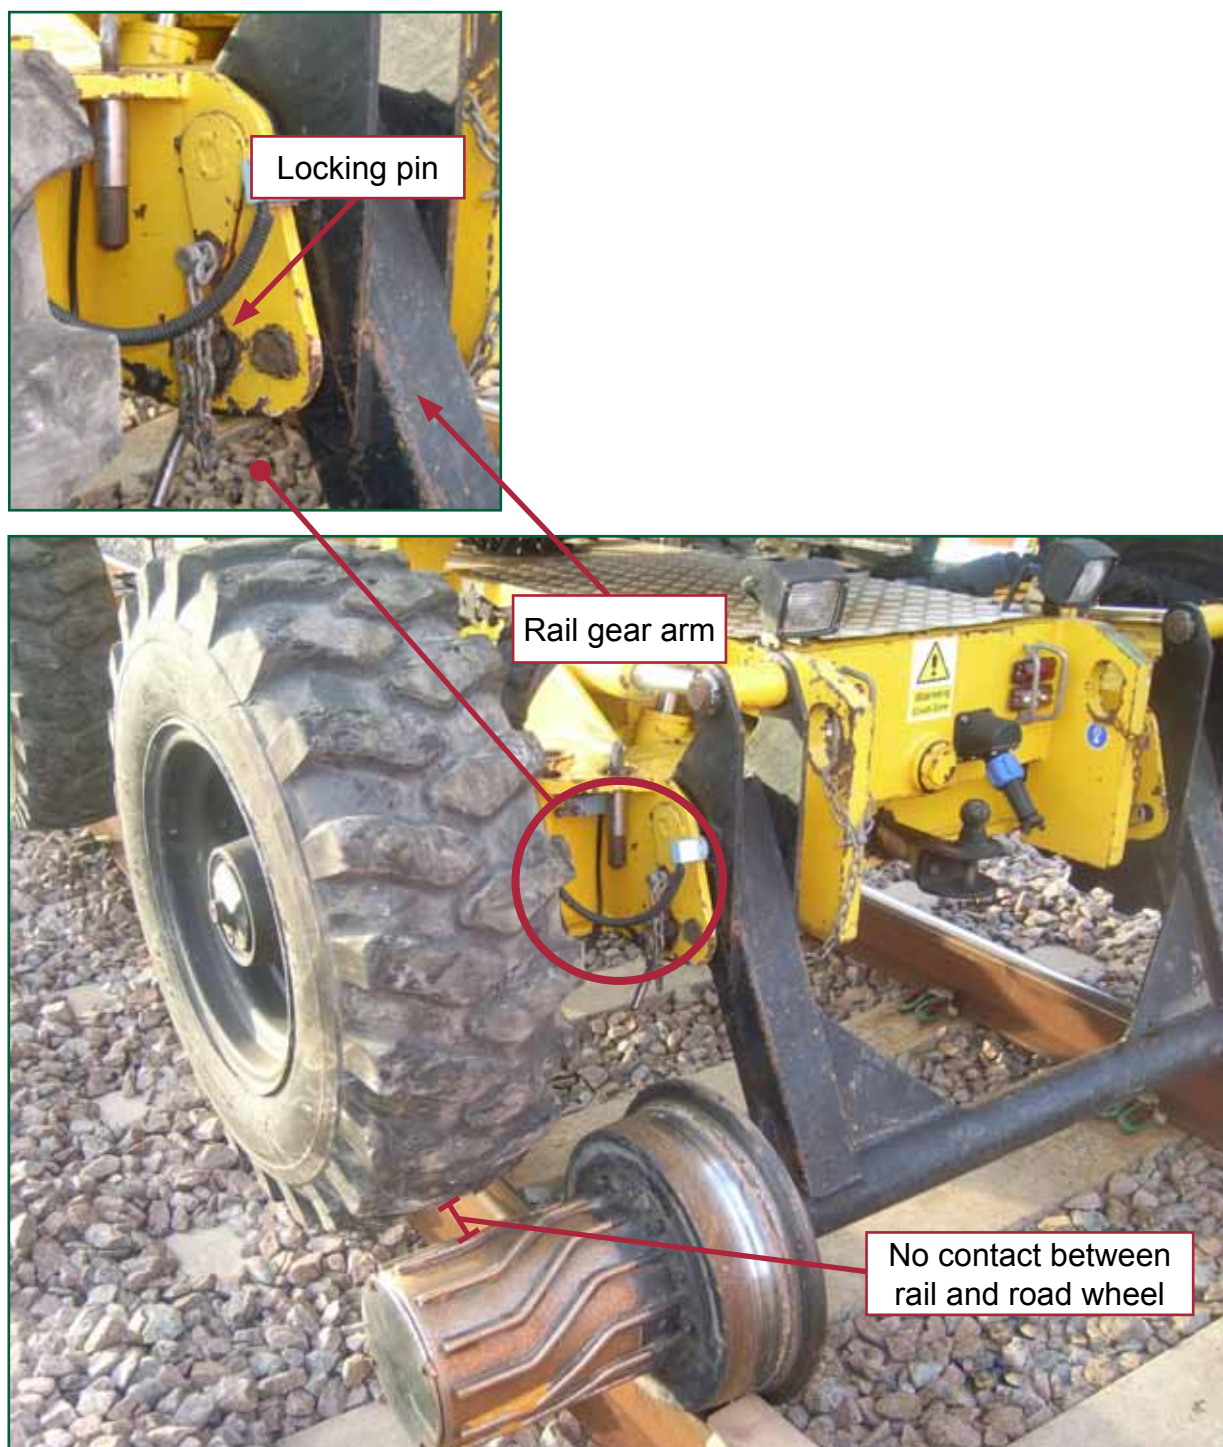
Figure 6: Basket 14 RRV locking pins and rail gear as found at Romford after the incident

- 70 The RAIB, with ETI's assistance, examined the Basket 14 RRV and found that:
- all rail wheels were on the track;
  - the rail gear arms, at both the fixed and the steered-ends, were in hard contact with locking pins; this was preventing the rail wheels contacting the road wheels, Figure 6;
  - the emergency stop button on the ground control panel was depressed and had been operated; and
  - the brakes and rail gear operated satisfactorily.

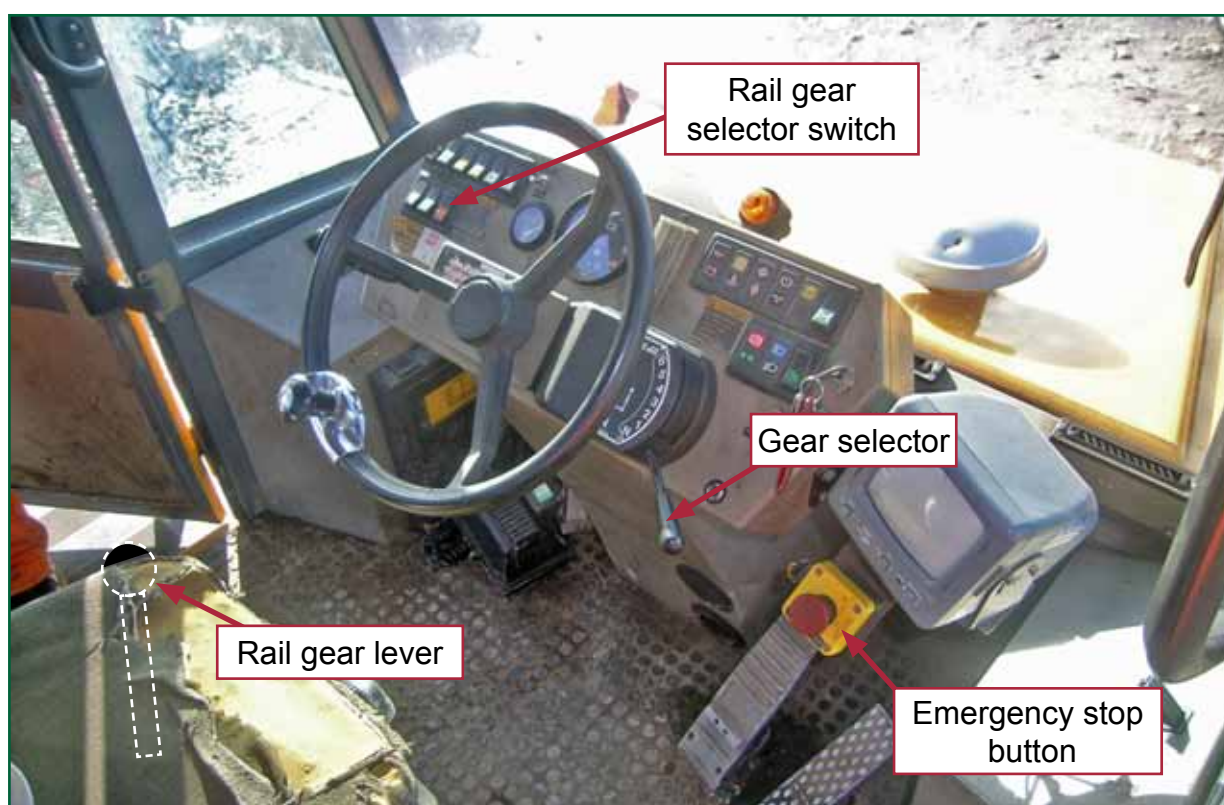
Figure 13: TD-18 RRV controls in the driver's cab

- 117 There is an emergency stop button in the cab.
- 118 The rear rail wheels are fitted with a parking brake. This brake is only applied when the gear selector is in 'neutral'. The front rail wheels are not fitted with brakes. When the gear selector is **not** in 'neutral', braking in rail mode is the same as on the Basket 14 RRV: it is indirect and reliant on frictional contact between the rail and road wheels.
- 119 Figure 13 shows the arrangement of the above controls. The gear selector is in the 'neutral' position.

- 183 The rear rail wheels of the TD-18 RRV have a parking brake (paragraph 118). Tests carried out by ETI afterwards showed that it would have automatically applied if the gear selector had been in 'neutral' (paragraph 103). This shows that the selector was not in 'neutral'; if it had been, the parking brake would have provided a brake force at the holding end. ETI found no evidence to indicate a fault with the parking brake.

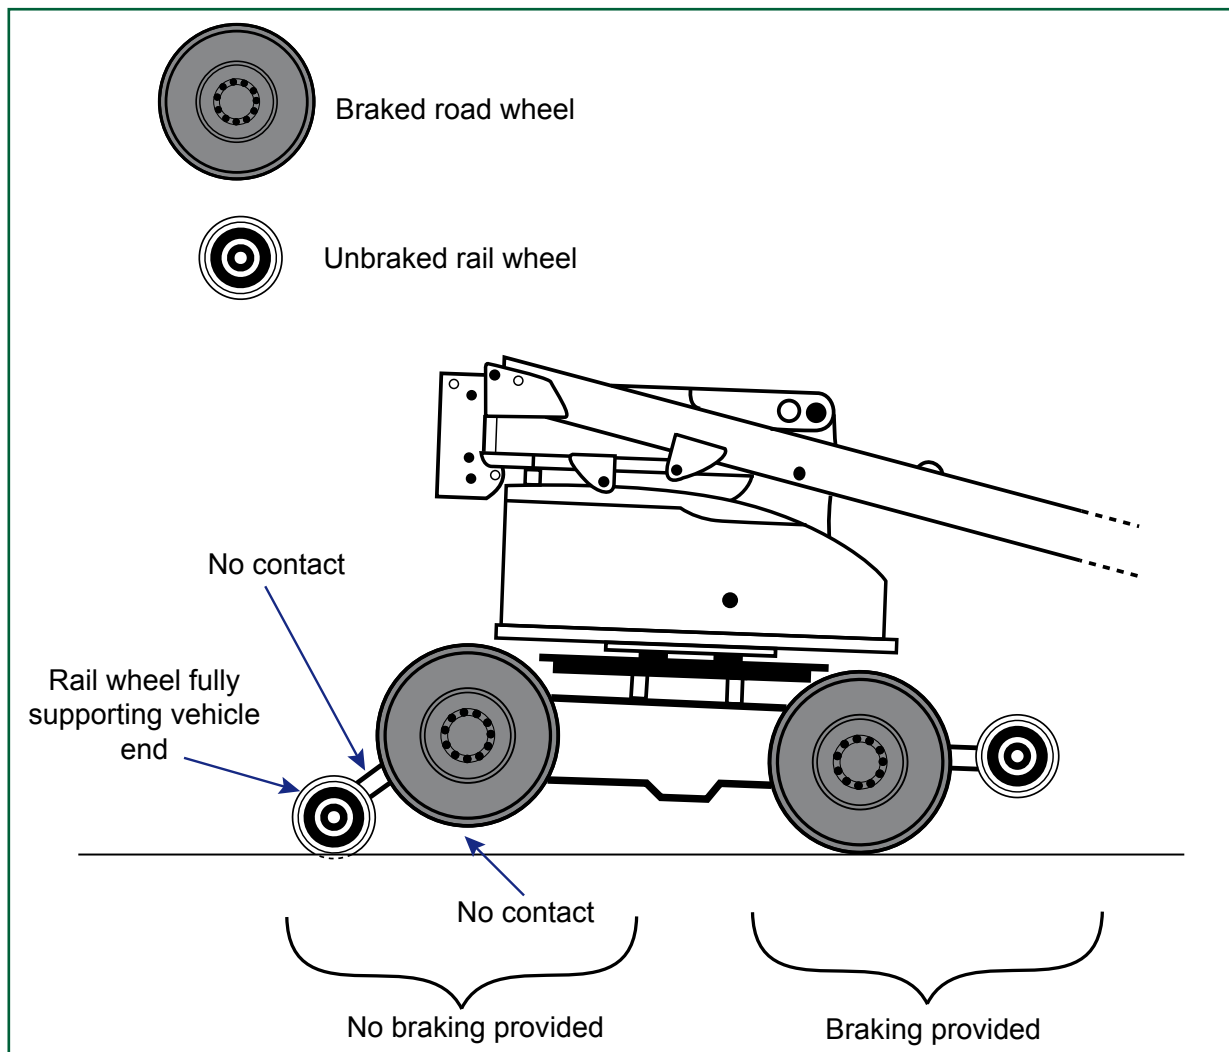
Figure 14: High ride RRV – transition condition that results in no braking being provided at one end of the machine during on/off-tracking

123 This transient condition is an inherent feature of the high ride design. Preventing a runaway condition relies on there being sufficient braking at the other end of the machine (subsequently referred to as the *holding end*) to overcome any gravitational force due to track gradient. If there is no brake force at the holding end, a point is reached, as the rail gear is lowered (or raised), when all braking is lost and, even on a modest gradient, the RRV will start to run away. Two risk conditions exist:

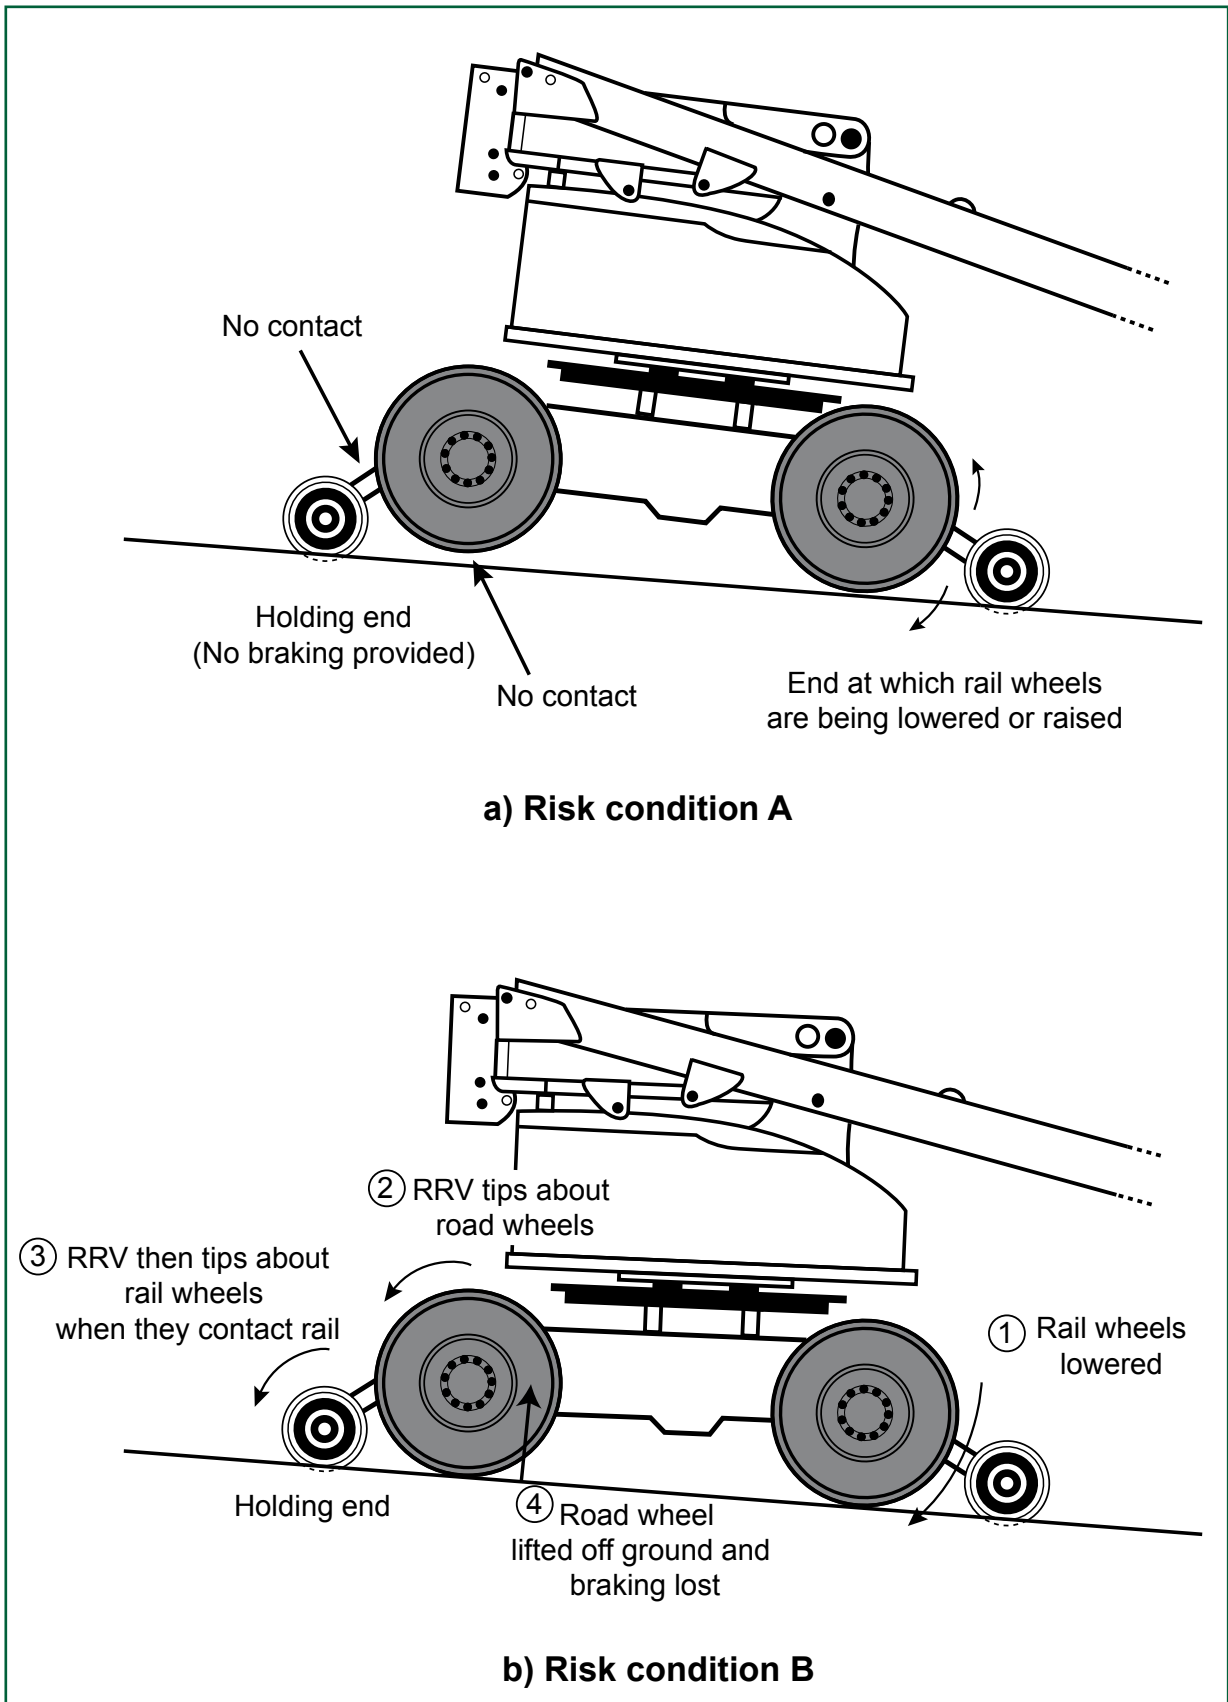
Figure 15: High ride RRV - on/off-tracking runaway risk conditions

The holding end is left in the transient condition with no braking provided (road wheels lifted off the ground, rail wheels not in contact with the road wheels) when the rail wheels at the opposite end are lowered (or raised), Figure 15(a).

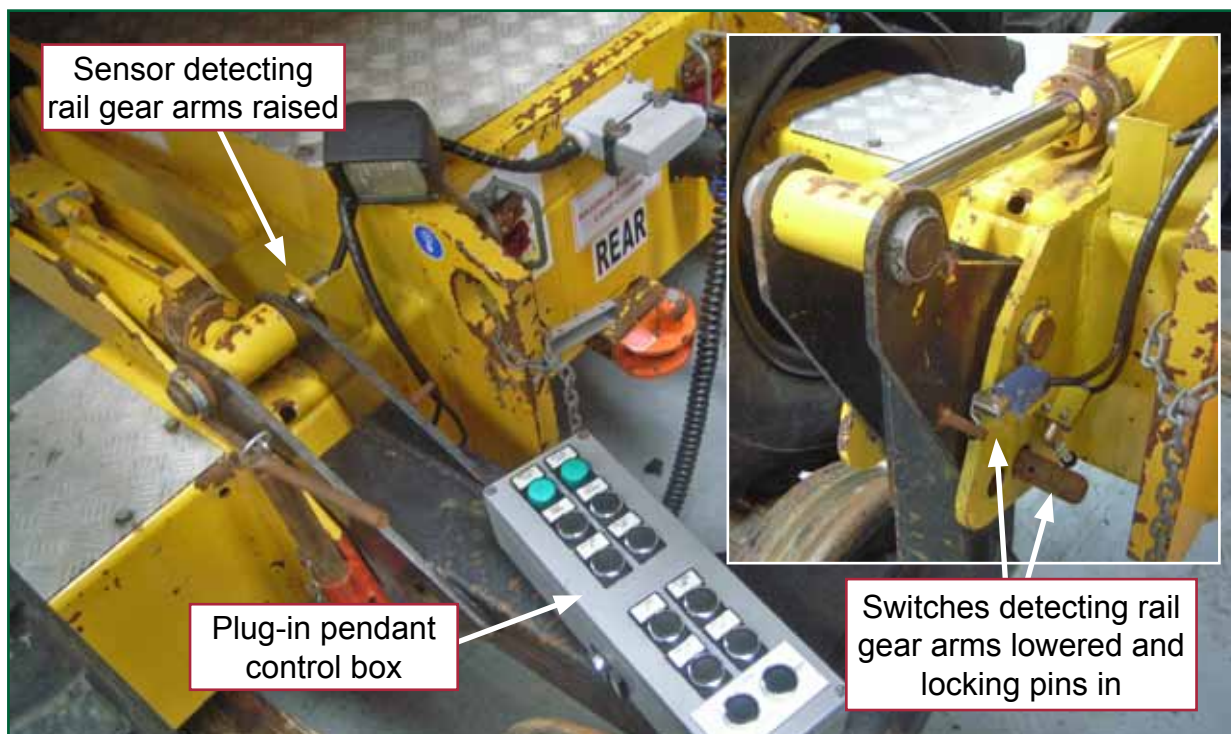
Figure 16: Basket 14 MEWP wander-lead modification

171 Alerted to the fact that locking pins were incorrectly located on the machine at Brentwood (paragraph 70), Interfleet found another fault condition - involving the incorrect insertion of these pins - that could cause the interlock function to be bypassed. Another detection switch was needed to remedy this.

172 All Basket 14 RRVs were finally modified and certified by 22 November 2007 – complying with Network Rail's deadline. Figure 16 shows the wander-lead modification that was fitted.

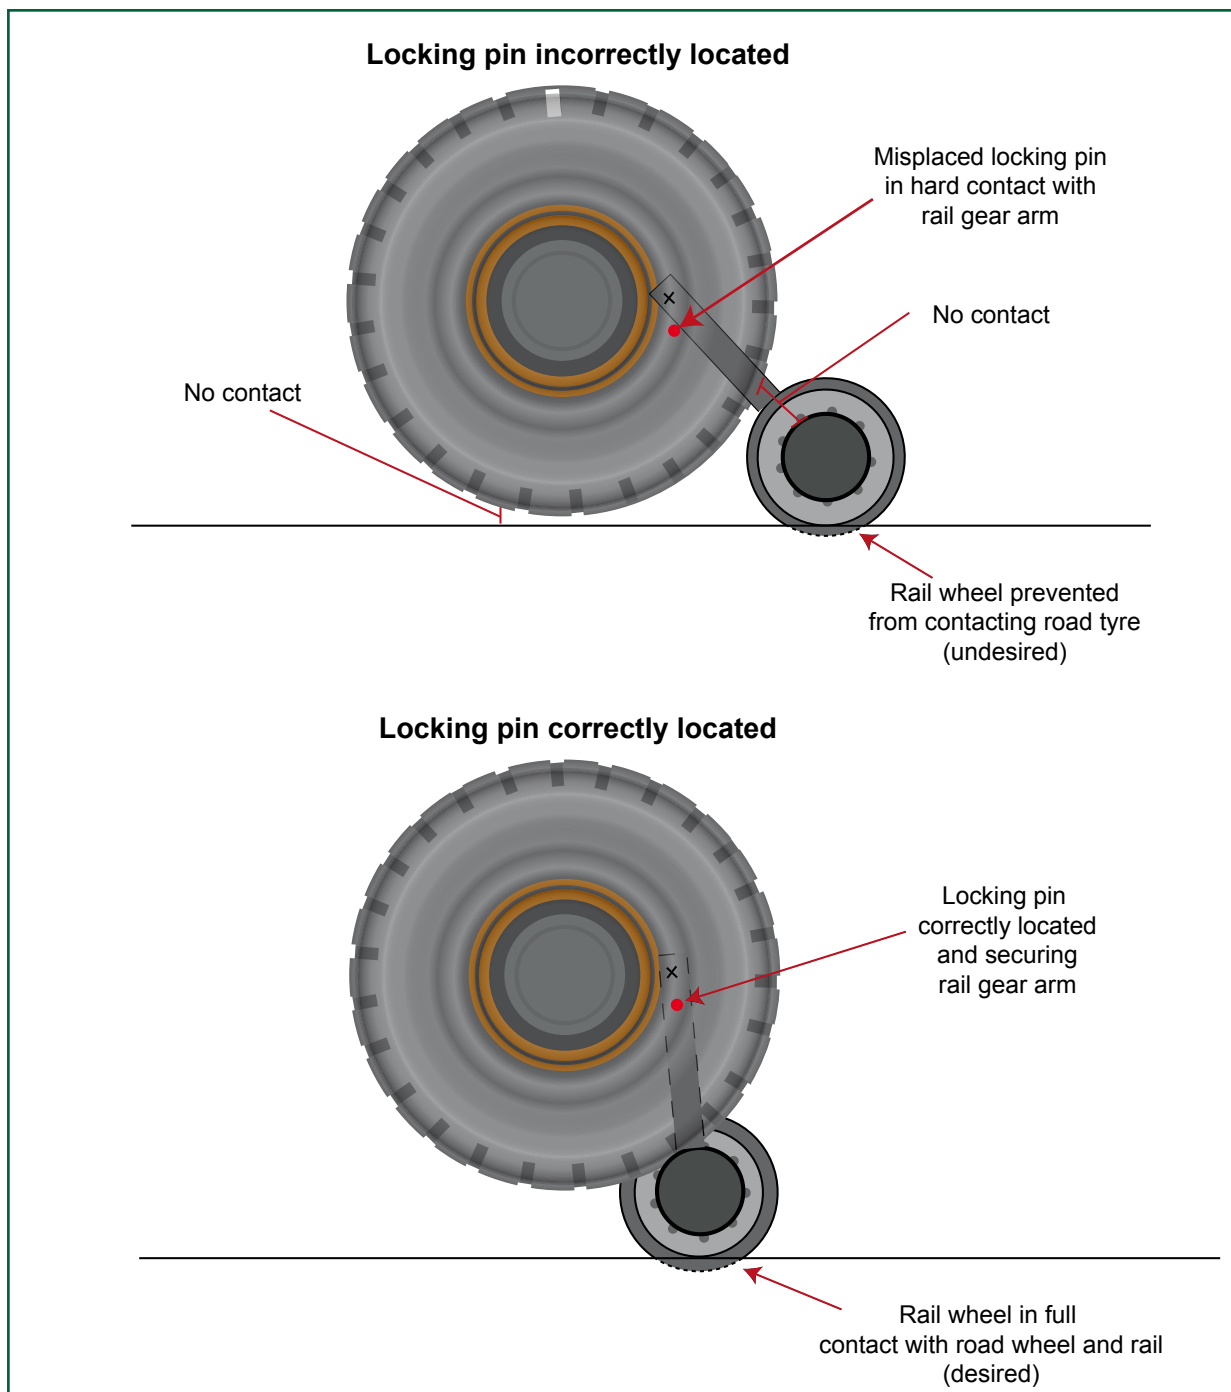
Figure 17: Locking pins incorrectly located and preventing the rail wheels contacting the road wheels

176 When not located in a hole, the locking pins hang from a length of chain, which attaches them to the chassis of the RRV for safekeeping. When examined at Romford, all the locking pins were in hard contact with the rail gear arms. This suggests that they were in the chassis bracket holes before the rail gear was first lowered at Brentwood; they had possibly been put there for storage or to prevent them swaying about on the chain. With the pins located like this, the rail wheels, carrying the weight of each end of the machine, were prevented from making contact with the road wheels (Figure 17). Therefore, although the machine controller did not observe them, it is almost certain that it was these incorrectly located pins that resulted in there being no brake force at the holding end (steered-end). In this state, the machine was prone to risk condition A (paragraph 123).

- 177 The fact no-one observed that, because the locking pins were incorrectly located, there was no contact between the rail and road wheels at the holding end (steered-end) before lowering the rail gear at the opposite end was causal to the Basket 14 RRV starting to run away.
