Rail Accident Investigation Branch

Rail Accident Report

Derailment of a freight train at Carrbridge, Badenoch and Strathspey 4 January 2010

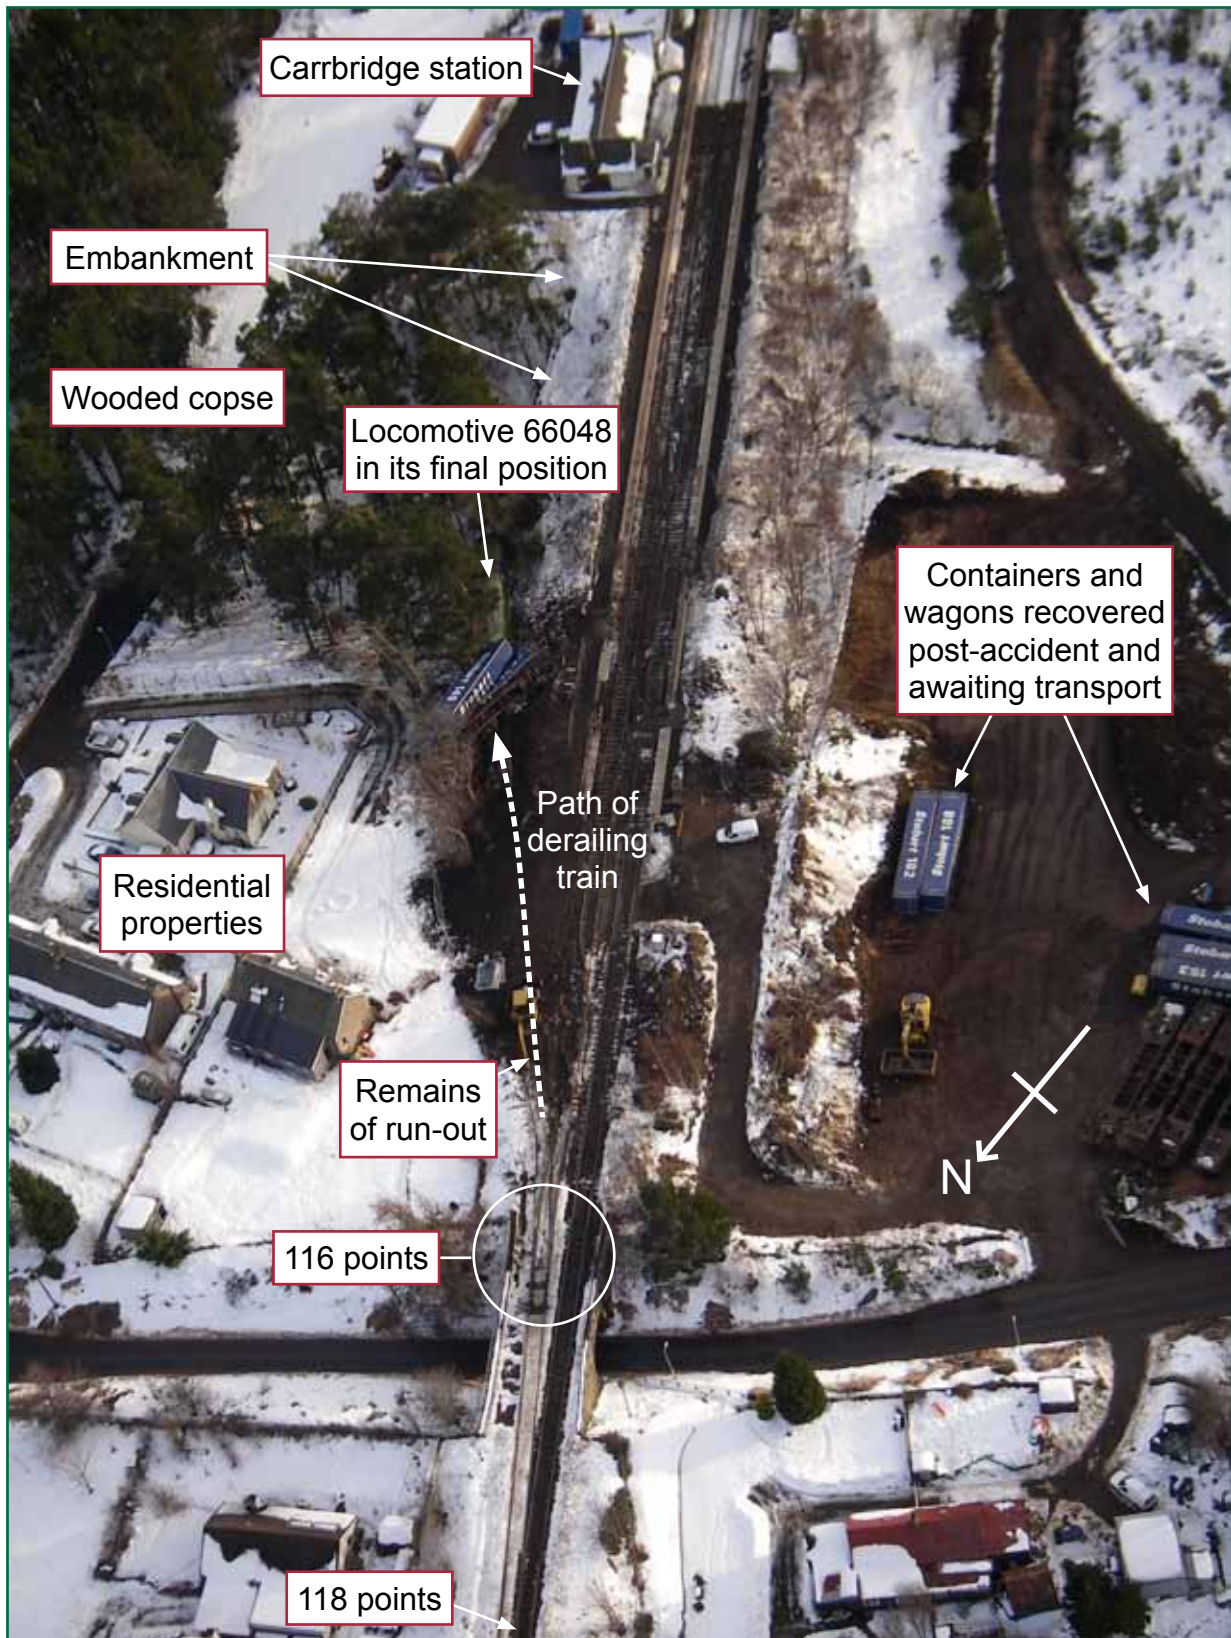
- 6 The train came to rest amongst trees on an embankment east of the railway, close to some houses (see figure 2). The locomotive and the front six 'twin' wagons (each wagon consisting of two element vehicles) derailed and they, and their container loads, came to rest in a number of locations including in the gardens of the houses and foul of the running lines through Carrbridge station. The rear four wagons (eight elements) did not derail or lose their containers.
- 7 The driver and technician onboard the train suffered minor injuries. Damage was caused to private property, the station platform, the *permanent way*, signalling equipment and the locomotive, wagons and containers which derailed.

Figure 2: Aerial view of Carrbridge from the north during post-accident recovery operations (image courtesy of the Ministry of Defence)

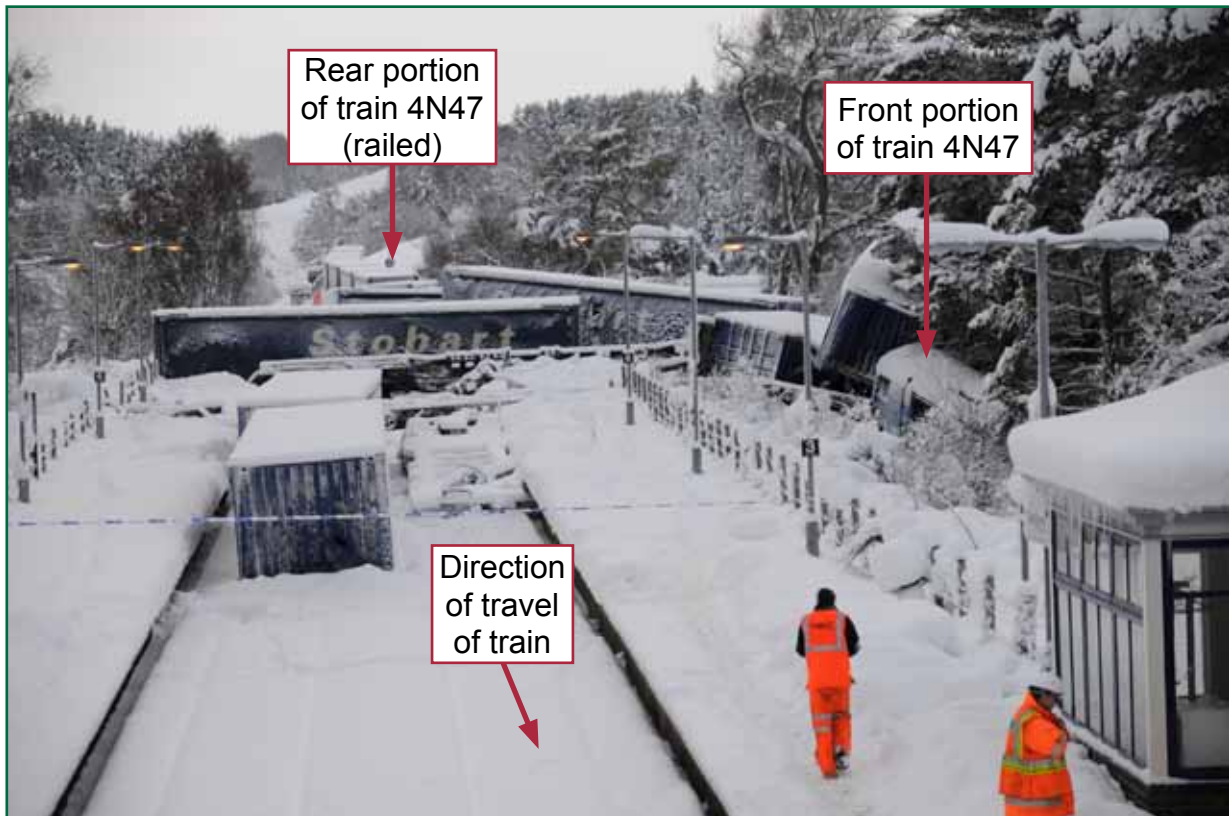
- 61 The locomotive and the front six wagons (twelve elements) derailed. They, and some container loads which had become loose, came to rest in a number of locations, including within the gardens of nearby houses and foul of the running lines through Carrbridge station. The rear four twin wagons (eight elements) did not derail or lose their containers.

Figure 11: Train 4N47 on the morning of 5 January 2010 (image courtesy of the British Transport Police)

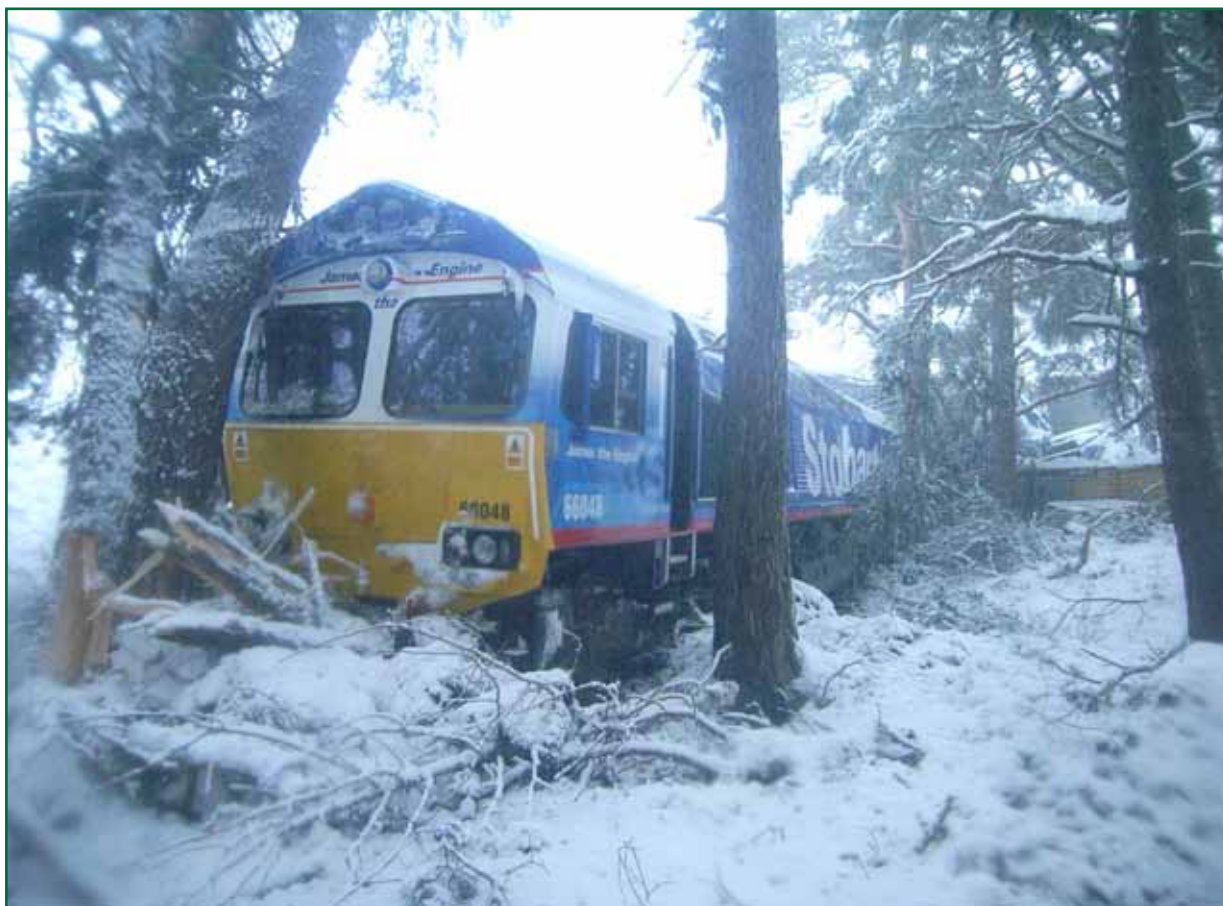
Figure 12: Final resting position of locomotive 66048

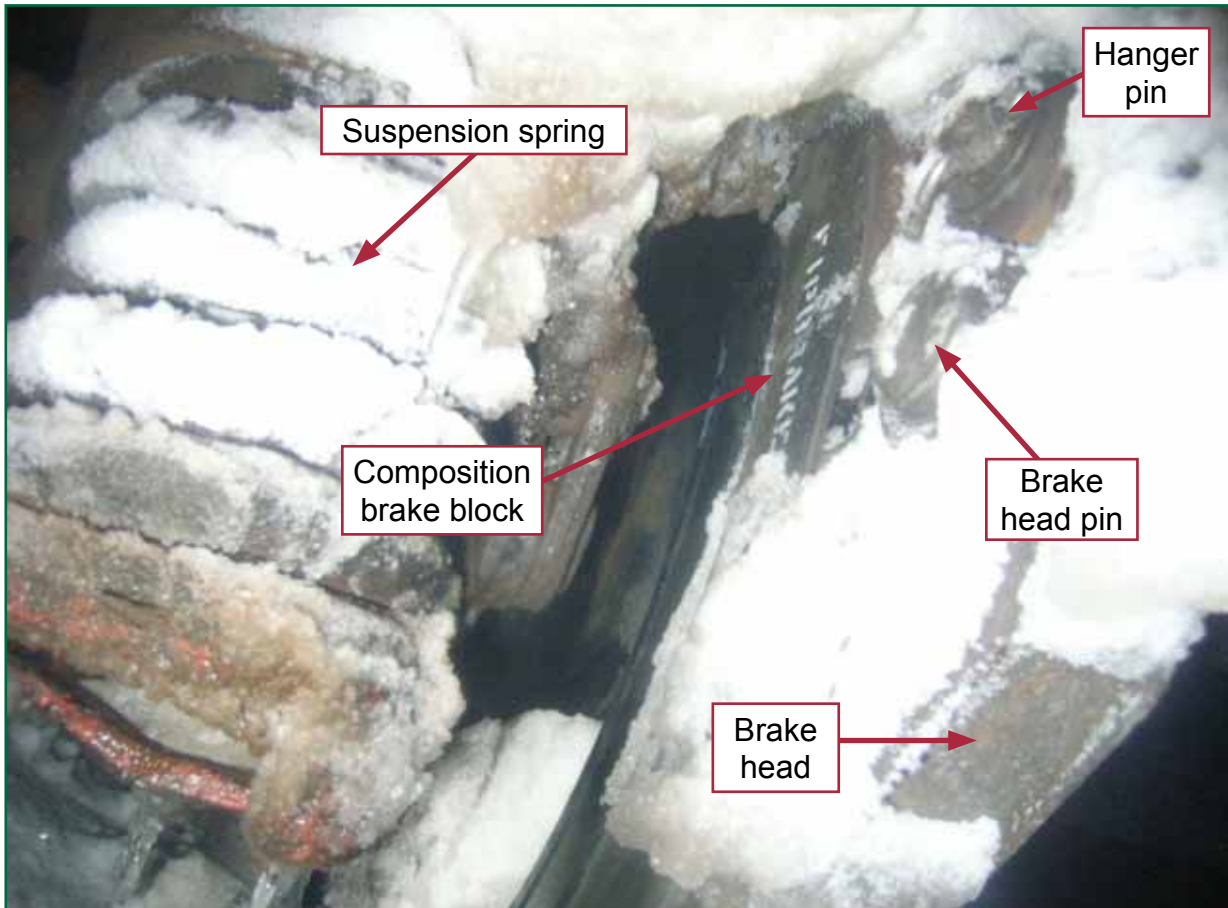
- 90 Snow and ice ingress between the brake block and the wheel tread can reduce the effective coefficient of friction for the portion of the block affected when it is applied to the wheel tread. This would in turn reduce the total braking force being generated to retard the wheel.
- 91 Photographs of the train taken in the hours following the derailment show that, on some of the wagons which did not derail, the brake blocks, brake heads, suspension springs and underframe were coated in a layer of snow, ice and slush. In some cases a thin layer of ice and snow could also be seen between the lower portion of the brake block and the wheel tread (see figures 13, 14 and 15).

Figure 14: Photograph taken on the night of the accident showing snow, ice and slush coating the brake block, brake head and suspension springs of one of the FKA wagons which did not derail

- 92 Snow and ice ingress between the face of the brake block and the wheel tread would have the effect of reducing the effective coefficient of friction for the portion of the block face affected when it was applied to the wheel tread. This would in turn reduce the total braking force being generated by the block to retard the wheel. If the entire face of the block were to be covered with ice and snow, this would remove almost entirely any retardation of its associated wheel.

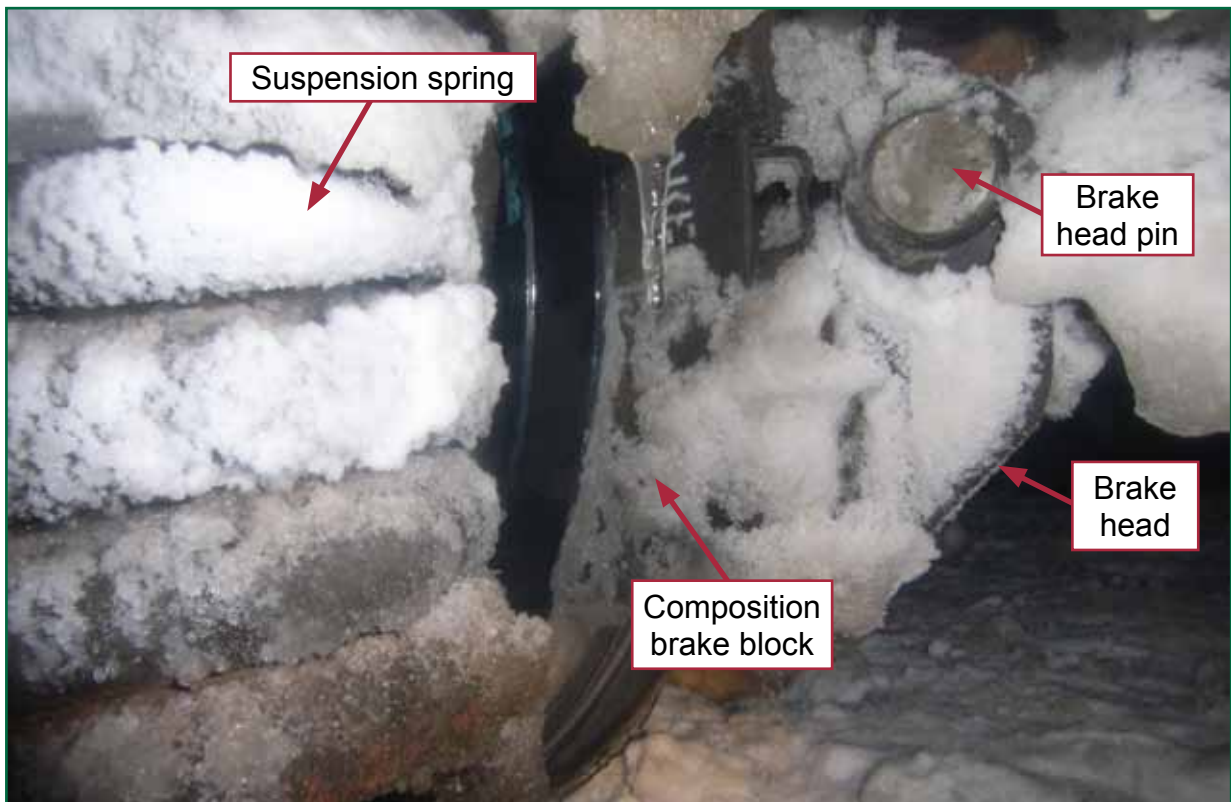
Figure 15: Photograph taken on the night of the accident showing snow, ice and slush coating the brake block, brake head, suspension springs and underframe of one of the FKA wagons which did not derail

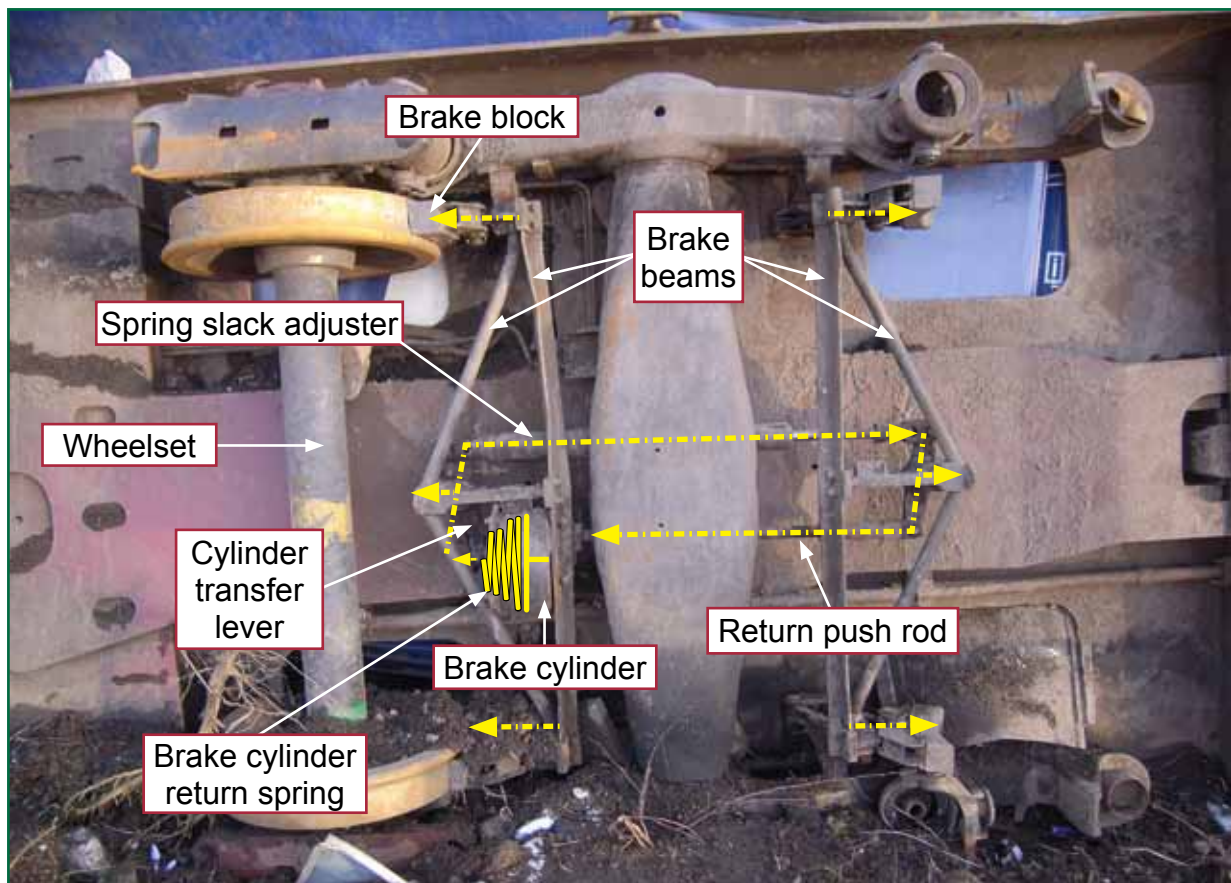
101 Testing on a comparable wagon demonstrated that an obstruction of the rigging at any one wheel on a bogie would not affect the application of the other brake blocks on that bogie. This means that for a widespread loss of braking to occur, blockages would have to have occurred either concurrently at multiple wheel locations or at a point which could have a common effect on all wheels on a bogie simultaneously (for example at the brake cylinder or cylinder transfer lever, as shown in figure 16).

Figure 16: A photograph taken post-accident of the brake rigging of a derailed FKA wagon - note that the right-most wheelset is missing from this bogie. Direction of movement of the brake rigging and brake blocks on application are shown by the dotted yellow lines.

- 102 Around 24 hours after the accident, the brakes on the wagons which did not derail were tested. The brakes were found to have become jammed in the applied position and could only be released once an external force was applied. It was found that these wagons, which had been left standing in freezing conditions during this period, had ice and snow on their brake rigging. This ice and snow had stopped the rigging from moving and releasing the brakes.

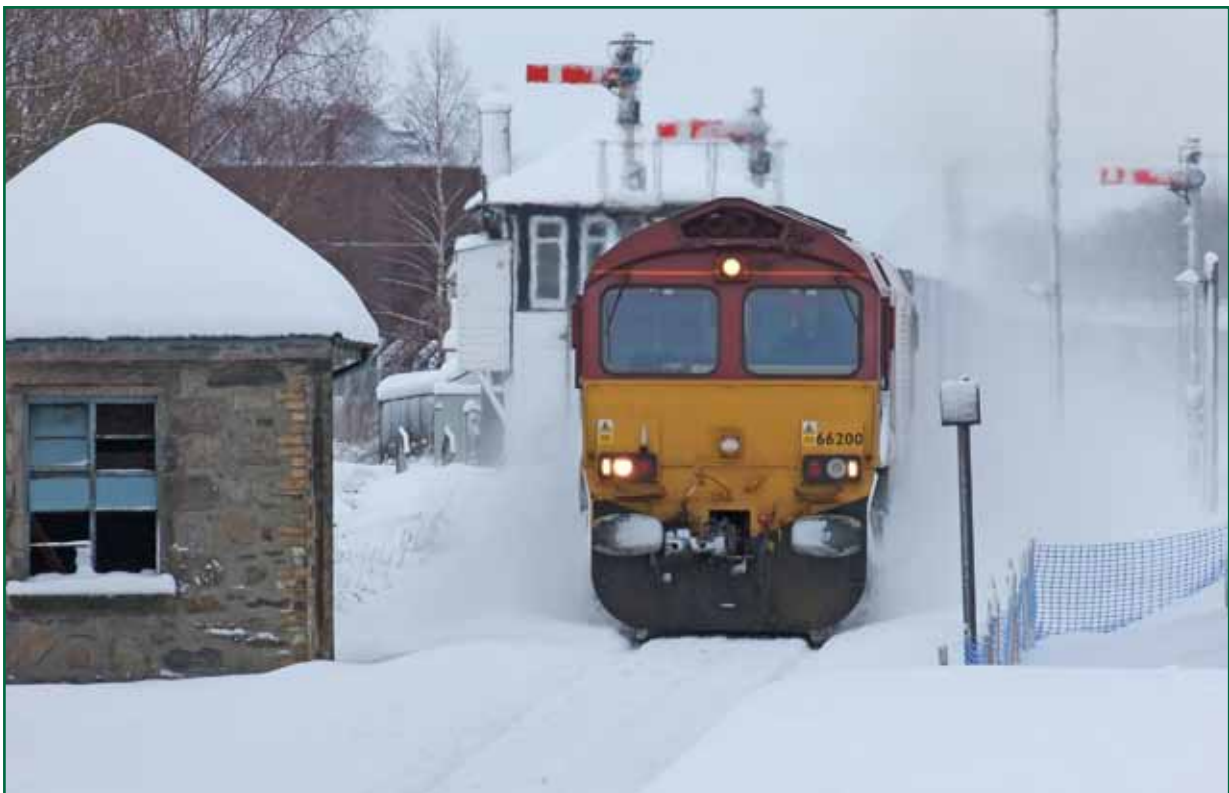
122 Lying snow being disturbed by the passage of trains and accumulating on bogie and brake components is understood, both in the UK and internationally, as having the potential to cause a reduction in braking effectiveness. This disturbance can take the form of a passing train throwing up loose snow flakes from the ground (sometimes described as 'snow smoke', see figure 18) or in snow which is coating the rail head being picked up by a train's wheels. This can result in the wheels spraying out a snow-water mix as they roll and in an accumulation of wet snow around brake block edges. Falling snow can also form a coating on the braking equipment components on some types of rail vehicle.

Figure 18: A Class 66 locomotive and FKA wagons disturbing lying snow on 6 January 2010 (image courtesy of Trevor Roots)

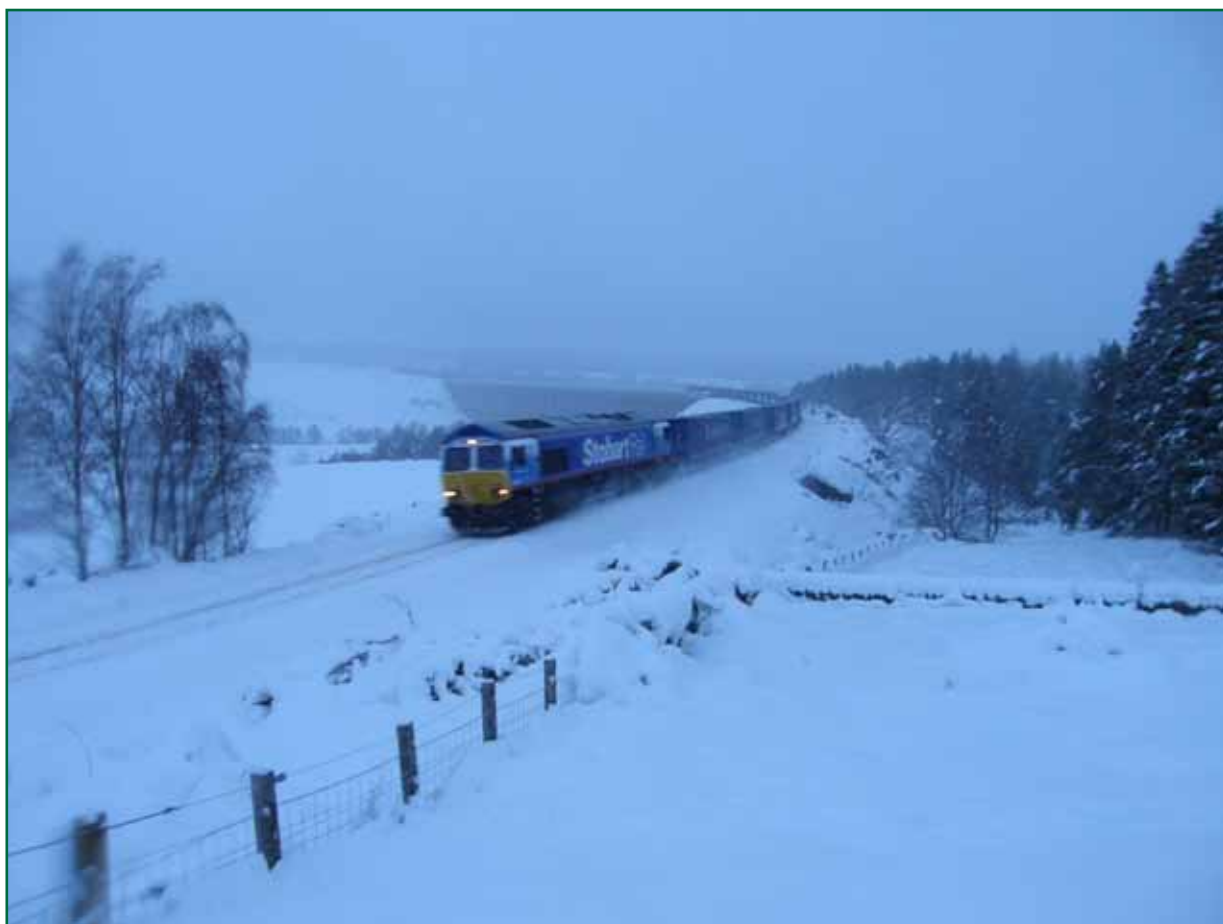
123 A photograph taken of train 4N47 (see figure 19) on 4 January as it left the Culloden Viaduct clearly shows snow being disturbed by the passage of the train. At this point the train's speed was around 30 mph (48 km/h). During the ascent towards Slochd summit, the speed of train 4N47 only occasionally dipped below 25 mph (40 km/h), and reached a high point of 54 mph (87 km/h). It seems probable therefore that the train's speed was high enough to have generated a similar disturbance through much of the 39 minute-long ascent of the summit. The disturbance of lying snow by train 4N47, due to the speed at which it ascended Slochd summit, was therefore probably causal to the accident.

Figure 19: Train 4N47 exiting Culloden Viaduct on 4 January 2010 (image courtesy of Phillip Watt)

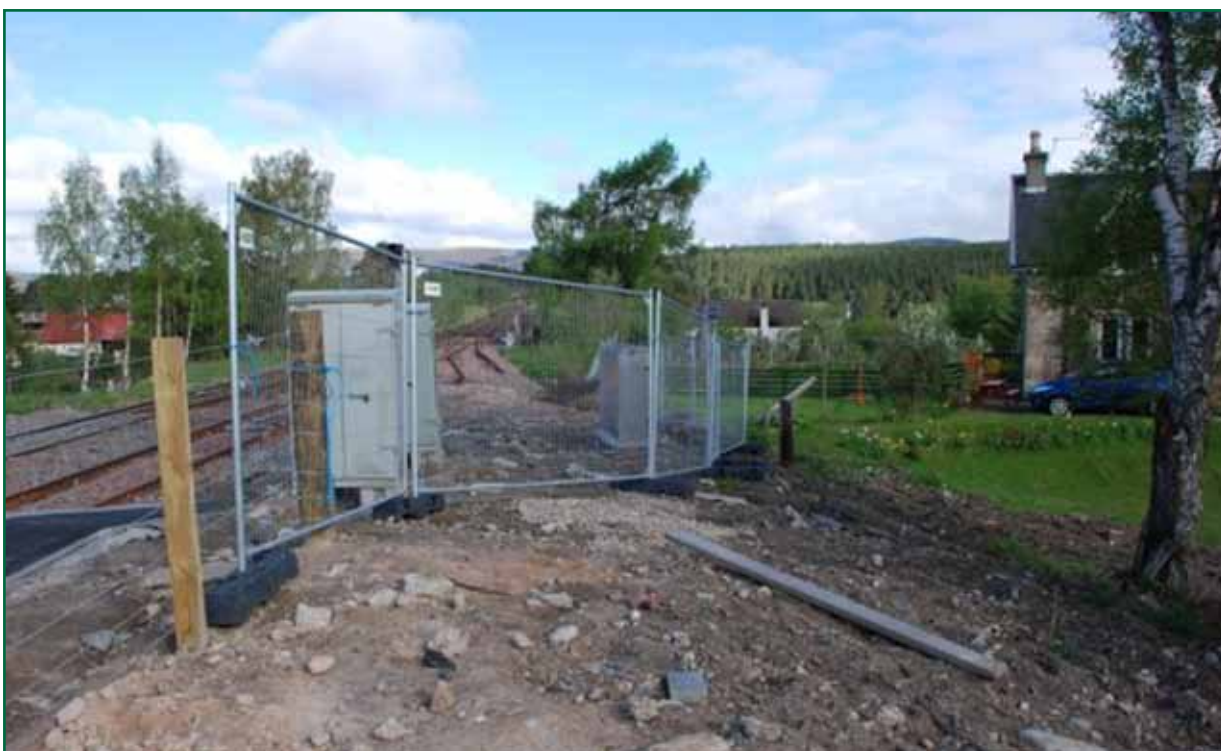
Figure 21: The run-out at 116 points as restored post-accident (image courtesy of Peter Carson).
