# Rail Accident Report

**Uncontrolled freight train run-back between  
Shap and Tebay, Cumbria  
17 August 2010**

# Uncontrolled run-back between Shap and Tebay, Cumbria, 17 August 2010

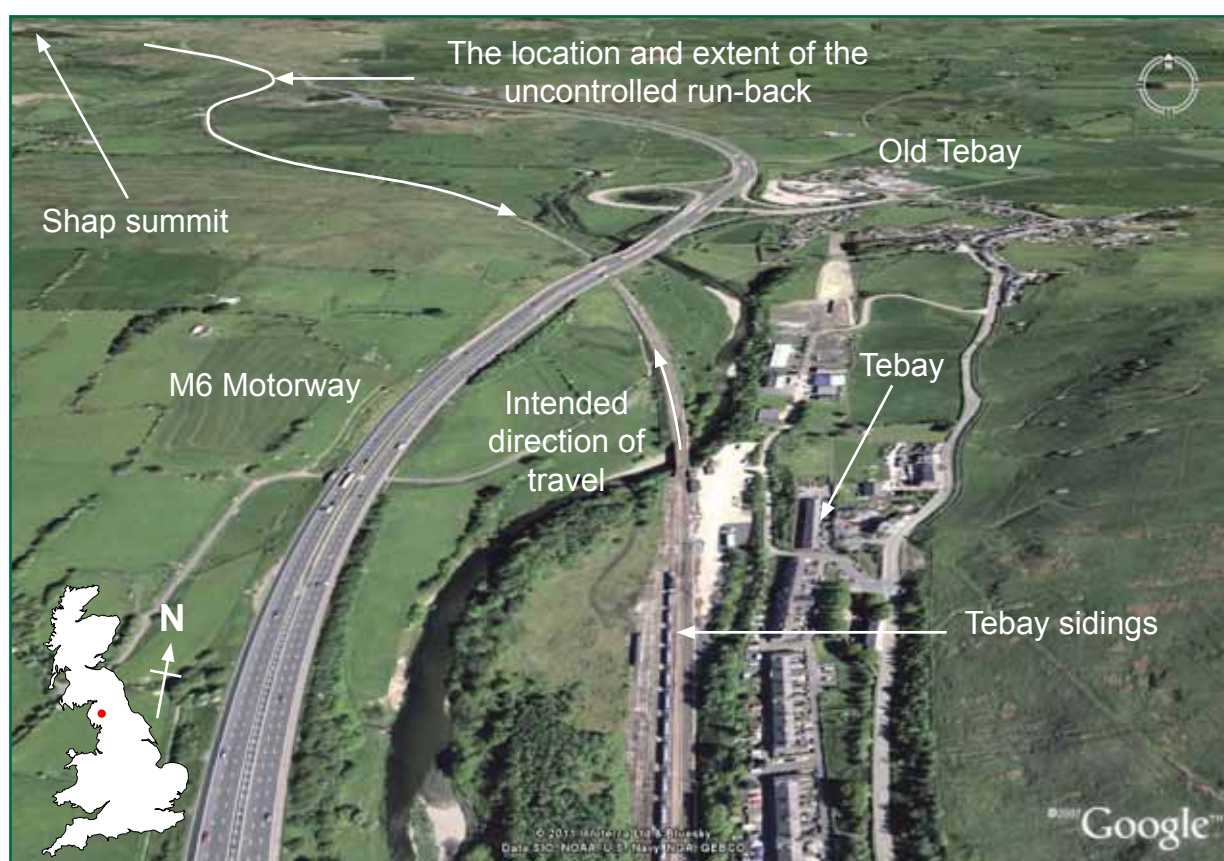
Figure 1: Tebay, Shap Summit and the incident location (courtesy of Google Earth)

- 3 In the early hours of Tuesday 17 August 2010, northbound freight train 4S25 was travelling uphill on the West Coast Main Line between Tebay and Shap Summit in Cumbria (figures 1 and 2). At 02:04 hrs the train slowed to a stop and then ran back until the driver braked and the train came to a stand at 02:09 hrs. During the run-back the train reached a maximum speed of 51 mph (82 km/h) and travelled 2.2 miles (3.5 km).

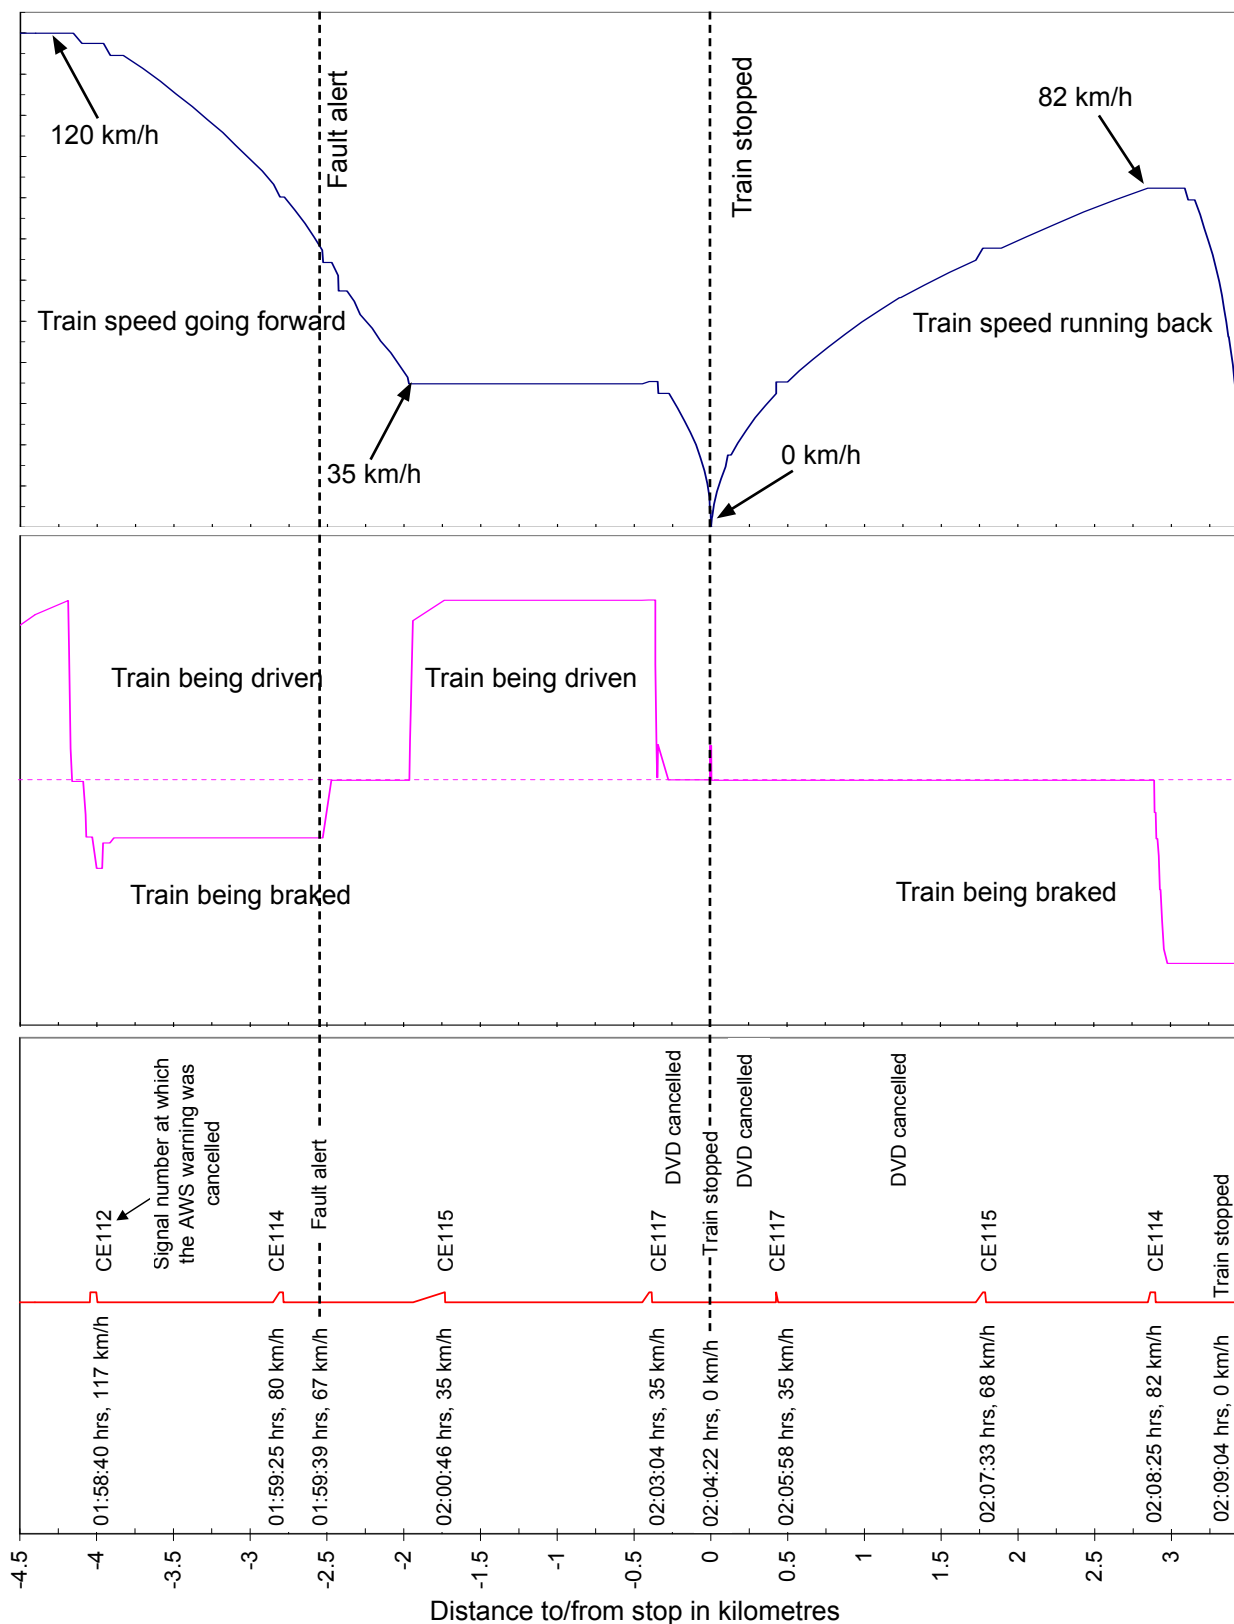
Figure 5: Events recorded by the data recorder

- 10 When the train arrived the driver spoke with the driver he was relieving, got into the cab and drove out of the station at 00:43 hrs. The journey was uneventful until the driver passed through Tebay and saw signal CE112 showing two yellow lights. From experience he correctly assumed he had caught up with a slower freight train so at 01:58 hrs he cancelled the warning for the signal and applied the brake to reduce speed. He then saw signal CE114 showing one yellow light and cancelled its warning. Figure 5 shows the events recorded by the locomotive's data recorder and figure 6 shows the locations at which the events occurred.

- 12 The train continued to slow as it passed signal CE117, stopping 1025 metres from Haybank level crossing before rolling back down the gradient. During this time the driver cancelled two vigilance device warnings as he had not operated any other cab control to reset the device in over two minutes (paragraph 7a). The locomotive then passed signal CE117 a second time, this time in the wrong direction. The driver cancelled the warning for this signal, another vigilance device warning and the warnings given after the locomotive passed signals CE115 and CE114.
- 13 The train was travelling at 51 mph (82 km/h) when the driver noticed that his train was moving away from the green light of signal CE114 so he applied the brake and brought the train to a stand, by which time the train had run back for over four and a half minutes and had travelled 2.2 miles (3.5 km).

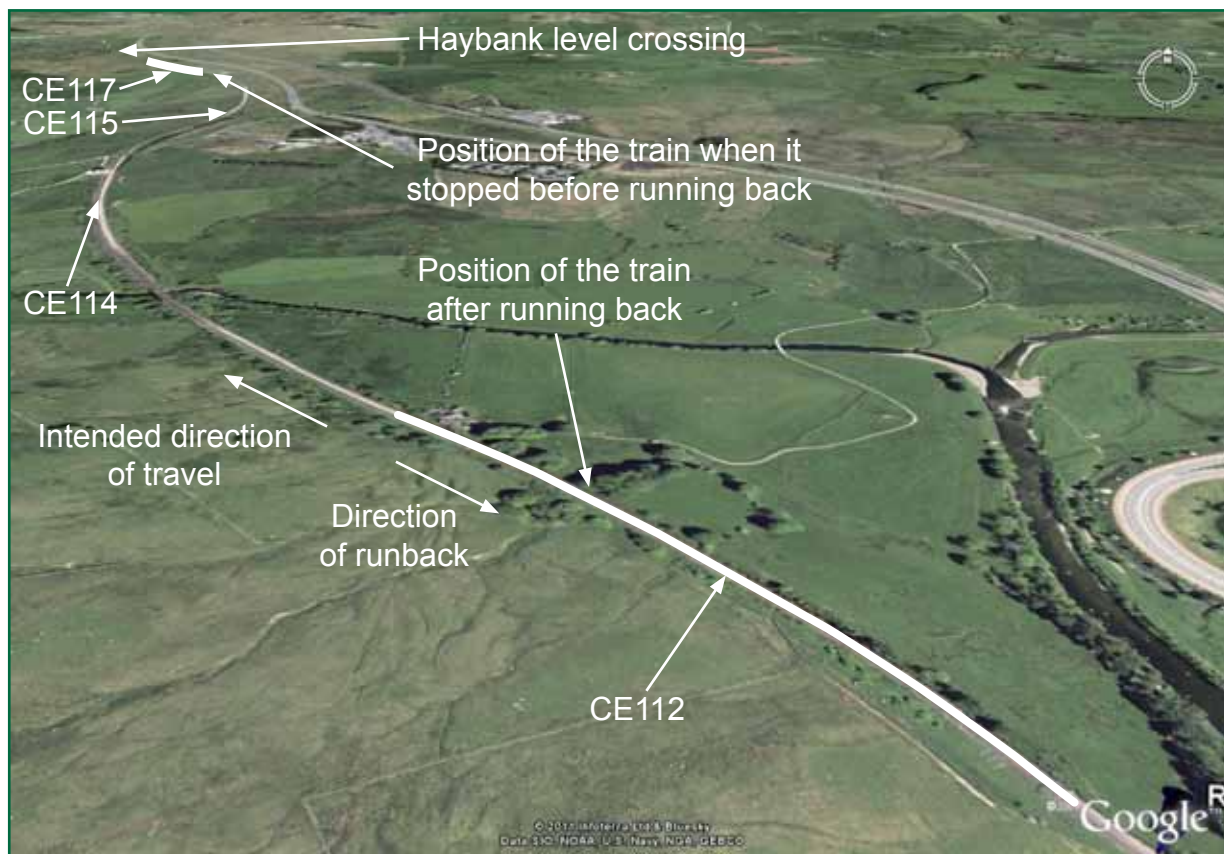
Figure 6: The location of events recorded by the data recorder (courtesy of Google Earth)

- 11 At 01:59 hrs the cab desk display screen alerted the driver to a fault: one of the two convertors that supply power to the locomotive's motors had shut down. The driver attempted to reset the convertor but could not, so he continued to drive the train normally as its loss had only a small effect on the locomotive's available power. The driver then saw signal CE115 showing one yellow light, cancelled its warning, stopped braking and applied power to maintain speed. The driver then cancelled the warning for signal CE117 which was showing one yellow light and reduced power to slow the train as he travelled up the gradient.

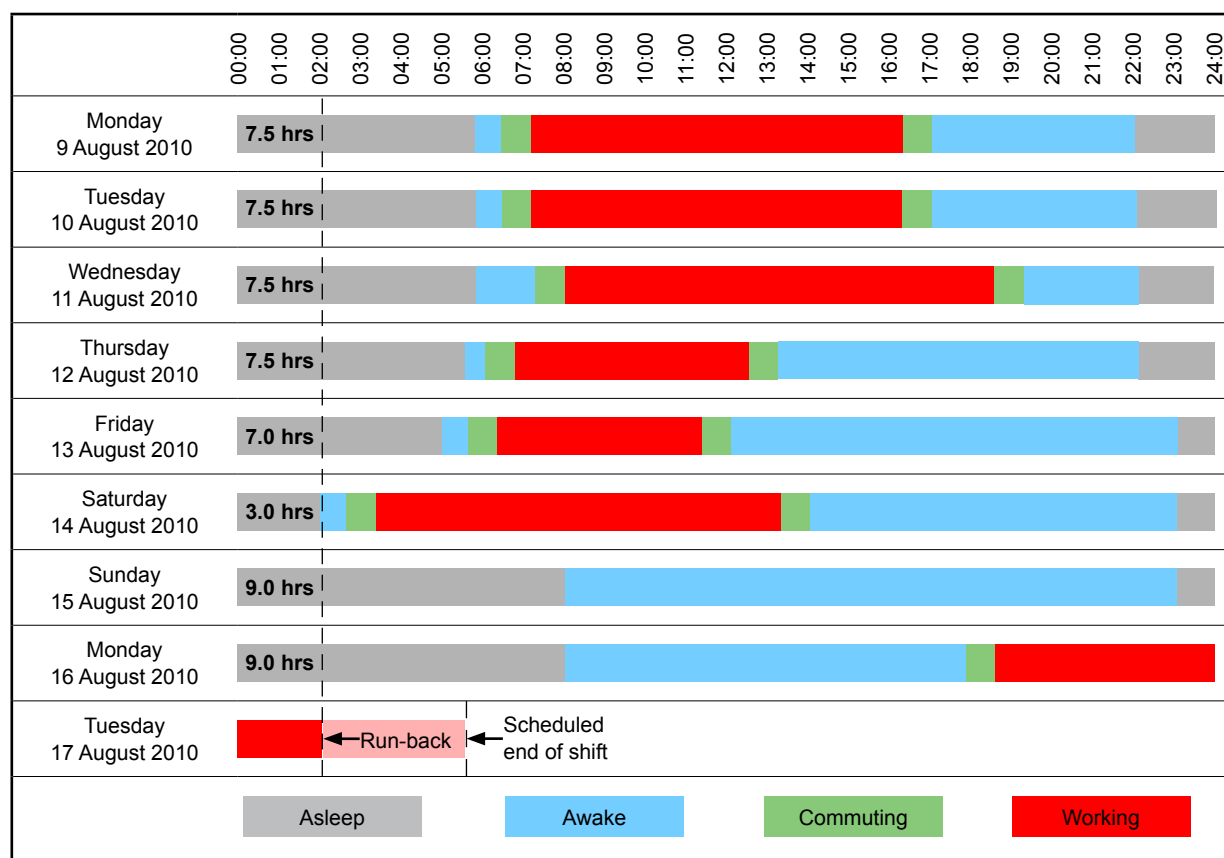
Figure 10: The driver's shifts and reported sleep patterns leading up to the incident

- 35 Figure 10 shows the driver's shifts and reported sleep patterns. When the RAIB compared the driver's shifts with the processes that influence fatigue (paragraph 20 and figure 11), it concluded that it was foreseeable that the driver may have been experiencing high levels of fatigue at the time of the incident as:
- he had been continuously awake for over 18 hours; he stated that he tried but could not sleep in the day before the first night shift so instead carried out light duties around the home;
  - he was driving his train at 02:04 hrs, a time of day when his alertness and performance levels were at their lowest; and
  - he possibly had some sleep loss due to progressively earlier shift start times from Thursday 12 to Saturday 14 August.

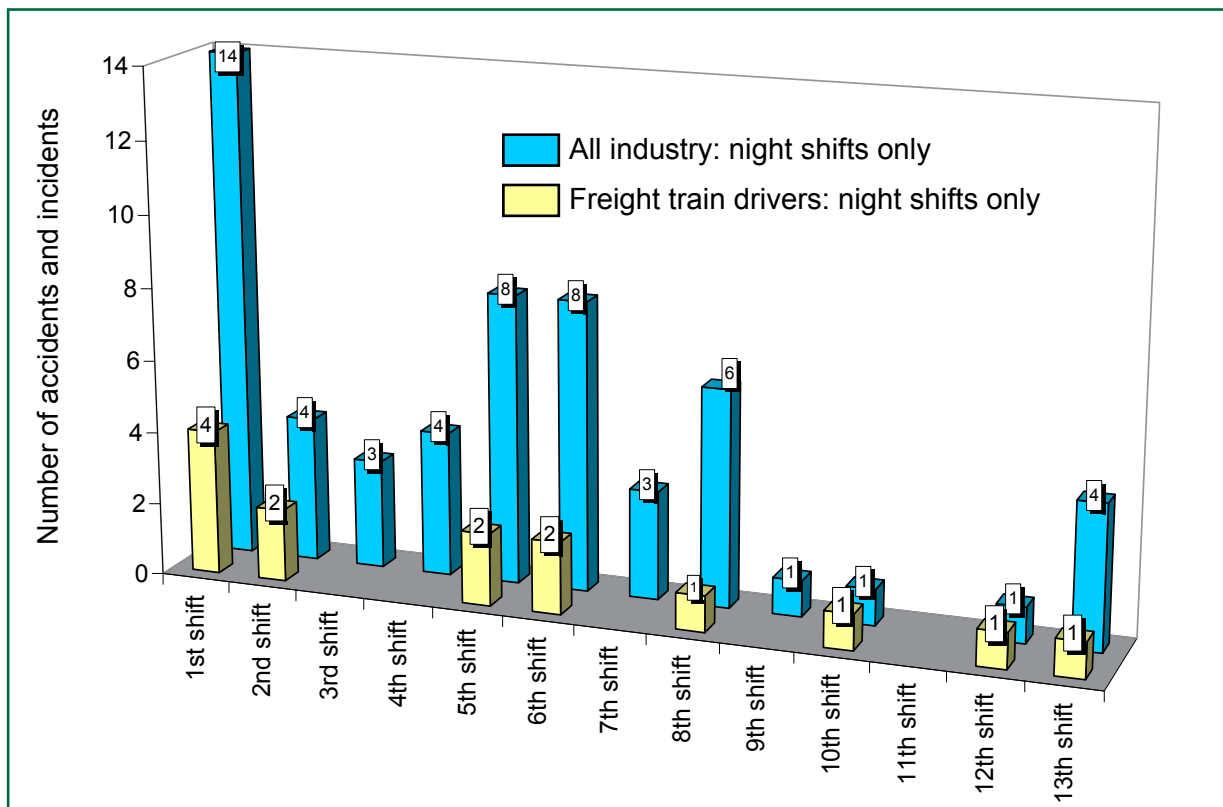
Figure 12: Night shift accidents and incidents with fatigue as a causal factor: years 2000 to 2010. Information courtesy of the RSSB's Safety Management Information System

- 36 The RAIB spoke with several freight train drivers in the course of this investigation. All stated that it is most difficult to remain alert on the first night shift and that alertness improves over successive night shifts. This supports the findings of a recent study<sup>10</sup> in which 81% of freight train drivers stated that they found their first night shift the most tiring.
- 37 Between March 2000 and November 2010, fatigue was a factor in 111 rail industry accidents and incidents for which information on shifts was available. Of the 111 events, 57 occurred on night shifts. More accidents and incidents occurred on the first night shift than on the following night shifts, and this was true for the industry as a whole and for freight train operations alone (figure 12).
