Rail Accident Investigation Branch

# Rail Accident Report

## **Passenger train derailment near East Langton, Leicestershire 20 February 2010**

Report 01/2012  
January 2012

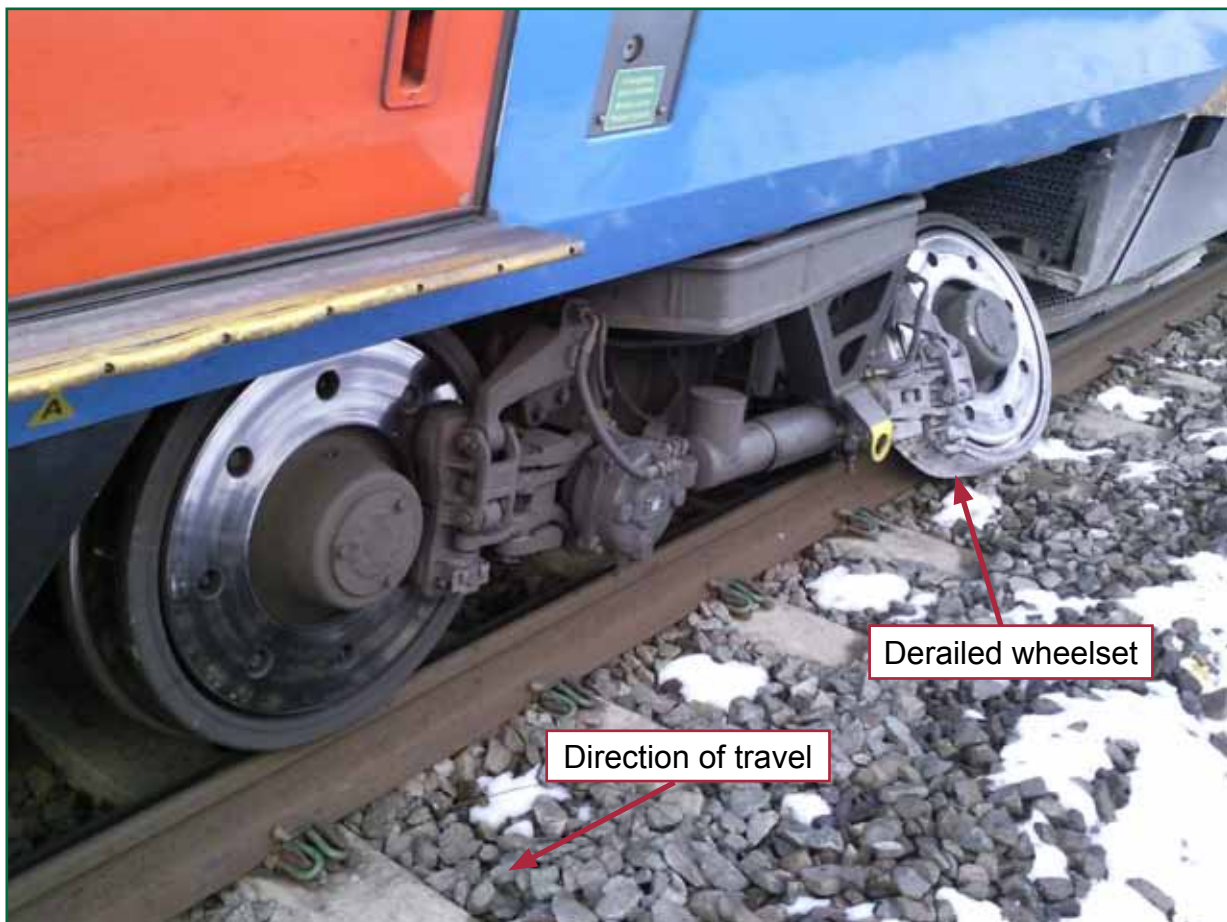
- 8 The train, a seven-car Class 222 Meridian, ran derailed for approximately 2 miles (3.2 km) before stopping. The derailed axle was the trailing axle of the leading *bogie* of the fourth vehicle. All the vehicles remained upright and clear of the adjacent *up* line throughout the derailment. Figure 2 shows the derailed left-hand side wheel.
- 9 There were 5 crew members and approximately 190 passengers on board the train. There were no reported injuries.

Figure 2: Derailed trailing wheelset of leading bogie (fourth vehicle)

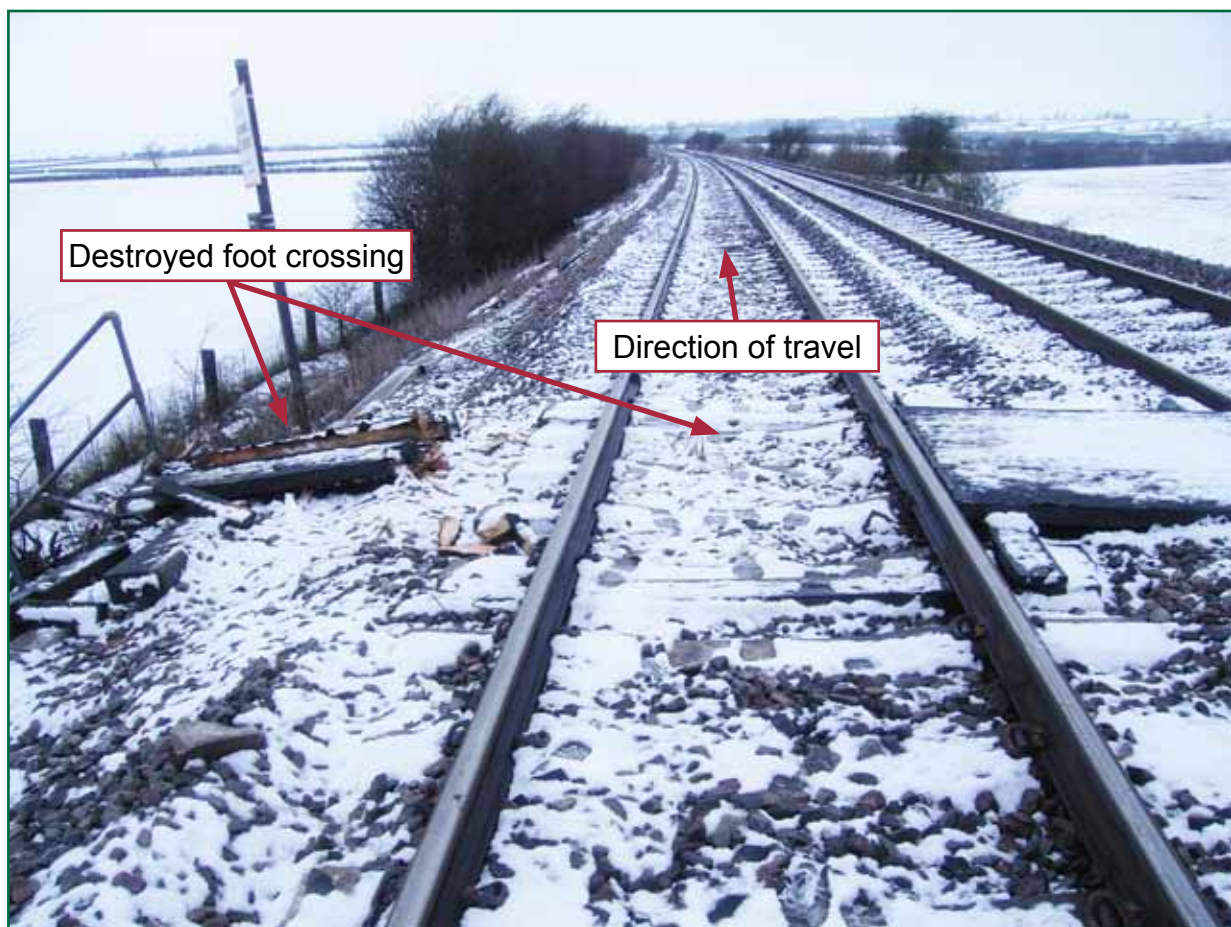
- 21 The railway at this location is double track with a permitted speed of 100 mph (161 km/h). The first part of this section of railway lies on an embankment (figure 4) which merges progressively into a cutting at the end of this section. The gradient of the line after Market Harborough station falls gently at between 1 in 165 and 1 in 500 to around the 86 mile post and then rises at 1 in 167 towards overbridge 25. The track construction in this area is continuous welded rail (CWR), laid on concrete sleepers. The condition of the track did not contribute to the accident.

Figure 4: The derailment site and the destroyed Thorpe Langton foot crossing

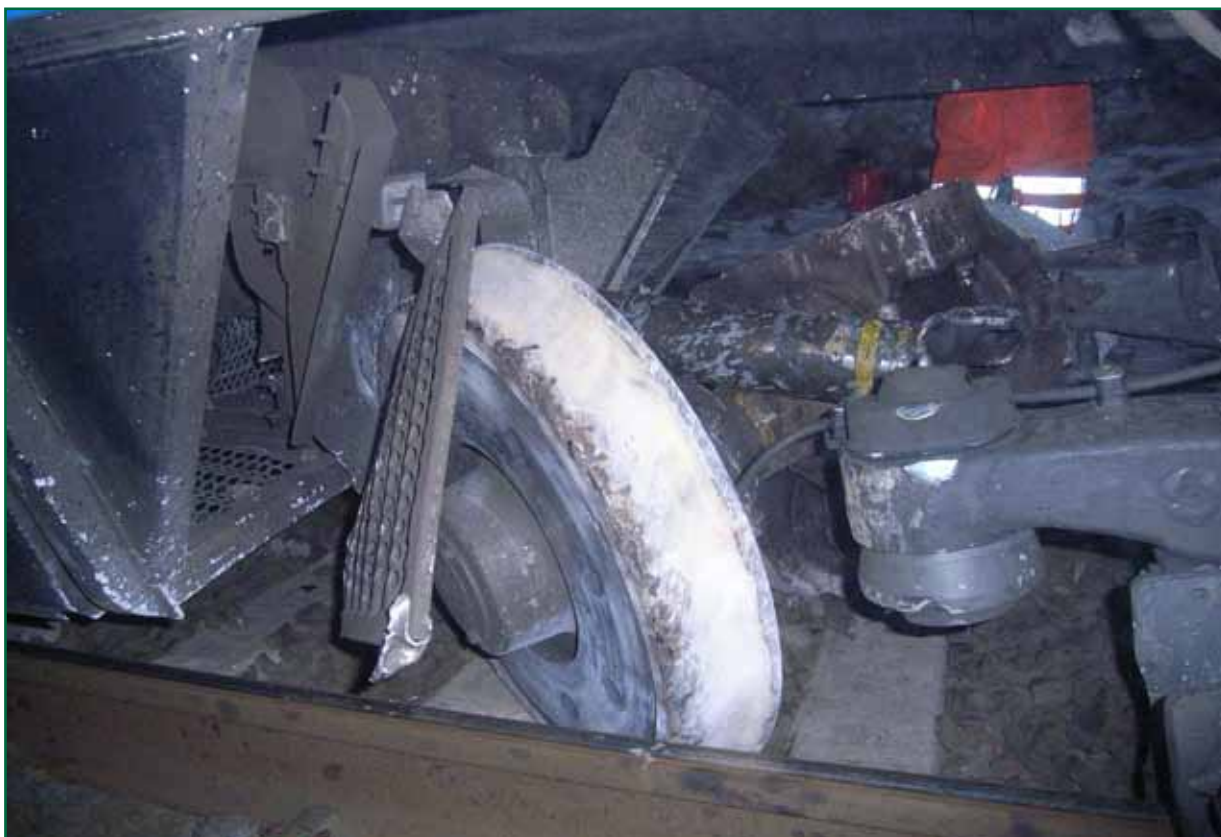
- 54 Witness evidence indicates that the driver carried out an inspection of the fourth coach (vehicle 60625), from the cress. He saw that the axle was fractured and the final drive gearbox was lying upside down in the four-foot (figure 7a). The portion of the axle around the fracture, just outboard of the left side of the final drive gearbox (figure 7b) was still glowing orange. He noted that the automatic fire extinguisher system on the vehicle underframe had operated and that the diesel tank had been punctured and was leaking. The driver deployed a hand-held fire extinguisher he had brought with him, onto the hot end of the fractured axle and shut down the engine on the vehicle. He then returned to the cab, made an announcement to reassure passengers, and informed the signaller and East Midlands Trains' control of the situation.

Figure 7a: Fractured axle as found on site (right-hand wheel side)

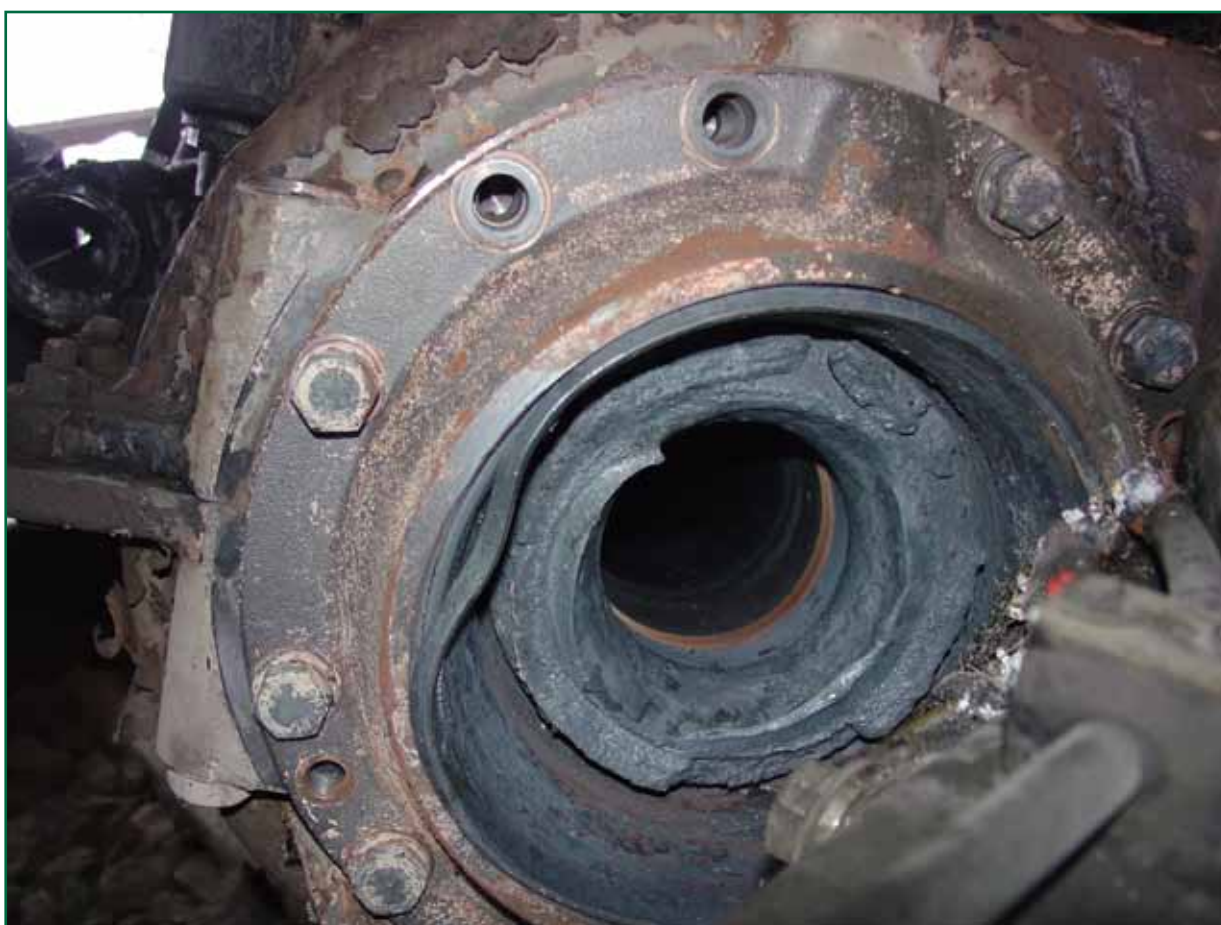
Figure 7b: Fractured axle as found on site (left-hand wheel side)

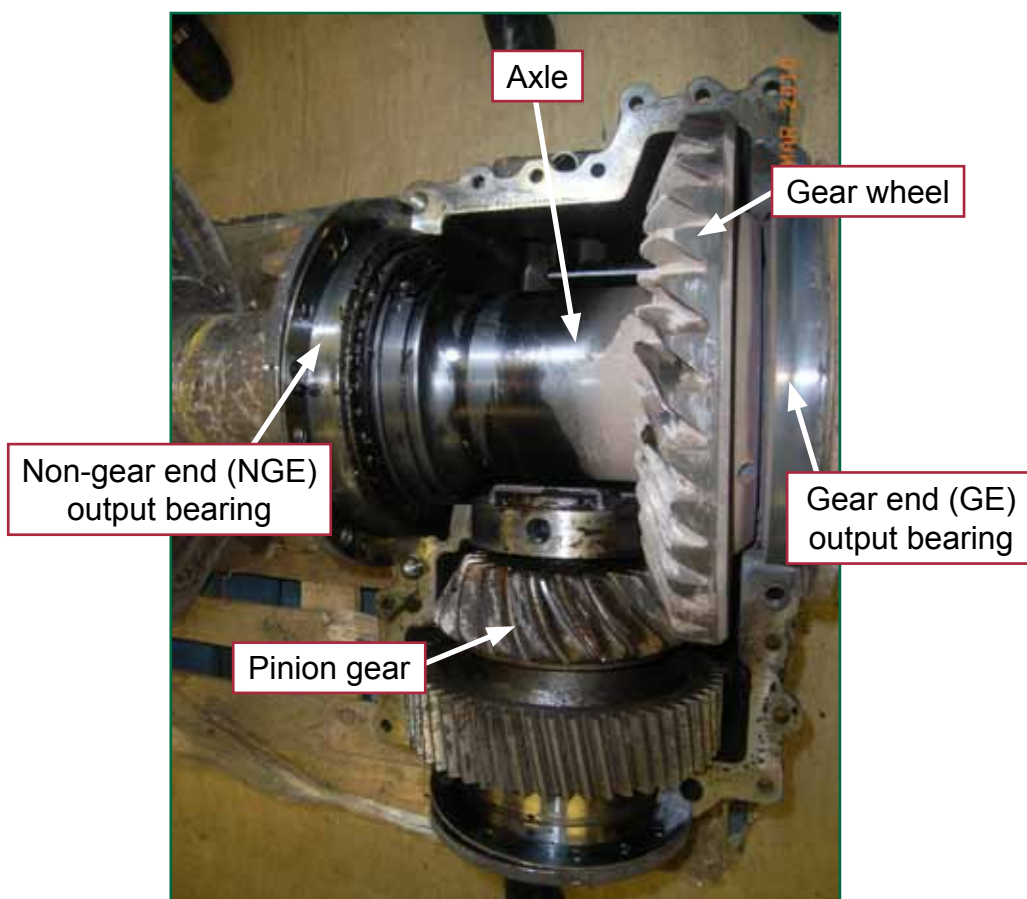
Figure 8a: Failed final drive gearbox (lower half)

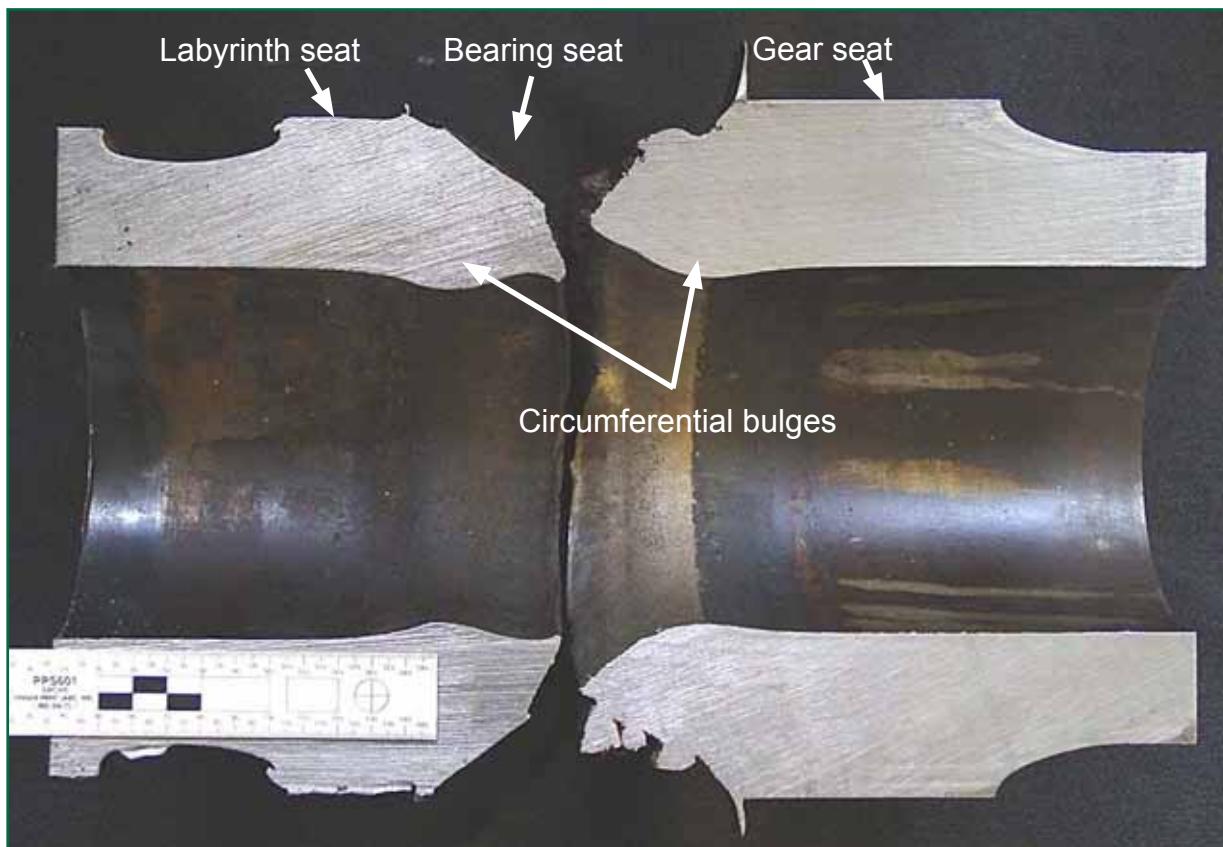
- 69 The cause of the overheating and consequent weakening and fracture of the axle was found to be spinning of the GE bearing inner ring relative to the axle. The evidence for this is explained in the following paragraphs. This spinning generated high temperatures by frictional heating, sufficient to cause loss of axle bending strength which resulted in *plastic strain* and fracture. A section through the axle either side of the fracture face is shown in figure 9a; the thinning of the axle either side of the fracture indicates ductile elongation.

Figure 9a: Section through axle either side of fracture face (courtesy of Serco)

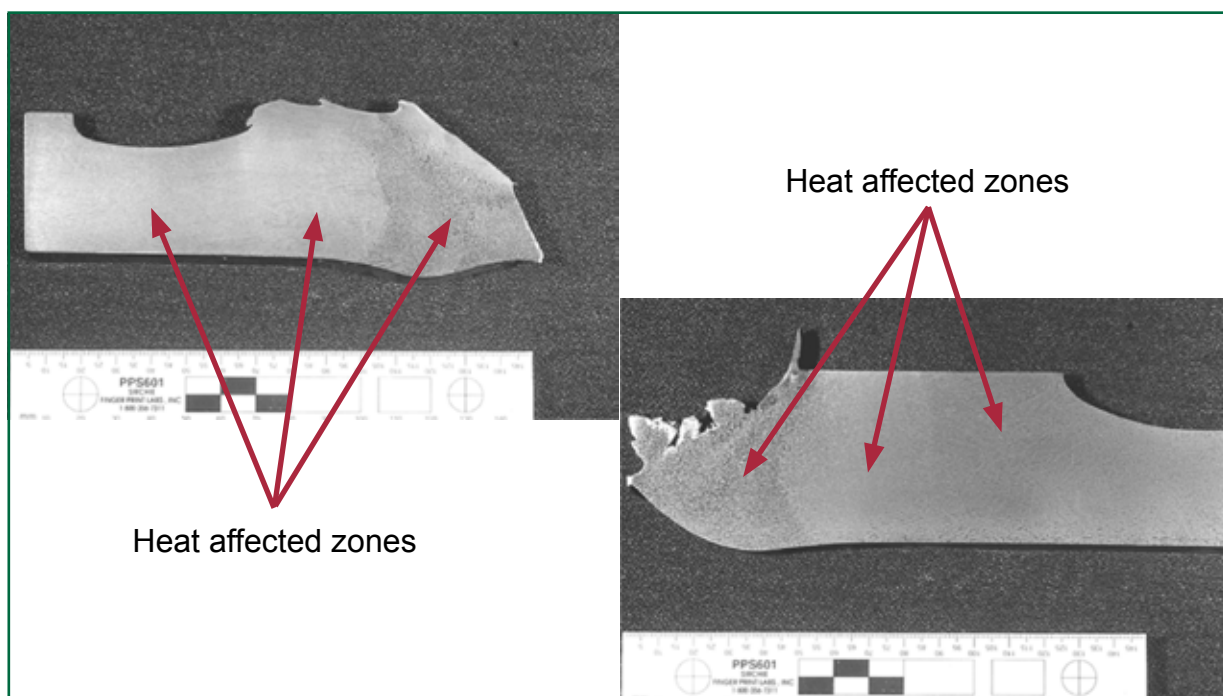
- 71 Metallurgical analysis of the axle material around the fracture faces showed that the highest temperature occurred at the GE bearing axle/inner ring interface, where the temperature had reached around 1100 - 1200°C, and therefore that this interface was the source of the heat. Figure 9b shows the heat affected zones on polished sections through the axles. Figure 9c shows a section through the GE bearing, labyrinth and bearing housing. The heat affected zone in this section is at the bore of the inner ring.

Figure 9b: Section through each half of axle fracture showing heat affected zones (courtesy of Serco)

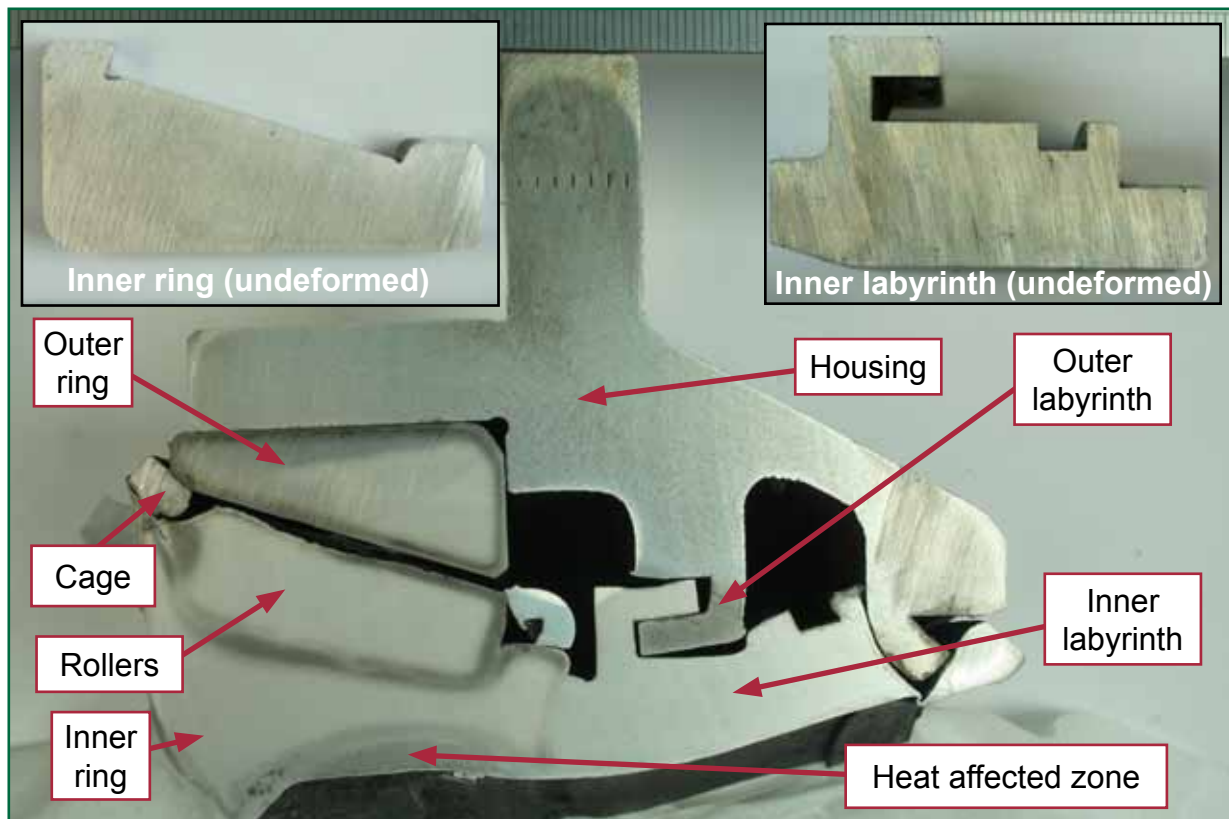
Figure 9c: Section through output bearing, labyrinth and bearing housing of failed gearbox (courtesy of ESR)

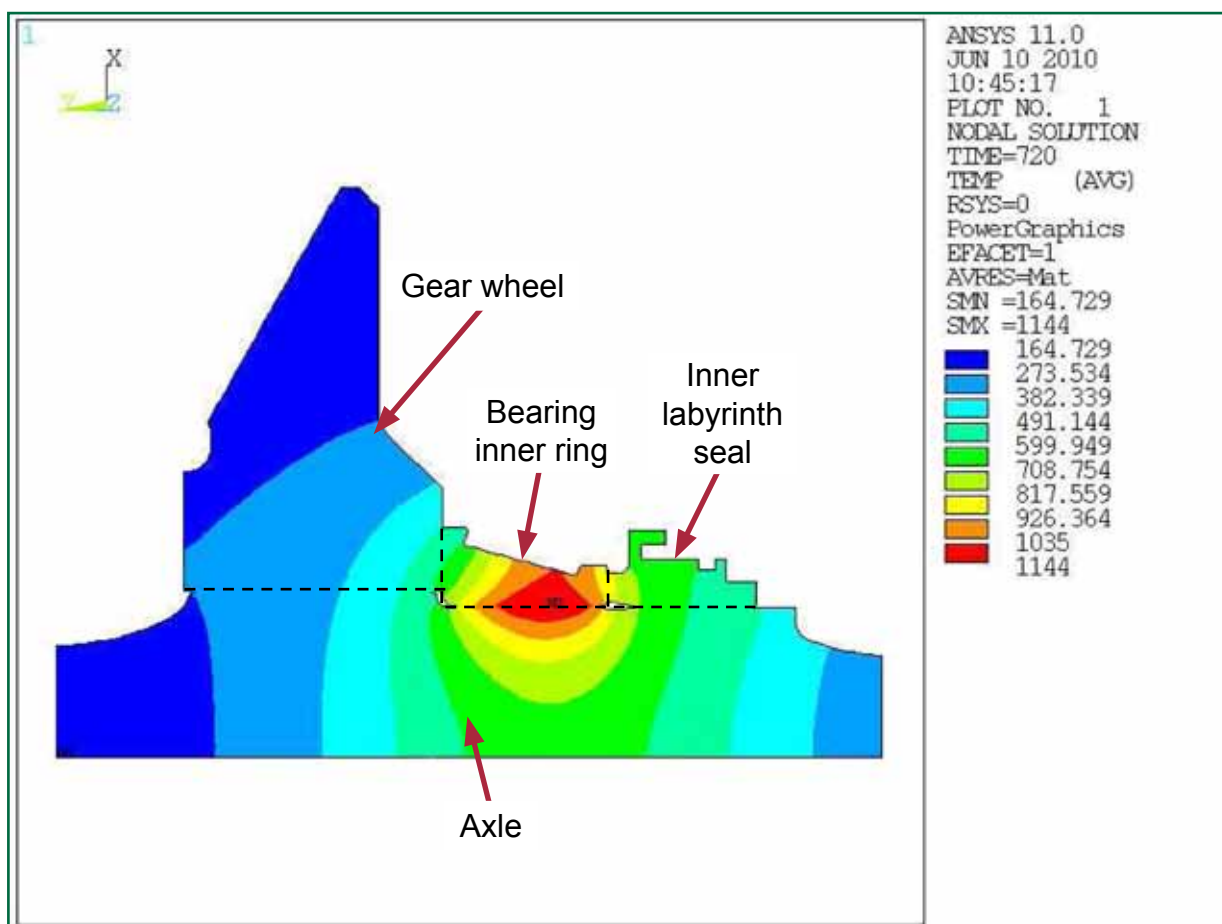
74 Figure 10 shows the calculated temperature distribution around the axle/inner ring interface after 12 minutes for a heat input of 30 kW. By this time the outer surface of the axle would be expected to have reached around 1100°C, and the inner surface around 650°C. At these temperatures, the strength of the axle material is likely to have been between 5% (outer surface) and 24% (inner surface) of its strength at room temperature<sup>6</sup>. While some of the heat input is lost from the axle/inner ring interface (mainly by conduction into cooler parts of the axle), a stage would have been reached when the temperature throughout the thickness of the axle was high enough for gross plastic strain, ductile thinning of the weakened material (paragraph 69) and fracture to occur.

Figure 10: Calculated temperature distribution at axle/inner ring interface after 12 mins with 30 kW heat input (courtesy of Interfleet Technology)

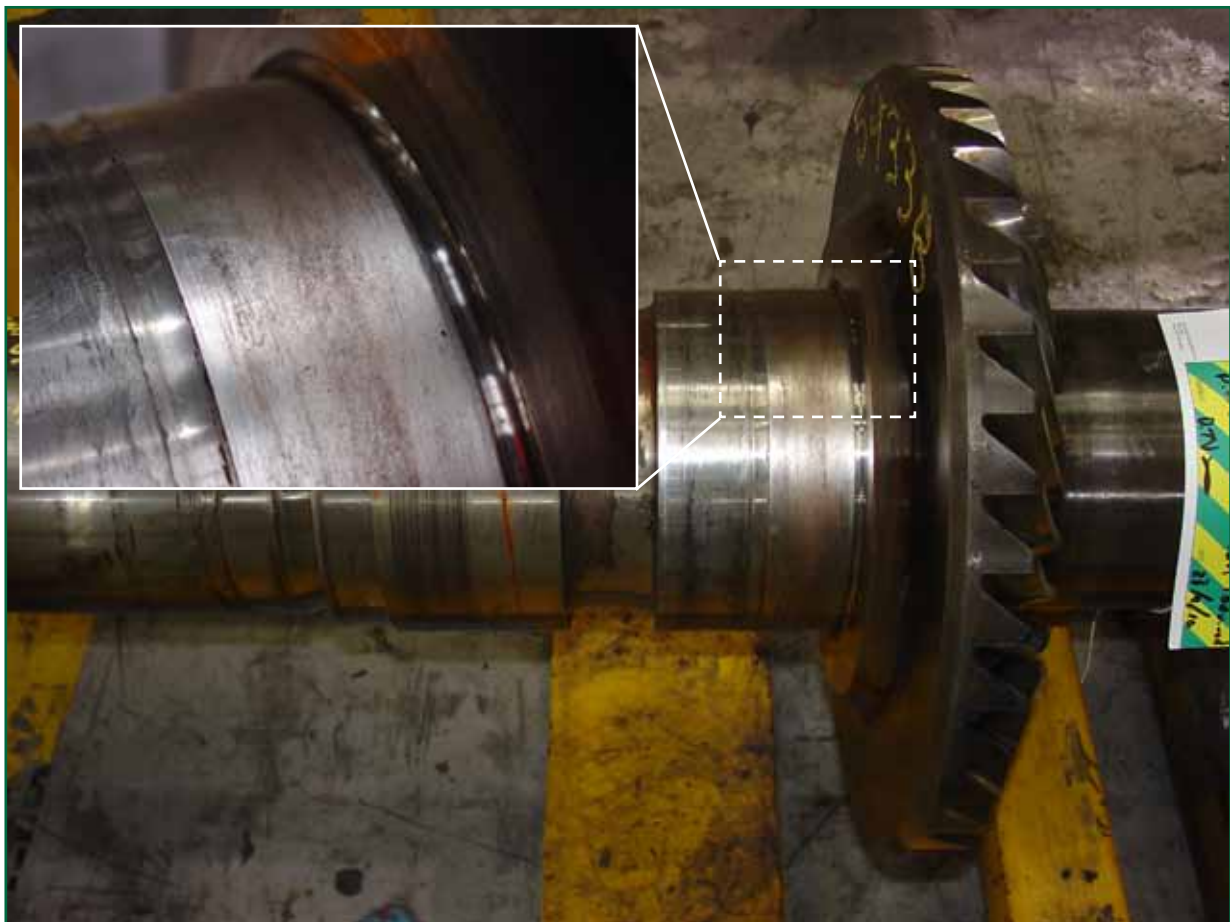
- 83 The first two axles in table 1 were found to have significant fretting, confined mainly to the bore of the inner ring, and evidence of the early stages of creep between the inner ring and axle. The other four axles were found to have axle/inner ring clearances of up to 79  $\mu\text{m}$  at the GE bearings. The inner rings on these axles had been creeping on the axle (figure 11), resulting in wear to both the axle and inner ring bore and clearances at the interfaces. On the bearing inner ring of wheelset E1604/10, there were regular scroll marks on the abutment face made by a piece of hard material caught between this face and the gear wheel. From these marks the maximum rate of creep of the inner ring relative to the axle and gear wheel was estimated to have been 0.22 mm per revolution. These observations were consistent with those described in Nagatomo and Toth<sup>8</sup>. None of these axles with clearances showed signs of overheating but they did have abnormally dark oil. Had they not been removed from service for the reasons given in table 1, it is possible that some of them could have progressed to failure.

*Figure 11: Final drive from wheelset E1604/58 after strip down, showing wear on bearing seat due to inner ring rotation*

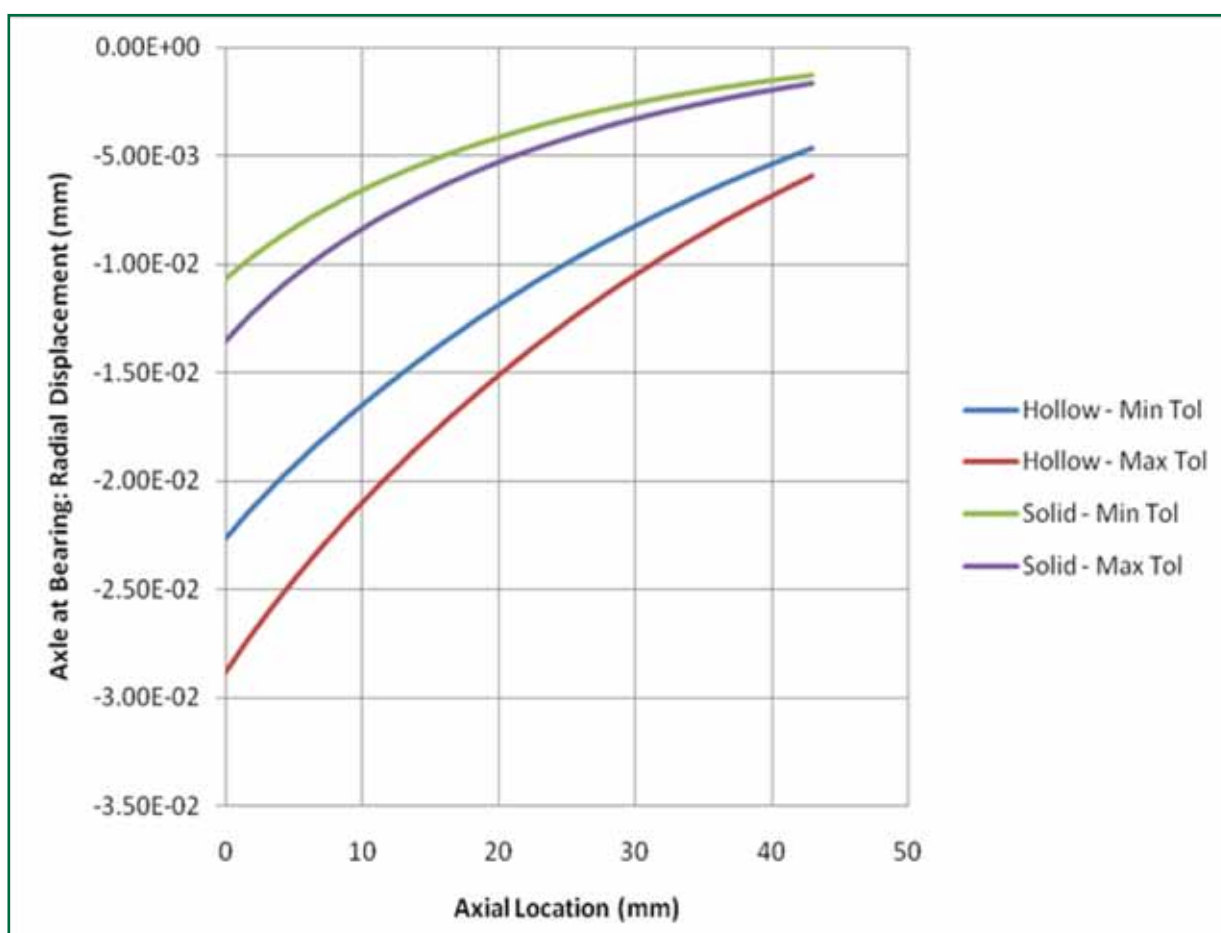
- 105 This shrinkage was confirmed by both calculation and measurement. Mathematical modelling of the Meridian axle, gear wheel and GE bearing indicates that between 24 and 30  $\mu\text{m}$  of shrinkage on diameter (12-15  $\mu\text{m}$  on radius) could occur at the centre of the bearing seat, depending on the level of interference between the gear and axle (figure 12). Another effect of the gear fit is that it causes the bearing seat to be tapered (figure 12); the inner edge of the seat closest to the gear wheel shrinks more than the outer edge. The corresponding amount of bearing seat shrinkage for a solid axle (figure 12) would be significantly lower at between 5 and 10  $\mu\text{m}$  on diameter. Measurements carried out on a sample of four Meridian bearing seats, with and without the adjacent gear wheel fitted, indicated an average amount of shrinkage of 27  $\mu\text{m}$  on diameter and a range of 21 - 38  $\mu\text{m}$ .

Figure 12: Calculated radial displacement of gear-side output bearing seat for Meridian (hollow) axle and equivalent diameter solid axle (courtesy of Interfleet Technology)

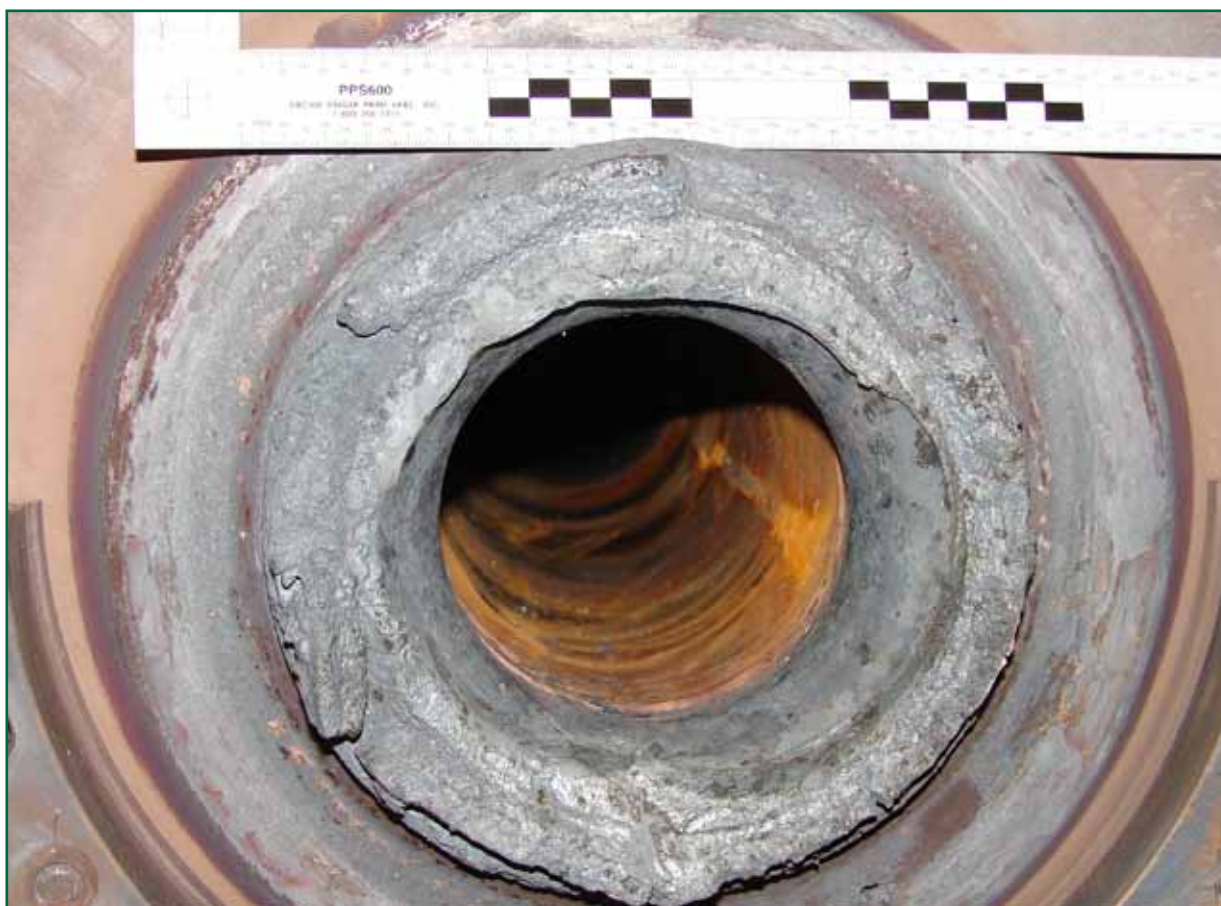
- D5 The total length of the axle (axle end faces to fracture extremities) was 26 mm longer than it had been originally. This was caused by ductile elongation of the axle and indicates that the axle had been overheated prior to the fracture. Had a fatigue crack caused the axle to fracture, the total length would have been similar to the original length or been shorter due to battering and wear between the faces.

Figure D1: Axle fracture face

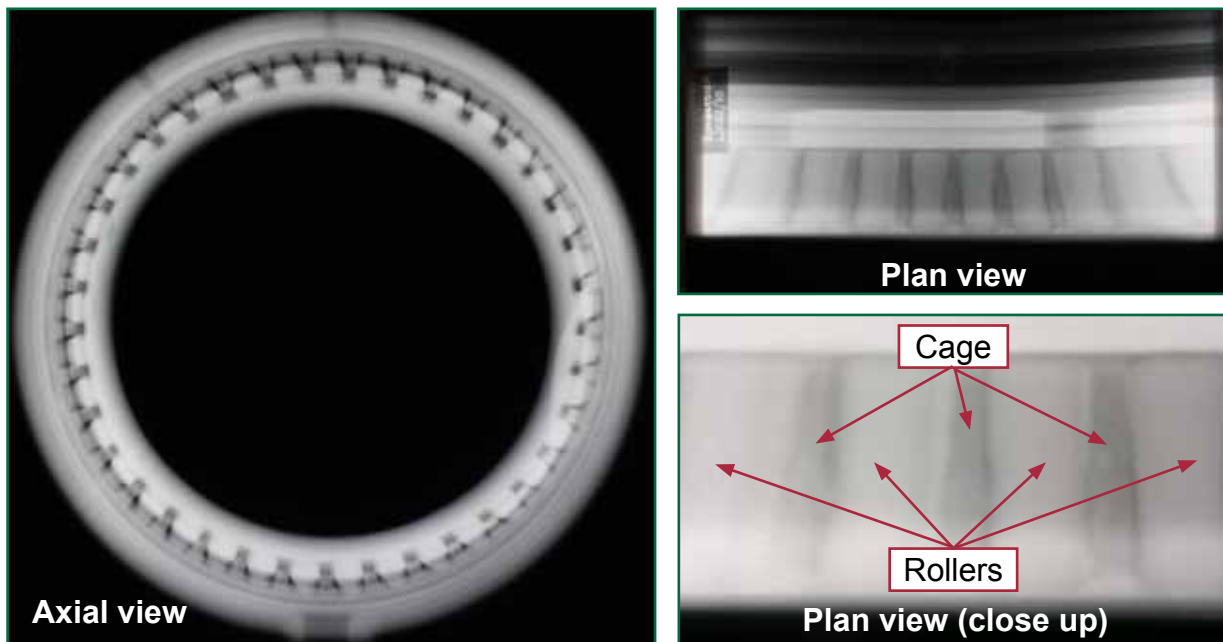
Figure D2: X-ray images of GE bearing (courtesy of Bombardier Transportation)

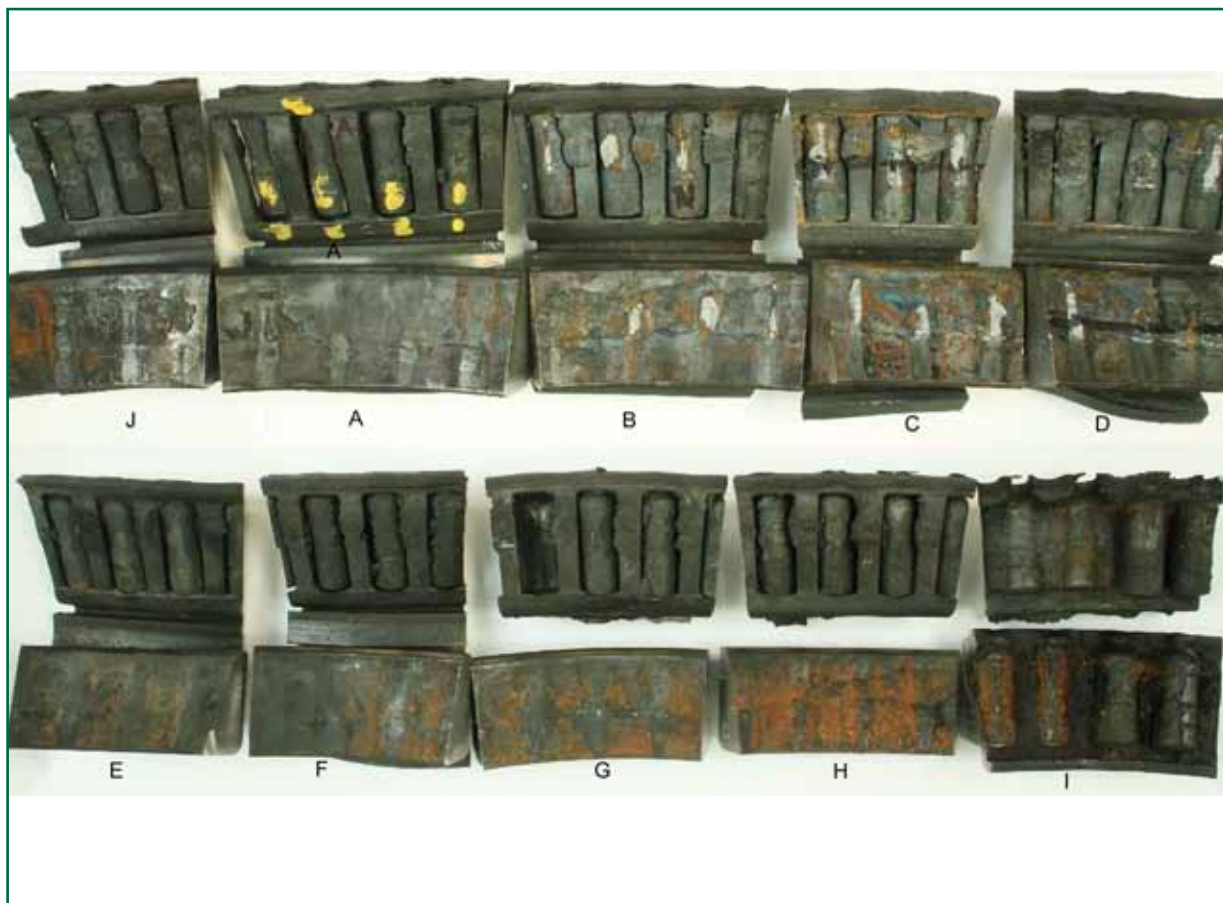
Figure D3: Segments of the GE bearing (courtesy of ESR)

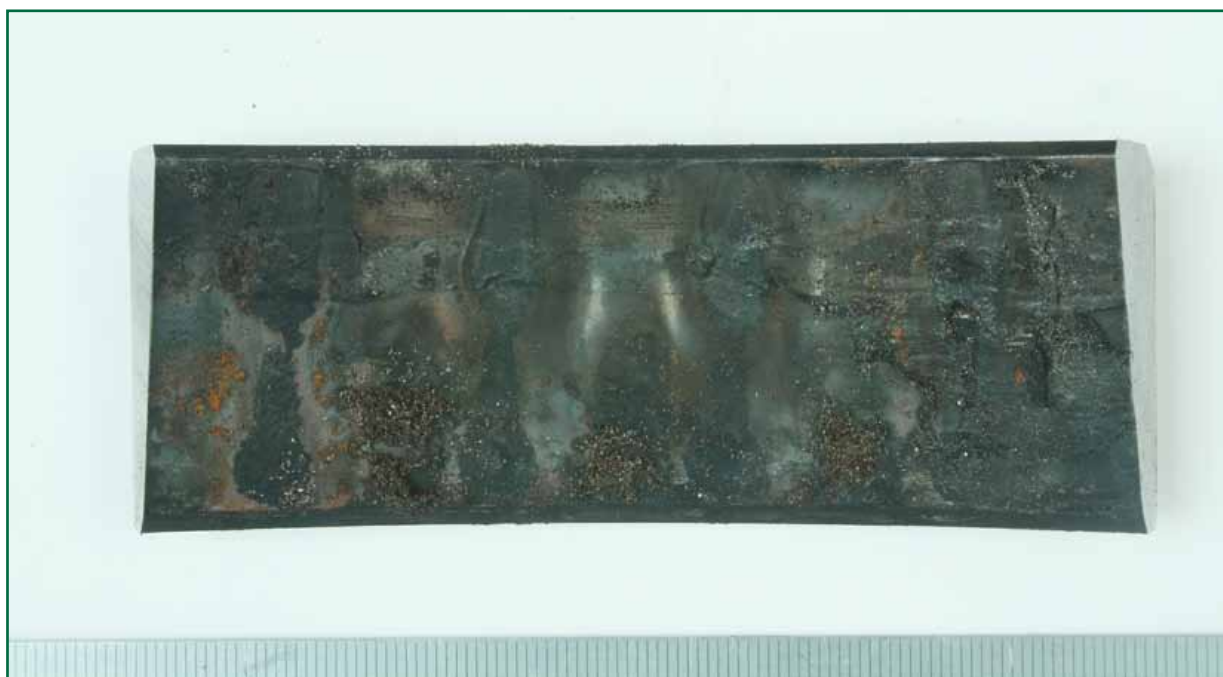
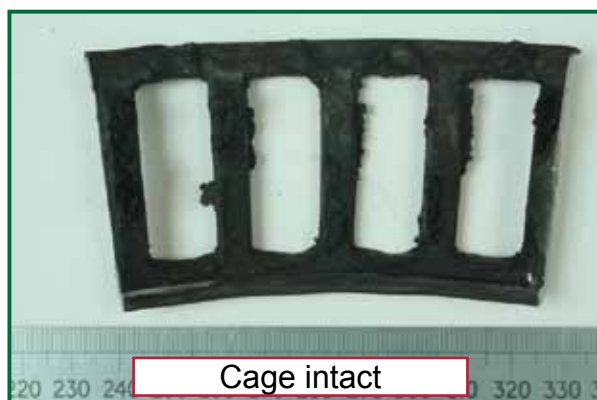
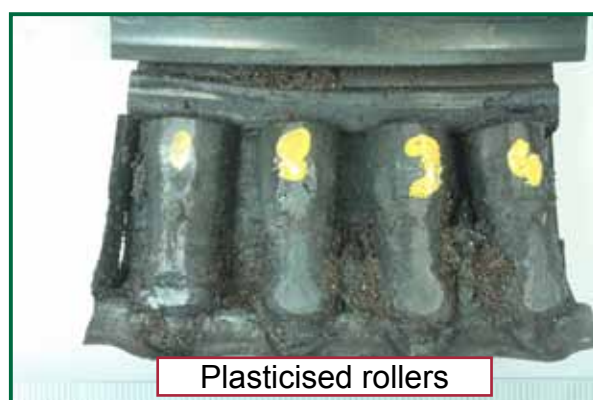
Figure D4: Close-up of outer raceway, cage and rollers from one segment (courtesy of ESR)

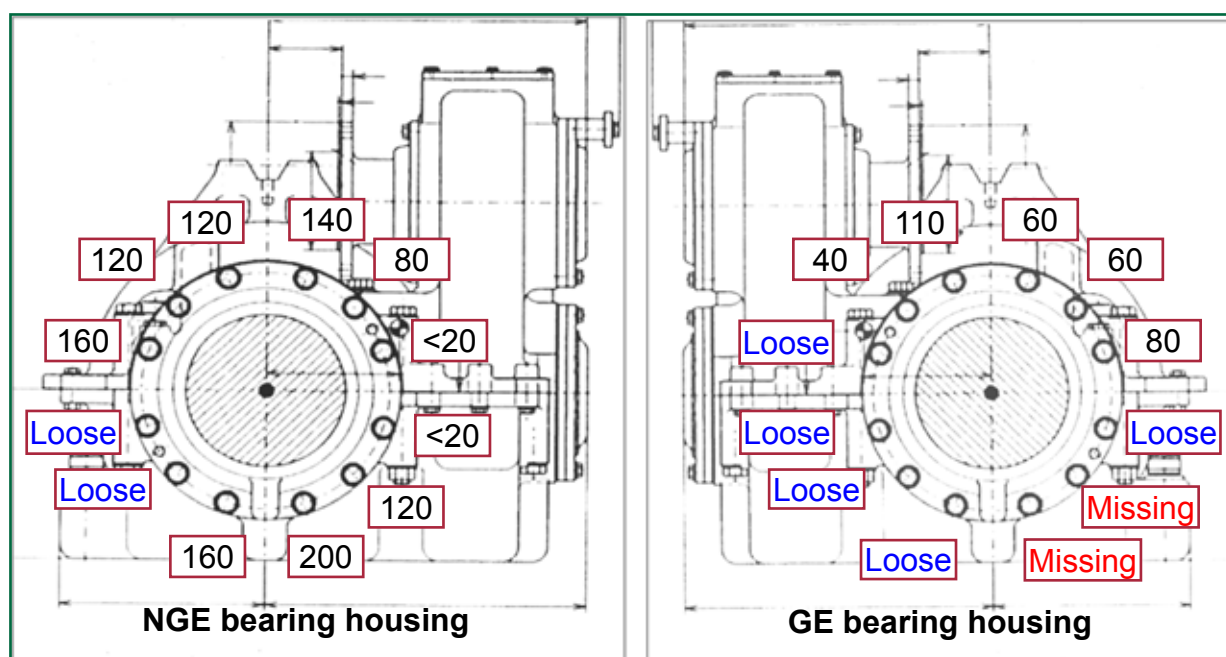
- D25 The external surface of the GE bearing housing is estimated to have reached 350°C – 400°C during the failure. At such high temperatures, some relaxation of the bolt pre-load from the original torque tightening would be expected due to thermal effects as the housing and bolt materials have different coefficients of thermal expansion. A tendency for the housing bolts to lose preload was also noted in the laboratory tests (see appendix E, paragraph E17). Following the derailment, the severe loadings from the impacts with the foot crossing and AWS magnet are likely to have caused the bolted joints to slip at the joint interface and the bolt pre-load to drop further. Once the bolt preload is lost, the bolts are vulnerable to unwinding under vibration.

Figure D5: Loose bearing housing bolts (values above in Nm of torque tightness)

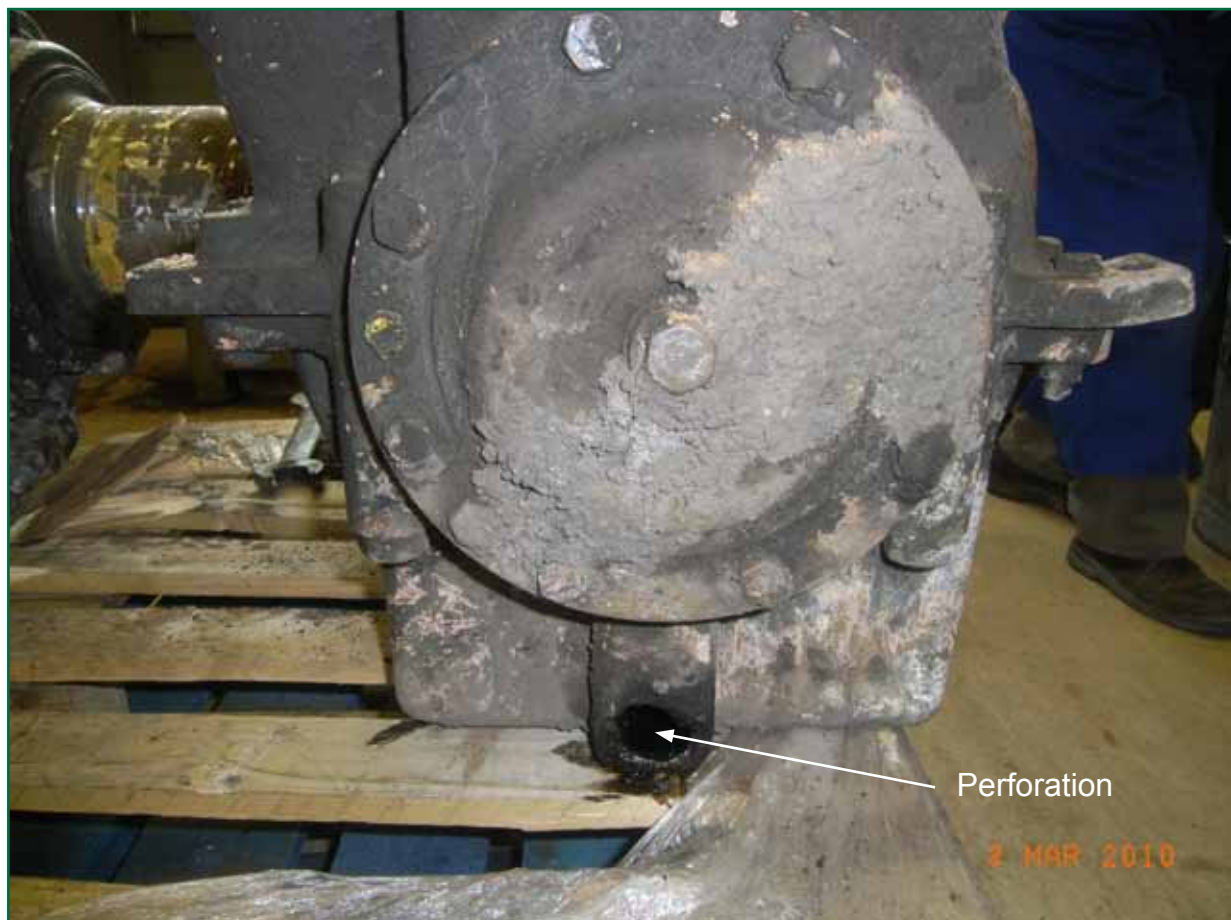
- The top cover plate had been sheared off by contact with the track when the gearbox was upside down. Observations from site are consistent with a band of smeared oil, approximately the width of this top cover plate, on the sleepers.

Figure D6: Perforation in the bottom of the gearbox

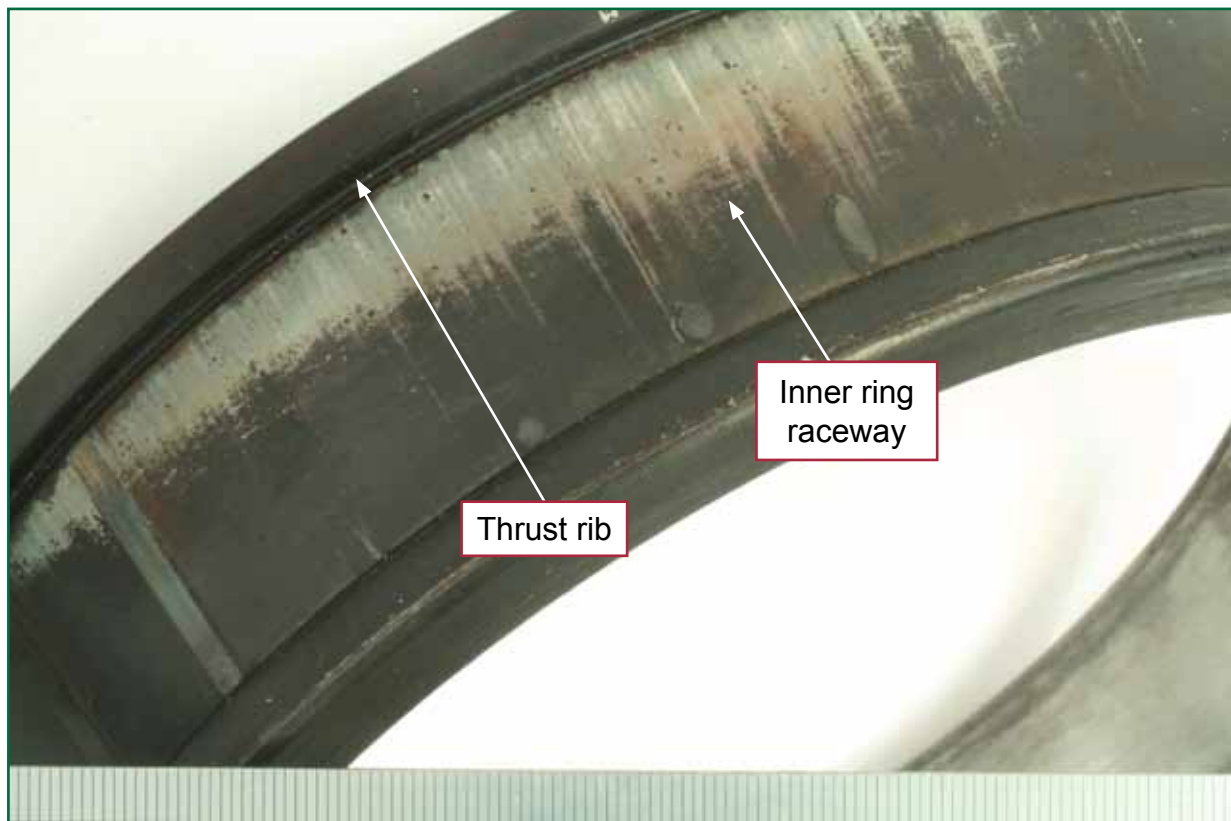
Figure D7: NGE bearing inner ring thrust rib (courtesy of ESR)

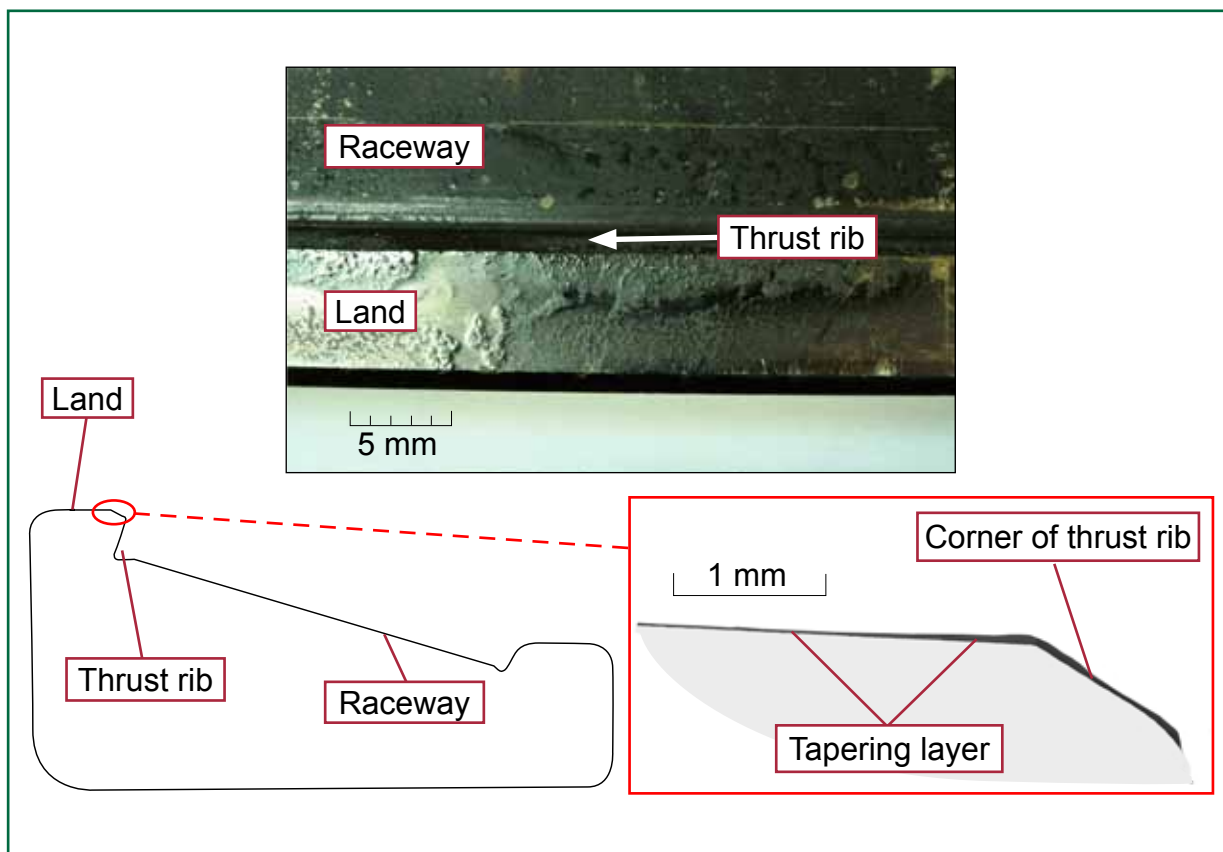
- D36 There was a blackish carbon deposit on the interior surfaces of the gearbox casing, axle and NGE bearing, indicating that oil had been falling on these surfaces during the failure. In particular the thrust rib of the NGE bearing (figure D7) had a layer of carbon deposit on the inner race and around the corner of the thrust rib. The thickest part of the layer on the thrust rib was around 40 - 50  $\mu\text{m}$  at the corner (the hottest exposed part of the rib) and tapered down in thickness over the land (figure D8). These deposits indicated that oil had been present while the bearing was running hot. Metal particles found embedded in the layer also indicated that the oil was in liquid rather than vapour form as vapour could not have transported the metal particles onto the surface of the thrust rib.

Figure D8: Carbon deposit on thrust rib of NGE bearing (photograph courtesy of ESR)
