Rail Accident Investigation Branch

# Rail Accident Report

## **Passenger train derailment near East Langton, Leicestershire 20 February 2010**

Report 01/2012  
January 2012

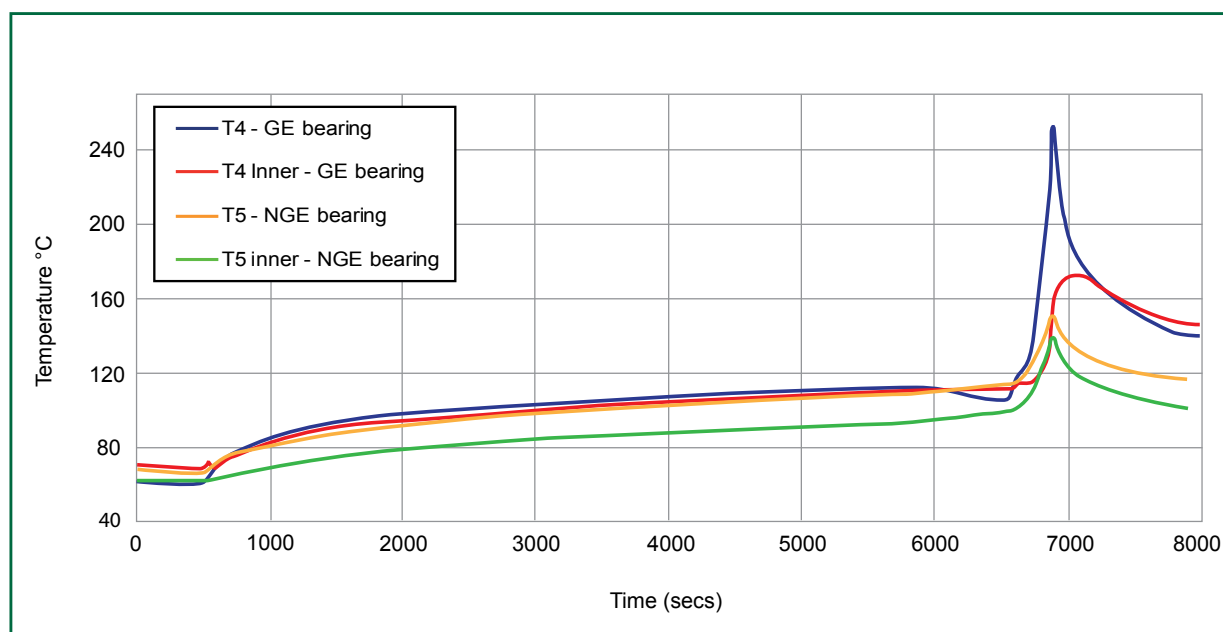
- E14 Increasing the oil fill to 7 litres or reducing the oil to 4 litres and then 3 litres did not have a significant effect on the output bearing temperatures. At 2 litres of oil, there was a drop in temperature to 100°C on the outer ring of the GE bearing. When the cooling fan was switched on, there was a noticeable rise in temperature at both the GE and NGE bearing, to 120°C and 109°C respectively. This tendency for the output bearing temperatures to rise when cooling air was directed at the casing was also noted on gearbox 3 (paragraph E20) and is discussed at paragraphs 88 and 91.
- E15 At 1 litre of oil, the gearbox ran for around 100 minutes without incident but shortly after the cooling fan was switched on, the GE bearing temperature rose sharply to around 250°C (figure E3) and then it failed. The NGE bearing temperature had also risen from around 112°C to around 150°C.

Figure E3: Output bearing temperature rise of gearbox 2 at failure with 1 litre oil

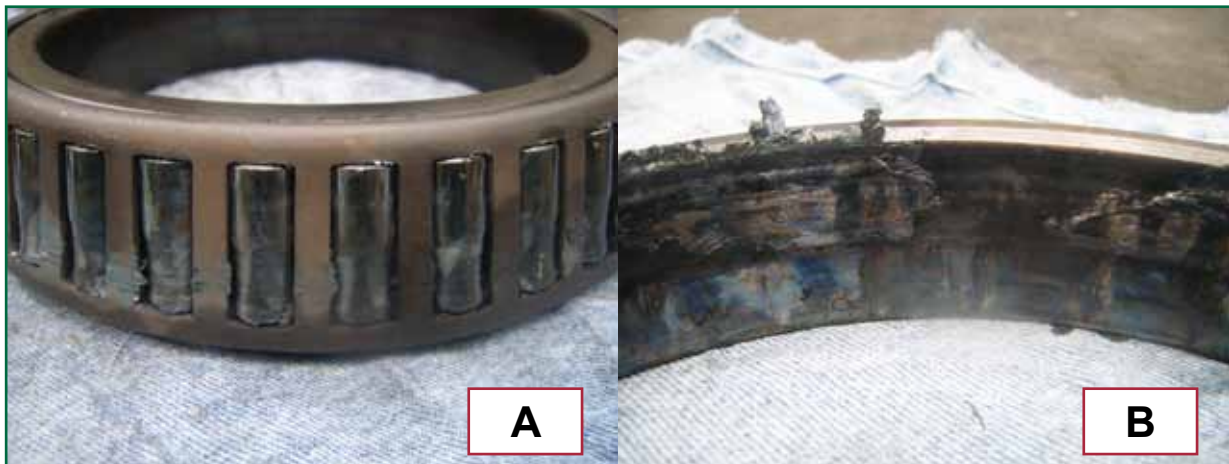
- E17 When gearbox 2 was stripped down the gears were found to be in good condition with no scuffing of the bevel gears and some minor indentation damage on the helical gears due to debris from the failing bearing. The seat of the GE bearing on the axle was covered in fretting residue and there was evidence of metal pick-up and welding between the inner ring and the abutment face of the adjacent gear wheel, indicating that the inner ring had been rotating relative to the axle and stopping from time to time. The GE bearing rollers were deformed (figure E4) and there was heavy metal smearing on the outer raceway. The torque tightness of 7 of the 12 bolts securing the gear-side output bearing housing were noted to have reduced (to between 140 and 190 Nm) from the nominal assembly torque tightness of 200 Nm.

Figure E4: GE bearing from gearbox 2 after failure at 1 litre oil showing rollers and cage (A) and smeared material on outer raceway (B)

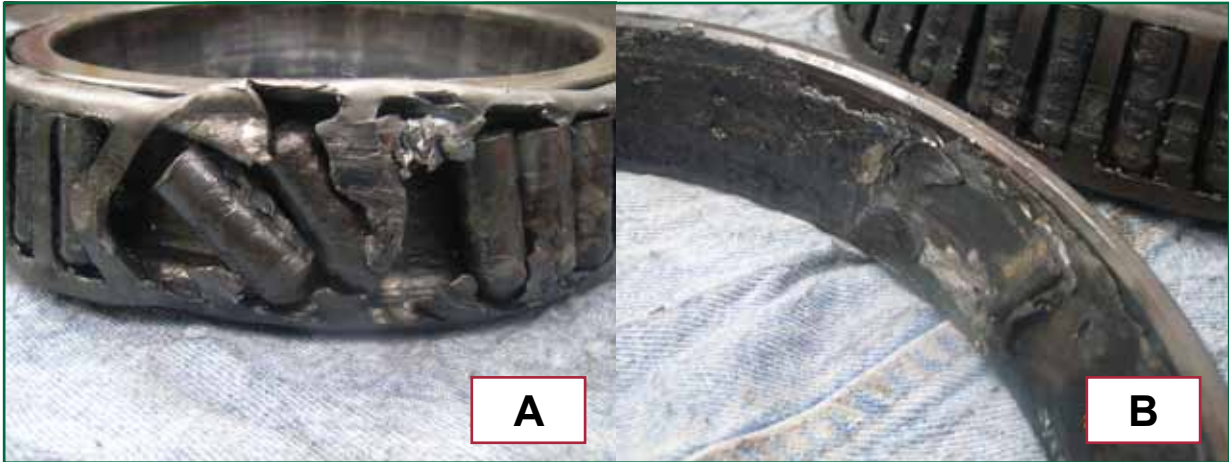
- E25 The GE output bearing was severely damaged (figure E7). The cage was broken and the rollers were skewed in the raceway and deformed, particularly at the ends running on the thrust rib, which had become rounded. There was also heavy metal smearing on the outer raceway.

*Figure E7: GE bearing from gearbox 3 after failure showing rollers and cage (A) and smeared material on outer raceway (B)*
