Rail Accident Investigation Branch

Rail Accident Report

**Tamper driver struck by a train at Torworth level crossing
8 January 2011**

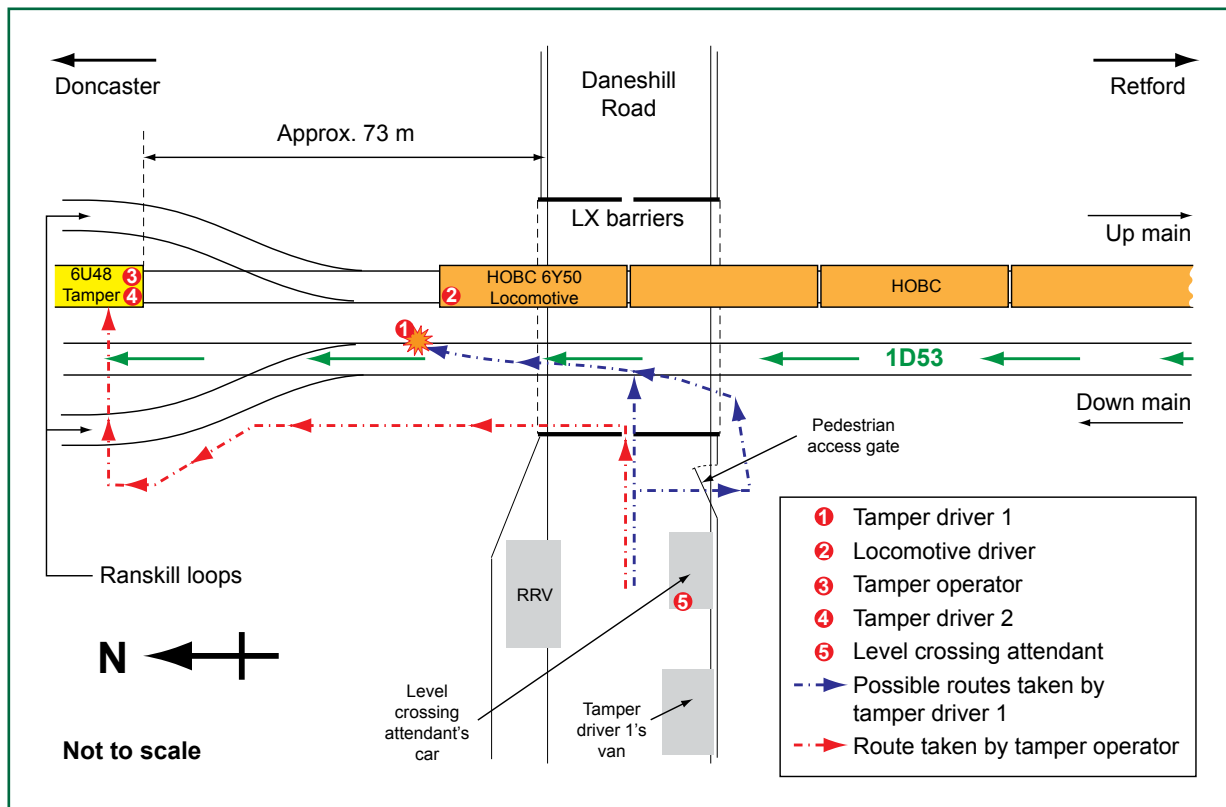
- 6 The tamper was stationary on the *up* main line, on the north side of Torworth level crossing (figures 2 and 5). Tamper driver 1 had accessed the *down* main line at Torworth level crossing and was walking toward the tamper in the *four-foot* of the down main line with his back to on-coming traffic.
- 7 He heard a train horn and turned to see train 1D53 approaching him at speed. He tried to get clear but was struck a glancing blow to the left side of his body. The train driver judged that tamper driver 1 had moved clear and did not stop his train or report a 'near miss'.
- 8 Tamper driver 1 was taken to hospital but not detained. He suffered severe bruising to his left upper leg from the impact and injuries to his right arm and shoulder from his fall. He was unable to work for 18 weeks.

Figure 2: Plan showing locations of witnesses to accident and different routes taken from level crossing to tamper

81 The down main cress at 1.7 metres wide was wide enough to provide a safer walking route than the four-foot. However, tamper driver 1 chose to take a more direct route to the tamper. He stated that he considered it necessary (paragraph 63) to walk in the four-foot because of the points machine and cabling in the cress (figure 5) which, with only the light from his head torch, he assessed to be tripping hazards. In contrast, the tamper operator had earlier walked in the down main cress and down loop cress before crossing directly to the tamper (figure 2).

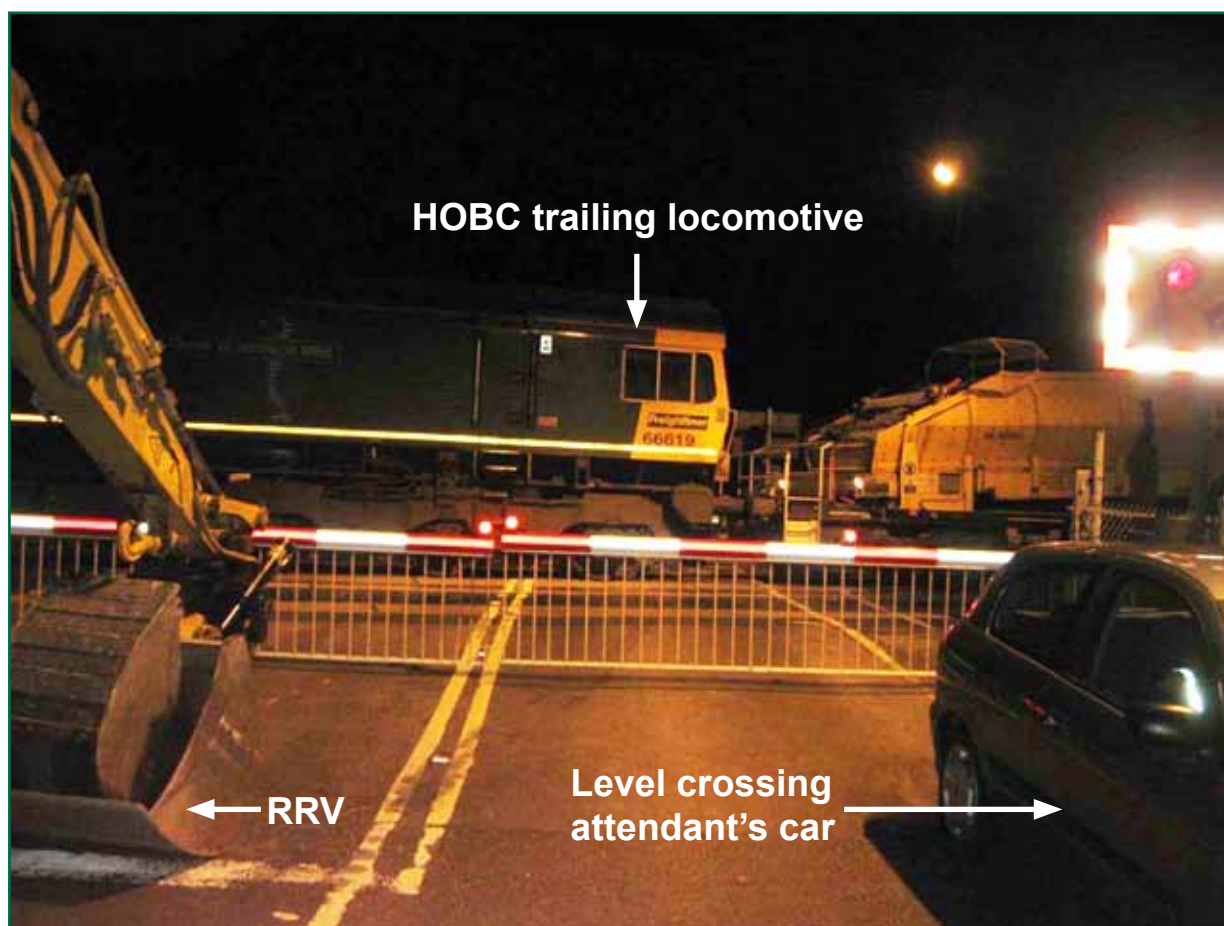
Figure 3: Torworth level crossing on the night of the accident (photograph courtesy of Network Rail)

- 20 The HOBC, train 6Y50, consisted of 45 vehicles comprising the ballast cleaning system, and a locomotive at each end of the train. The train, which was approximately 760 metres long, had been formed at Doncaster Wood Yard depot and departed around 21:00 hrs for the *work site*. At 23:22 hrs it was brought to a stand in the work site on the up main line with the trailing locomotive on Torworth level crossing (figure 3).

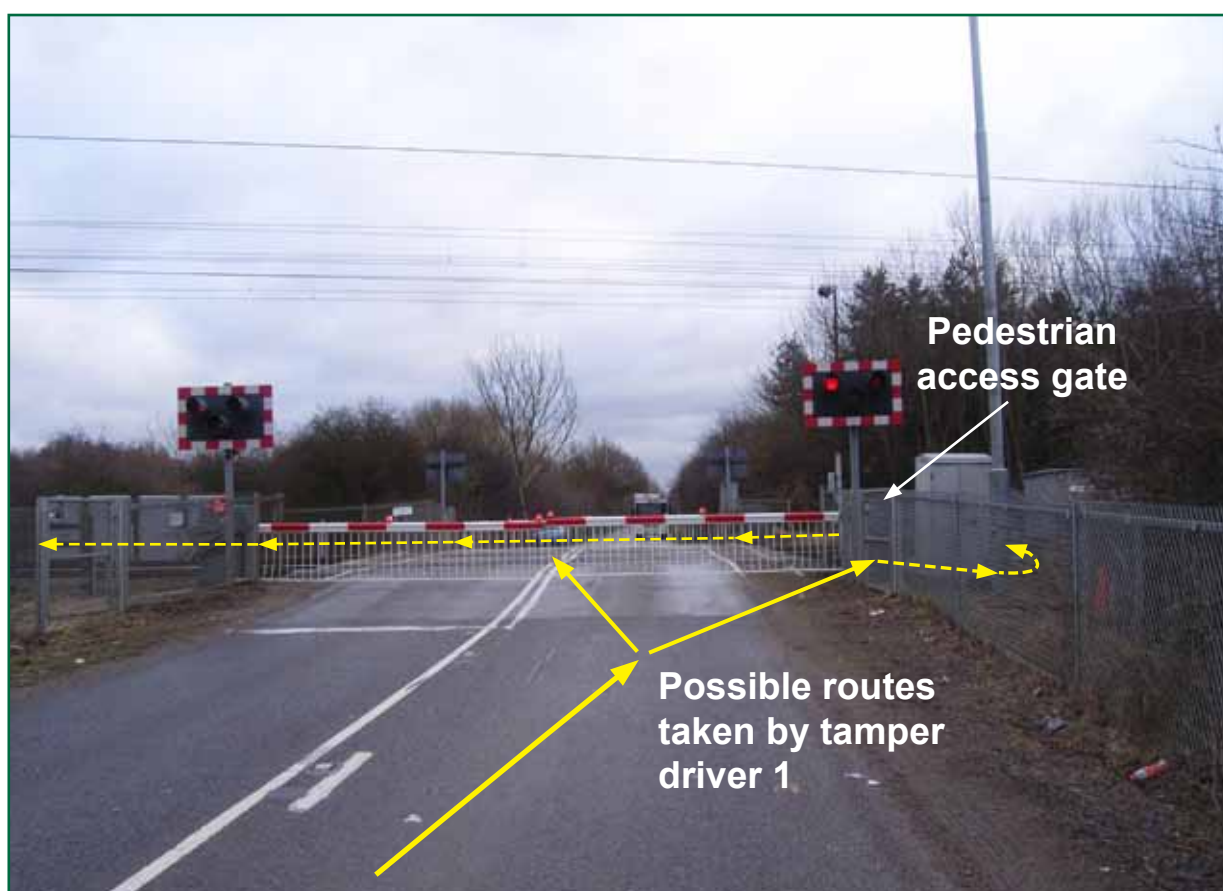
- 41 Tamper driver 1 was unable to follow the directions and got lost, finding himself in Retford, about 8 km beyond Torworth. He telephoned tamper driver 2 again for further directions and finally arrived at Torworth level crossing at around 23:50 hrs.
- 42 Tamper driver 1 parked his van on the roadway with other vehicles on the west (down) side of the level crossing and put on his PPE, including an orange overall and a hard hat with a head torch. He set off towards the level crossing carrying a shoulder bag on his right shoulder (figure 4).

Figure 4: Torworth level crossing viewed from the west, showing location of access and route of tamper driver 1

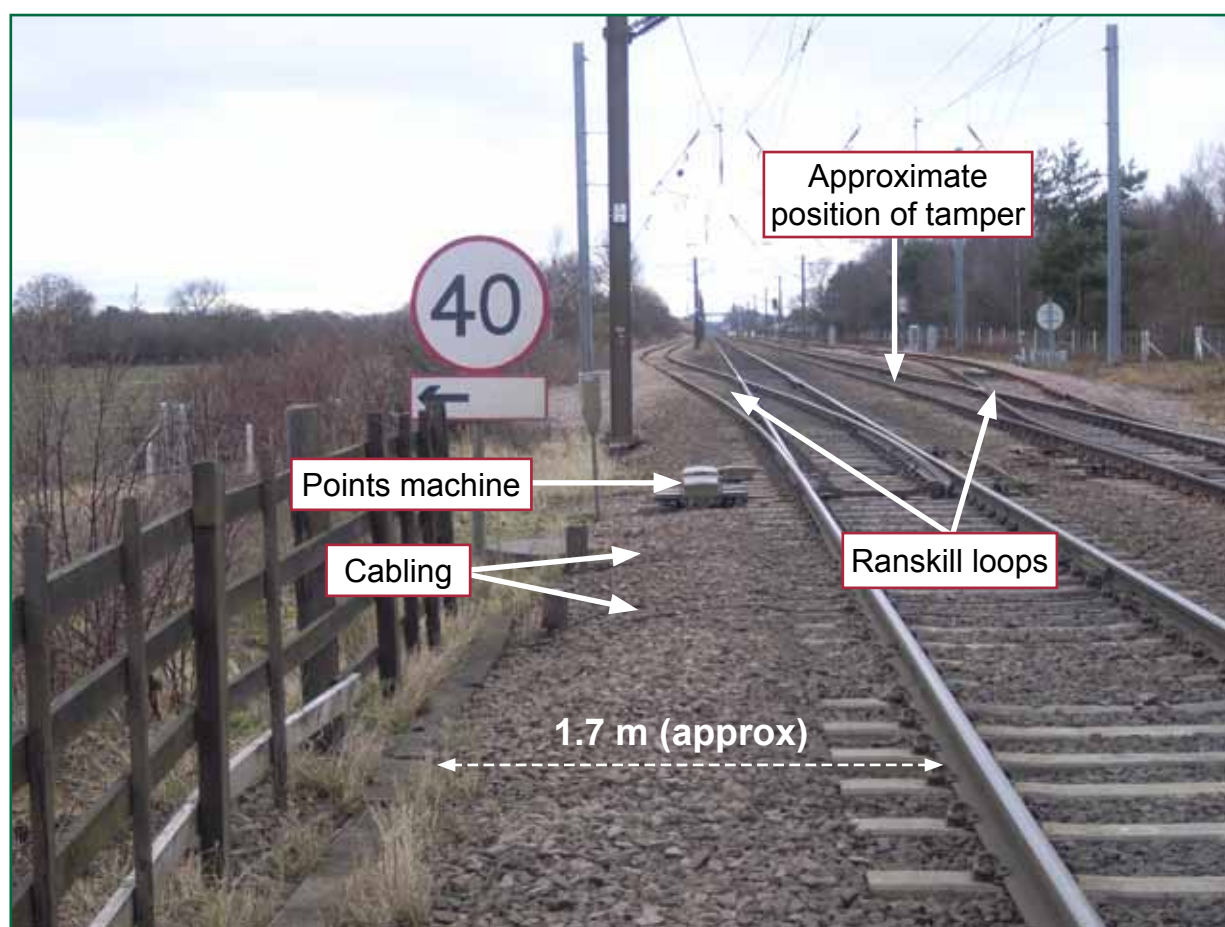
- 64 There was no authorised walking route or pathway on the down side, north of Torworth level crossing. The cess on the down main line side is approximately 1.7 metres wide and continues around the down loop line. There is a points machine and cabling in the cess approximately 22 metres north of the level crossing (figure 5).

Figure 5: Photograph showing down main cess on north side of Torworth level crossing
