Rail Accident Investigation Branch

Rail Accident Report

Incident at Llanbadarn Automatic Barrier Crossing (Locally Monitored), near Aberystwyth, 19 June 2011

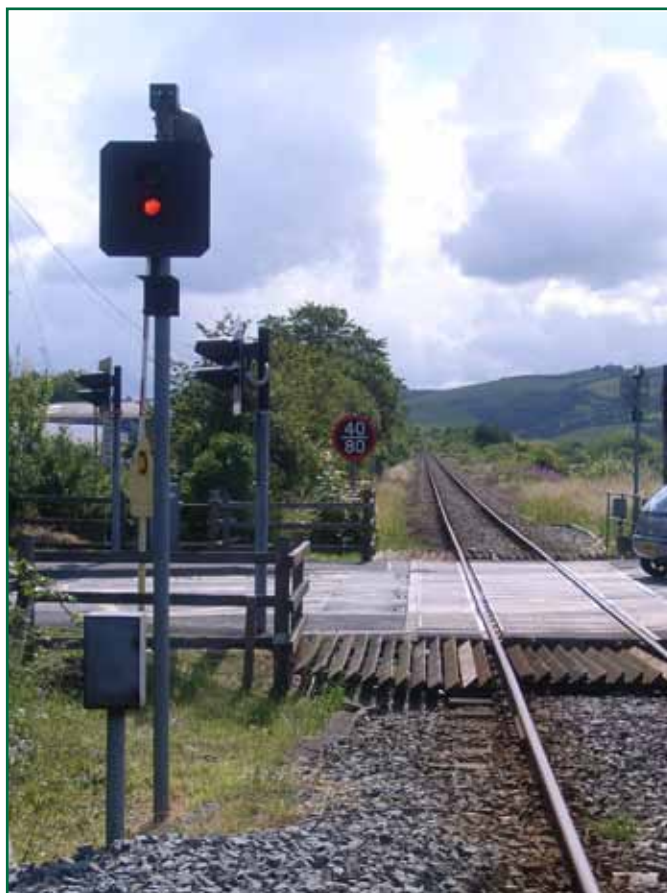
Figure 6: Llanbadarn ABCL showing driver's crossing indicator (DCI) flashing red

- 97 **The immediate cause of the incident was that the driver did not notice that the driver's crossing indicator (DCI) was flashing red until it was too late to stop at the crossing.**
- 98 Forward facing CCTV evidence confirms that at the time of the incident the DCI was flashing red and that the crossing was operating as designed.
- 99 The driver did not apply the brakes until four seconds after passing the sighting board. Had he applied the brakes at the time he reached the sighting board, he would have been approximately 50 metres further from the crossing in the braking sequence and would have stopped 46 metres before the crossing and 39 metres before the DCI.

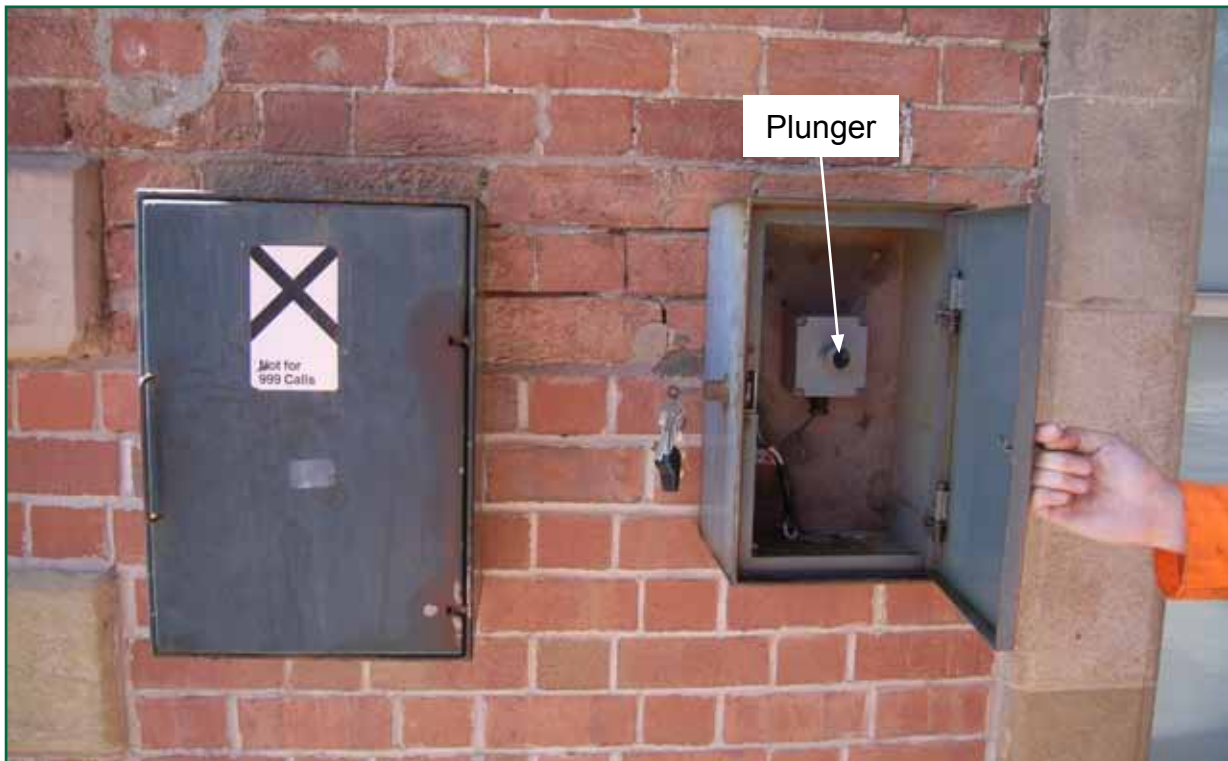
Figure 7: Plunger on platform

⁴ A plunger (push button) that is operated by a member of train crew, when the train is ready to depart. The plunger operates signalling equipment associated with Llanbadarn ABCL and AOCL crossings.

- a. The plunger at Aberystwyth will not reset and begin timing again, if pressed again during its 10 minute timing period. The absence of a train driver's awareness of this may lead to potential confusion (**paragraph 170, Recommendation 2**).
- b. The RSSB were unable to provide the RAIB with information concerning why the Control Command and Signalling Standards Committee chose not to follow the RSSB's recommendation (**paragraph 155, Recommendation 6**).

- 2 *The intention of this recommendation is to provide automatic protection at Llanbadarn crossing (similar to that provided at manned barrier crossings) and to remove the plunger at Aberystwyth station.*

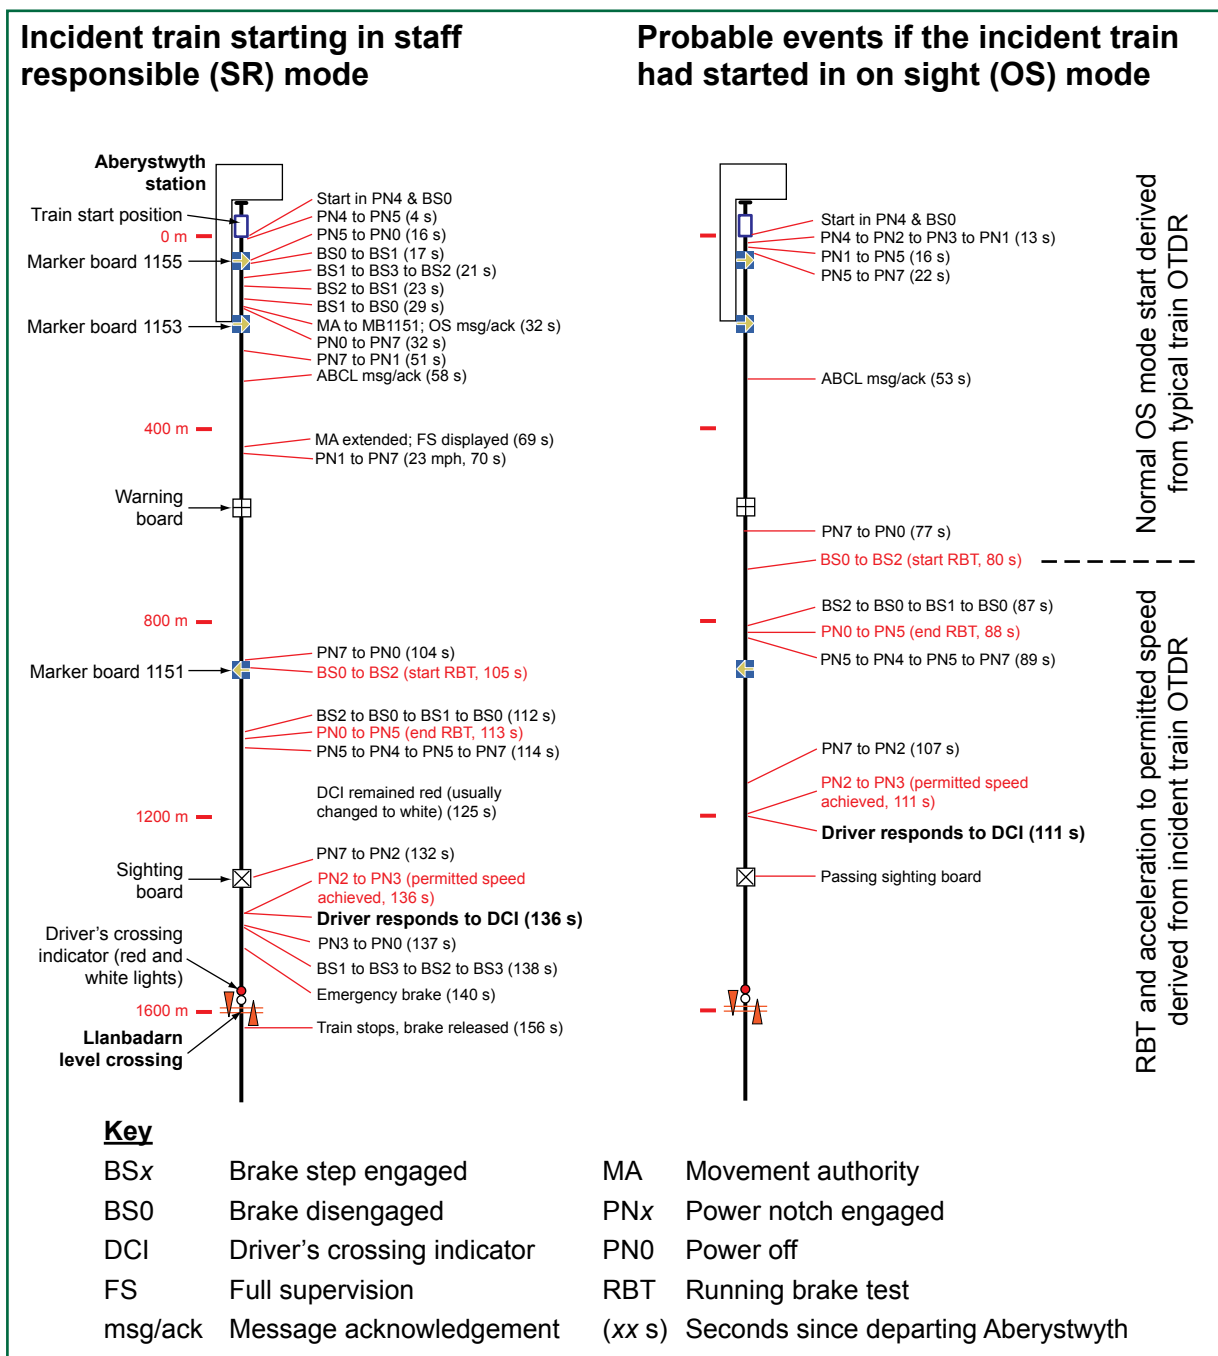
Figure 12: Driver's tasks for incident train (The start and end of the RBT and achieving the permitted speed are highlighted in red)

- a. The driver's workload (on departing Aberystwyth) was such that he was distracted by concentrating on the ERTMS DMI screen (**paragraph 100, Recommendations 3 and 4**);
- b. Llanbadarn ABCL crossing closure sequence did not start (barriers or lights) when train 2J50 reached the strike-in point (**paragraph 123, Recommendation 2**);
- c. The driver was pre-occupied with accelerating after the running brake test (**paragraphs 104 and 117, no recommendation made (paragraph 182)**); and
- d. The ERTMS system (on-board the train) was reset by the driver on instructions of the signaller (**paragraph 110, no recommendation made (paragraph 181)**).

- 3 *The intention of this recommendation is that the train operating company undertake a study into drivers workload when departing Aberystwyth station.*
