Rail Accident Investigation Branch

Rail Accident Report

Derailment at Bordesley Junction, Birmingham 26 August 2011

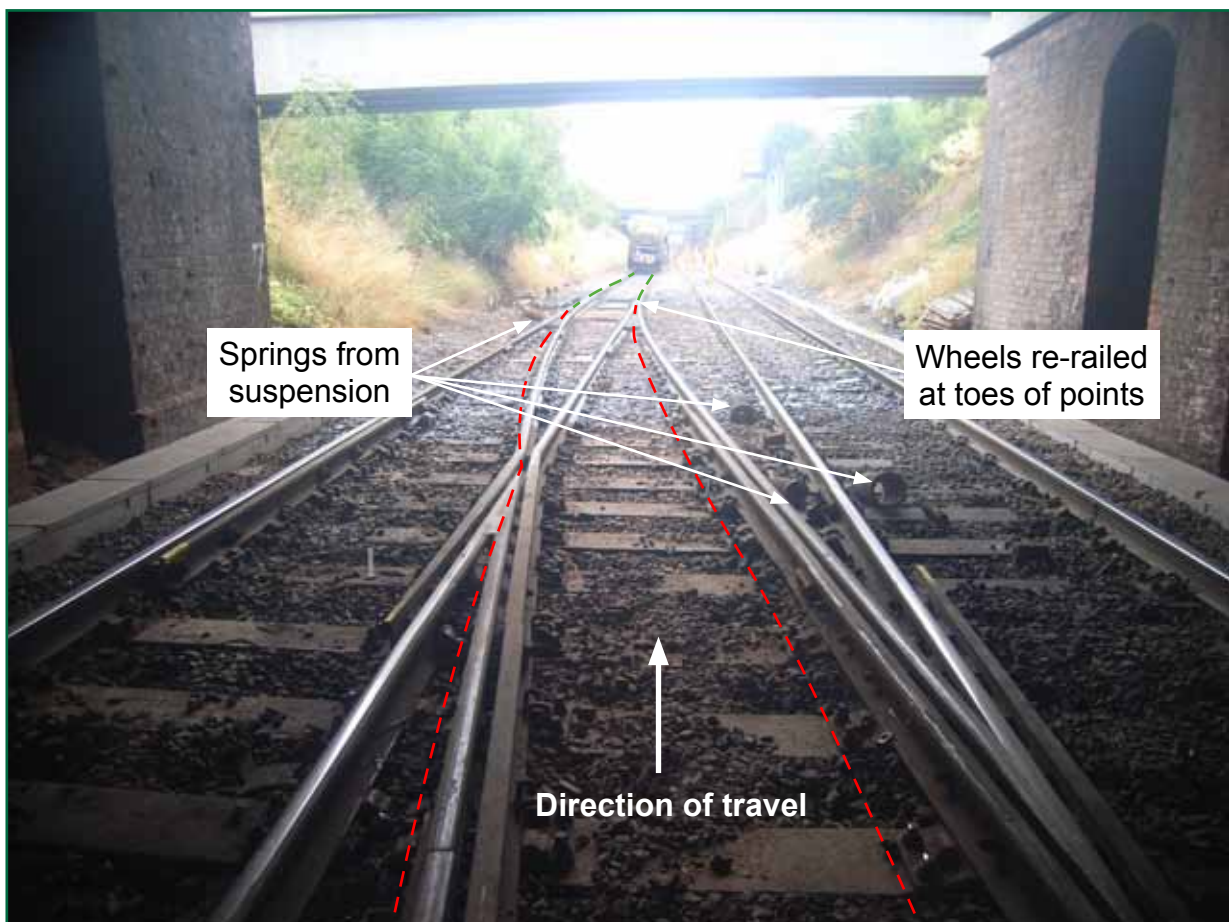
Figure 6: Crossing for 633A points where the wheels re-railed

- 30 After about 100 metres, the derailed wheels were guided back towards the Up Camp Hill line by the rails that form crossover number 633 (figure 4). All of the derailed wheels then re-railed on the Up Camp Hill line at the *toes* of 633A points (figure 6). While these wheels ran derailed, ten sets of coil springs were dislodged from suspensions and found between the fixed crossing and 633A points. The springs were found at places where the derailed wheels were subjected to large vertical movements, such as where they had struck rails and been dragged over them.

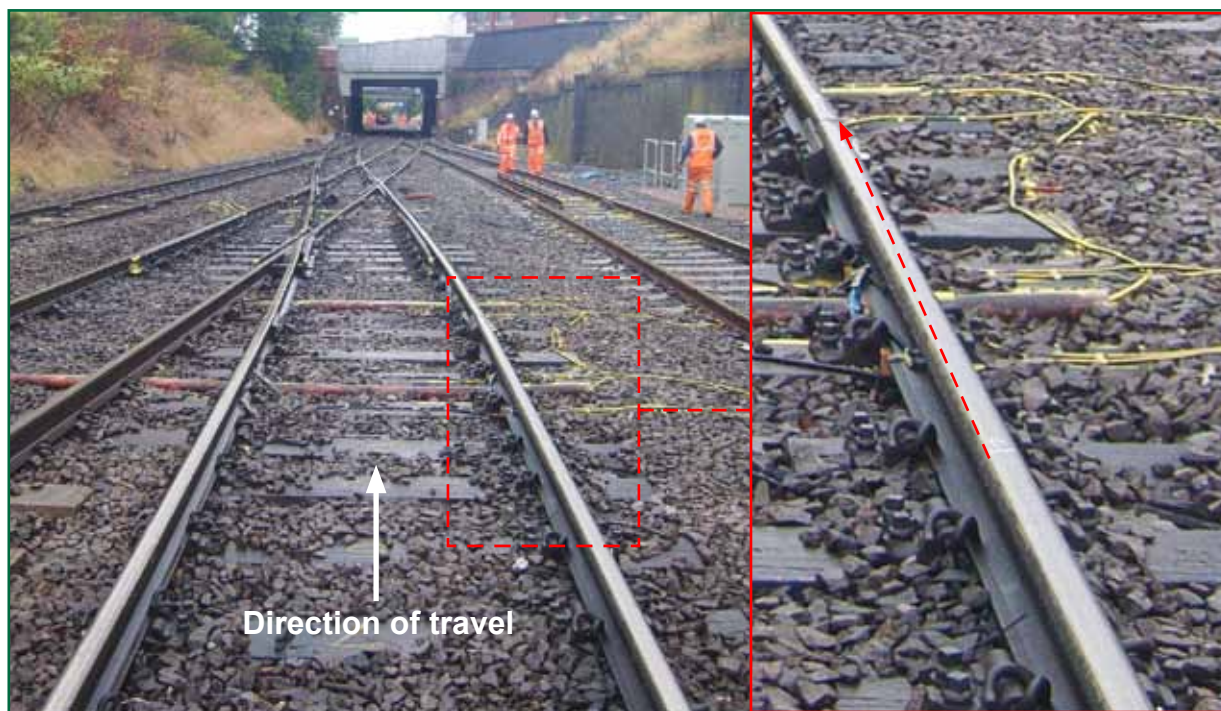
Figure 8: Point of derailment on the approach to the junction

- 53 **The leading right-hand wheel flange on wagon REDA 16066 climbed onto the rail head and then derailed to the right. This was due to a combination of factors related to the suspension on wagon REDA 16066 and the track geometry at Bordesley Junction.**
- 54 The RAIB found marks on the right-hand running rail that showed a wheel flange had climbed and run along the top of the rail for 3.6 metres before derailing to the right (figure 8). The RAIB did not find any other derailment marks on the track before this point.
- 55 The RAIB found no evidence or damage to the preceding wagons to indicate that they had run derailed; none of the wagons before REDA 16066 had scuff marks on their wheels caused by running on ballast. Only the rear four wagons had damage to their suspension.

- 56 The track where the leading right-hand wheel of REDA 16066 derailed was on a left-hand curve, and also canted with the right-hand rail higher than the left-hand rail. Both of these factors alter the angle at which the wheel flange makes contact with the running rail and make the leading right-hand wheel more prone to a *flange climb* derailment. These same factors also make it very unlikely that the trailing right-hand wheel on this wagon was the first wheel to derail.
- 57 The RAIB examined the marks on the track after the initial point of derailment and the couplings on the wagons. This evidence indicates that the following wagons were pulled into derailment at the fixed crossing where the Down Main (Bordesley) intersects the Down Camp Hill line. There is no evidence that the wagons behind REDA 16066 pulled it into derailment.

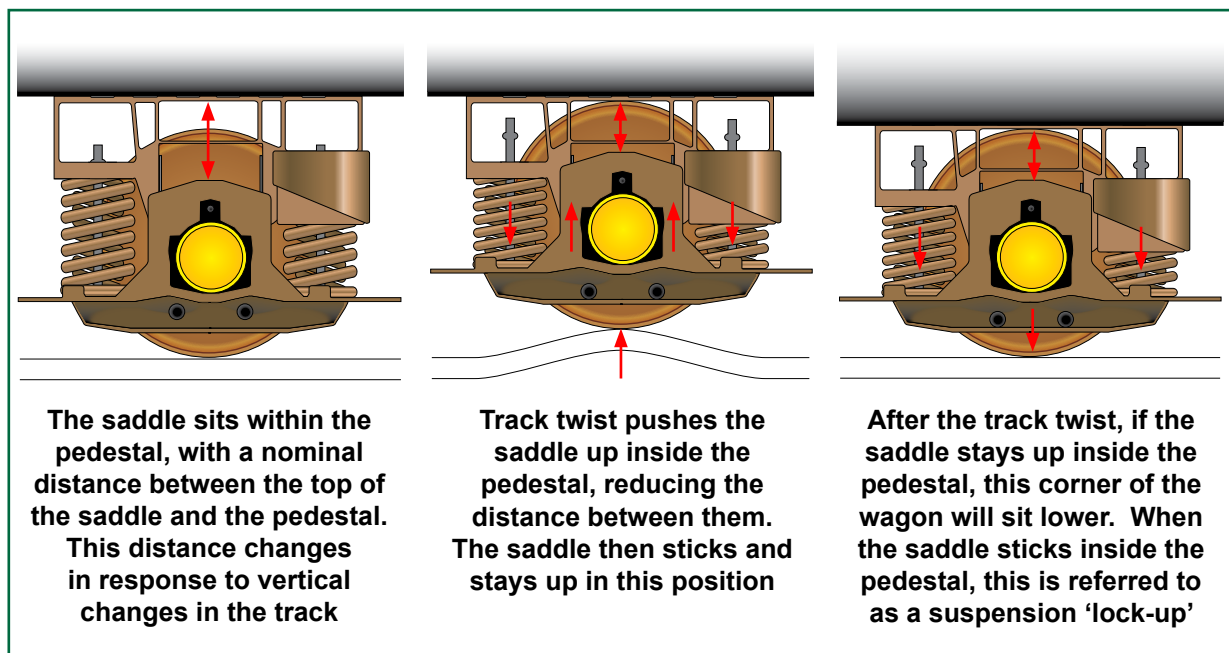
Figure 9: No vertical movement of the saddle within the suspension - a lock-up

- 60 Before the point where it derailed, REDA 16066 passed over track geometry that would have caused its trailing left-hand wheel to carry increased dynamic load. It is probable that this occurred at a track twist that the RAIB found about 8 metres before the point of derailment. At this location, the RAIB measured a 3 metre dynamic track twist of 1 in 193 (cant difference of 16 mm) and a dynamic twist of 1 in 212 (cant difference of 23 mm) over the wheelbase of the wagon (which is 4.775 metres).
- 61 When a wheel is loaded, the suspension on a PHA wagon reacts by allowing the saddle that sits on the end of the axle bearing to be pushed up inside the pedestal (figure 10). This meant that the track twist measured 8 metres before the point of derailment would have pushed the saddle on this corner up inside the pedestal by 23 mm relative to the other corners.

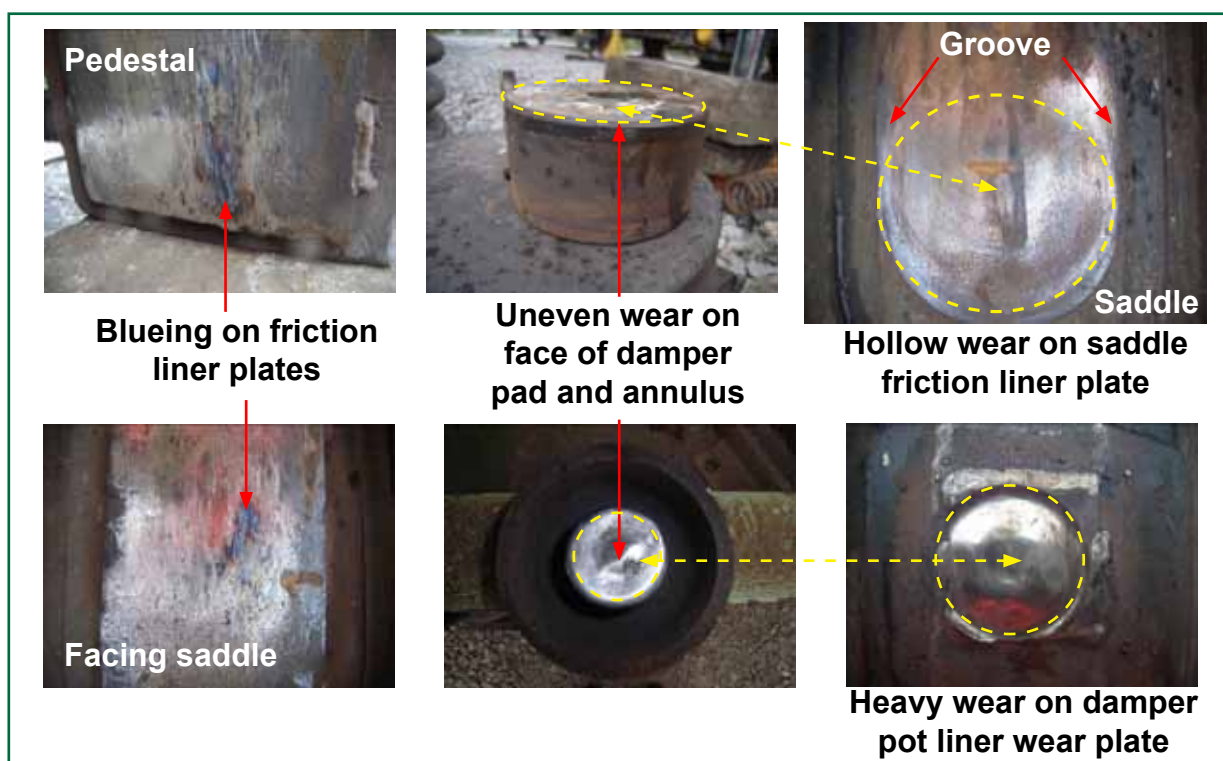
Figure 11: Components found on REDA 16066's trailing left-hand corner suspension

- 63 The RAIB's examination of the suspension components on the trailing left-hand corner of REDA 16066 found a groove worn into the saddle friction liner plate to a depth of 1.8 mm, uneven wear on the damper pad's face and also wear on the damper pot liner wear plate that was beyond the permitted maintenance limit (figure 11). The wear found on these components was consistent with the previous findings of the PWRAMG, which showed that such wear patterns would probably have caused the saddle to stick inside the pedestal in the loaded position.

- 64 The RAIB also found blueing on the pedestal friction liner plate and facing saddle friction liner plate (figure 11). This occurs when the material becomes heated to a temperature of about 300°C. Friction heating can occur when the two surfaces are pushed hard against each other and rub under load. It is a sign that the suspension had not been working normally and is often found after a wheel has run derailed.

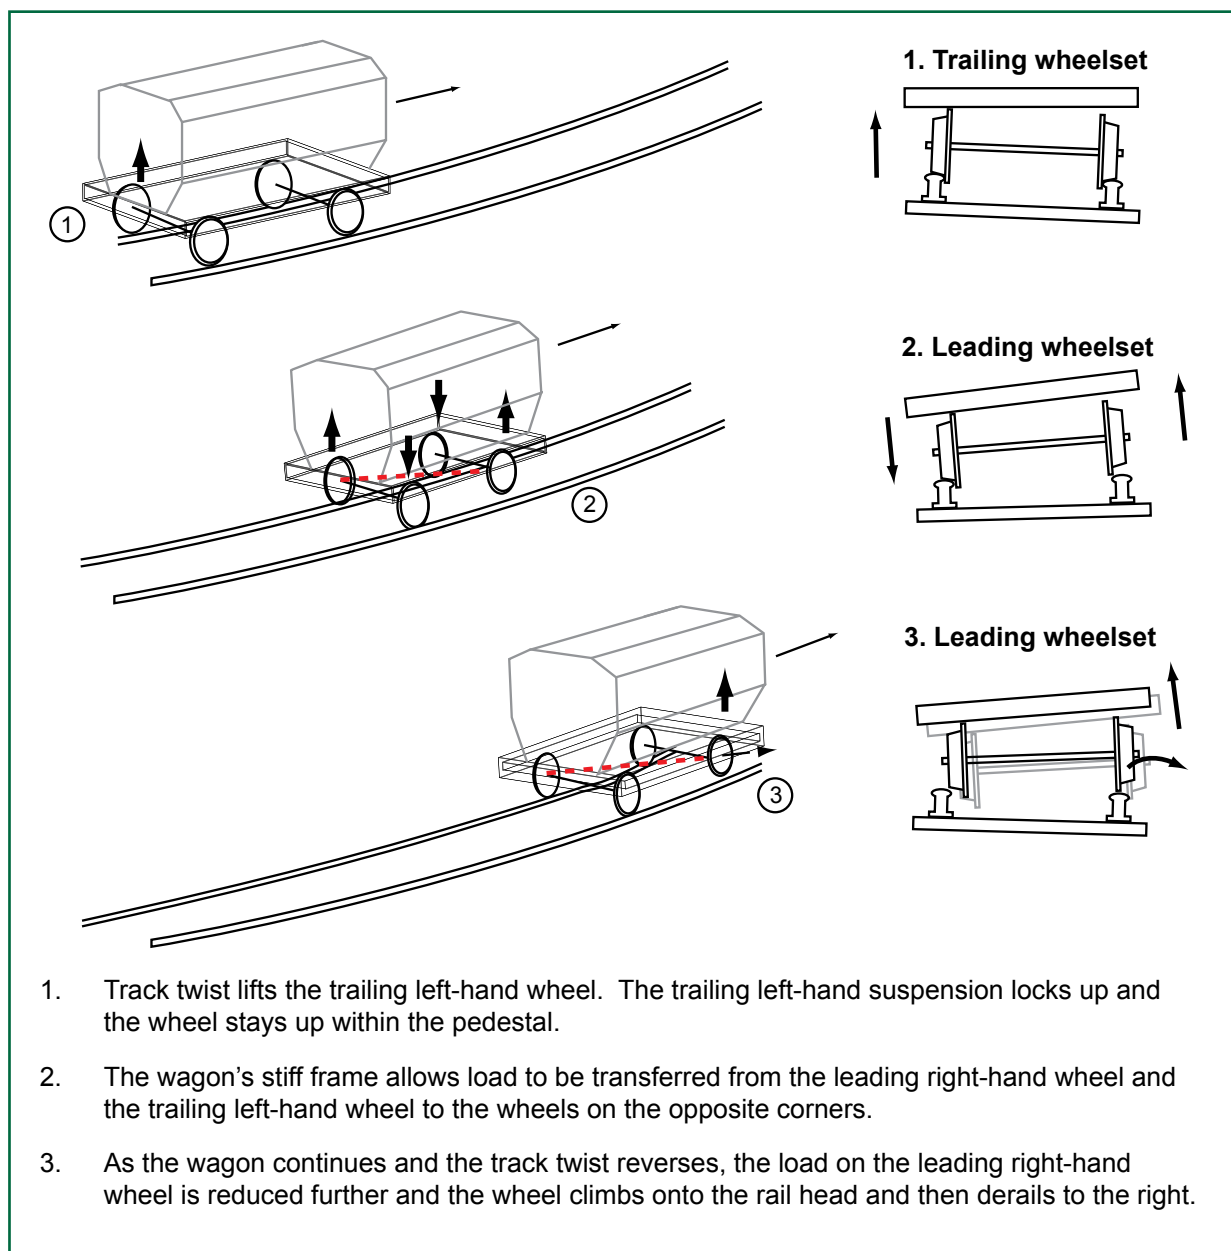
Figure 12: Transfer of wheel load on REDA 16066

- 65 Calculations showed that when a suspension lock-up occurs, the stiffness of the PHA wagon's frame allows wheel load to be transferred from the locked-up and diagonally opposite corner to the other two corners. As a consequence, if the suspension on the trailing left-hand corner of REDA 16066 locked-up in a loaded state, load will be transferred away from it and also the wagon's leading right-hand wheel (figure 12). With a reduced load on the leading right-hand wheel of REDA 16066, this wheel is then much more susceptible to derailing when a track twist is encountered that further reduces the load on it.

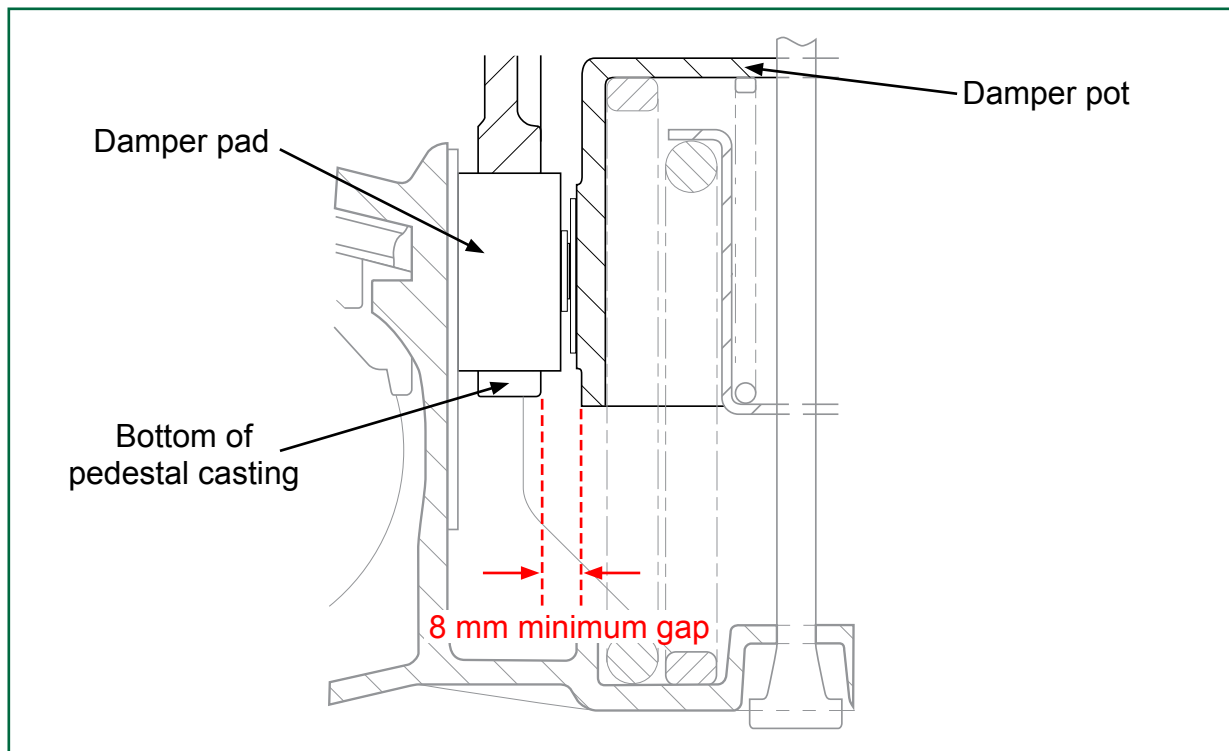
Figure 13: Damper pot clearance measurement

- 72 When the wagon is not lifted, staff assess the overall amount of wear within the suspension by taking a single measurement between the pedestal casting and the damper pot (figure 13). This distance is referred to as the damper pad clearance and the instructions allow a minimum distance of 8 mm. In February 2010 the clearance was 16 mm, and marked as a pass when the last VIBT and PPM examination took place. After the accident, the clearance was measured as 15 mm. However, post-accident repairs to the suspension to allow the wagon to be moved, meant this measurement was not representative of the condition before the derailment.

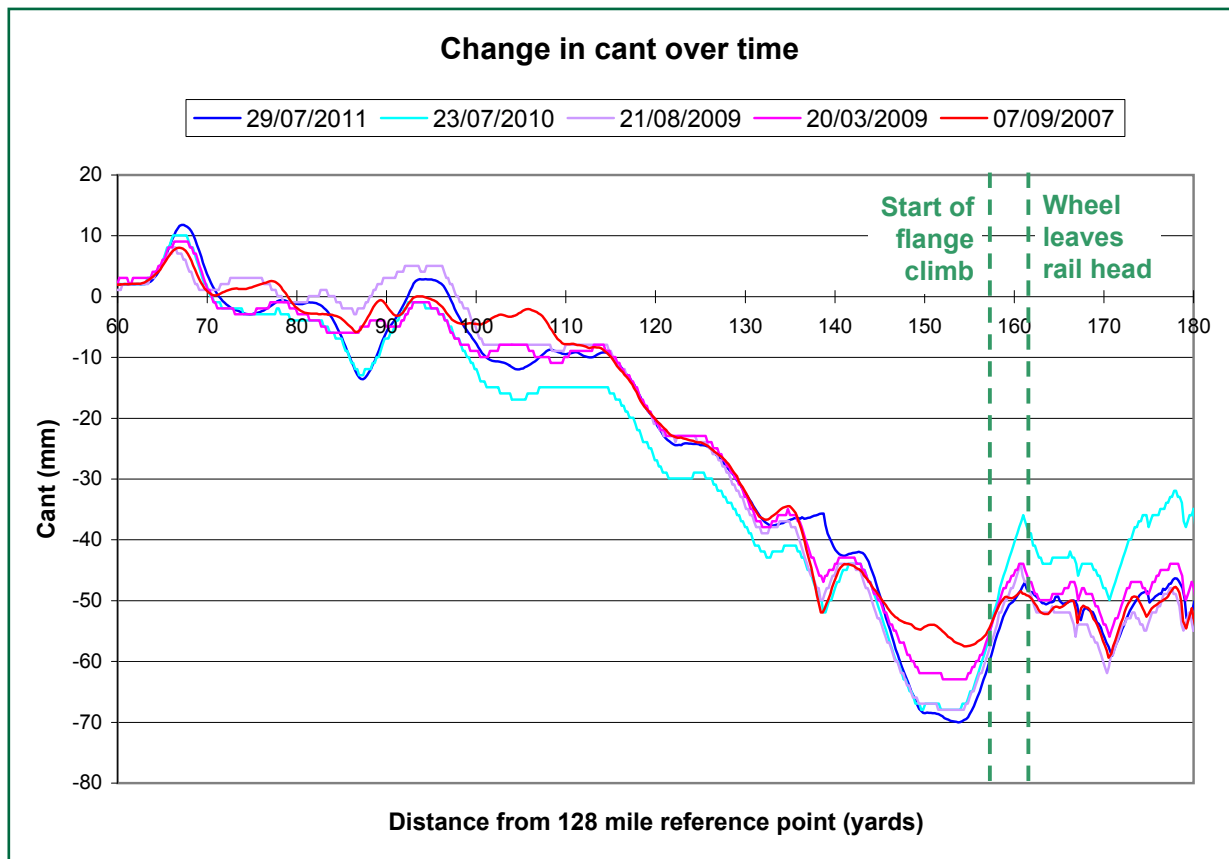
Figure 19: Change in cant over time at Bordesley junction

- 120 Similarly, the review meetings checked whether the faults had been signed off within the required time but no one took any action to look at why repeat faults were happening at Bordesley Junction. There was a general acceptance that the track formation in the vicinity of Bordesley Junction was poor which led to track geometry faults regularly being recorded there. The meeting attendees also knew that *tamping* work was planned to take place at the junction in August 2011 (paragraph 123).
- 121 The RAIB analysed the available track geometry data for the Down Main (Bordesley) line back to 2005. This showed that the track geometry where the track twists were found had deteriorated to the condition in which it had been at the time of the derailment by August 2009, but had not worsened since then (figure 19).

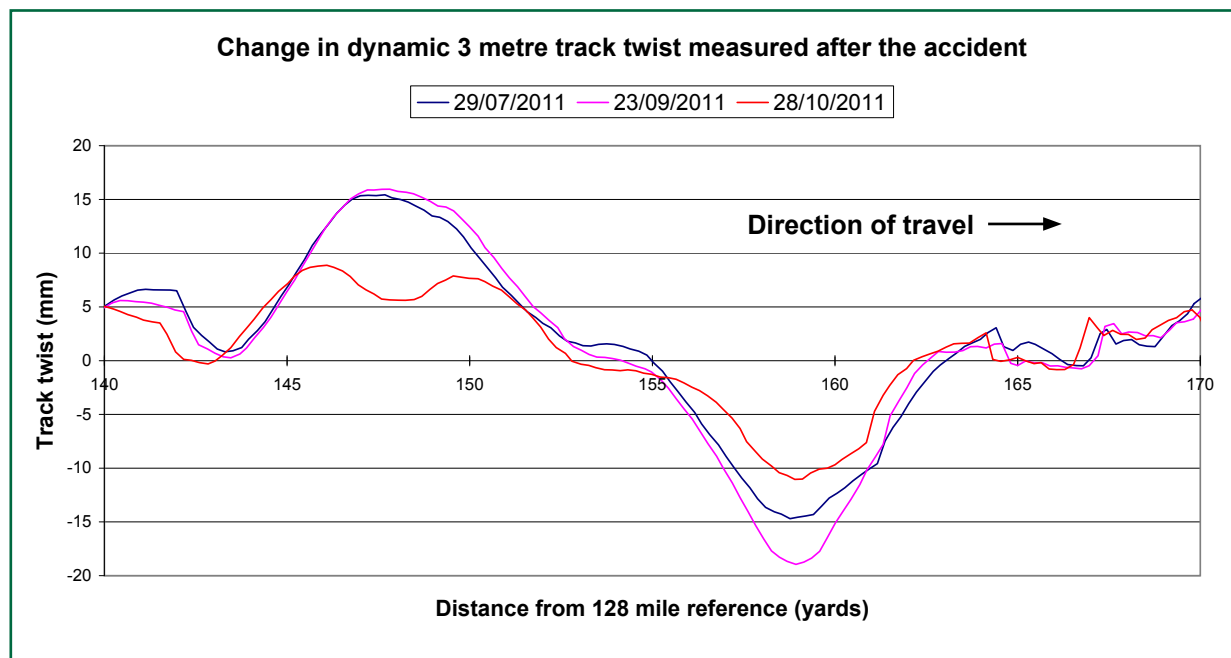
Figure 21: Changes in the measured track twist after the accident at Bordesley junction

143 On 23 September 2011, the track geometry recording train measured a track twist of 1 in 158 on the Down Main (Bordesley) line, just where train 6Z31 had derailed (figure 21). This was the first track geometry recording run after the accident.

144 A fault report was issued which required Network Rail maintenance to repair this fault within 14 days. Maintenance records show that measured shovel packing repair work took place over this mileage on 29 September. The next track geometry recording train run took place on 28 October and the amount of track twist that was recorded was reduced (figure 21). This indicates that on this occasion the repair work had been carried out in the correct place, as the track geometry had been improved, and it did not require further maintenance intervention after four weeks of traffic passing over it. Since Network Rail has carried out work to reduce the track twists on the Down Main (Bordesley) line, there is no need for the RAIB to make a recommendation about this.

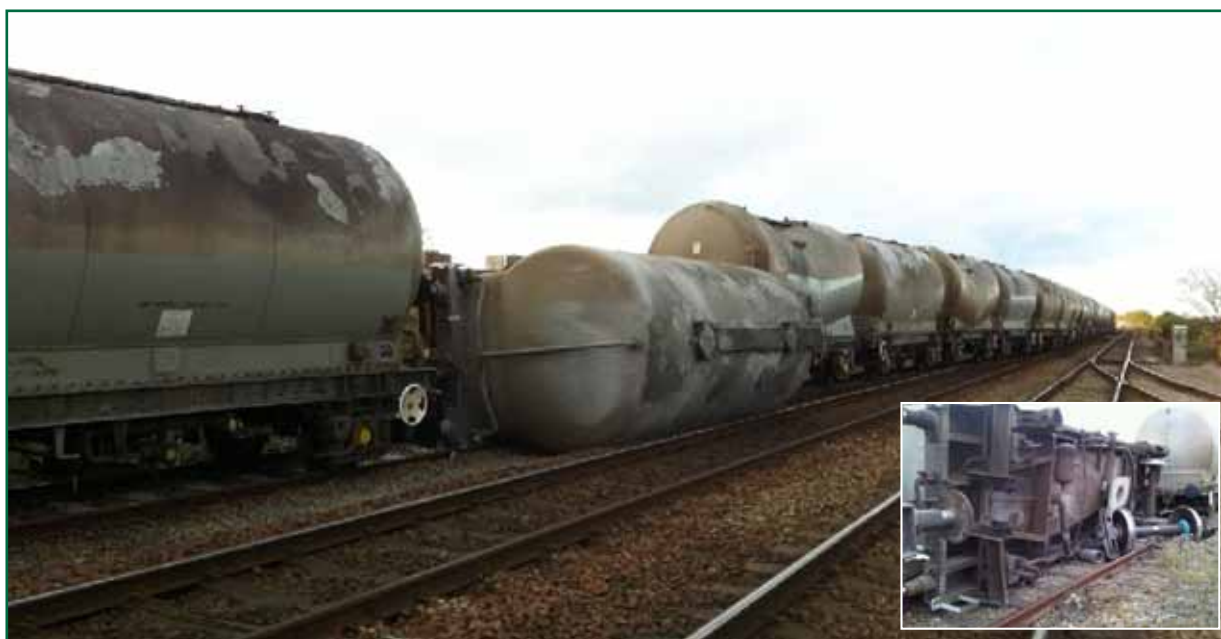
Figure 22: Train 6B32 derailed on exit to Craiginches Yard, Aberdeen (images courtesy of Network Rail)

- 151 While this investigation was in progress, a further derailment of PCA tank wagons happened at Craiginches yard, Aberdeen on 9 May 2012. The train involved was train 6B32, the 16:52 hrs Craiginches Yard to Oxwellmains service, operated by Freightliner. As the train of 25 empty PCA wagons was leaving the sidings, the flange of the leading left-hand wheel on the 19th wagon climbed onto the rail head on plain line within the yard. The derailed wagon was dragged for about 200-metres, overturning onto its side, before stopping foul of the running line the train was joining (figure 22).

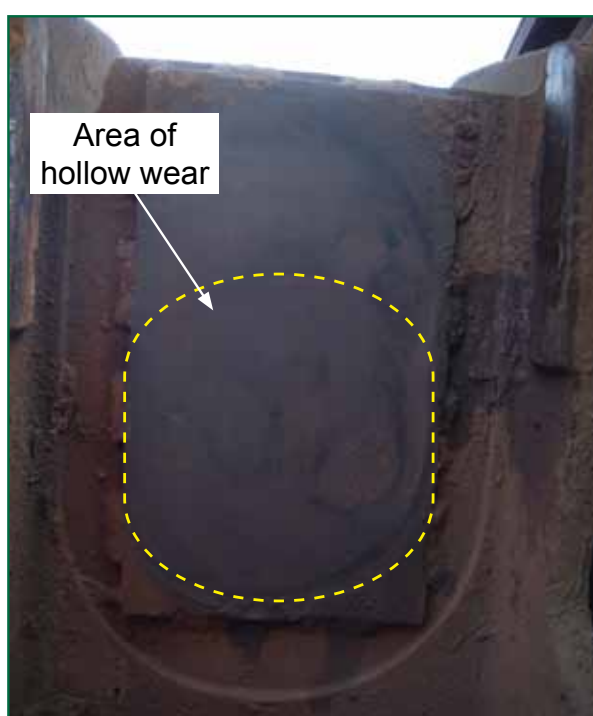
Figure 23: Hollow wear on the saddle friction liner plate on the leading left-hand corner

152 Network Rail surveyed the track, and voiding was measured before and at the point of derailment. This revealed a large dynamic 3 metre track twist of 1 in 96 just before the point of derailment. The RAIB examined the wagon after it was recovered and found hollow wear on the saddle friction liner plate in excess of 2 mm on the leading left-hand corner (figure 23). This pattern of wear was consistent with that found on REDA 16066 and the previous findings of the PWRAMG. Although the industry investigation of this accident is in progress, so its cause has not yet been formally confirmed, the wear patterns found indicate that the saddle on this corner would be susceptible to sticking inside the pedestal (paragraph 63).
