Rail Accident Investigation Branch

Rail Accident Report

Road vehicle incursion and subsequent collision with a train at Stowmarket Road, 30 November 2011

Report 25/2012
November 2012

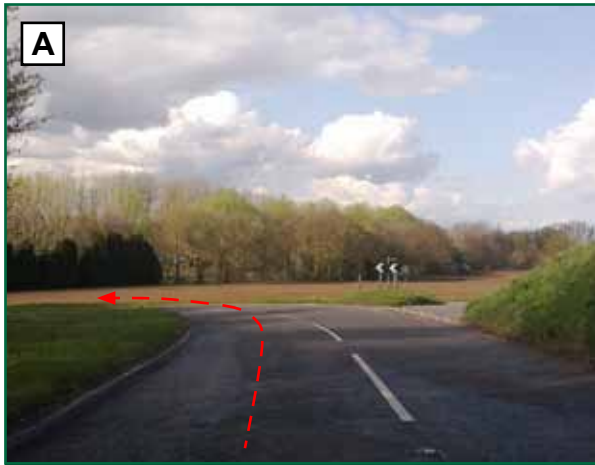
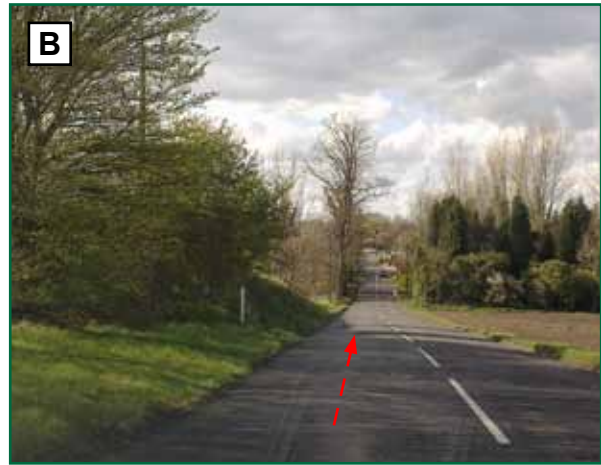
- 14 The highway at the location where the vehicle left the road has a soft verge to the left with a rising one metre high earth *bund* towards the boundary fence. The land then descends relatively steeply towards the cess and railway track.

Figures 3a and 3b: (left) Image showing left-hand bend on the Stowmarket Road leading to the downward gradient shown in figure 3b (right)

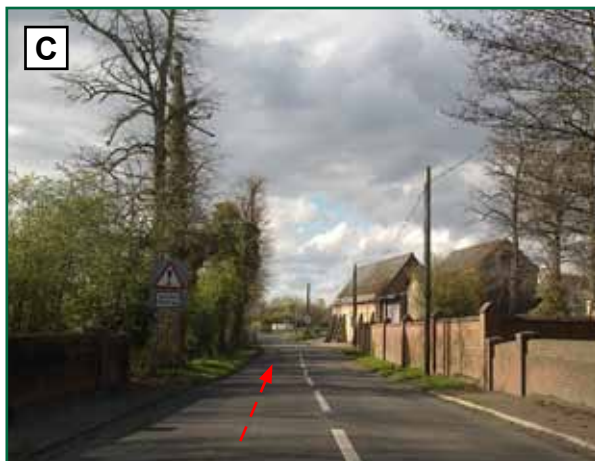
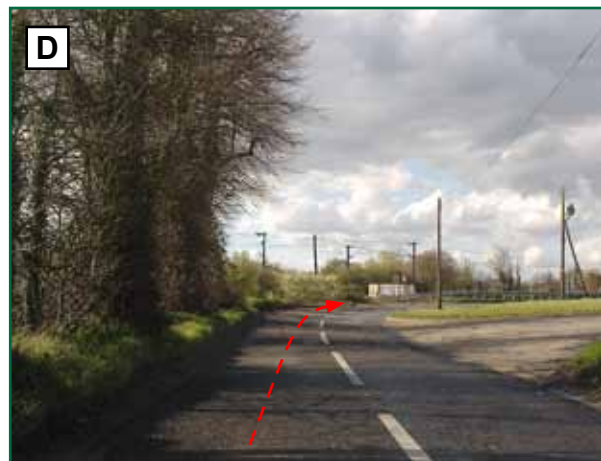
Figures 3c and 3d: (left) Image showing right-hand bend on the Stowmarket Road (LGV park entrance on right) leading to right-hand 'kiss bend' shown in figure 3d (right) where the road runs parallel to the railway

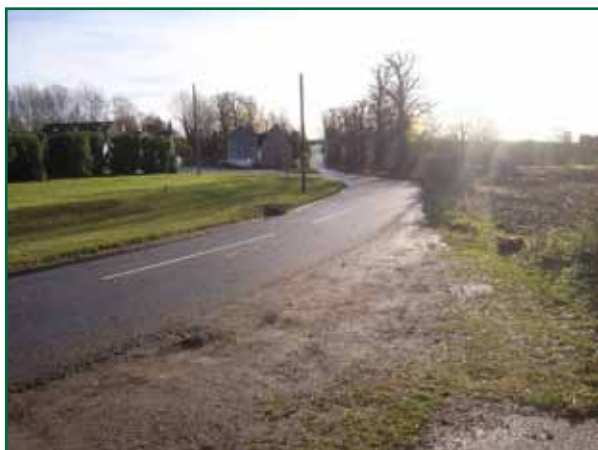
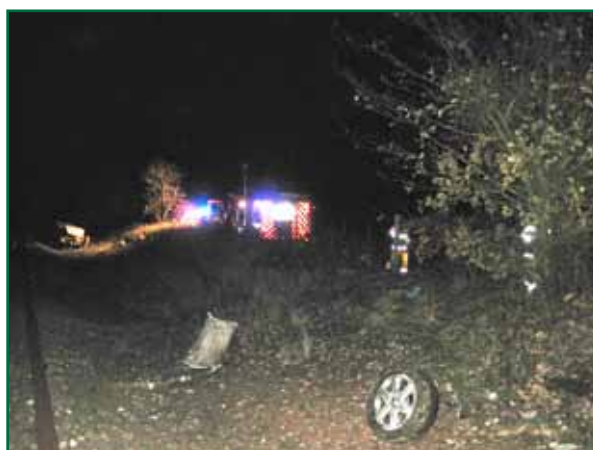
- 30 The motorist left his home south of Stowmarket at approximately 19:15 hrs to travel to Old Newton. At approximately 19:34 hrs, as he negotiated the right-hand bend adjacent to the railway, he felt the front and then rear of the car slide towards the left of the road. He attempted to rectify the skid and bring the car under control but was unable to do so. The vehicle hit the nearside verge and rolled over, turning lengthwise through 180 degrees, becoming airborne as it travelled backwards through the boundary fence, coming to rest upright with the rear of the vehicle foul of the railway line (figures 4a and 4b).

Figure 4a: (left) Image showing the direction of travel of the vehicle and image 4b (right) showing the accident scene from the railway side with motor vehicle in the background and associated debris in the foreground.

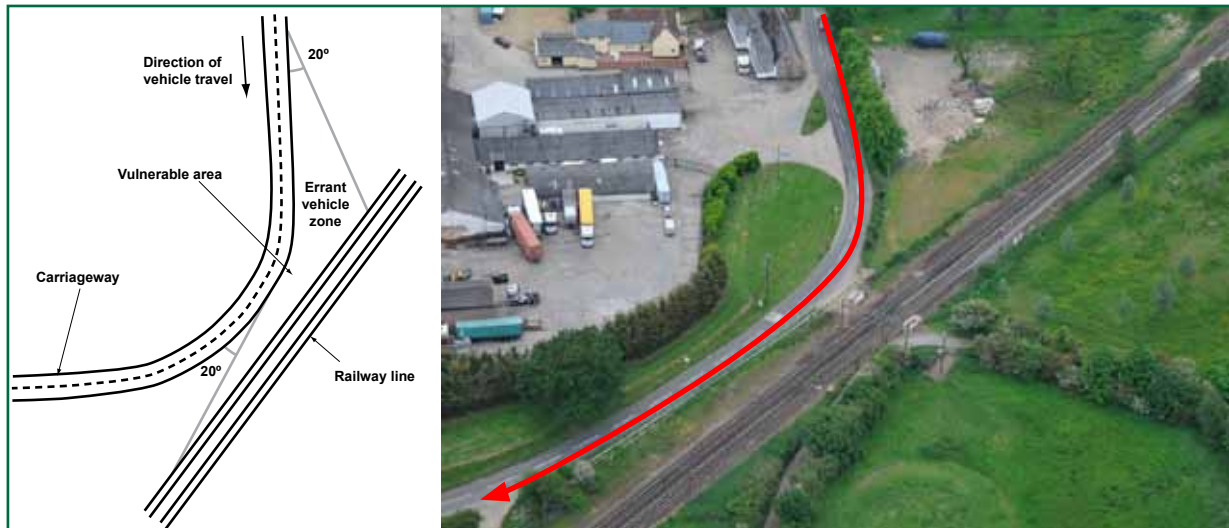
- 39 The RVI process requires an engineer undertaking an initial risk assessment and data gathering exercise at possible road vehicle incursion sites to consider 14 factors, including road alignment, volume of traffic, data on any previous accidents and the speeds and types of trains. Each factor is then given a score to produce a combined total. The scoring system is used as a tool to identify high risk sites, to provide input to a cost benefit analysis for possible risk mitigation measures and to apportion budgets for mitigation works. The DfT protocol requires assessment of sites where the highway passes over or runs parallel to the railway. This includes locations where the highway approaches close to the railway for only a short distance (known as a 'kiss bend' (figures 6a and 6b)).

Figures 6a and 6b: Diagram of typical 'kiss' bend (left) and aerial view of the B1113 Stowmarket Road 'kiss' bend location (right) (image courtesy of Suffolk Police air support unit)

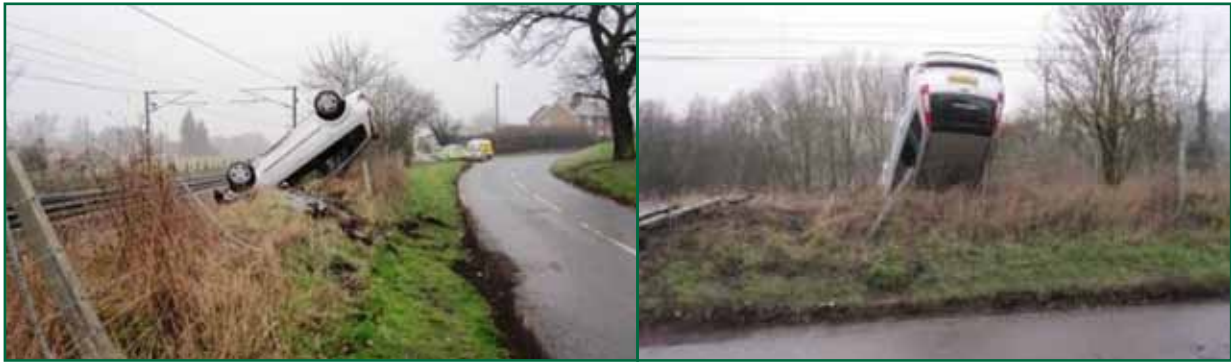
- 46 In addition, on 27 January 2010, a motorist travelling from Stowmarket to Old Newton failed to negotiate the right-hand bend and crashed through the railway fence in circumstances that were nearly identical to the accident on 30 November 2011 (figures 7a and 7b). However, on this occasion the car did not foul the railway line. The motorist did not require hospital treatment and the police took no further action. The BTP was not made aware of the accident. As there were no injuries, the data was neither passed to the police road safety management unit nor discussed with engineers within SCC's road safety team (paragraphs 85 to 89).

Figures 7a and 7b: Images of the accident on 27 January 2010, at the same location as the accident on 30 November 2011

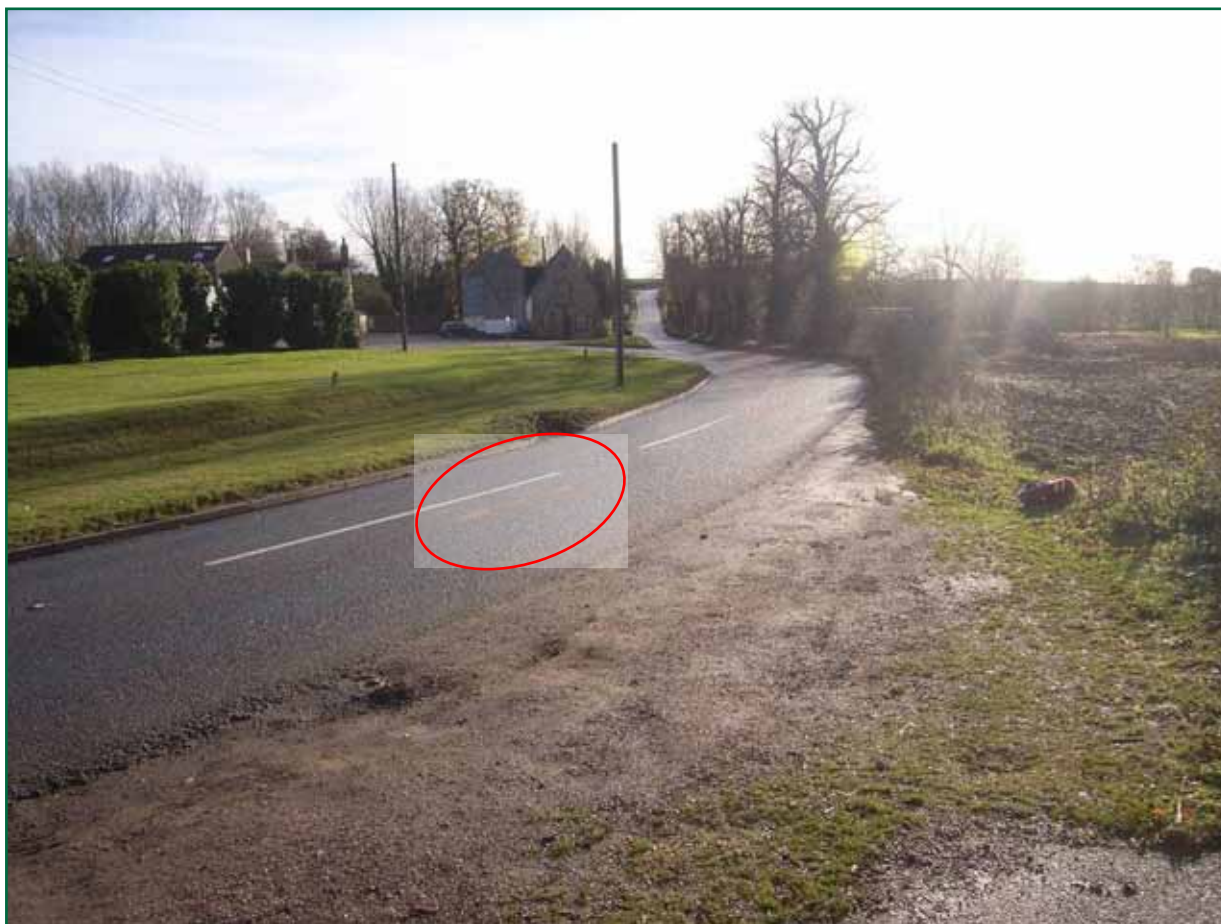
51 The police officer attending the accident reported that road conditions were damp from the rain that had fallen during the day, and there was evidence of contamination (fuel/oil/mud) on the surface of the road in the vicinity of the centre of the carriageway just beyond the bend (figure 8). The RAIB has not investigated the cause of this road traffic accident and no accident investigation or survey was undertaken by Suffolk police. The source of the contamination is unknown, but it was treated with sand by Network Rail staff after the accident. No police action was taken in respect of the motorist.

Figure 8: Image of the accident scene the following day (01/12/11) showing area of contamination (circled in red) on the road

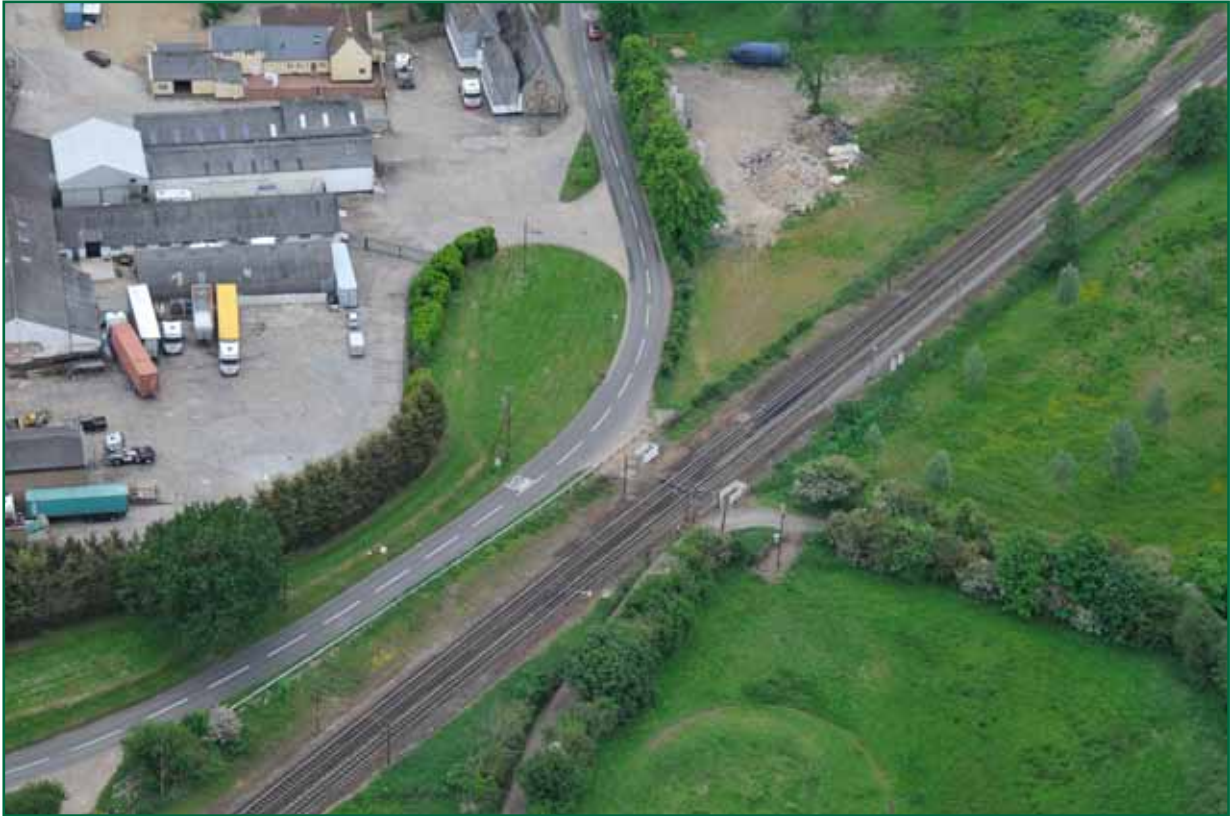
Figure 9: Aerial view of the B1113 Stowmarket Road 'kiss bend' location showing the business park (top left of the image) (image courtesy of Suffolk Police Constabulary air support unit)

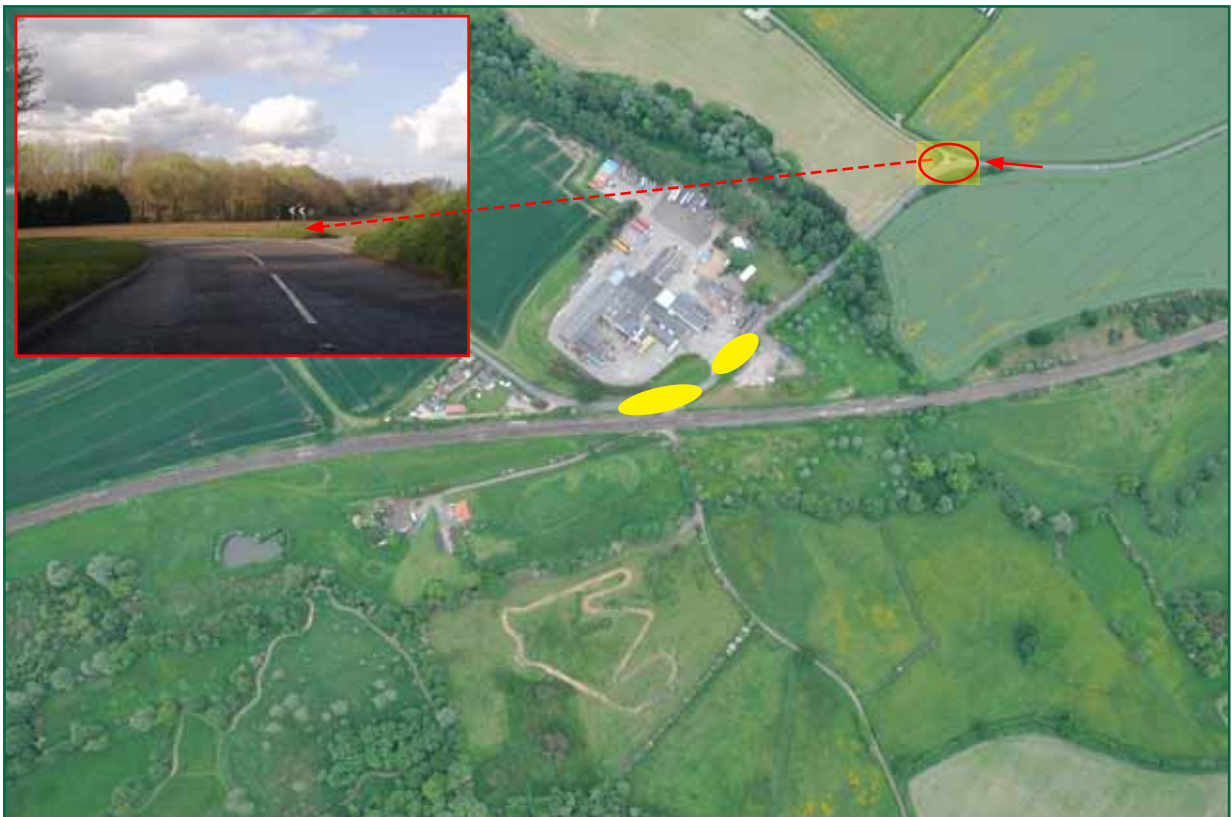
- 66 Engineer 2 received this intelligence and completed a road sign and surface assessment. However, for reasons the RAIB has not been able to establish, this assessment was not undertaken at the location reported by the residents, but at a nearby location on the same stretch of road where there had also been known reports of vehicles leaving the road (figures 10a and 10b). Chevron markers were installed and road markings were improved at this other location but no work was undertaken at the location originally reported by the local residents.

Figures 10a and 10b (inset): Image of location where road vehicle incursions were reported (bottom yellow areas) and inset image showing the incorrect location (red circled area)

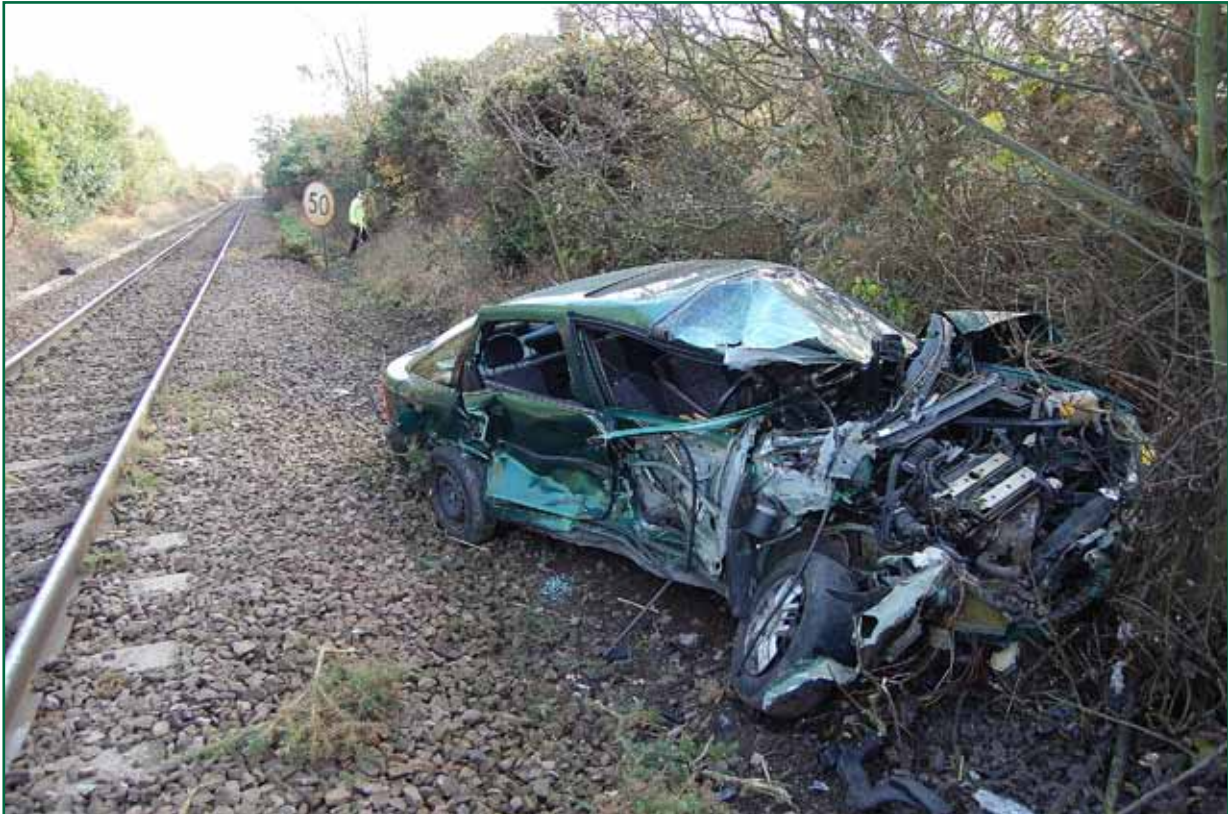
125 During the investigation the RAIB identified three other incidents where a vehicle incursion had occurred, but the location had not been assessed (figure 11) or recorded on the Network Rail database for known RVI sites. The RAIB considers that potential problems at some of these locations could not have been foreseen. However new mapping technology (eg Google Earth / Street View / DfT / ACPO crash database) is available, which may allow Network Rail or the local highway authorities to identify locations which pose a risk to the railway (paragraph 143).

Figure 11: Image showing a road vehicle incursion incident at a previously unidentified RVI location that occurred in Ipswich in November 2010

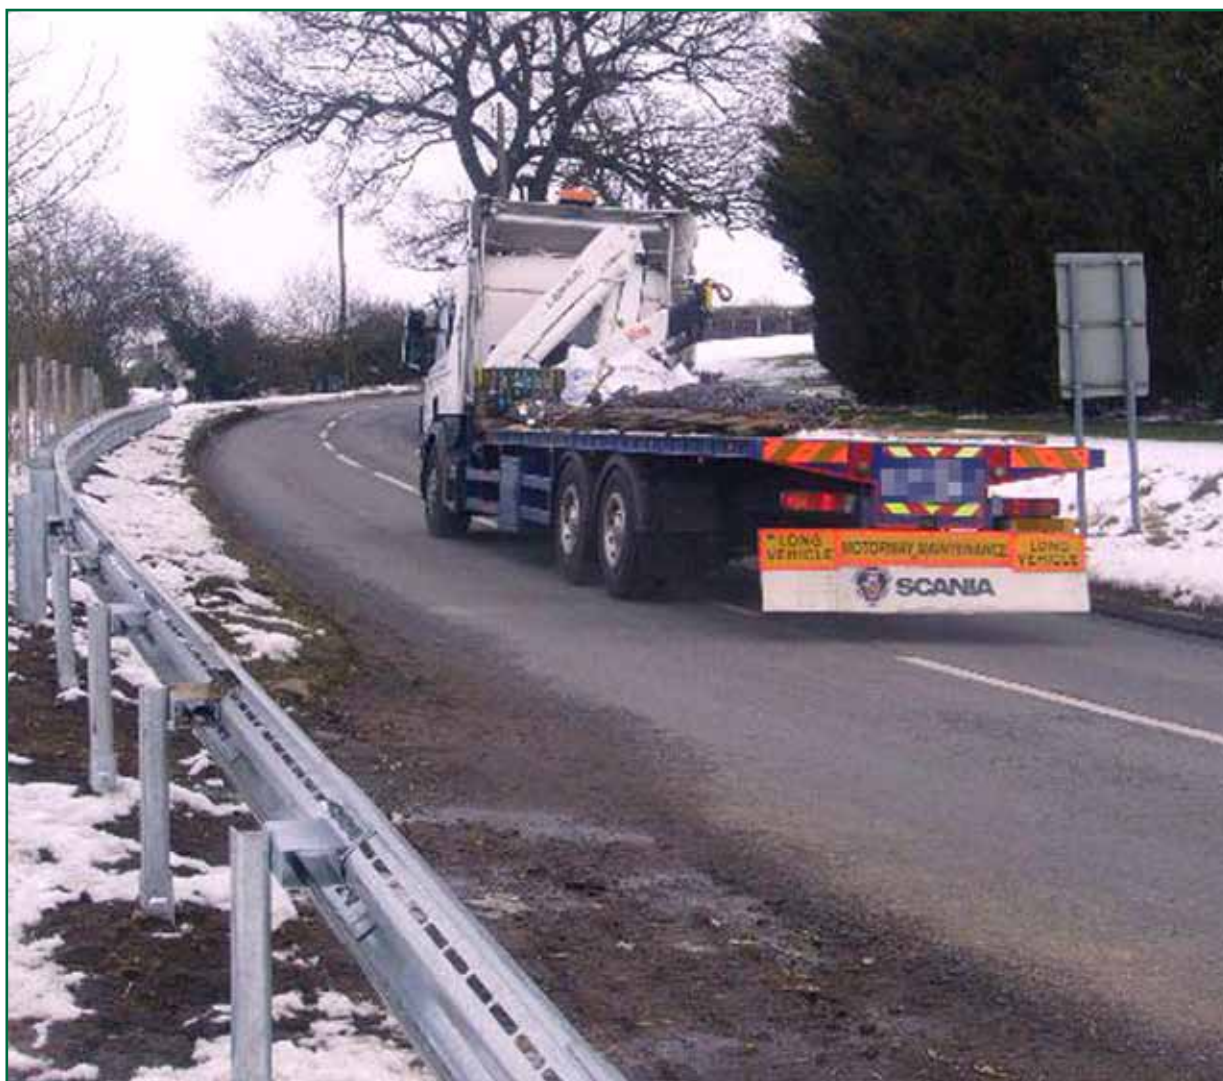
127 The RAIB observed vehicles travelling on the approach road to, and negotiating the kiss bend at the Stowmarket Road location. These observations showed that some motor vehicles were travelling at 40 to 50 mph (64 to 80 km/h). Although such speeds are permissible at this location (paragraph 12) there is a danger of drivers losing control of their vehicles in circumstances similar to those where accidents and incidents referred to in this report have occurred. Vehicles were negotiating the bend close to the left side verge or over the centre line. Two large goods vehicles were also seen to travel at speeds of 45 to 50 mph causing the vehicles to straddle or negotiate the kiss bend on the opposite carriageway (figure 12). The RAIB has informed the police and SCC road safety team of its concerns about how vehicles were negotiating the bend.

Figure 12: Image of a large goods vehicle negotiating the right-hand bend after the installation of the safety barrier (Feb 2012)
