Rail Accident Investigation Branch

Rail Accident Report

**Fatal accident at Bayles and Wylies footpath crossing, Bestwood, Nottingham
28 November 2012**

Report 19/2013
September 2013

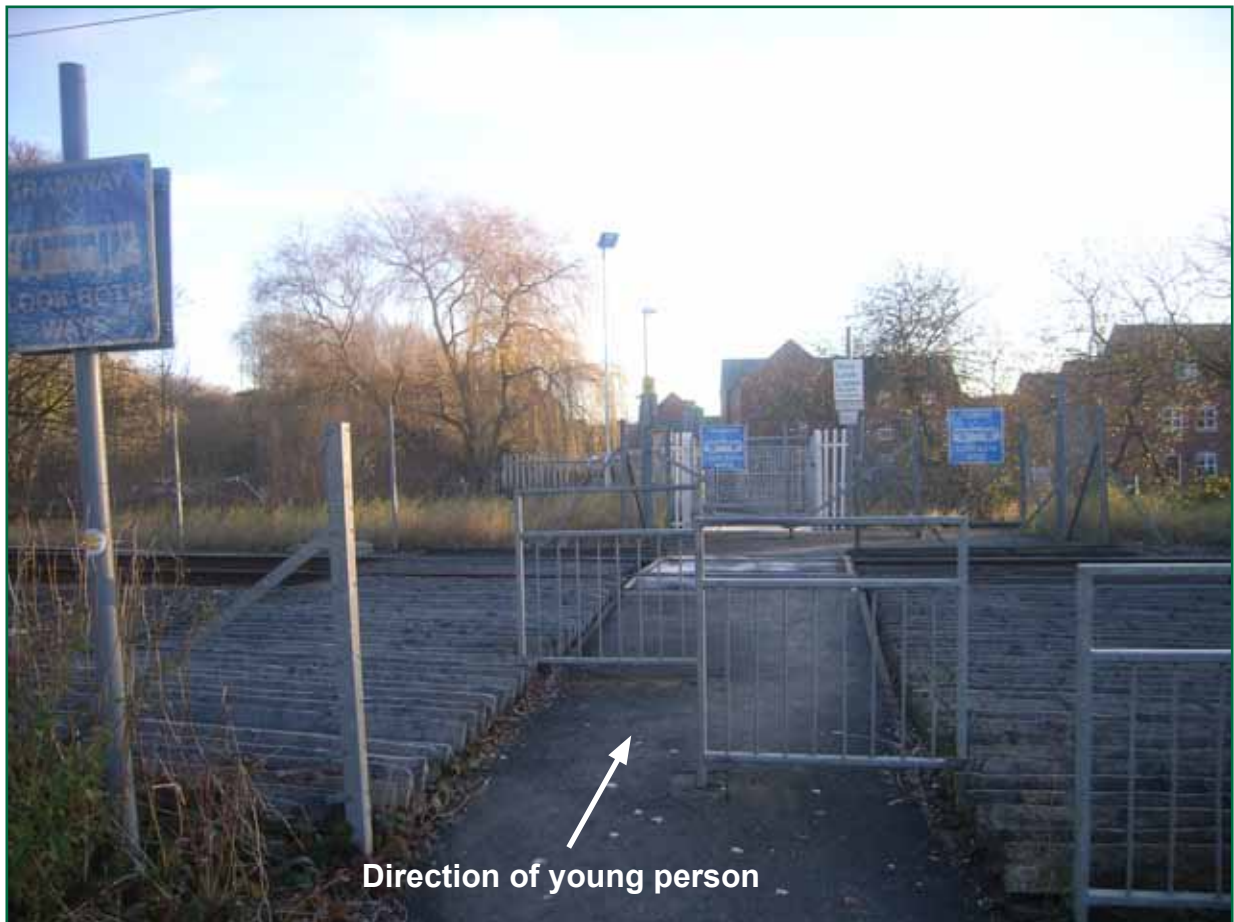
Figure 2: Bayles and Wylies footpath crossing

- 33 Access to the crossing over the tramway from its west side was provided through a chicane (figure 2), about 3 metres from the tram track. This consisted of a separated pair of railings, with the intention of both preventing pedestrians making a direct route on to the tramway and guiding them to face oncoming trams before they crossed the track³. Once across the tramway, pedestrians entered a refuge between NTL's tramway and Network Rail's railway, also containing a chicane, before crossing the railway.

- 34 Before reaching the chicane on the west side of the tramway, from the A611 road, any visibility of approaching trams was severely restricted by vegetation. However, once at the chicane, there was good visibility in both directions along the tramway. This meant that, provided pedestrians looked for approaching trams at the chicane, there was sufficient *warning time*. Northbound trams could be seen from the chicane as they departed from Moor Bridge tram stop, about 475 metres away, and took about 50 seconds to reach the crossing. The view of an approaching tram was partially obstructed by the closest overhead electrification mast to the crossing as it passed around 200 metres away, but was fully in view again by 180 metres away. The tram would have been fully in view when the first three girls crossed the tramway and when the young person was at the chicane and then walked on to the crossing.

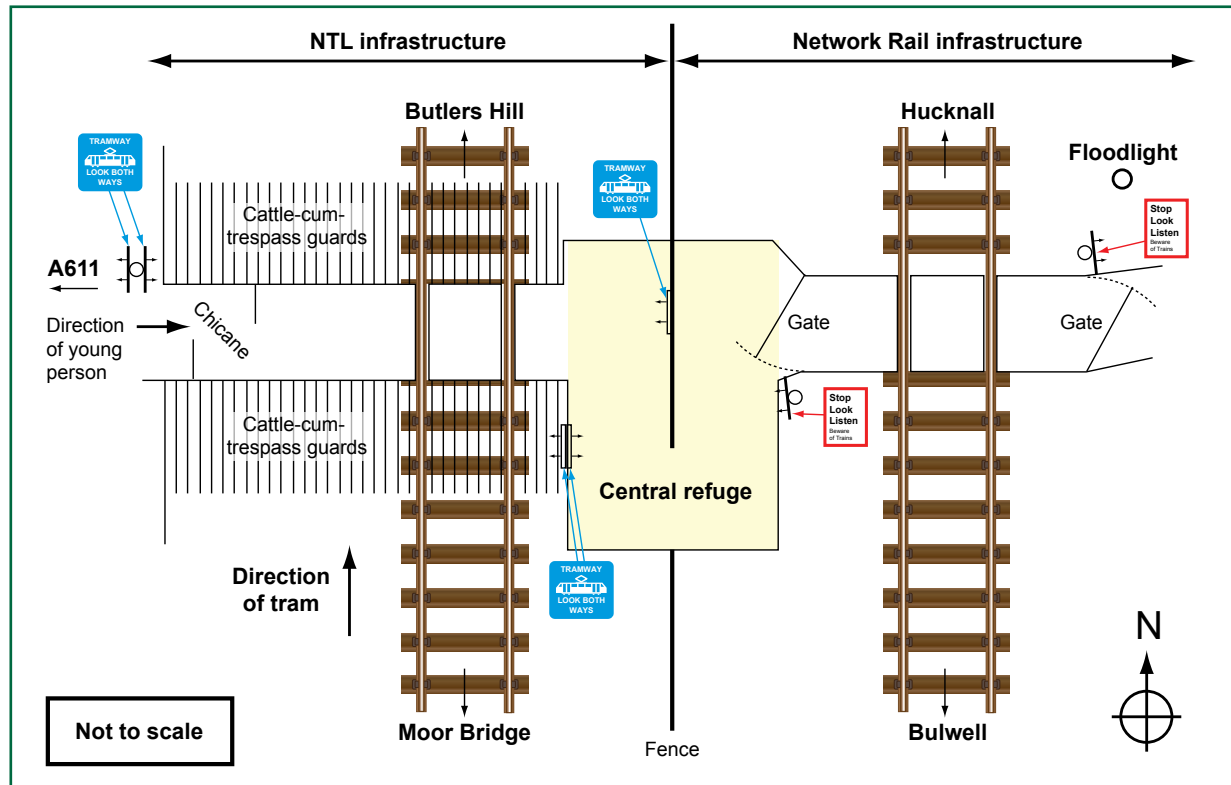
Figure 4: Layout of Bayles and Wylies crossing

- 32 Figure 4 shows the general layout of the crossing. The crossing walkways over each infrastructure were at right angles to the track and the crossing design was such that pedestrians had to assure themselves that it was safe to cross by checking for approaching trams/trains before doing so.

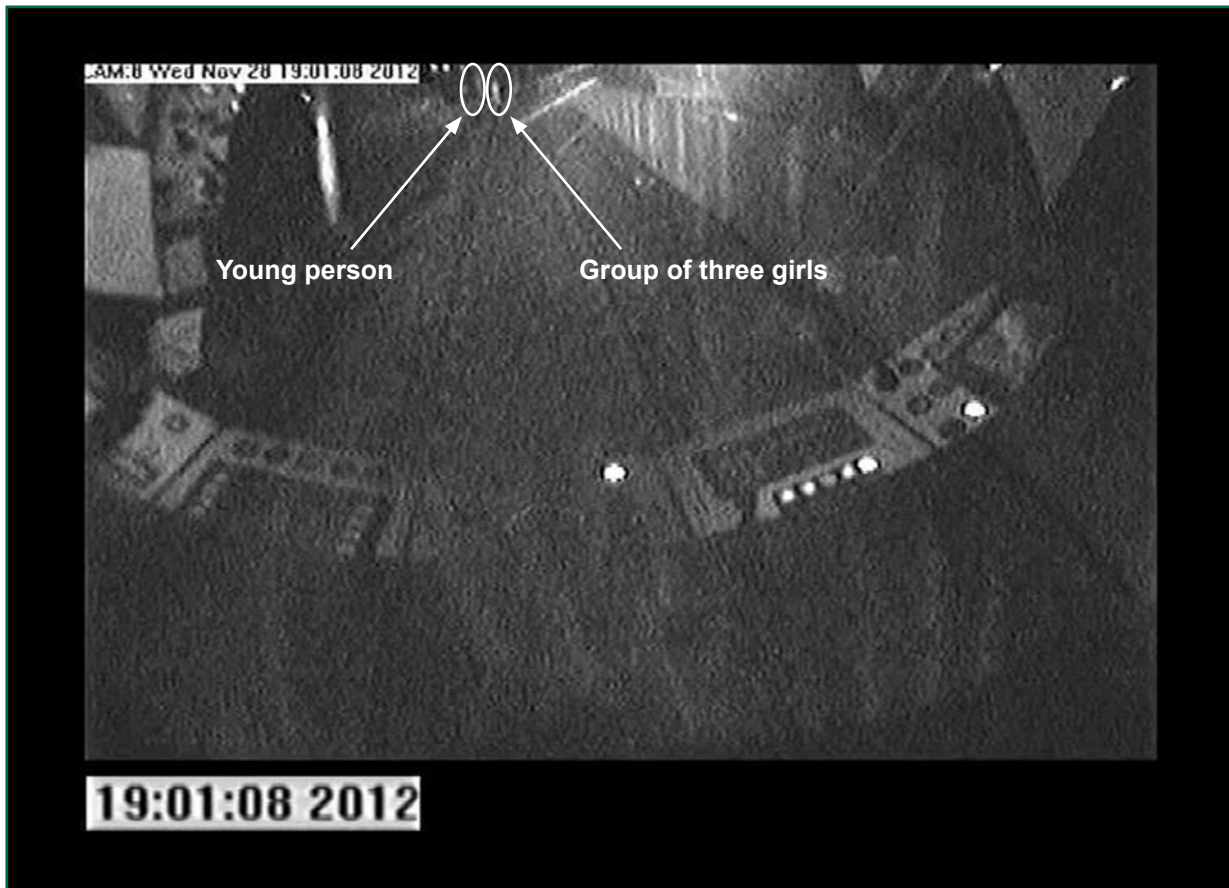
Figure 5: View of the crossing from tram 211 about 60 metres away⁴

- 39 It appears that the first three girls reached the first rail of the tram track when the tram was about 60 metres from the crossing. The young person, who was the last of the group to arrive at the crossing, was at the chicane at this time, following about 3 metres behind (figure 5). The three girls in front continued over the tram track and appear to reach the central refuge at 18:59:08 hrs. It was not possible to discern from the FFCCTV whether or not any of them looked towards the tram while crossing or waiting in the central refuge. At this point the tram was about 25 metres from the crossing, and the young person was about 0.5 metre from the tram track.

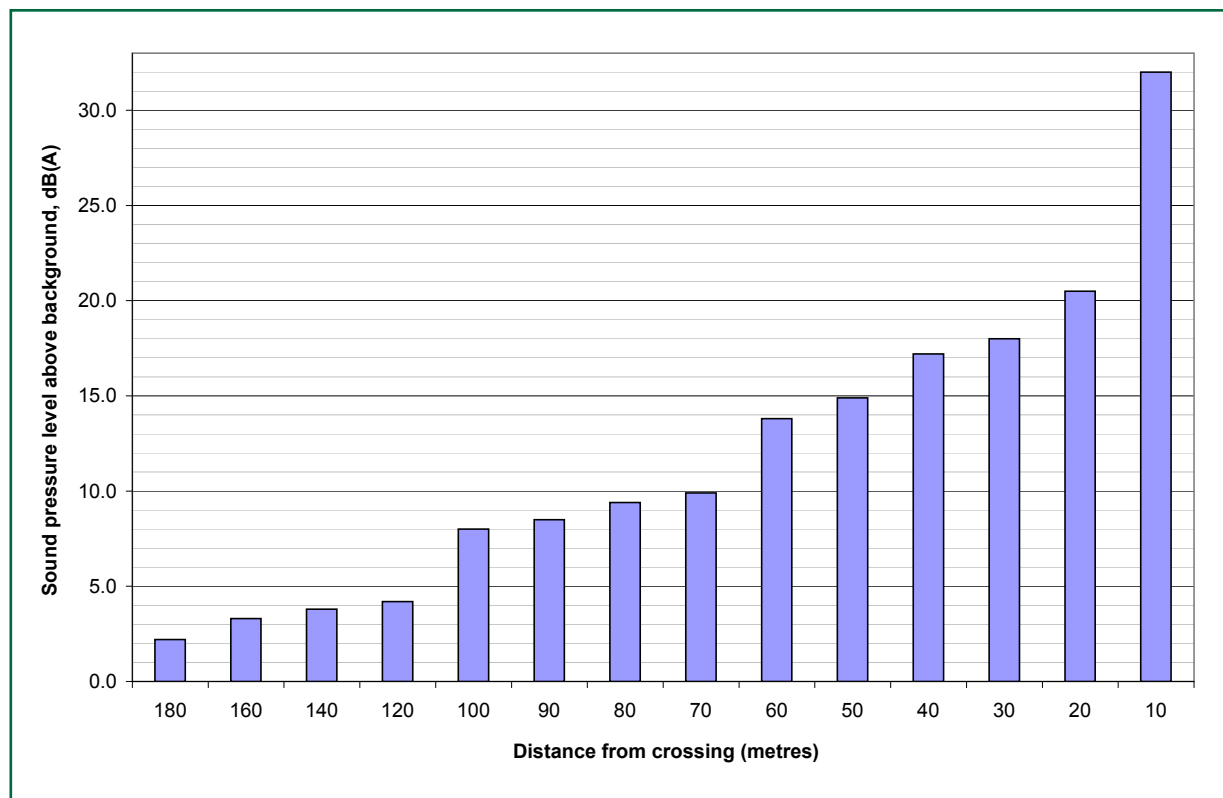
Figure 6: Results of tram horn tests at Bayles and Wylies crossing

- 52 The RAIB commissioned specialist consultants to carry out acoustic tests to investigate the audibility of the tram horn as the tram approached the crossing and to assess whether it complied with any relevant standards. The tests on the approach to the crossing were carried out at the same time of day as the accident and when the wind speed and direction was similar (paragraph 29). Figure 6 shows the measurements of the *sound pressure levels* above the background level⁷ from the horn at different distances along the tram line away from the crossing.

- 53 Although there are no specific requirements for the audibility of tram horns, there are two possible documents against which their acceptability could be judged, namely the standard for motor vehicles⁸ and the ORR's guidance on tramways (paragraph 33). The standard for motor vehicles is relevant because trams run in and among road vehicles at similar speeds while running along street sections.
- 54 The warning horns fitted to both ends of tram 211 complied with the standard requirement for motor vehicles of 105 – 118 dB(A), measured at a distance of 2 metres, within the defined *frequency* range. The sound pressure level of the 'A' end of the tram was 106.9 dB(A), and the 'B' end, the end leading at the time of the accident, was 107.0 dB(A).

- 1 *The intent of this recommendation is that a review is carried out to determine the most effective means of warning persons who may be in the path of a tram.*

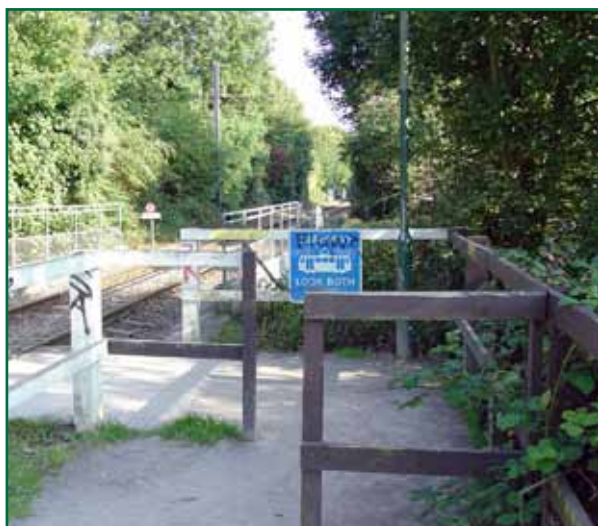
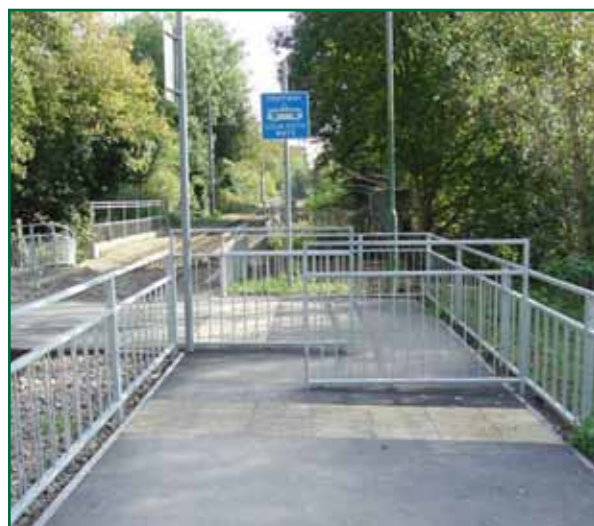
Figures 7a and 7b: Changes to the chicane at Morden Hall Park footpath crossing, London Tramlink

- 68 As a result of the accident at Morden Hall Park crossing, London Tramlink installed a new chicane at the crossing. The railings overlap requiring cyclists to slow down more and pedestrians to follow around them to get through rather than being able to walk straight through as was formerly the case. Figure 7a shows the chicane at the time of the accident, and figure 7b shows it after the changes had been made¹¹.

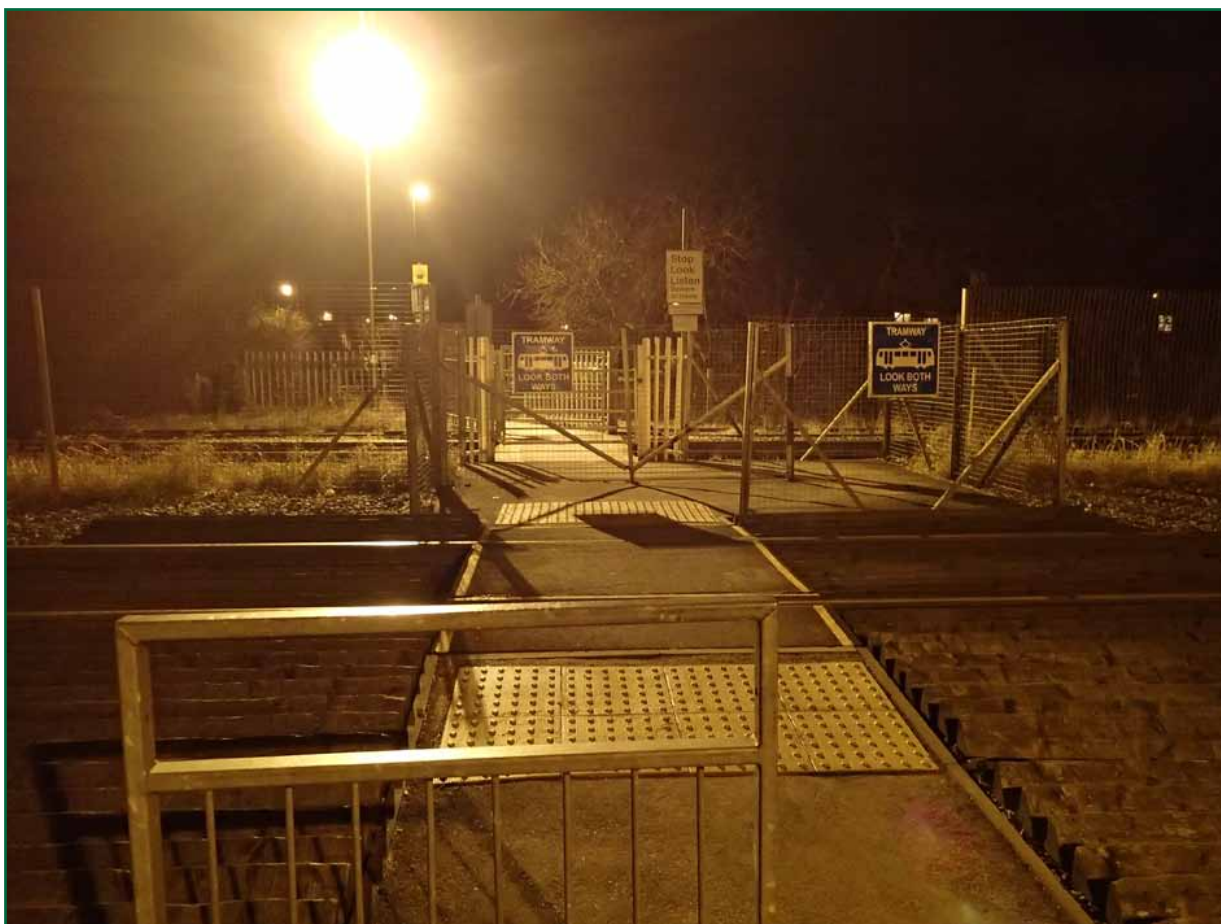
Figure 8: The light on the Network Rail side of the crossing

- 73 Measurements taken by the RAIB's specialist consultant indicated that the light on the Network Rail side of the crossing (paragraph 29 and figure 8) was sufficiently bright as to cause visual discomfort and *disability glare* which could reduce the visual performance of anyone approaching from the west side of the crossing. This could affect their ability to visually identify the approach of a tram. Such effects were likely to be brief¹⁴, lasting less than a second for a young person, but of possible significance to anyone who just happened to glance quickly along the tramway as they passed through the chicane.

- 74 The *brightness* of the light also had a second effect, known as veiling glare, in which objects in a person's peripheral vision could be more difficult to see. This could have reduced the possibility of the young person seeing the movement of the approaching tram in her peripheral vision as she approached and started to cross the tram track. This would be of likely significance if the young person had not looked before crossing (paragraph 71).
- 75 When Network Rail fitted the light following the double fatality on 22 November 2008, their objective was to improve pedestrian safety by illuminating the crossings of both infrastructures. It was not identified that the light's brightness could be a source of glare potentially affecting the visual performance of pedestrians approaching the crossing from its west side.

- 4 *The intent of this recommendation is for Network Rail and tram operators to issue guidance to their staff and contractors on the best way to illuminate pedestrian crossings while minimising any visual impairment of pedestrians when looking out for approaching trains/trams.*

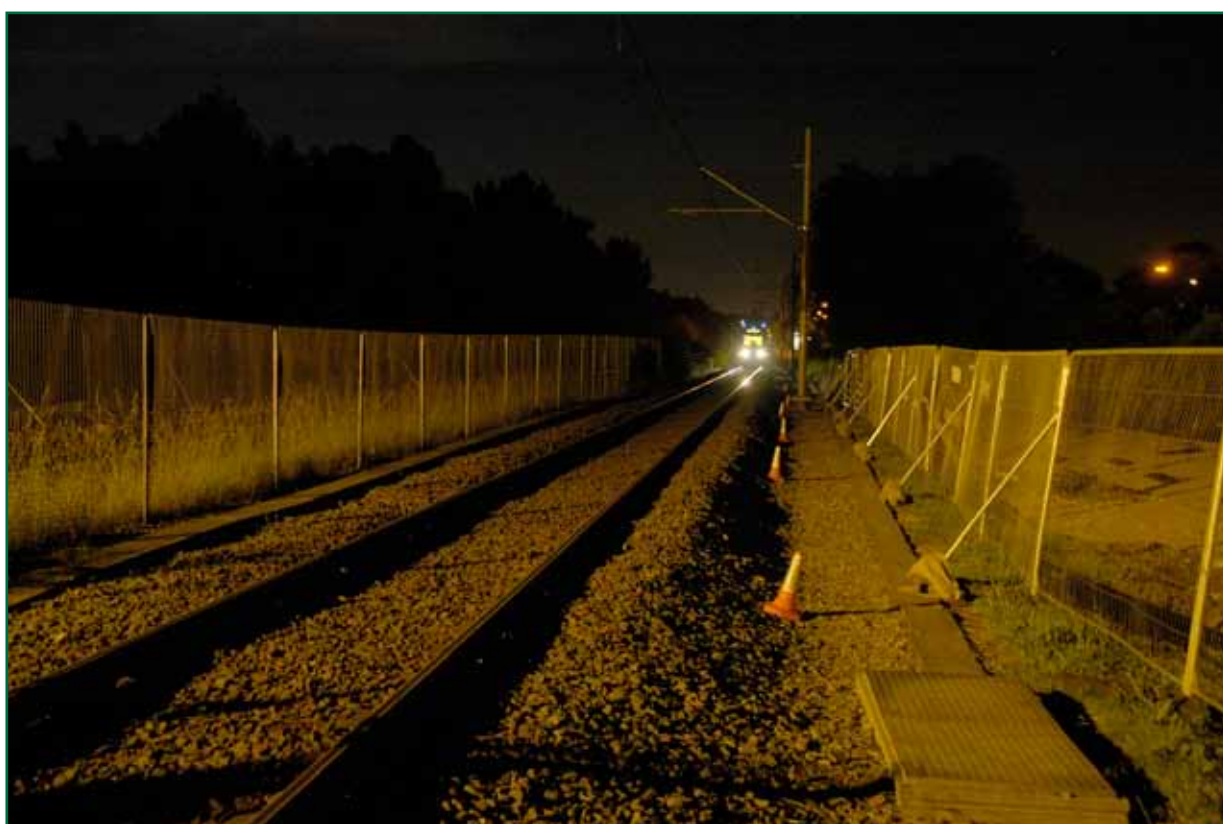
Figure 9: Tram 211 approaching Bayles and Wylies crossing from Moor Bridge

- 85 Although the tram headlights were found not to comply with the relevant standard, the RAIB has concluded from its own observations that the approaching tram would have been clearly visible from the crossing chicane from the point at which it left the tram stop at Moor Bridge. Figure 9 shows tram 211 approaching the crossing from Moor Bridge while about 200 metres from the crossing and the amount of light cast by the light on the Network Rail side of the crossing (paragraph 73).

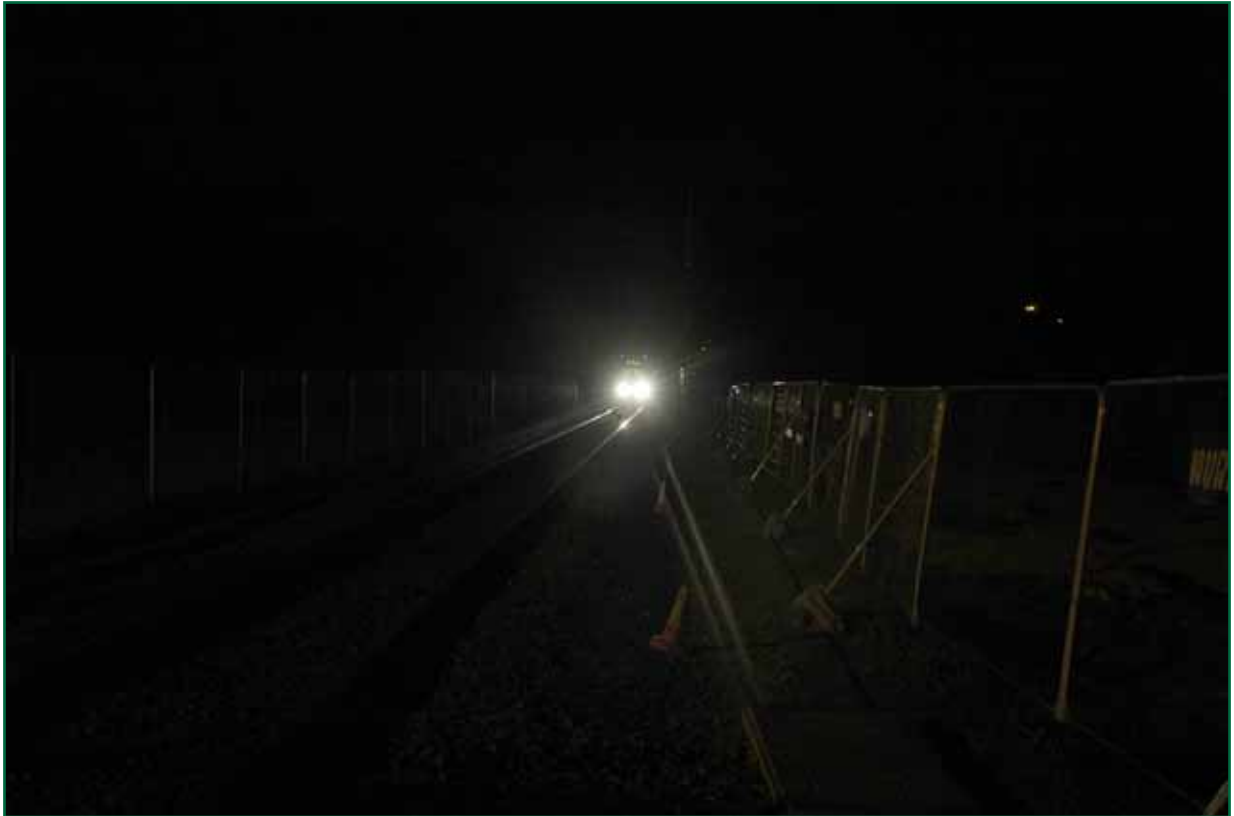
Figure 10: The appearance of tram 211 at a distance of 100 metres from the crossing

- 86 The evidence from the FFCCTV and OTDR is that the first group of girls entered the crossing from the chicane when the tram was around 100 metres away (paragraph 38). Figure 10¹⁷ shows tram 211 at 100 metres from the crossing when it was dark.
- 87 The young person entered the crossing when the tram was around 60 metres from the crossing (paragraph 39). Figure 11 shows tram 211 at 60 metres from the crossing when it was dark.
