Rail Accident Investigation Branch

Rail Accident Report

Locomotive derailment at Ordsall Lane Junction, Salford, 23 January 2013

Report 07/2014
March 2014

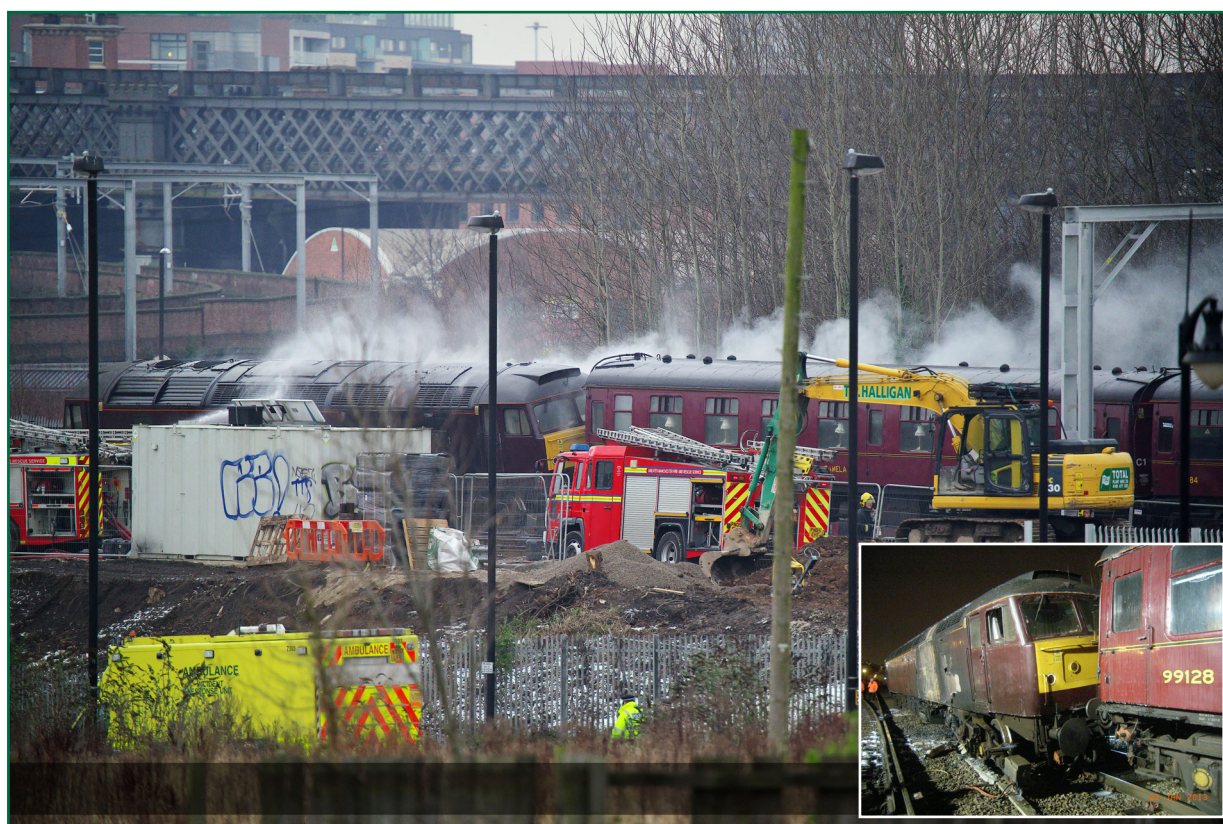
- 29 Shortly after crossing bridges 130A and 130B, the driver in charge stated that the train came to a gentle stand just as he was about to apply power to traverse the junction. Because his cab indications did not show why it had stopped, he looked back along the train. He saw smoke coming from a fire on locomotive 47500 and immediately pressed the emergency call button on the train radio; the other driver in the cab then spoke with Network Rail's *route control*. The driver of another train stopped at the junction also saw the fire; he alerted the signaller at Manchester Piccadilly on a *signal post telephone*. The fitter in the rear cab of locomotive 47854 felt a longitudinal movement through the train and, on looking back, also saw the smoke. Both he and the guard immediately got out to investigate. They found locomotive 47500 derailed, with both bogies straddling the right-hand rail (figure 5). Analysis of the *on-train data recorder* showed that the locomotive was travelling at 14 mph (23 km/h) when it derailed.

Figure 5: Derailed locomotive (main photograph courtesy of Greater Manchester Fire and Rescue Service)

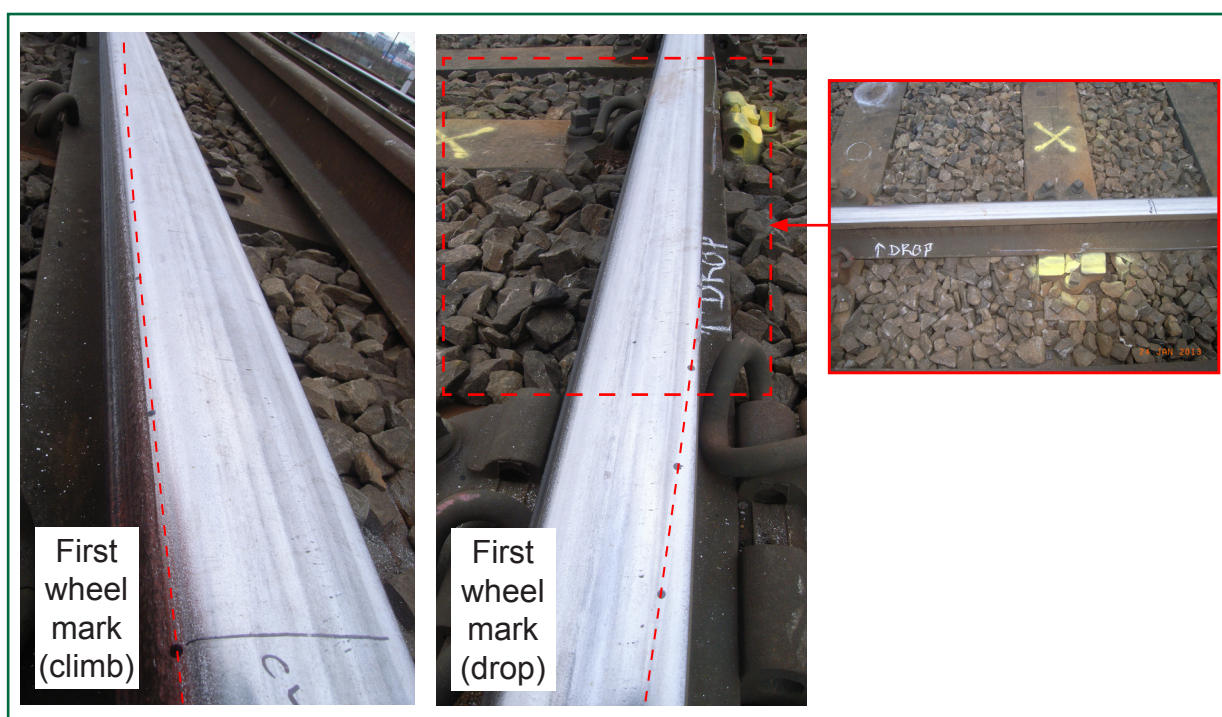
- 34 The RAIB inspected the track and found two sets of marks on the outer rail of the curve on the Down Bolton line that were consistent with the flanges of the right-hand wheels of locomotive 47500 climbing onto the railhead and then dropping into the *six-foot* (figure 6). The first set (which contains the RAIB designated point of derailment) started at 14 metres after the end of bridge 130B; the second set started 22 metres further on.

Figure 6: First mark showing evidence of a wheel flange climbing over the railhead

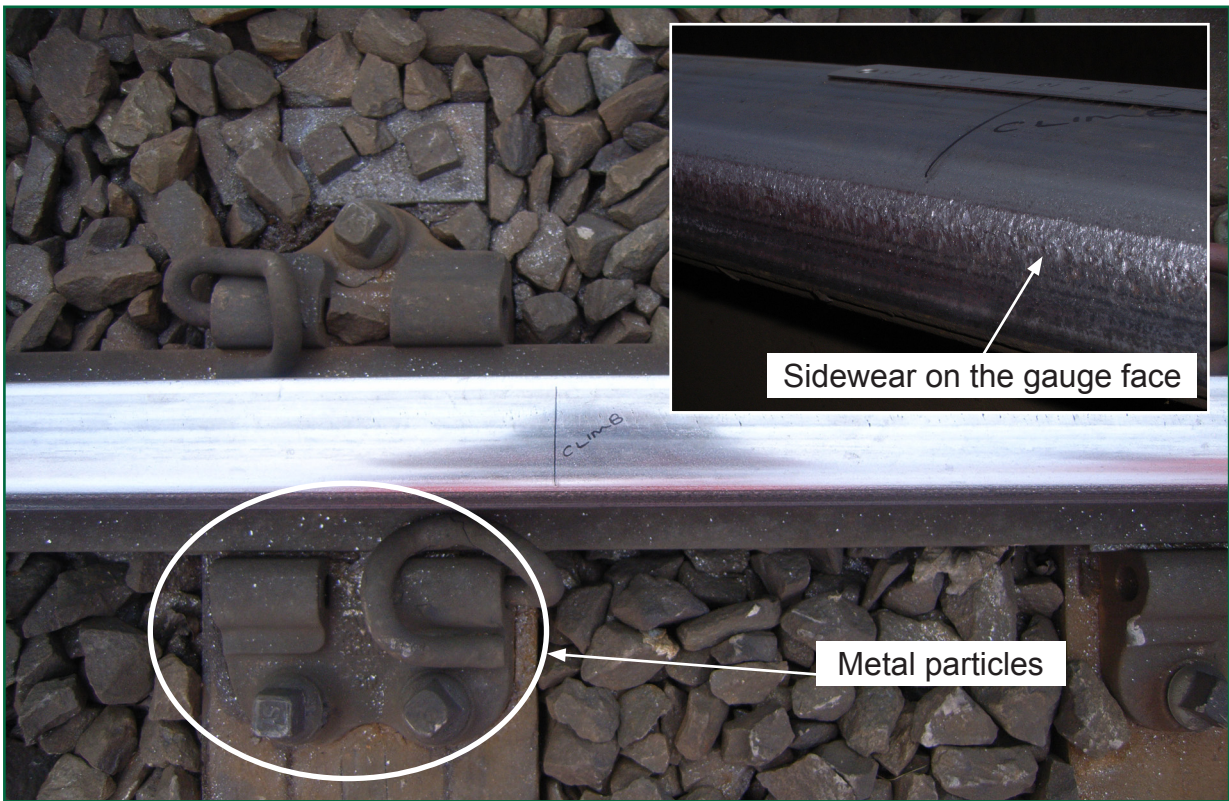
- 35 The *gauge face*, where the wheel flange had been in contact with the railhead of the outer rail, was dry, clean and shiny, with no evidence of naturally-occurring metal oxides, lubricants or other contaminants. There were also signs of aggressive *sidewear* on the railhead, with metal particles deposited on the ballast and sleepers below (figure 7).
- 36 The RAIB measured sidewear readings of between 8 and 10 on the outer rail in the vicinity of the derailment. These measurements were made using the Network Rail NR4 stepped sidewear gauge⁶ (figure 8). The gauge readings range from 18, when the rail is new, to 0 when the rail needs to be replaced or transposed⁷.

Figure 7: Condition of the gauge face of the outer rail of the curve and the deposits of metal particles

- 82 The dry and uncontaminated state of the rail (paragraph 35) was necessary for high wheel-rail contact friction to occur; this is also the most likely explanation for the aggressive sidewear observed on the gauge face of the outer rail. It is therefore significant that the derailment occurred during a period of dry weather (paragraph 24) and that naturally-occurring contaminants, such as metal oxides, had been removed leaving the gauge face shiny and showing bare metal (figure 7).

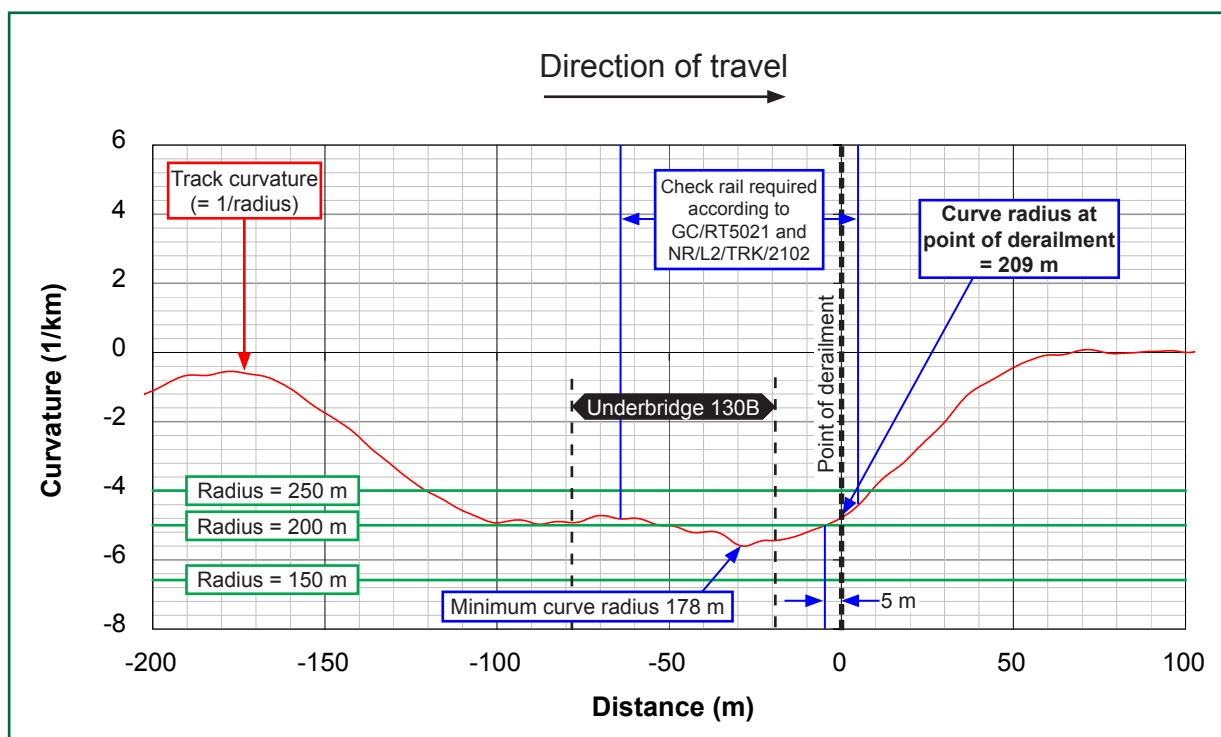
- 44 There was no check rail fitted to the curve on the Down Bolton line approaching Ordsall Lane Junction at the time of the derailment.

Figure 10: Track curvature in the vicinity of the derailment showing where a check rail was required

74 There was no check rail installed on the curve approaching Ordsall Lane Junction although its location and radius met the criteria for fitment. Without a check rail there was nothing to prevent the lateral wheel-rail forces tending to cause the right-hand wheel flanges to climb the outer rail and into derailment. This was a causal factor.

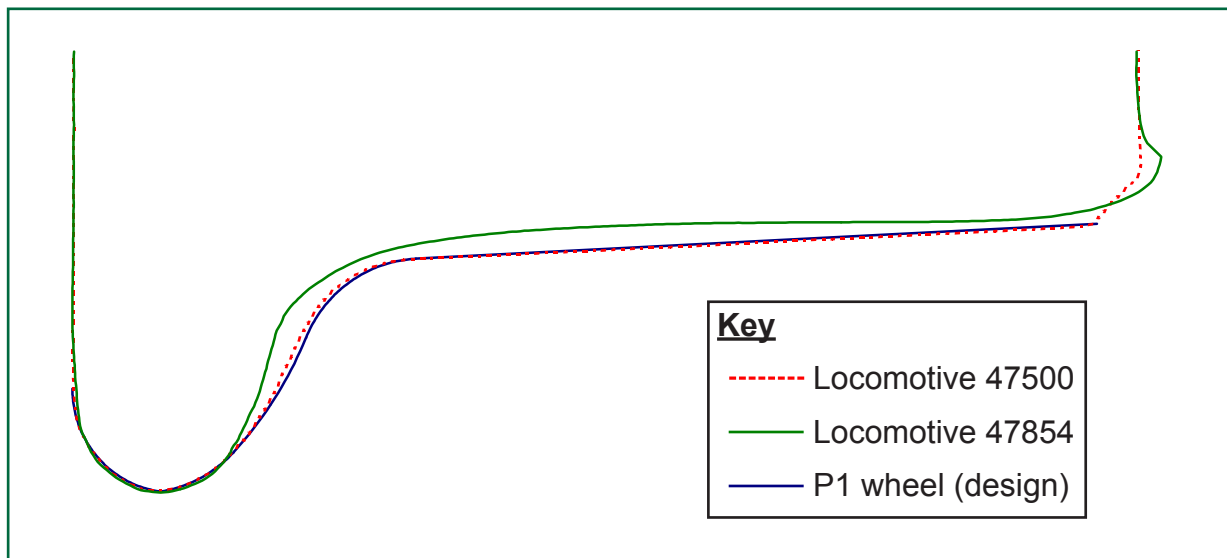
- 57 The RAIB's measurements showed that the wheels on locomotive 47500 had been correctly reprofiled to the P1 wheel profile. Figure 11 shows the measured profile of the leading right-hand wheel compared to the specified design. It also shows the differences with the worn shape of the leading right-hand wheel profile on locomotive 47854.

Figure 11: Comparison of the measured profiles on the leading right-hand wheels of locomotive 47500 and 47854

- 97 A comparison of the measured profiles of the outer rail and the new P1 wheel profiles on locomotive 47500 showed that the peak flange contact angle was around 62° at the point of derailment²⁴. Modern wheel profile designs comply with the *flange angle*²⁵ requirement of 68-70° defined in clause 2.5.1 of Railway Group standard GM/RT2466: for example the *P8 wheel profile*, which became widely used after the class 47 locomotives were built in the mid-1960s. The peak flange contact angle for the P8 wheel profile on the same rail was found to be around 70°.

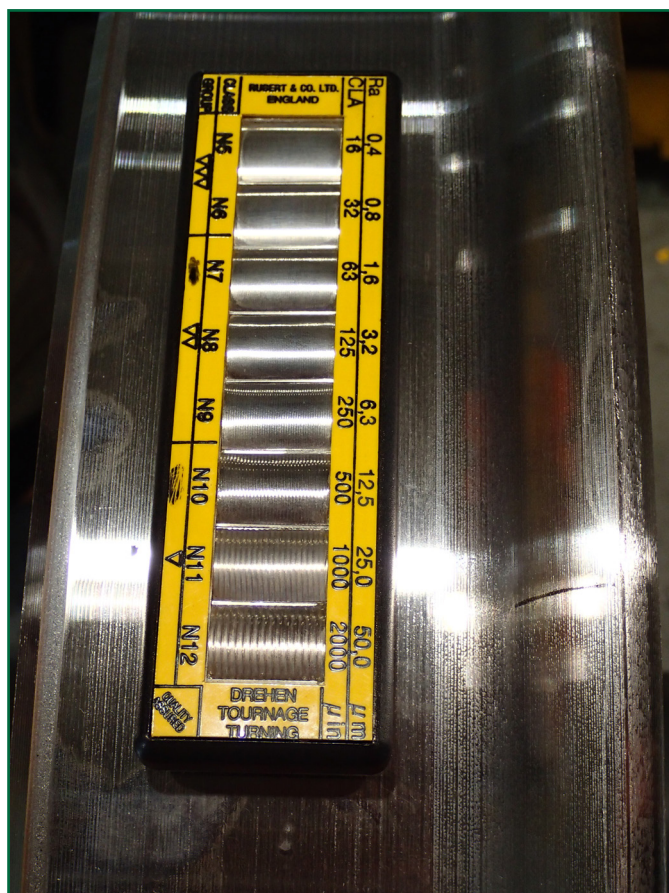
- 60 The maximum wheel diameter difference recorded on a wheelset on locomotive 47500, after wheel reprofiling, was 0.108 mm. The wheel lathe procedure requires operatives to regularly monitor the surface finish during wheel reprofiling by visual comparison with a roughness specimen machined to a range of finishes from N5 to N12 (figure 13). There was no requirement to record the results of the comparison. However, from an inspection of the post-derailment condition of the wheel surface the RAIB estimates that a surface finish of between N10 and N11 was achieved, which was marginally rougher than the value of N10 that was specified (paragraph 93).

Figure 13: Surface finish sample gauge against a typical newly-reprofiled wheel

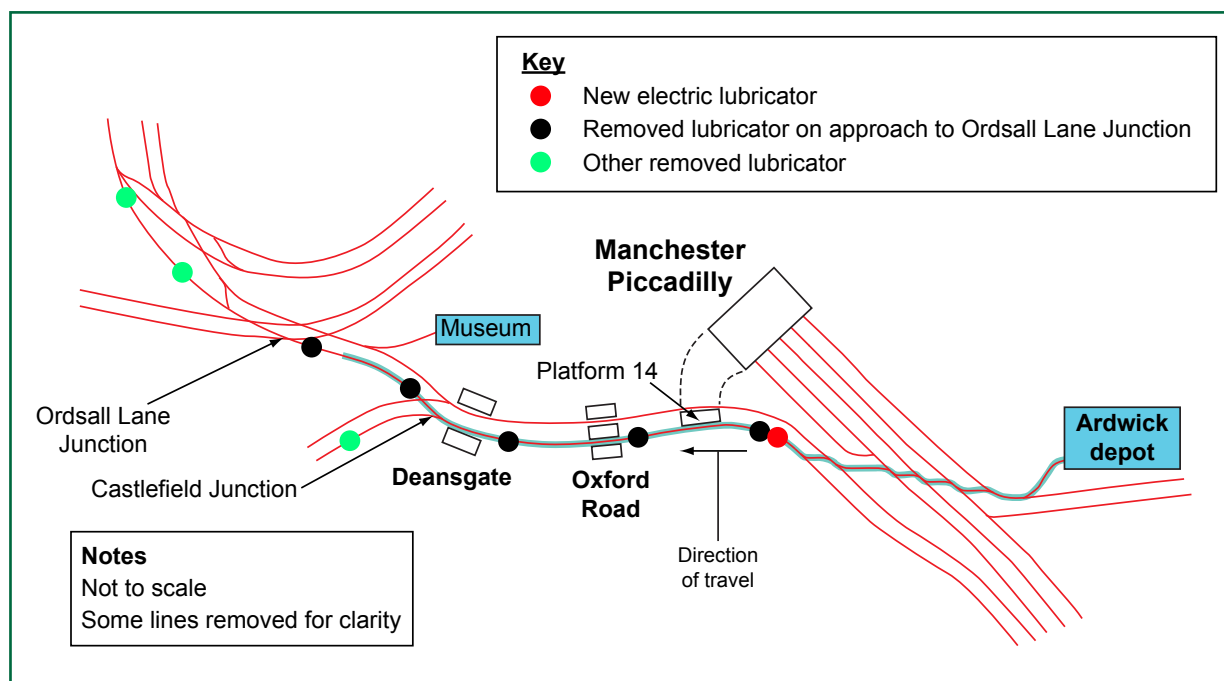
Figure 14: Map showing the location of the lubricators that were removed after the new electric lubricator was installed on the approach to platform 14 at Manchester Piccadilly

- 84 Network Rail had extensive arrangements in place to lubricate curves in the Manchester area. However, because of the recent lubricator replacement project (paragraph 63), lubrication of the outer rail of the curve approaching Ordsall Lane Junction became reliant on grease applied by the new electric lubricator near platform 14 at Manchester Piccadilly (paragraph 64).

- 86 Network Rail repaired and tested the new electric lubricator near platform 14 at Manchester Piccadilly station after the derailment. It found that lubricant did not transfer as far as it expected, and did not reach Ordsall Lane Junction²². However, it is unlikely that this finding is significant to the derailment; if the new lubricator had been working, the wheels on locomotive 47500 would almost certainly have picked up enough grease to reduce the friction by the small amount necessary to prevent derailment.

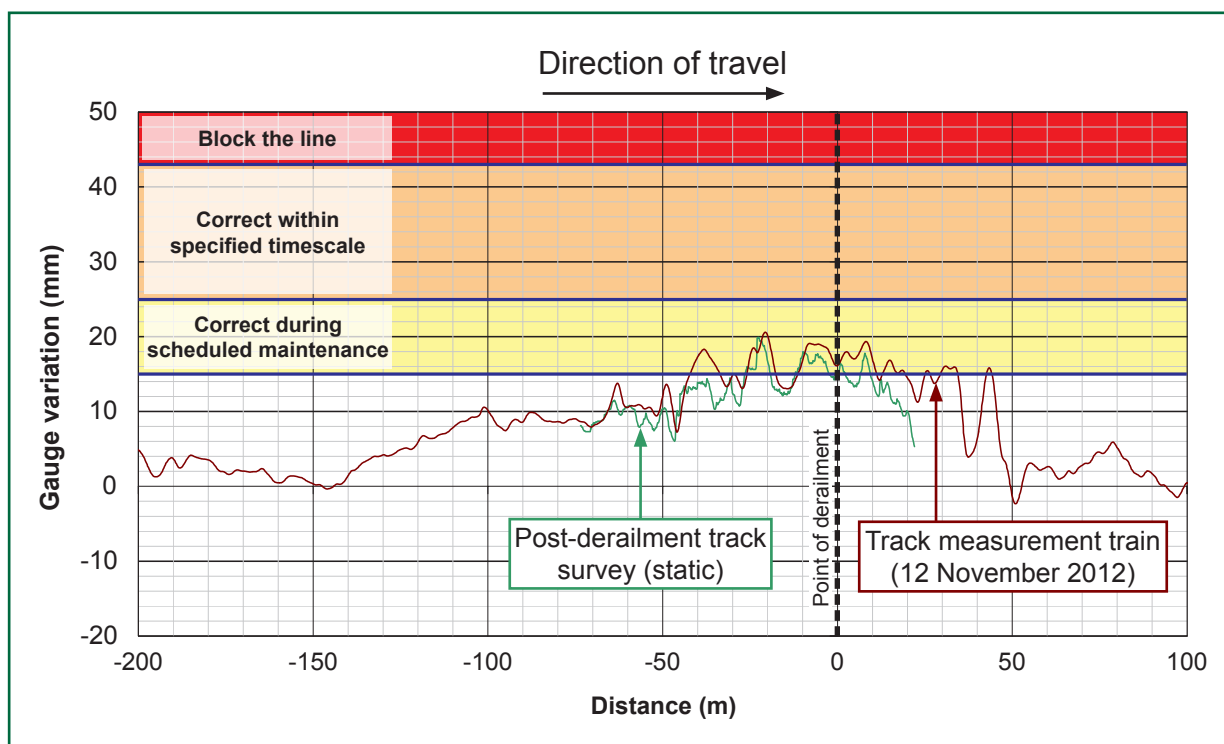
- 104 The vehicle dynamic study found that the derailment risk was sensitive to track gauge variation. This was because of the consequent increase in the clearance between the wheel flange and gauge face allowed additional bogie rotation within the track gauge, therefore increasing the *angle of attack* of the leading right-hand wheel and, as a result, the lateral (Y) force on the rail (paragraph 66).

Figure 15: Track gauge measured in the vicinity of the derailment showing the relevant maintenance limits
