Rail Accident Investigation Branch

Rail Accident Report

Accident at Balnamore level crossing, Ballymoney, Northern Ireland 31 May 2013

Report 10/2014
May 2014

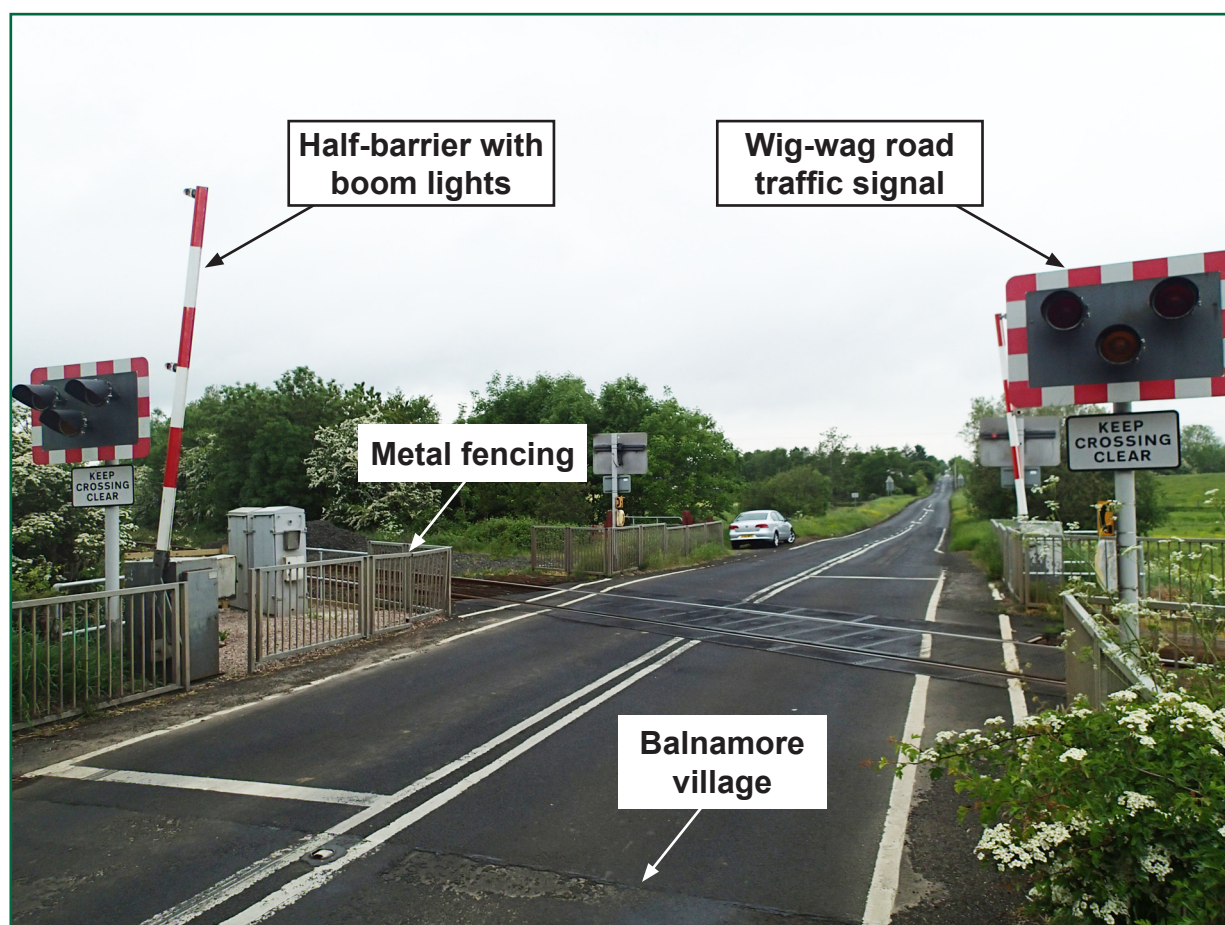
Figure 3: Balnamore AHBC level crossing

- 13 Balnamore AHBC is equipped on both sides of the crossing with road traffic signals (known as 'wig-wags'), one of which is positioned to either side of the carriageway (figure 3). Each wig-wag signal consists of a single steady amber light and two flashing red lights. In addition to these signals, the crossing is protected on both sides by a half barrier which, in normal operation, will lower across the entrances to the crossing after the wig-wag signals have been operating for a set period. Two *boom lights* mounted on each half barrier illuminate in both directions along the road once the half barriers start to lower. An audible warning to pedestrians is also provided; this will sound as soon as the wig-wag signals start to operate. Telephones for public use are also provided on both sides of the crossing.

- 17 The crossing equipment at all four corners of Balnamore AHBC (eg barrier units, LCU cabinets and wig-wag signals) is protected by metal fencing and gates (figure 3).

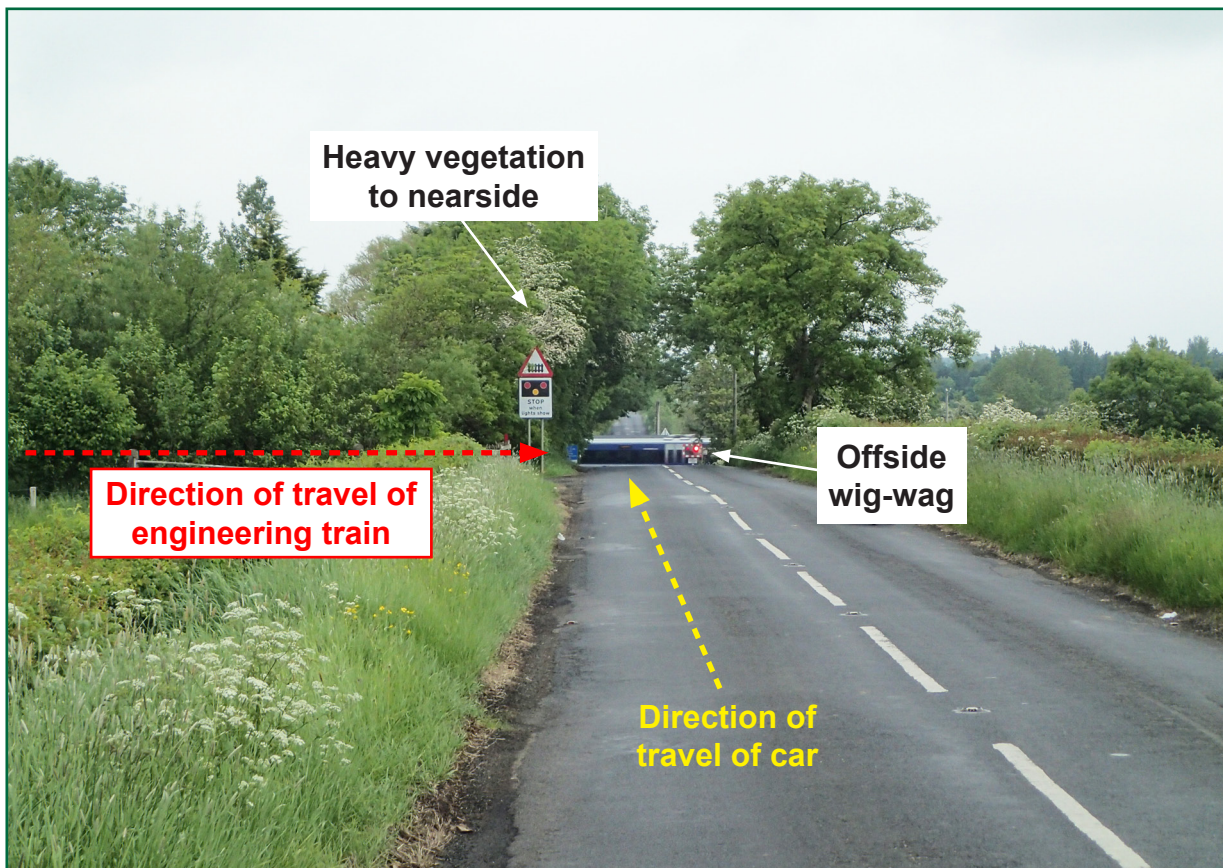
Figure 4: Approach to Balnamore AHBC from the south

- 14 At the time of the accident, there was heavy vegetation to the *nearside* of road users approaching Balnamore AHBC from the south. This partly obscured the visibility of the nearside wig-wag signal, which would not have been visible to road users approaching from the south until they were around 50 metres away from the crossing. The half barriers and crossing surface would have become visible to road users once they had passed over a significant dip in the road, around 160 metres to the south of the crossing. The offside wig-wag signal was not obscured by vegetation or the road profile and would have been visible for over 400 metres to the south (figure 4 and figure 5).

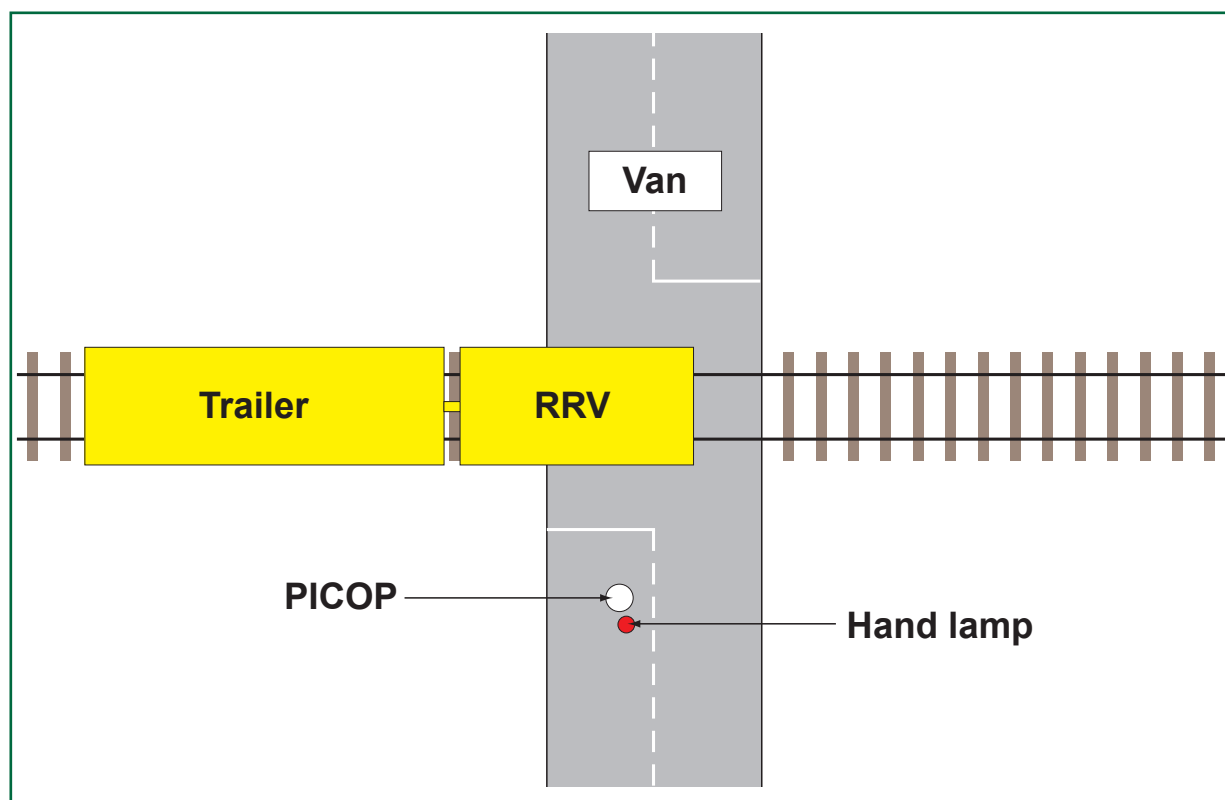
Figure 8: Diagram of how the PICOP protected level crossings during the initial movement from Coleraine to Portrush

- 34 The engineering train was then driven from Coleraine to Portrush (figure 7) in reverse formation (ie with the rail trailer leading) and with the spraying equipment switched off. The first crossing reached by the train during this movement was Artillery Road CCTV level crossing, to which the PICOP had driven by road in order to act as EO. At this crossing, the PICOP did not lower the barriers using the crossing's LCU (paragraph 16). He instead implemented a method of work where the train would stop short of the crossing (around the cattle/anti-trespass guards) whilst he controlled any approaching road traffic. The PICOP did this by parking his van (with its hazard lights switched on) to one side of the crossing, while he stood on the other side and signalled road traffic to stop using a hand lamp (figure 8). Once he judged that it was safe for the train to pass over the crossing, the PICOP signalled the RRV operator to proceed using a green hand lamp (paragraphs 48 to 52).
