Rail Accident Investigation Branch

Rail Accident Report

Dangerous occurrence at Denmark Hill station 1 August 2013

Report 23/2014
October 2014

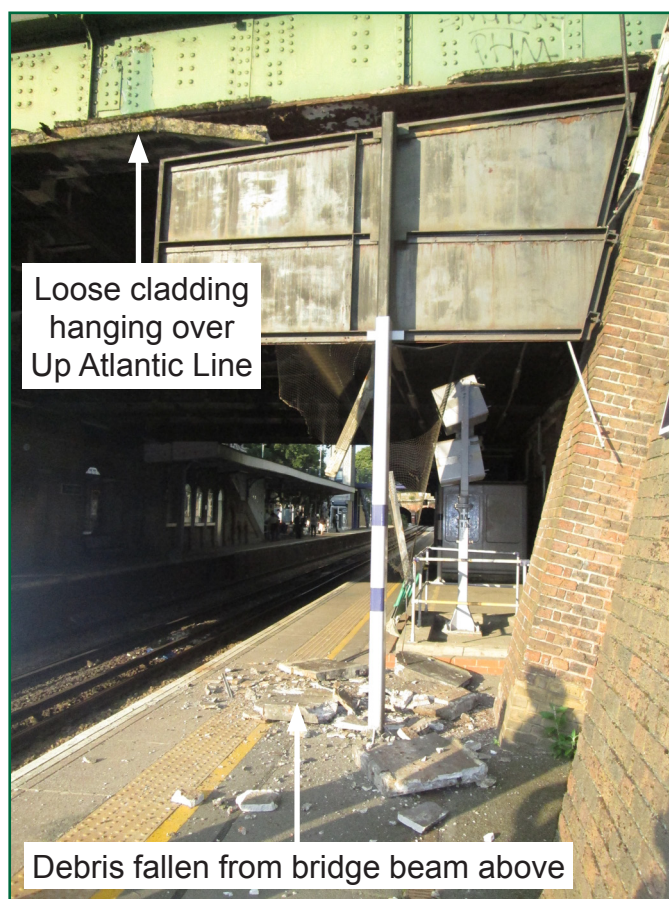
Figure 2: The incident

- 4 At 16:14 hrs on 1 August 2013 the driver of train 9M44¹, the 16:00 hrs service from Clapham Junction to Highbury & Islington, reported to the signaller that there was an object hanging from a bridge at Denmark Hill station. About six minutes later, the driver of train 2U56, the 15:38 hrs service from Dartford to London Victoria, reported that a section of concrete had fallen onto platform 1 and that it was unsafe for his train to proceed (figures 1 and 2).

- 5 One line through the station was closed immediately and a second was subsequently closed to permit emergency repairs. These were completed to allow reopening of both lines at 02:48 hrs the following day. The incident caused no injuries but did result in disruption to train services. However, had the concrete fallen when a passenger was underneath, it could have caused serious injuries.

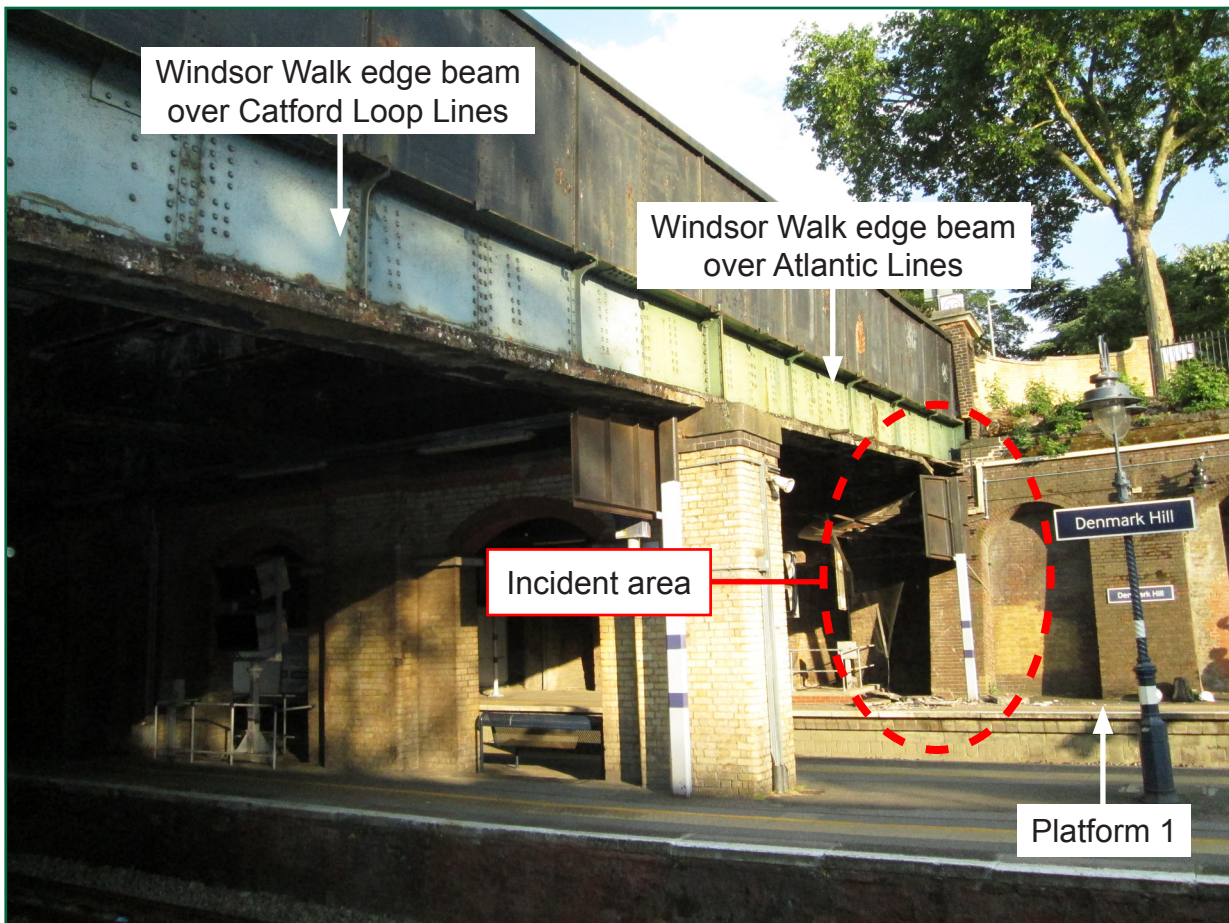
Figure 4: Windsor Walk edge beam over Catford Loop Lines

- 7 The bridge was built in about 1865 using metal girders to span across the railway. Drawings dated 1910 show that the girders were clad with concrete at about that time but neither the detail of the cladding, nor the reason for cladding, are given. The outermost girder adjacent to Windsor Walk is referred to as the Windsor Walk edge beam in this report.

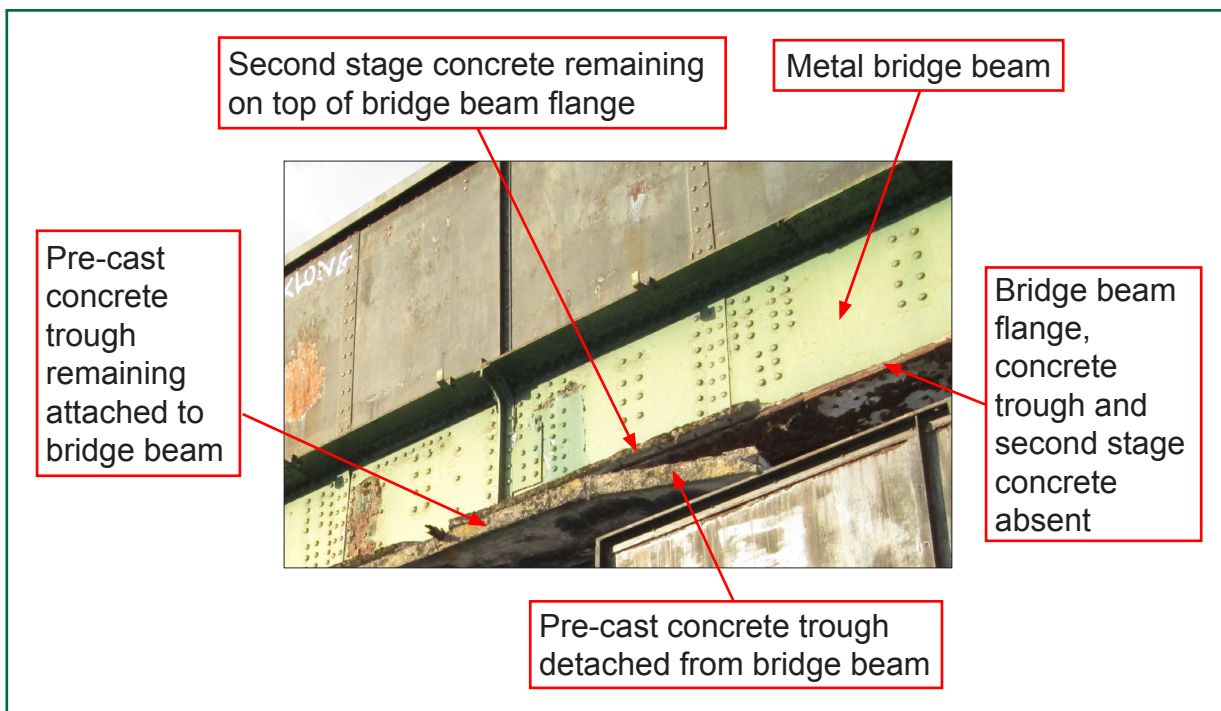
Figure 7: Cladding components

- 16 The presence of open joints meant that the metal rods were more susceptible to corrosion. It is the view of the RAIB that corrosion of the rods over many years caused a gradual weakening of the cladding until it reached the point when the trough was no longer adequately supported.

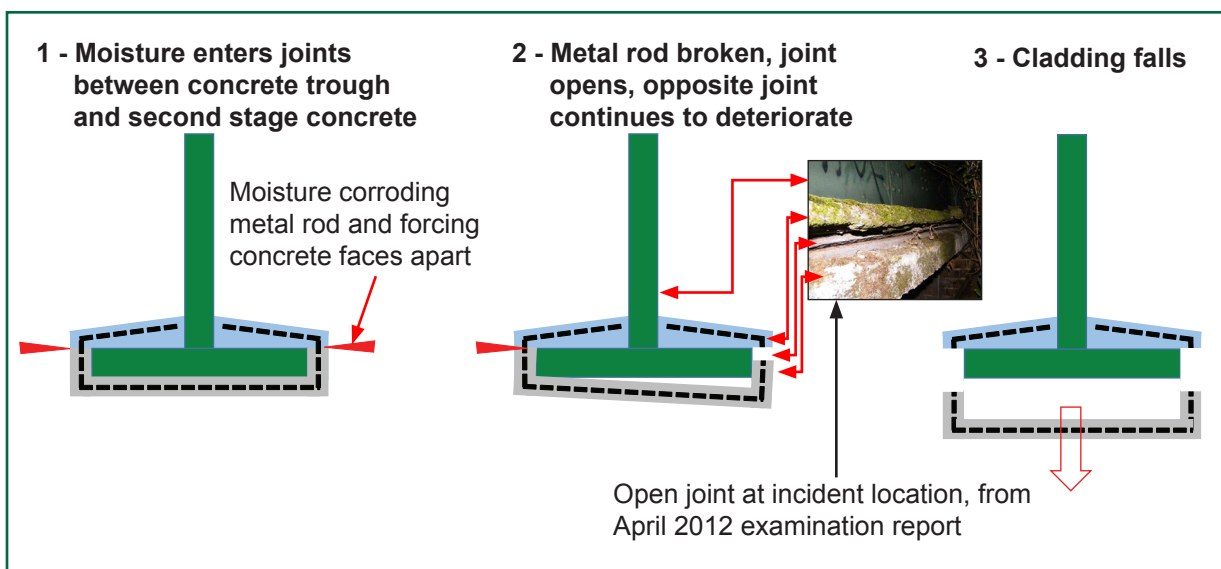
Figure 8: Failure mode

- 12 **The concrete and steel components of the cladding failed, which caused a section of reinforced concrete to drop onto the platform below.**

- 13 **The concrete and steel components of the cladding deteriorated to the point where a part became detached from the metal beam [causal factor 1].**

- 17 It is possible that the failure was triggered on 1 August 2013 by the normal small movements of the bridge due to thermal expansion and contraction on a particularly hot day (a maximum temperature of 33°C was recorded in central London).

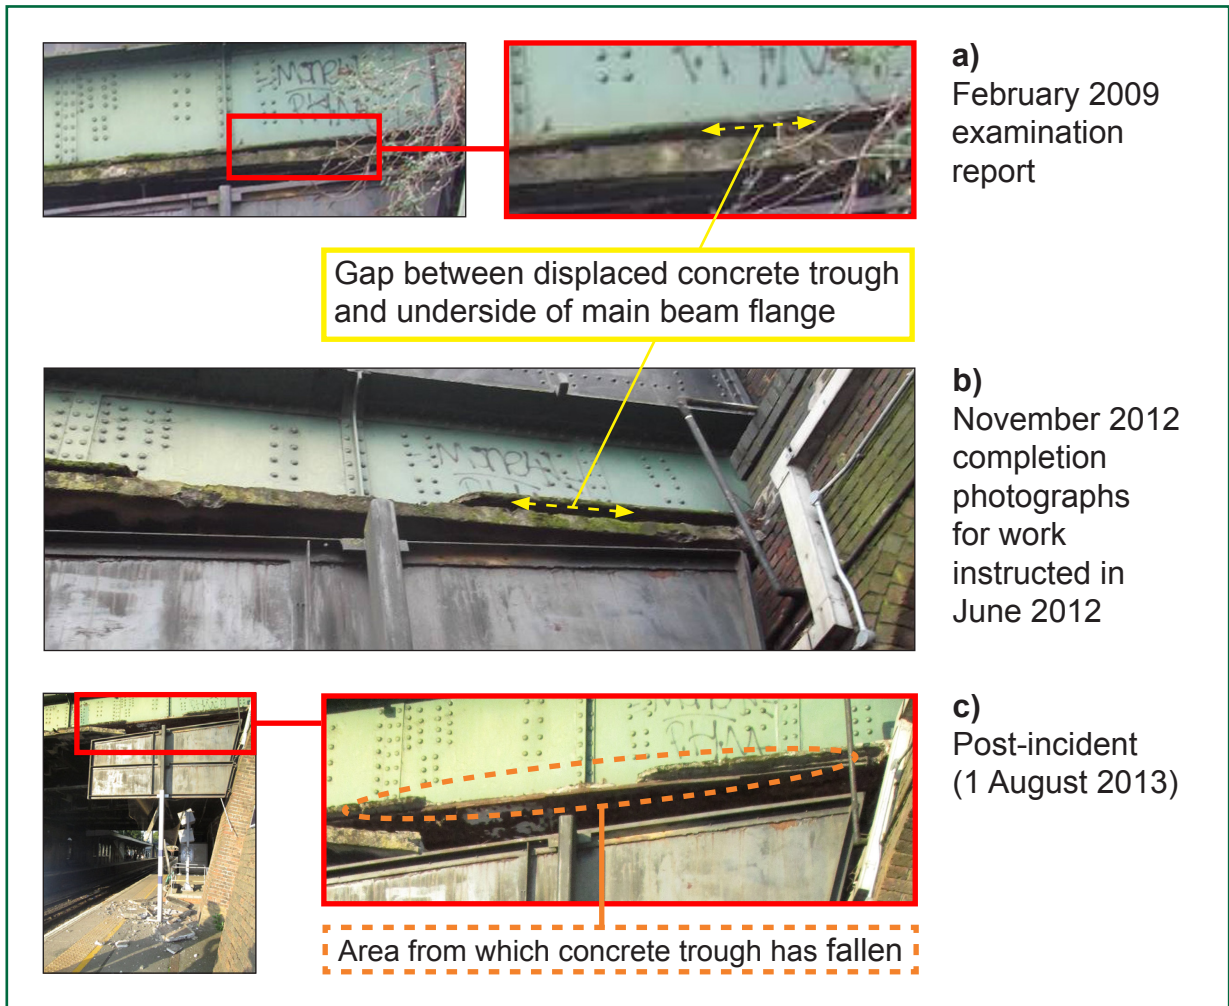
Figure 9: Windsor Walk edge beam above platform 1

Date	Event	RAIB Note	Linked underlying management factors
1 August 2013	A 5 metre long section of concrete trough falls from the underside of the bridge and lands on platform 1 (figure 9c).		
Post-incident	Network Rail implements a nationwide programme to identify structures with similar concrete cladding, to review the condition of this cladding and to carry out any necessary remedial work. This activity has resulted in work being carried out at several sites.

- 54 After the incident, all concrete was removed from beneath the Windsor Walk edge beam and significant amounts of concrete were removed from beneath other parts of the bridge. Network Rail reports that all areas of concrete 'with fractures' were removed.

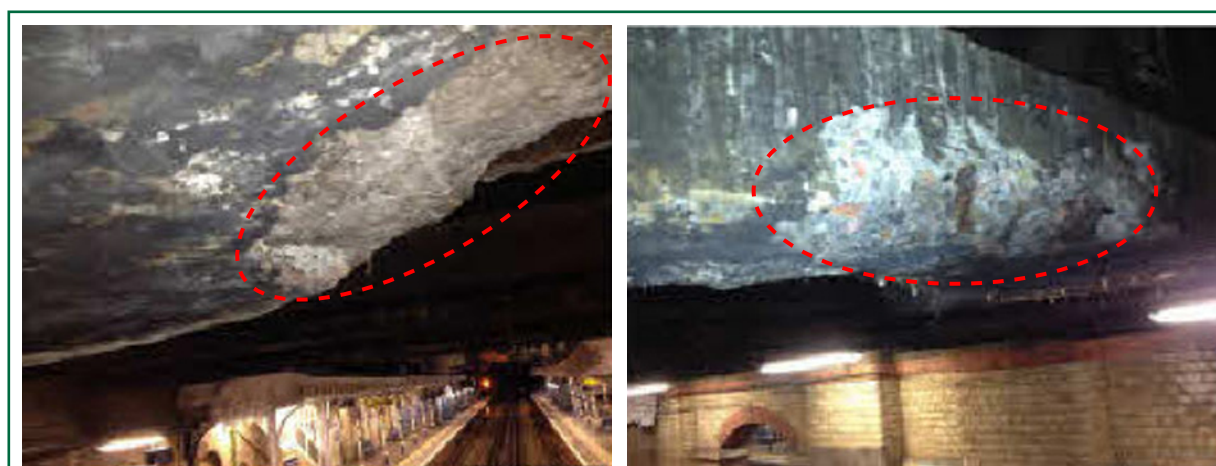
Figure 10: Defects possibly capable of identification by hammer test

- 38 The RAIB has identified at least three occasions where the minor works contractor was simply instructed to check for loose concrete. In these cases, the instruction was interpreted by the minor works contractor to mean that staff should hit the concrete with hammers in order to gauge its robustness and that anything that sounded 'drummy' (ie hollow) should be removed.

- 39 This crude method is not defined in Network Rail's procedures and had not been endorsed by the asset management engineers. However, no alternative method of checking for loose concrete had been specified for the guidance of the minor works contractors. Although this test could identify relatively small pieces of loose concrete (figure 10), it is unlikely to identify large pieces of loose concrete (eg the partially detached trough shown in figure 7) which the asset management engineers intended to be removed.

Dashed lines show areas from which concrete debris has fallen, or been removed. It is probable that this happened due to cracking which developed within the concrete so, when partially detached, the portion of concrete now missing is likely to have given a hollow (drummy) sound when struck with a hammer. The photographs were taken during the May 2013 callout but records do not show the extent to which concrete debris fell in an uncontrolled manner and/or the extent to which it was deliberately removed.
