Rail Accident Investigation Branch

Rail Accident Report

Buffer stop collision at Chester station 20 November 2013

Report 26/2014
November 2014

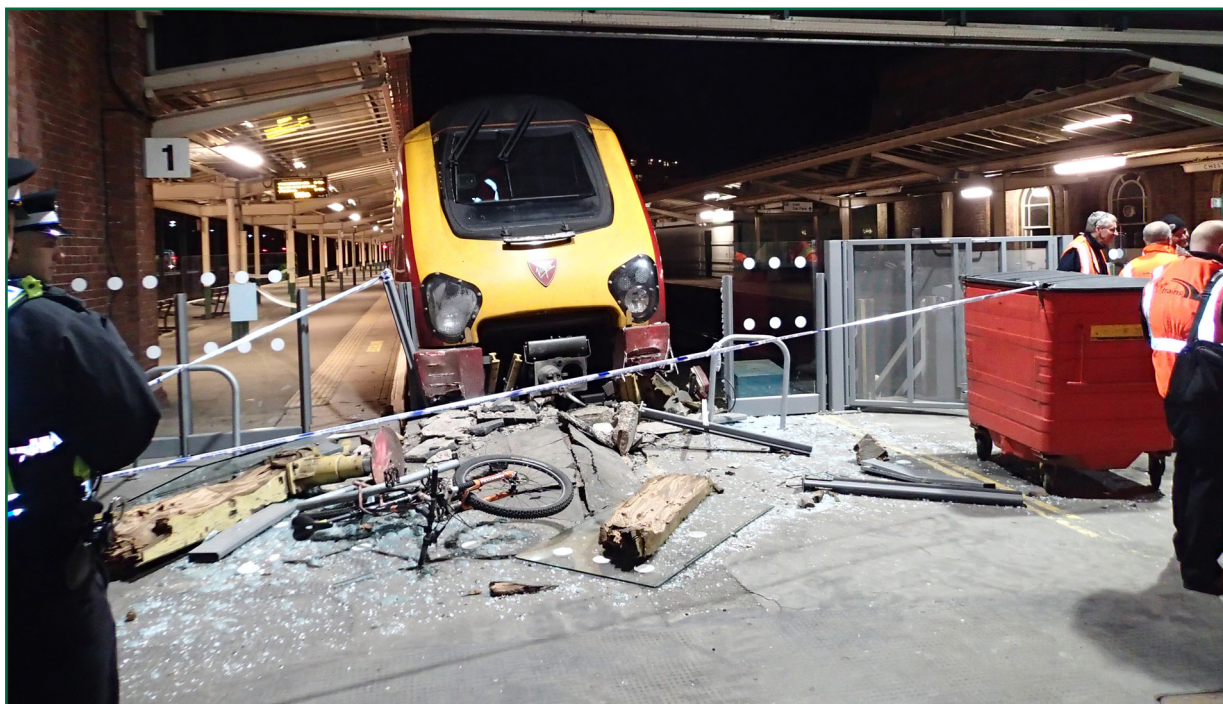
- 7 The impact destroyed the buffer stop and caused the leading vehicle in the train to start to override the platform, demolishing a glass screen and damaging the platform (figure 2). It was fortunate that there was no-one in this area at the time.
- 8 Several passengers fell over as the train stopped, but did not report injuries. One passenger was taken to hospital as a precaution as he had recently undergone a back operation. He was released later the same day.
- 9 The front of the train was damaged during the impact and the leading bogie was derailed.
- 10 Platform 1 at Chester station was closed until 04:15 hrs on 22 November for recovery of the train and repairs to the buffer stop.

Figure 2: Position of train after the accident

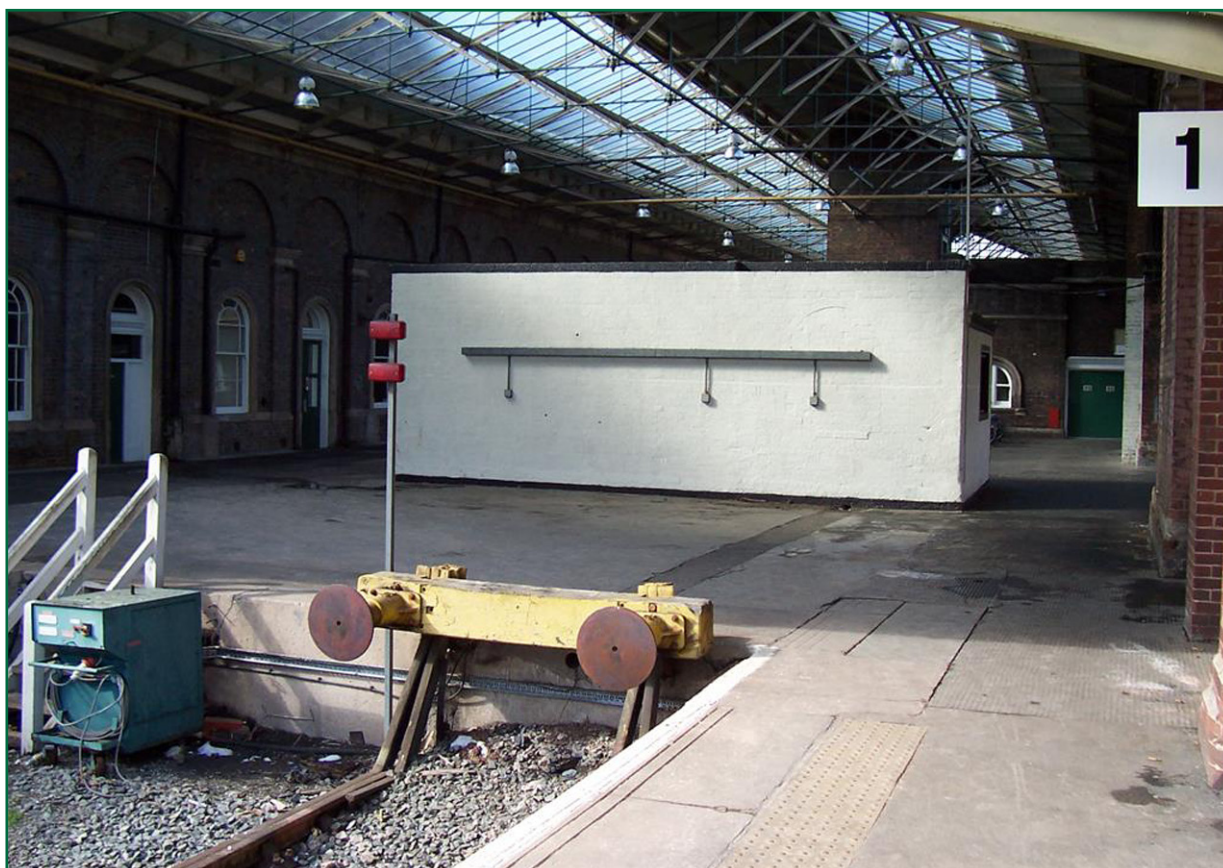
- 23 The buffer stop in platform 1 was of an old design built from bent rails bolted together (figure 5). It had a timber beam across the top to which were attached hydraulic wagon buffers. The rear part of the buffer stop, behind the timber beam, was concealed beneath the concrete platform surface.

Figure 5: Buffer stop in platform 1 prior to accident and before installation of a glass screen (courtesy of Network Rail)

- 138 The buffer stop was of an old design (figure 5) which did not comply with the current Group Standard, GC/RT5033 'Terminal Tracks – Requirements for Buffer Stops, Arresting Devices and End Impact Walls'. This requires that new buffer stops are of an energy-absorbing design. For existing buffer stops, the standard requires that all terminal or bay platforms have a current, documented, assessment of the risk arising from a collision with the buffer stop. RSSB document GC/RC5633 'Recommendations for the Risk Assessment of Buffer Stops, Arresting Devices and End Impact Walls' provides a recommended method of meeting this requirement.

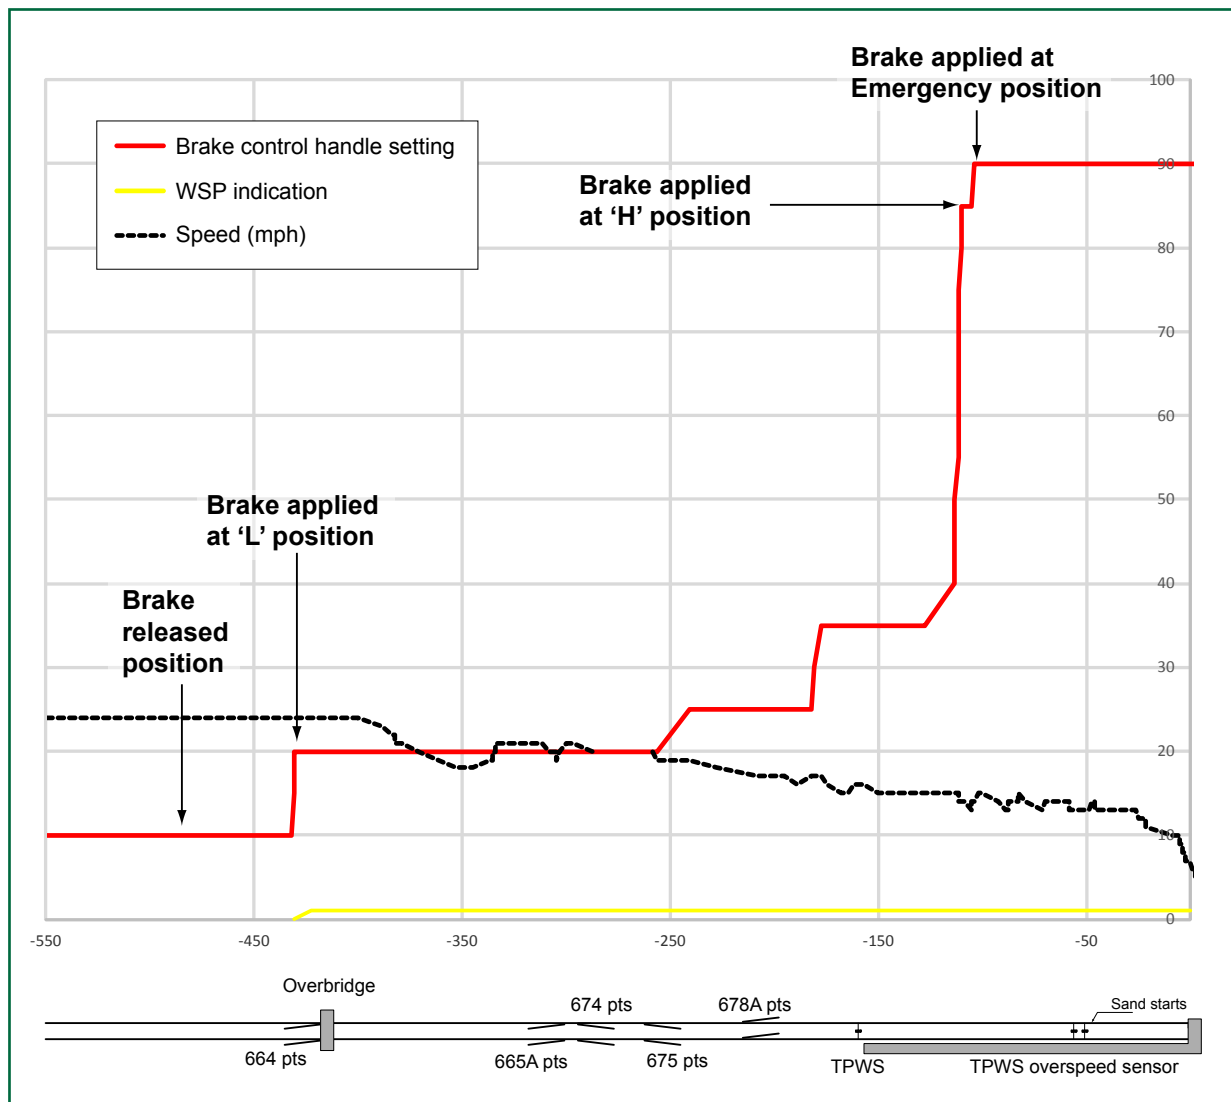
- 35 As the train approached the station, the driver applied the brake again to reduce the speed for the 20 mph (32 km/h) speed restriction through the points towards platform 1. He applied the brake in the 'L' (low – ie first mark on the scale beside the control handle) position. The WSP indicator immediately became steadily lit. Figure 6 shows the key events recorded by the OTDR plotted on a diagram of the approach to the platform.

Figure 6: Key events from OTDR recording approaching platform 1 at Chester

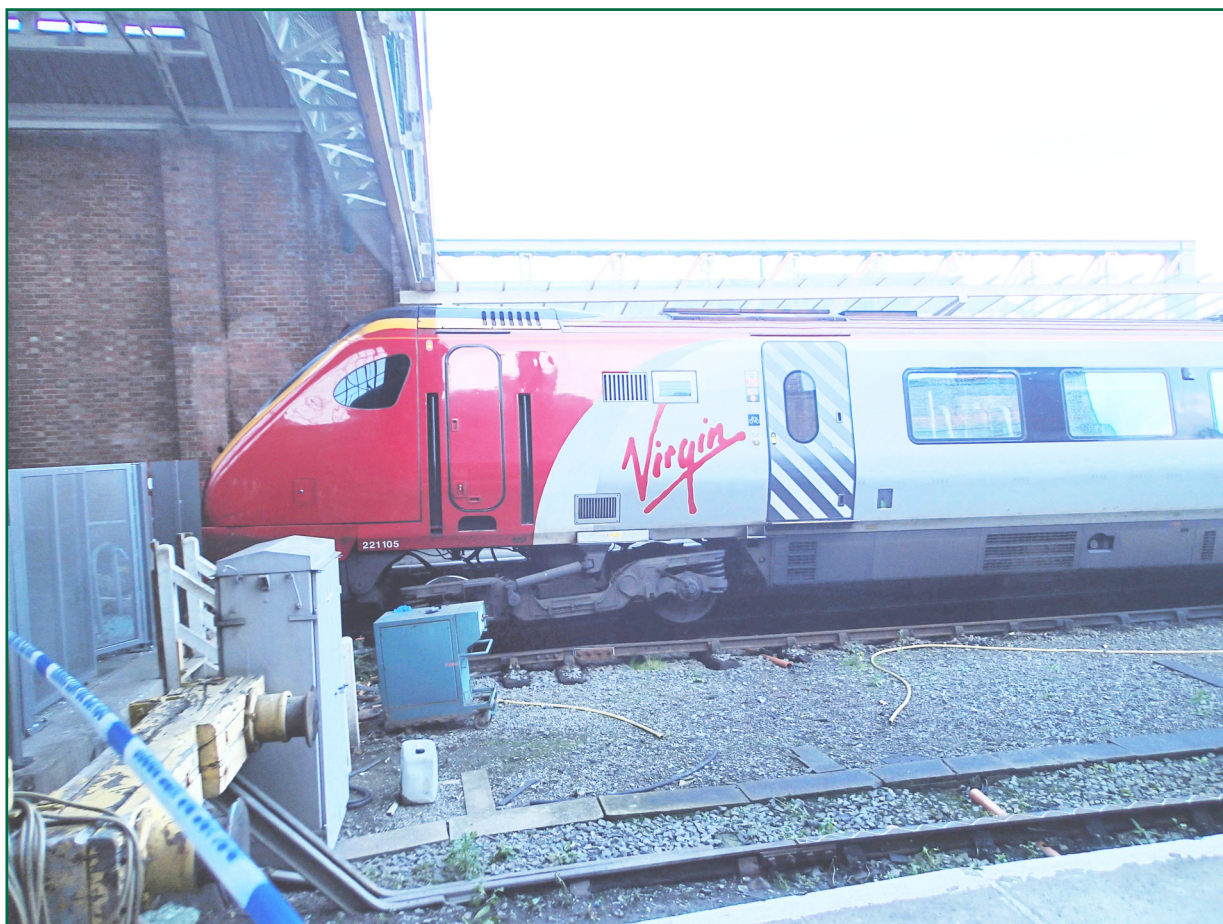
- 41 The impact with the buffer stop caused the buffers mounted on it to break away, along with the timber beam on which they were mounted. The timber beam and one of the buffers were thrown onto the platform beyond the buffer stop.

- 42 The front of the train engaged with the steel rails which formed the uprights of the buffer stop, bending them back and causing the front of the vehicle to override them onto the platform beyond, where it came to rest (figure 2). As the vehicle rode up over the remains of the buffer stop, its front bogie was lifted off of the track (figure 7).

Figure 7: Front of train resting on platform showing derailed bogie

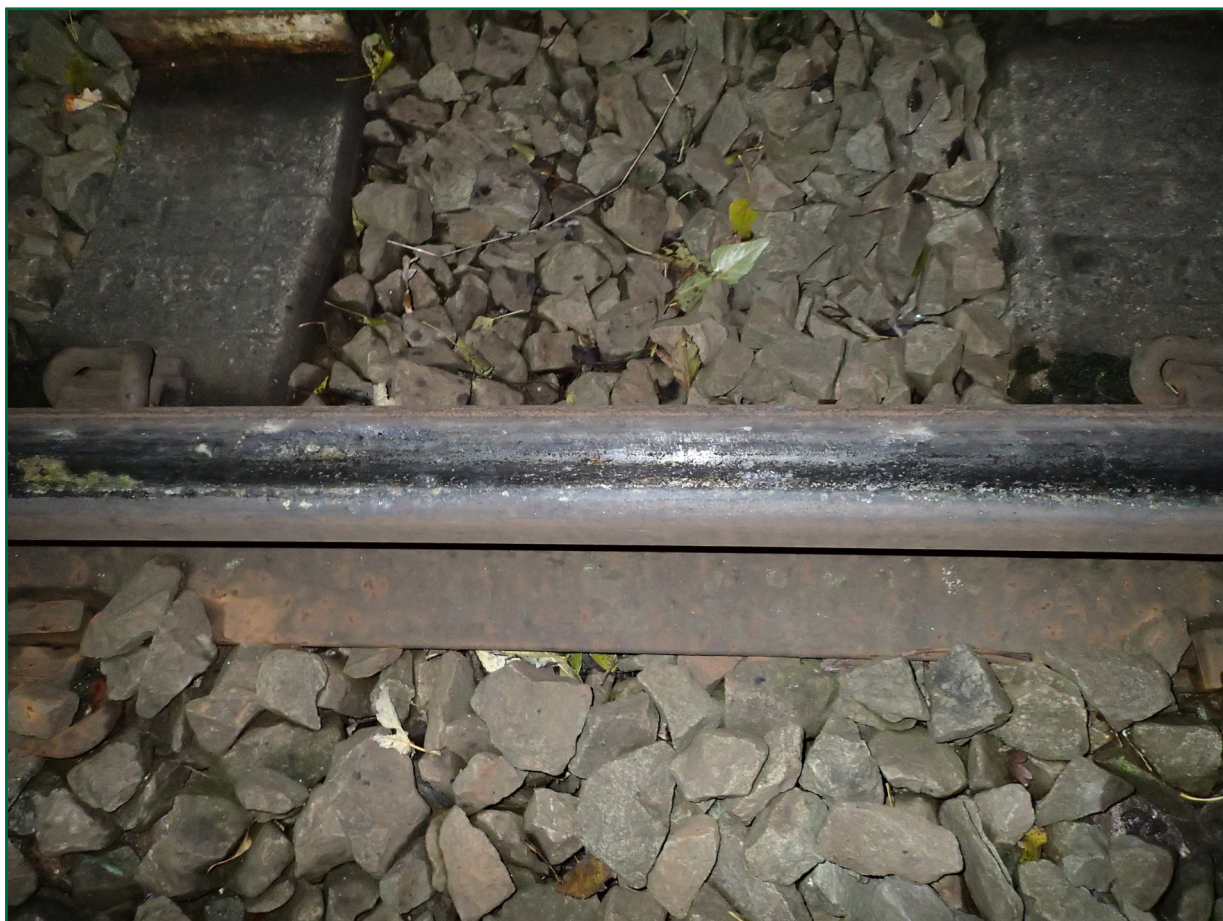
- 90 The chemical analysis showed evidence of ‘highly degraded leaf/vegetative matter’ in the samples taken from the wheels of the last vehicle in the train and in the samples from the *six-foot* rail at signal CR29, the cess rail at the AWS magnet for that signal and the cess rail at signal CR27. The cess rail at the AWS magnet for signal CR27 was not sampled by Network Rail but had a black coating, indicative of heavy leaf contamination, when photographed by the RAIB later that evening (figure 9).

Figure 9: Rail contaminated with leaf material at AWS magnet for signal CR27

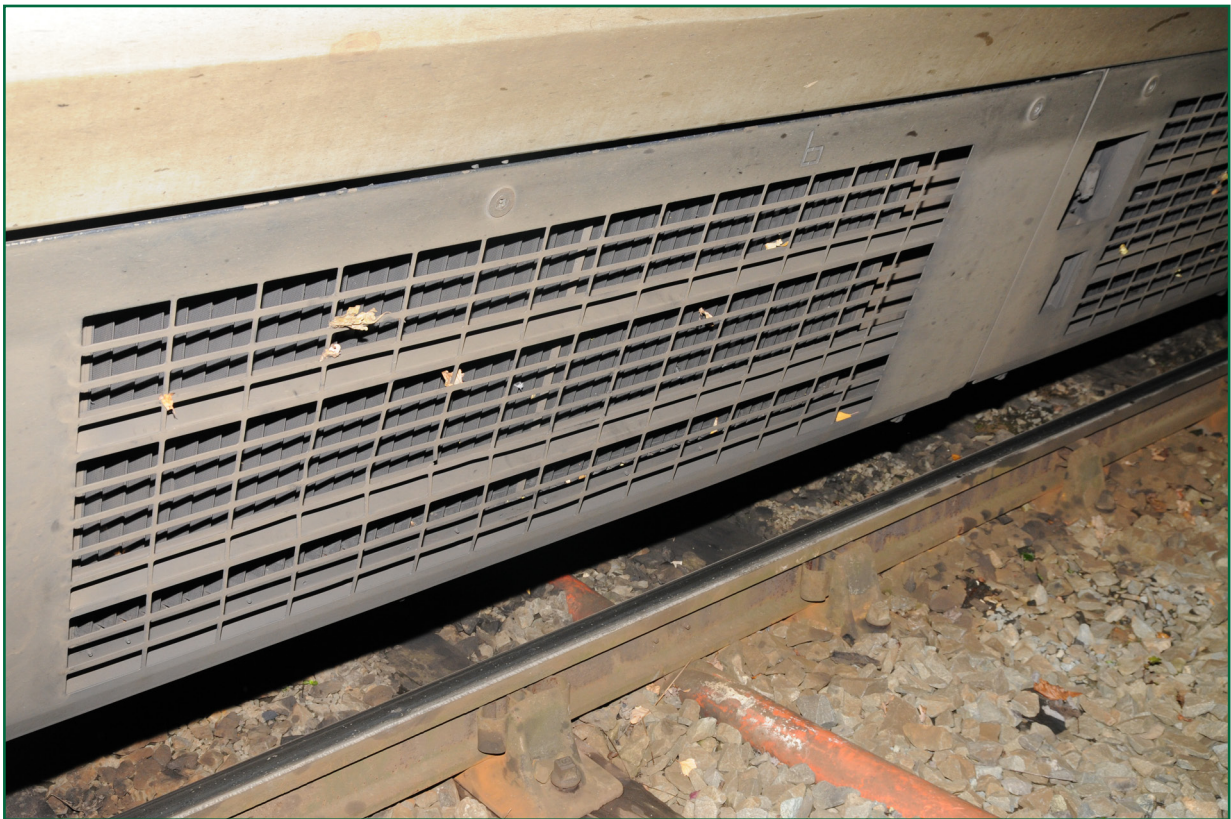
- 93 The chemical analysis of the samples from the wheels of the train and the rail furthest from the platform face within platform 1 showed that all samples contained traces of a hydrocarbon lubricating oil. However, the RAIB observed that the rail appeared to be generally clean and there were no traces of fresh oil (figure 10).

Figure 10: Rail beneath the train after the accident
