Rail Accident Investigation Branch

# Rail Accident Report

## **Collision at New Addington on Croydon Tramlink, 23 November 2005.**

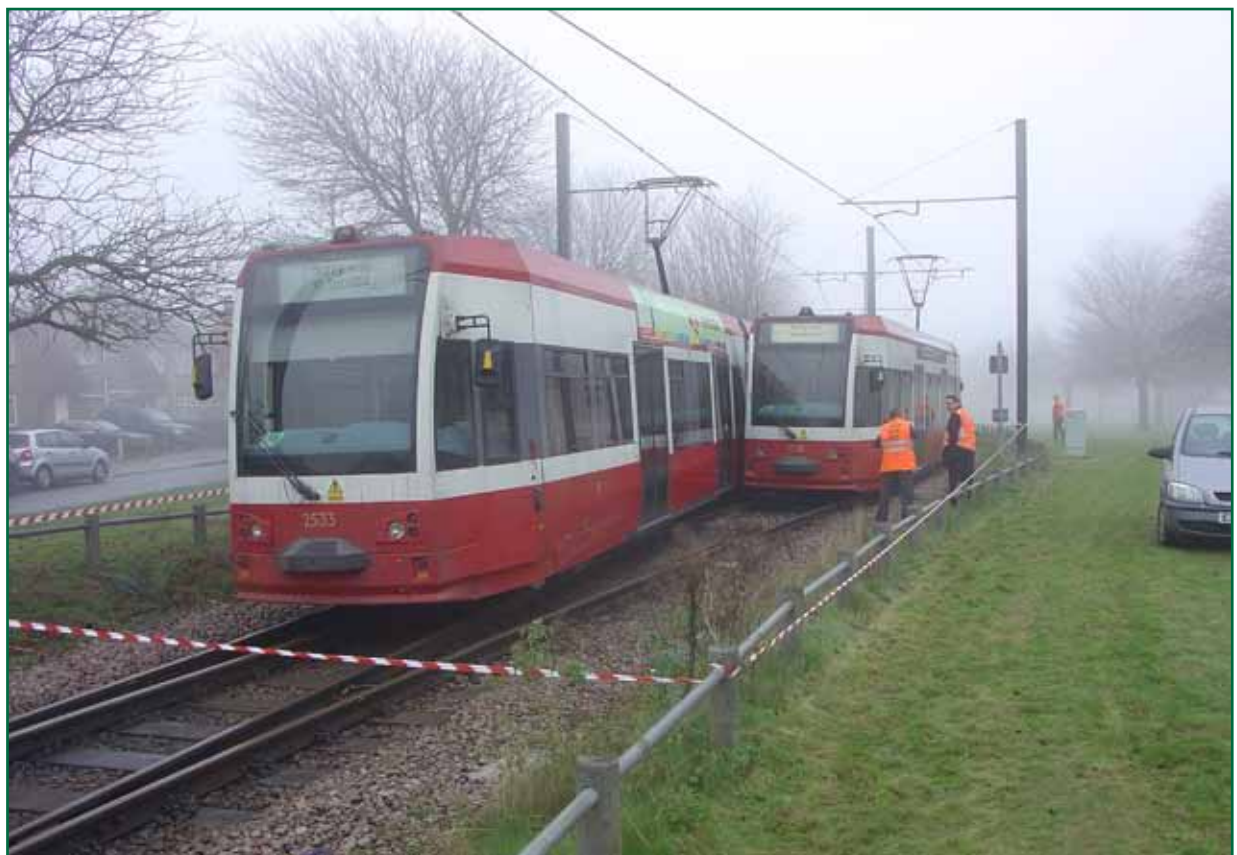
Figure 2: Site of the collision looking towards King Henry's Drive tramstop, showing the rear of tram 2533 (on left) and the front of tram 2538 (on right). The rear of KHD02 signal is on the shorter post to the right of tram 2538.

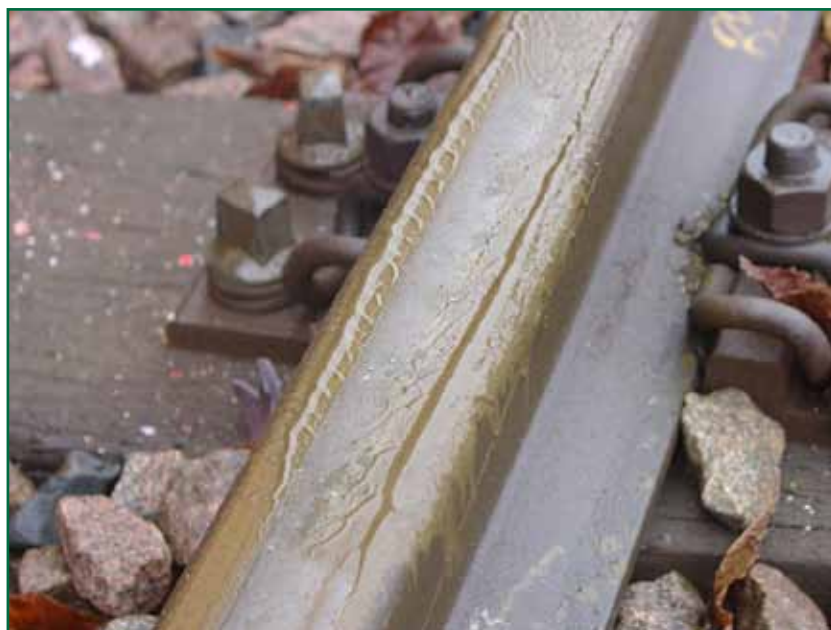
- 29 On the morning of 23 November, trams 2533 and 2538 were operating on the Line 3 service from Croydon to New Addington (Figure 3). Thick fog had descended during the night and remained in the area until late morning reducing visibility to approximately 70 m (this is estimated from witness commentaries and CCTV records). Rail conditions were very damp and the southbound line adjacent to KHD02 signal was visibly contaminated with a rusty sludge or paste. There is no evidence of poor wheel-to-rail adhesion which would have adversely affected the braking capability of the tram. Consequently the presence of this sludge does not appear to have had any bearing upon the accident.

Figure 5: Rail condition in the vicinity of KHD02 signal

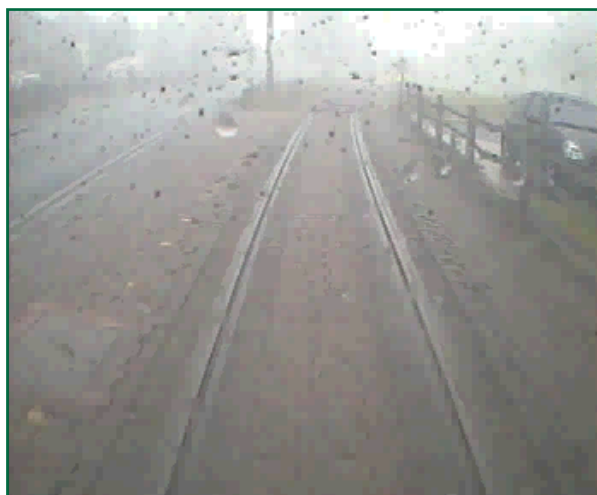
Figure 6: CCTV record from Tram 2533.  
Tram 2538 not visible.

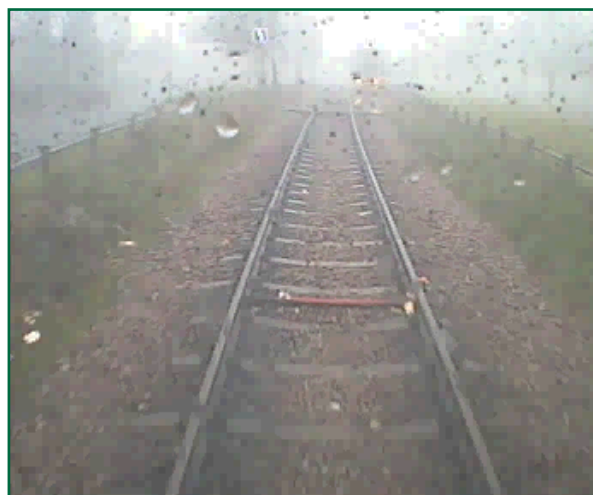
Figure 7: CCTV record from tram 2533.  
First sighting of headlights of tram 2538.

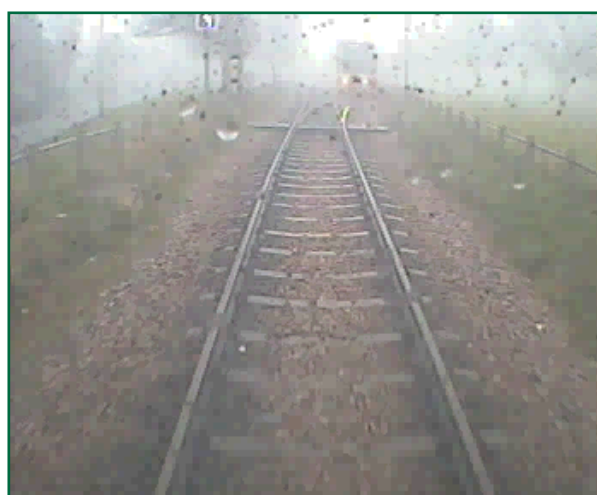
Figure 8: CCTV record from tram 2533.  
Tram 2538 outline and headlights just visible

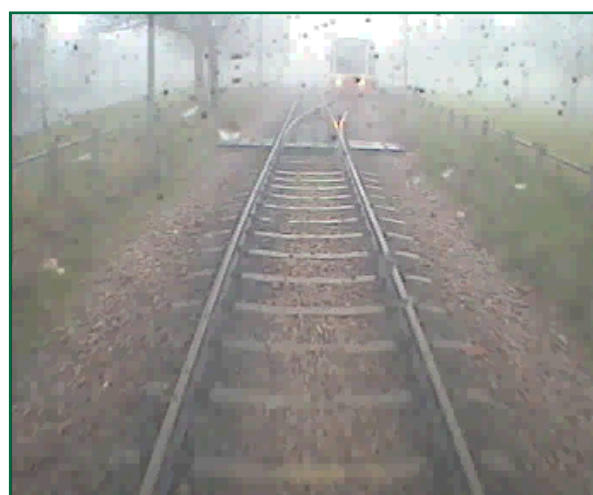
Figure 9: CCTV record from tram 2533.  
Tram 2538 clearly foul of running line

48 The driver of tram 2533 departed normally from New Addington after a slightly shortened layover. From inspection of the CCTV record, at 10 m from the toe of points, even with the poor visibility then present, tram 2538 can clearly be seen to be foul of the line. Had a hazard brake application been made here, the tram would have come to rest about 15 m from tram 2538. If the hazard brake application had been made still later, at the toe of the points, a collision would still have been avoided. The driver did not take any action until the distance between the trams was only 1.5 m, only then applying a full service brake.

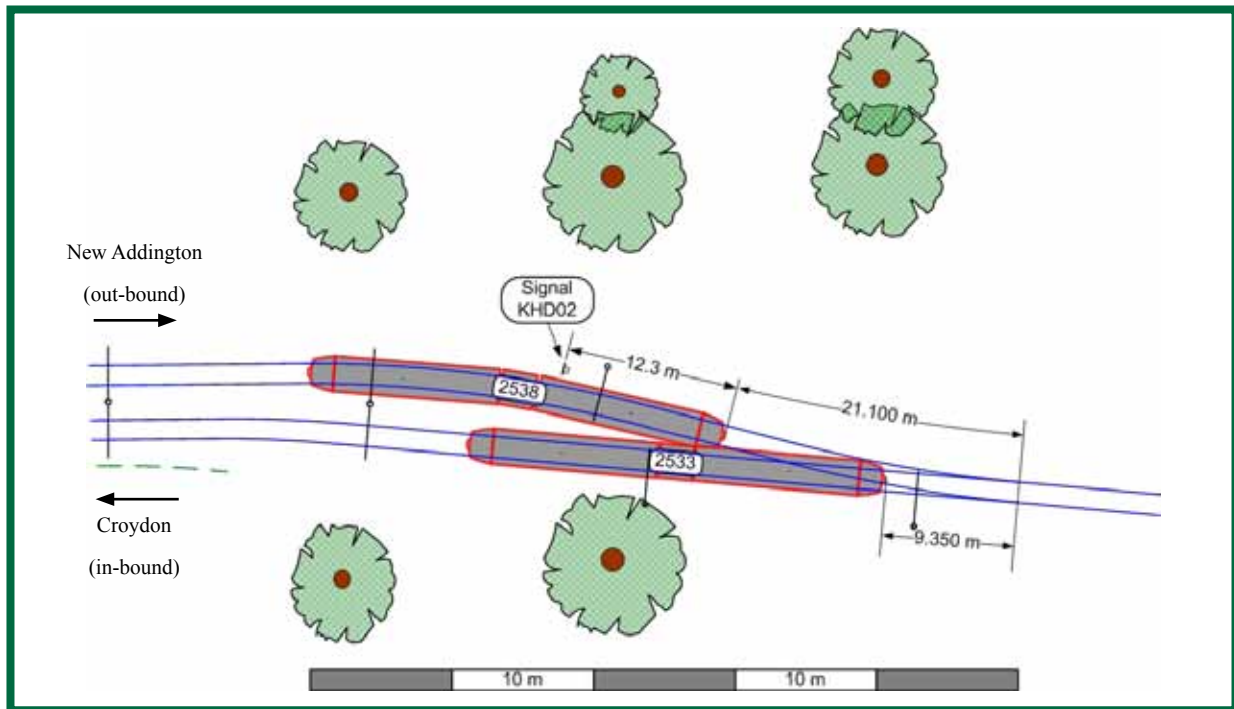
Figure 14: Diagram showing final positions of trams 2533 and 2538 in relation to toe of points

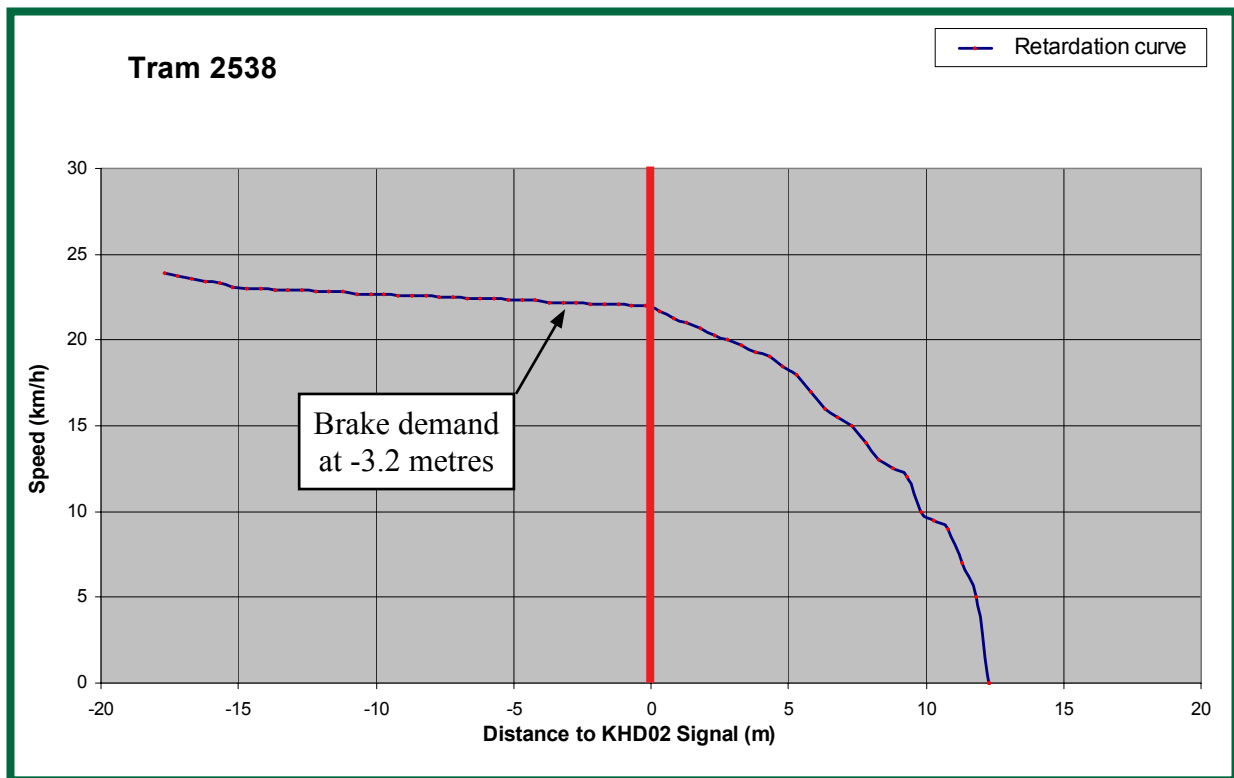
- 24 The position of signals in relation to fouling points follows normal tramway practice in that prescribed over-run distances are not necessarily provided. In some locations, an over-run is present; at KHD02 signal this is about 10 m.

Figure 15: Speed - Distance record for tram 2538, (Negative distances are on approach to signal)

Speed at signal	=	21.9 km/h (6.1 m/s)
Retardation rate	=	2.75 m/s <sup>2</sup>
Retardation distance	=	$\frac{(\text{entry speed})^2}{2 \times \text{retardation}} = \frac{(6.1)^2}{5.5} = 6.8 \text{ m}$
Brake application distance	=	4.6 m
(assuming a hazard brake application time of 0.75 seconds)		
Total stopping distance	=	11.4 m
Predicted over-run of KHD02	=	(11.4 - 3.2) m = 8.2 m
(assuming same location for application of the brake)		
Predicted distance short of fouling point	=	(10.0 - 8.2) m = 1.8 m

- 1 Tram Operations Ltd should carry out a programme to re-train all their drivers on the necessity to use the hazard brake in an emergency. Training and routine assessments should include understanding and demonstration by the driver in the operation of the hazard brake. The process of ‘feathering’ to avoid the final jerk should be retained (paragraph 50).

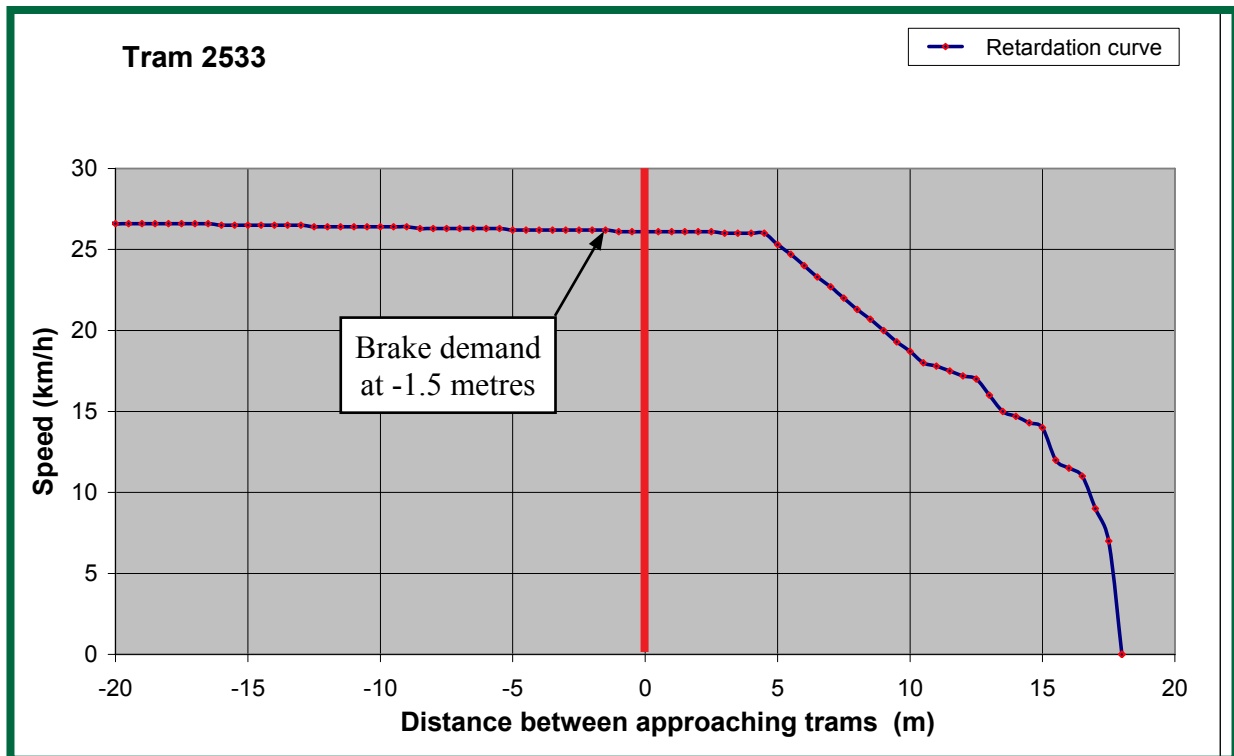
Figure 17: Speed - Distance record for tram 2533 (negative distances are on approach to point of collision)

Speed at toe of points	= 26.7 km/h (7.4 m/s)
Retardation rate	= 2.75 m/s <sup>2</sup>
Retardation distance	= $\frac{(\text{entry speed})^2}{2 \times \text{retardation}}$ = $\frac{(7.4)^2}{5.5}$ = 10.0 m
Brake application distance (assuming a hazard brake application time of 0.75 seconds)	= 5.5 m
Total stopping distance	= 15.5 m
Distance, toe of points to front of 2538	= 20.9 m
Predicted distance between trams	= (20.9 – 15.5) m = 5.4 m
