Rail Accident Investigation Branch

Rail Accident Report

Huntingdon train door incident 15 February 2006

Report 11/2007
v2 - April 2007

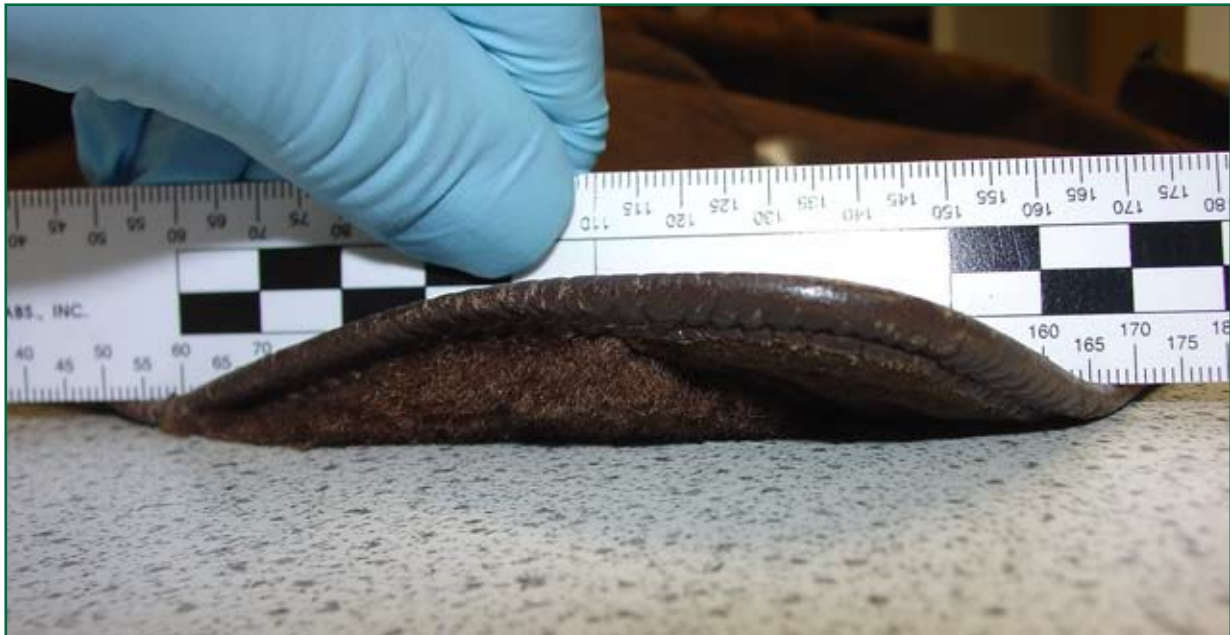
Figure 6: Coat material

- 31 The coat was made from a heavy suede type fabric lined with a fur type material, as shown in Figure 6. It is possible that one of the coat buttons became trapped either in the door or behind the closed door during the incident. For the purposes of assessing the force required to extract the trapped fabric it was assumed that this button had not played a part in the trapping process. Had it been trapped behind the closed door then the extraction forces would have been greater than those recorded during the tests. The tests were configured to establish if the lower force to extract the coat in the scenario where the coat button was not trapped were significant.

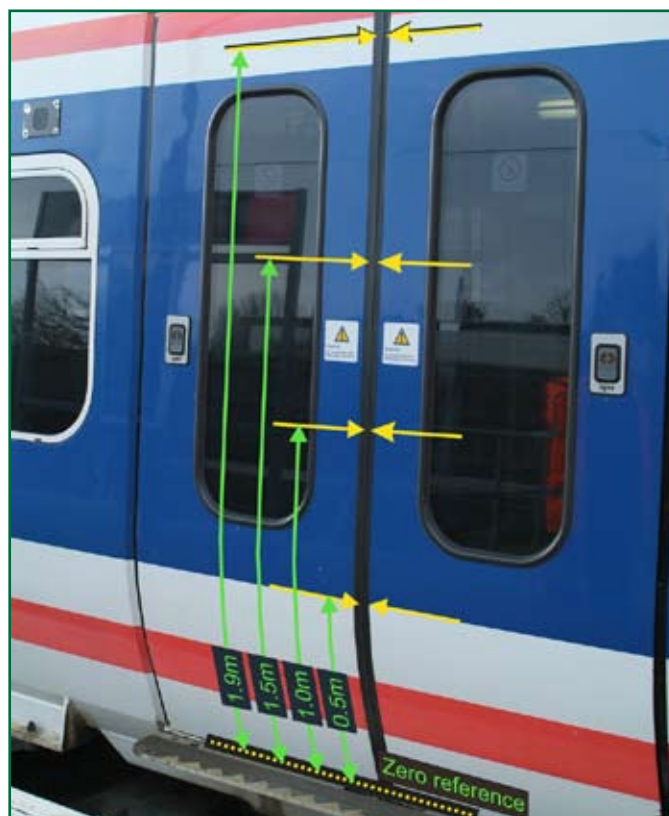
Figure 7: Positions where door closing forces were measured

- 34 The door closing forces were recorded from two door sets. These were the trailing doors - vehicle [72242] and the incident leading door – vehicle [72243]. The forces were recorded at a number of positions as shown in Figure 7. It should be noted that 1.0 m from the door tread was the estimated position where P2's coat became trapped in the door.

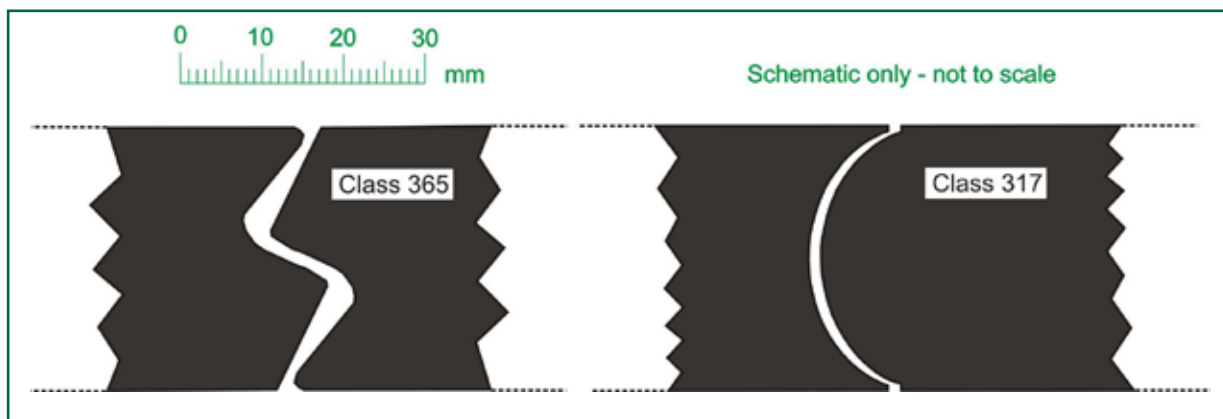
Figure 8: Schematic of Class 365 and Class 317 door seal configurations

- 49 During the door closing tests the seals from the incident door were measured and casts were taken. Figure 8 shows a plan section through the seals taken from these casts.
- 50 The Class 365 Unit has a door seal design such that when the door is closed the two seals interlace. This improves the sealing and reduces any lateral movement but has the effect that when any fabric or clothing is trapped the forces required to extract the trapped material are likely to be greater than the simpler seal found on the Class 317 Unit.

- 51 Group Standard GO/OTS300 (Reference 5), to which the Class 365 Units were built, makes no mention of seal design. The current Group Standard GM/RT2473 (Reference 4) states in Section B7.9 – Door closing edges – ‘The design of the closing edge shall minimise both the risk of trapping objects and the risk and extent of injuries caused by the door equipment’.
- 52 It is concluded that the door seal of the Class 365 Unit does not comply with the current Railway Group Standard. The current Railway Group Standard does not require compliance for stock predating the standard coming into force.

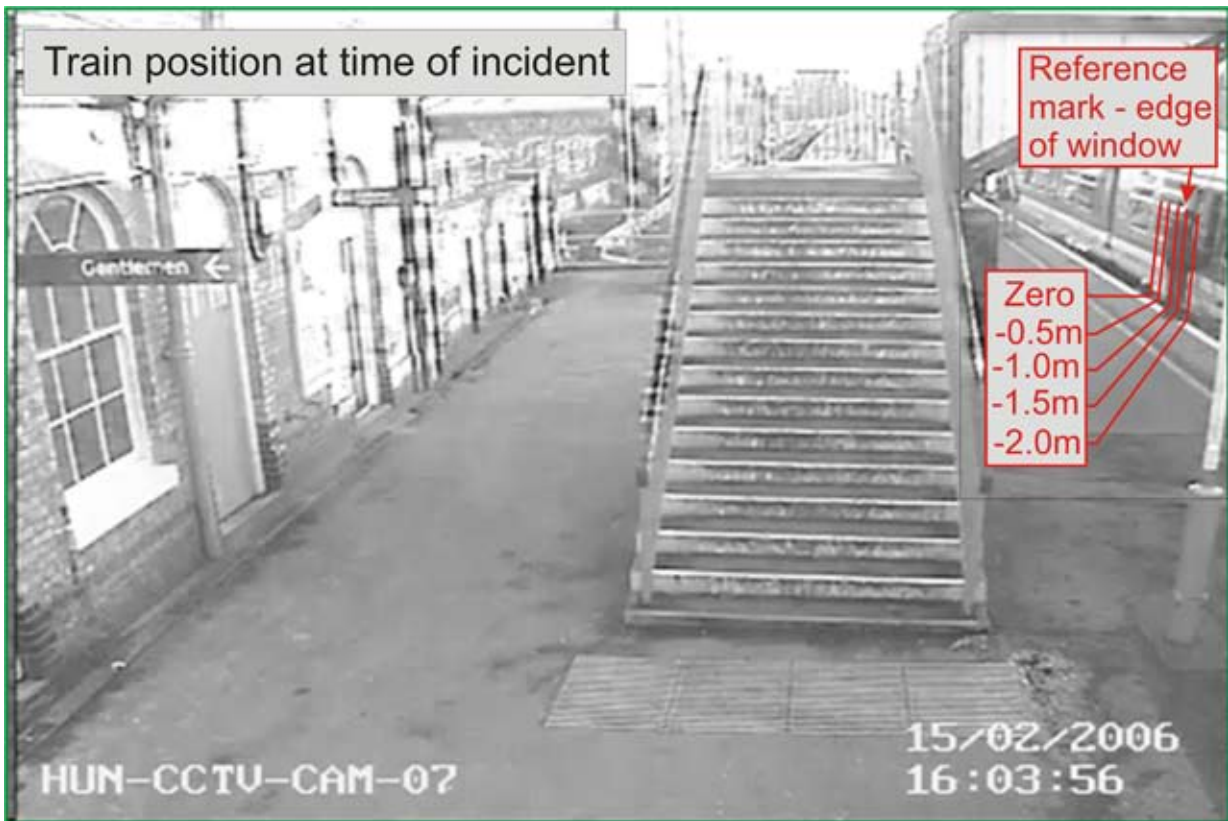
Figure 13: Image from security camera 7 showing train position at the time of the incident

- 81 That the driver came to a stand approximately 1.4 m short of the monitor bank centre line may have affected the quality of the image seen by the driver showing on the right-hand (D3) monitor.

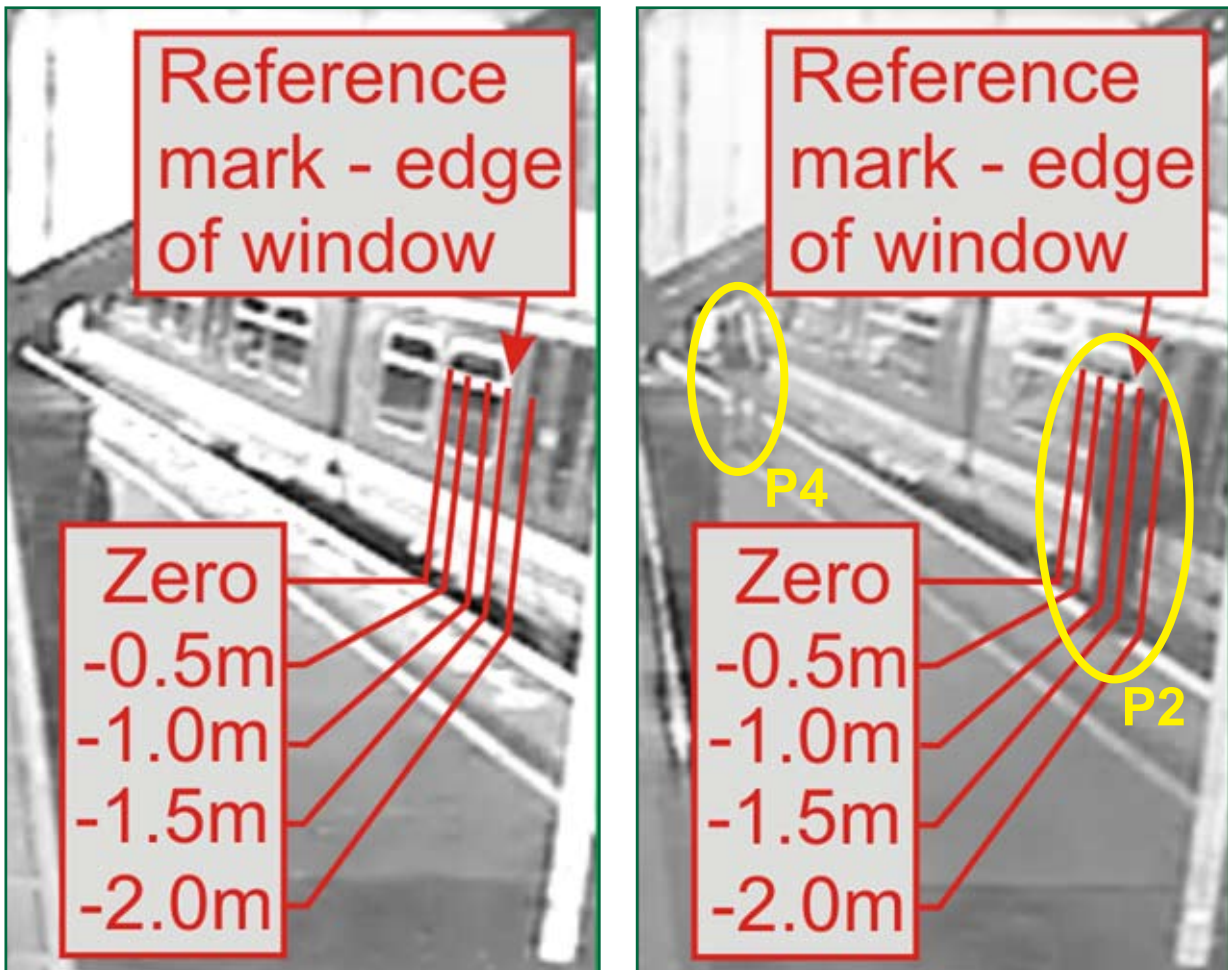
Figure 14: Enlarged images showing train comparison positions – incident train right-hand image – reference test train left-hand image

- 75 The right-hand image in Figure 14, shows the presence of a person, P4, stood in close proximity to the trailing door of the second vehicle [72242]. P4 appears to be dressed in an anorak with a light coloured stripe down each arm. The security camera video frames reveal that P4 also appears to be seeing someone off (P5). When the train doors close P4 moves away from the closing doors and stands within the area bounded by the painted yellow stripe and the platform edge.

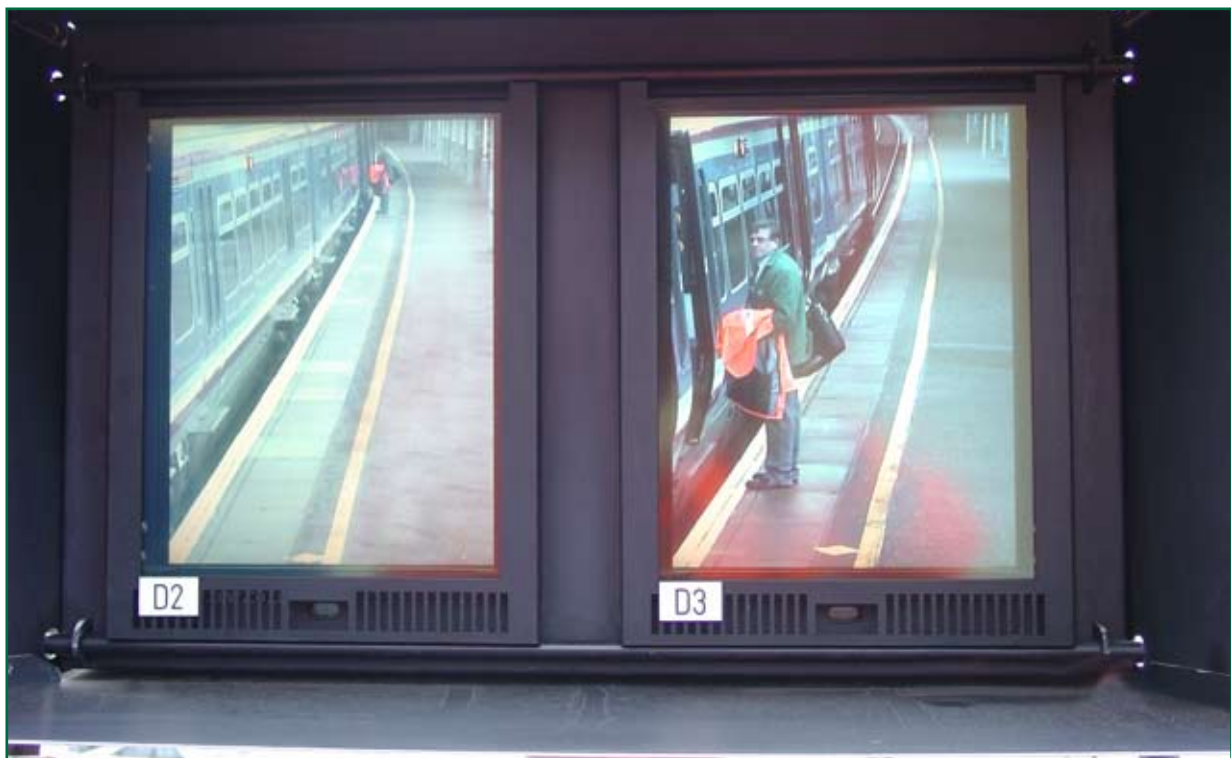
Figure 17: View from four-car monitors with a person stood at the incident door

- 71 The left-hand monitor in Figure 17, D2, shows that a person standing at the leading door of the third vehicle should, under good daylight conditions, be visible to the driver. This photograph gives an indication as to where the D3 camera is positioned and the extent of the platform two curve.

- 72 The right-hand monitor in Figure 17, D3, shows clearly the person standing at the leading door of the third vehicle. Under good visibility conditions a person standing at this door should have been readily observed (the orange flare in each image is from the jacket worn by the RAIB Inspector photographing the scene).

- 73 These images also show that the cameras had not been disturbed since installation and setting up. The targeting diamonds are visible at the centre of the lower edge of each frame. These diamonds are painted on to the platform edge such that when they aligned with the monitor centre line the camera is in the correct position. Therefore the cameras were set up correctly with the target diamonds approximately in mid-screen at the time of the incident.

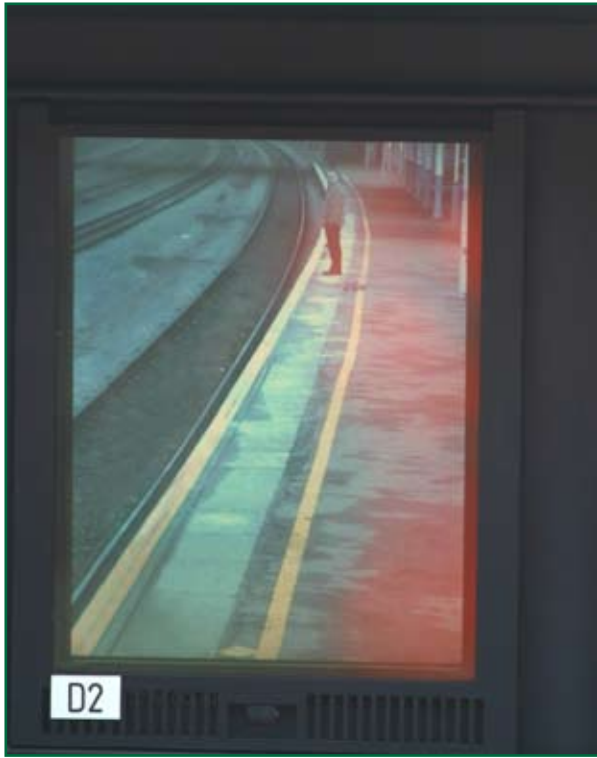
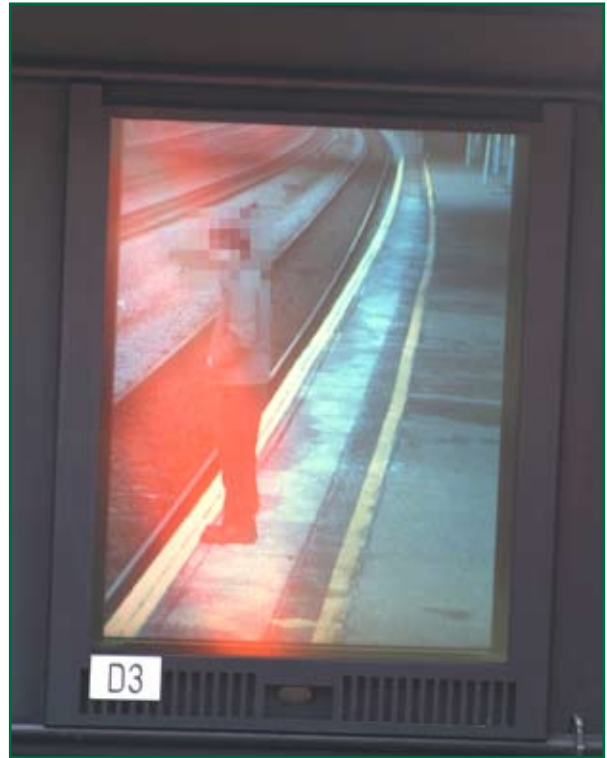
Figure 19: Volunteers at the relevant door positions

- 77 One set of observations is shown in Figure 19. In the image on the D2 monitor only one person appears to be in view and that person appears to be within the edge of the platform edge and the yellow line and well clear of the door/platform edge. The view from the right-hand D3 monitor also indicates that only one person is present but this person is now in closer proximity to the edge of the platform edge. For clarity the image of the photographer has been removed from the D2 monitor image. Figure 19 shows that the person at the trailing door of the second vehicle can readily obscure the driver's view of a person at the leading door of the third vehicle. The effect is highlighted further in Figure 20 which is an enlargement of the image from the D2 monitor with two persons in view.

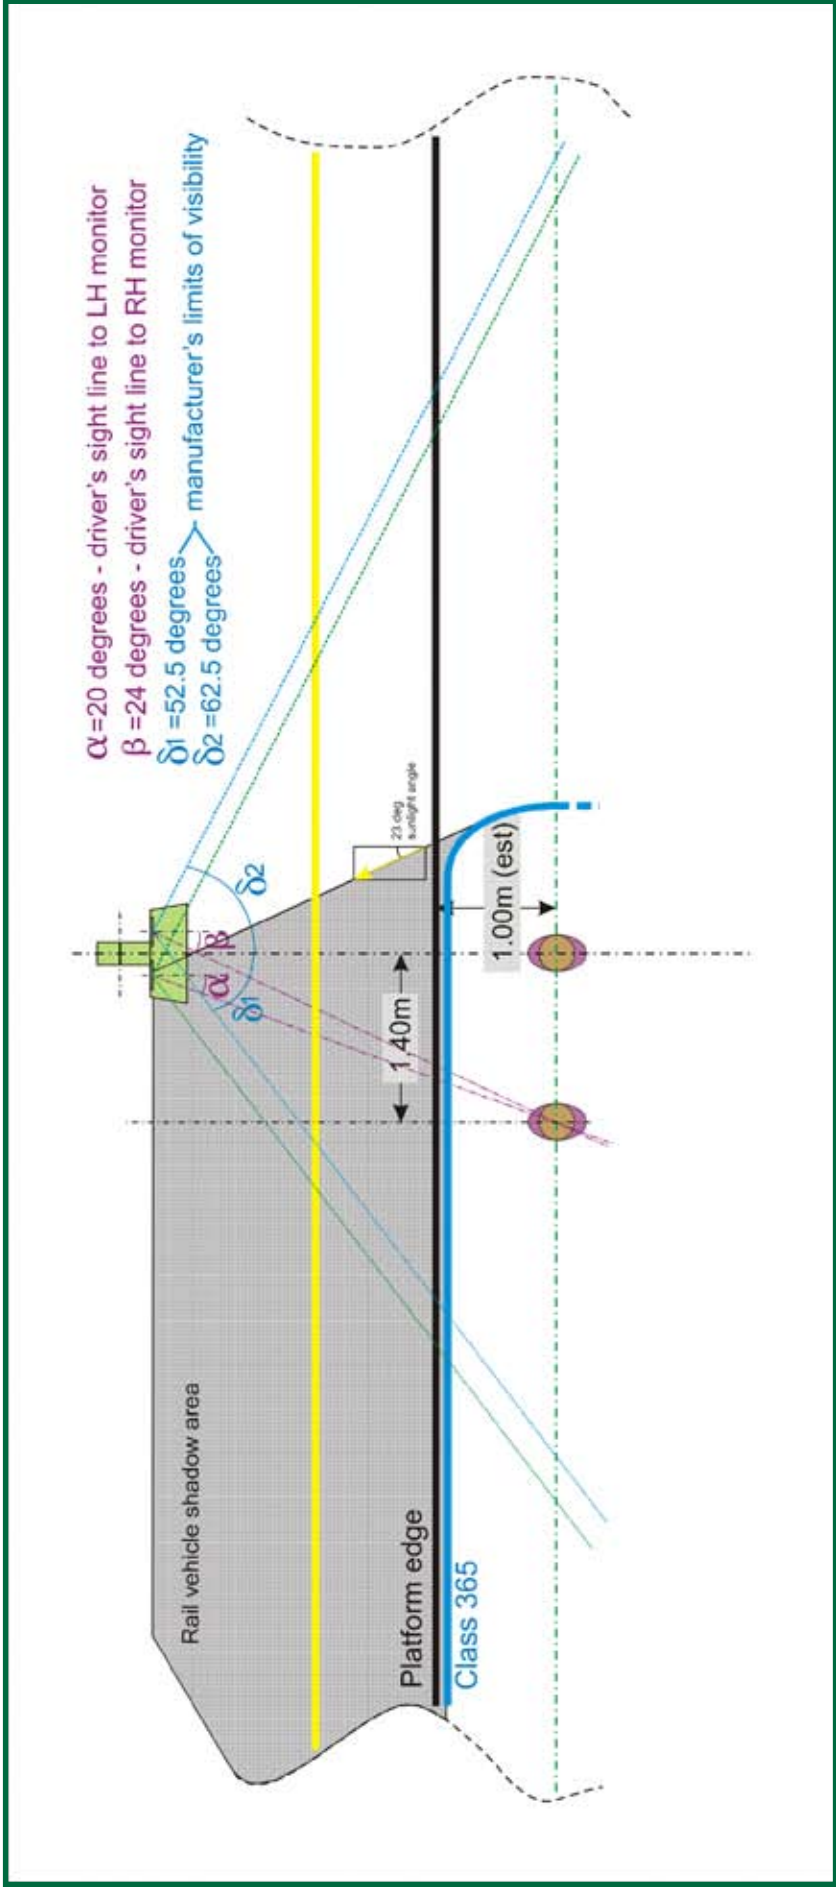
Figure 24: Driver sight line and position of sun/shadow information

- 89 Both viewing angles are well within the manufacturer's quoted maxima of 52.5° and 62.5° respectively see (Figure 24), but when the system was demonstrated at the TEW premises on 13 March 2006 there was a noticeable reduction in contrast level when the monitor screen was observed from the left-hand side.

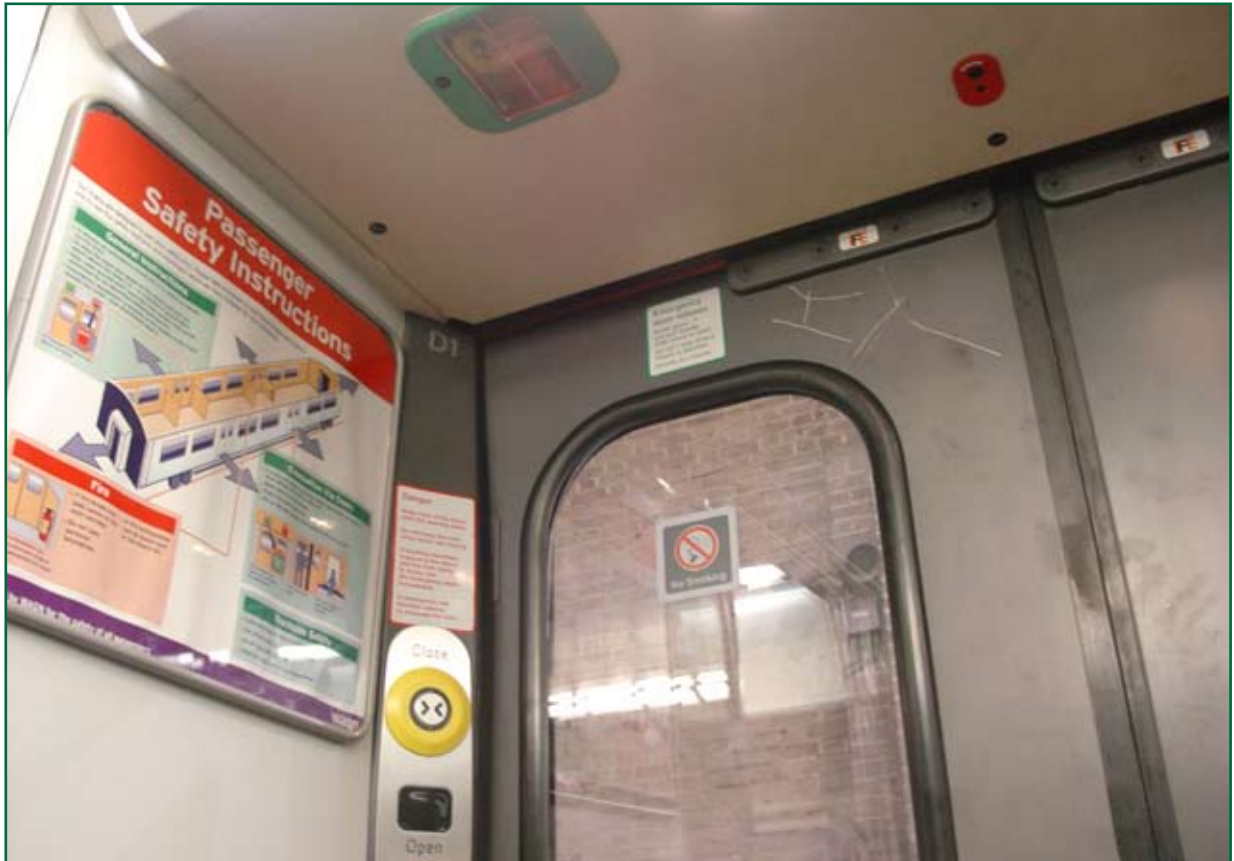
Figure 25: Signage left-hand side of the Class 365 Unit door

- 96 The only sign in the vicinity of the incident door relating to the Emergency Door Release is found on the left-hand door leaf (D1). If this release had been activated the train would have stopped immediately; however, passengers are instructed not to use this release if the train is moving. Figure 29 shows the text associated with both the 'Emergency Alarm' and the 'Emergency Door Release'.
