Rail Accident Investigation Branch

Rail Accident Report

**Derailment at Trooperslane near Carrickfergus,
Northern Ireland
23 April 2006**

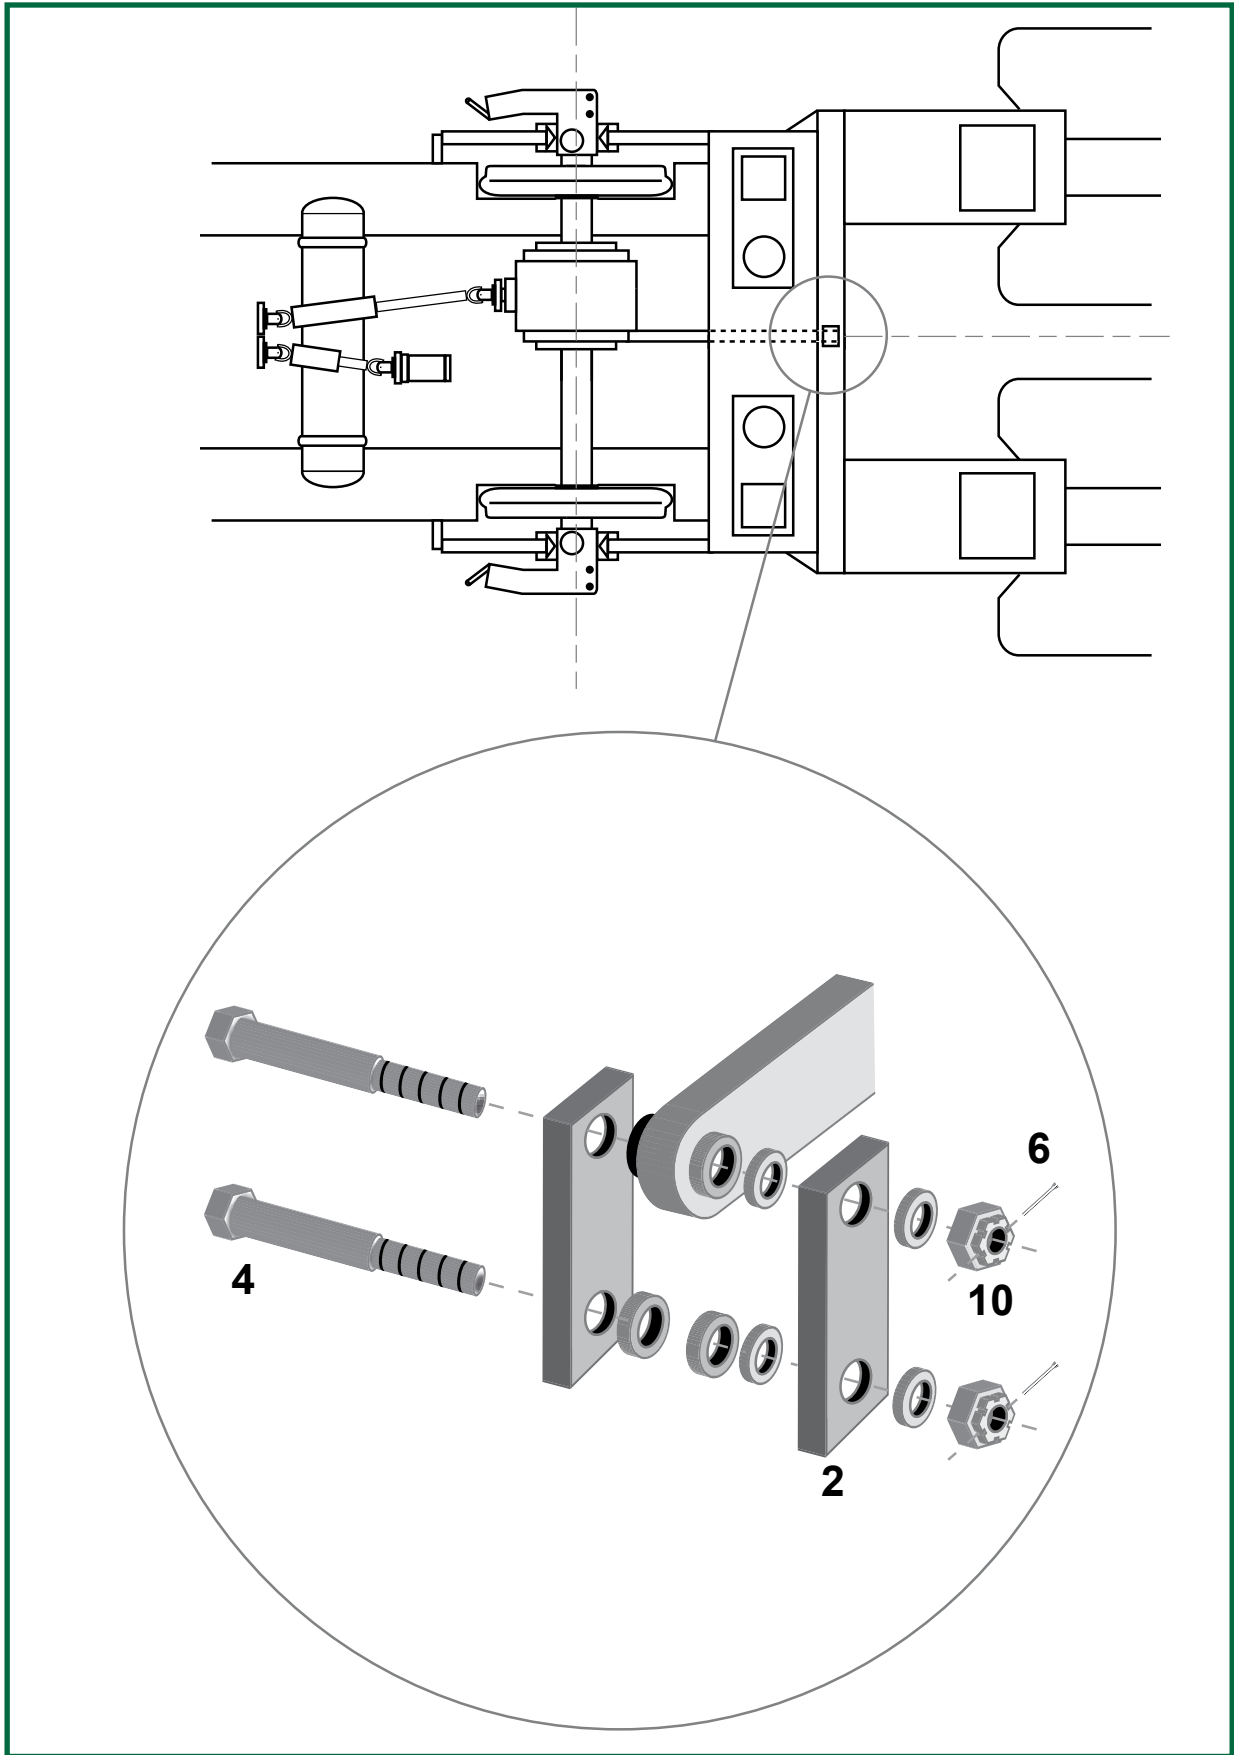
Figure 3a (above): plan view of underside of ballast regulator showing the torque reaction arm assembly attached to the front axle and headstock bracket

Figure 3b (below): Assembly diagram of torque reaction arm anchor fixings. The pin (4), castellated nut (10) and split pin (6) arrangement is duplicated at the top and bottom of the fishplates (2)

- 99 The headstock end of the arm is retained by two securing pins which pass through the torque arm and the headstock bracket. Each securing pin is secured by a *castellated nut*. The nut is in turn prevented from working loose by a split pin through the castellations of the nut and the securing pin (see Figures 12, 15 & 16).

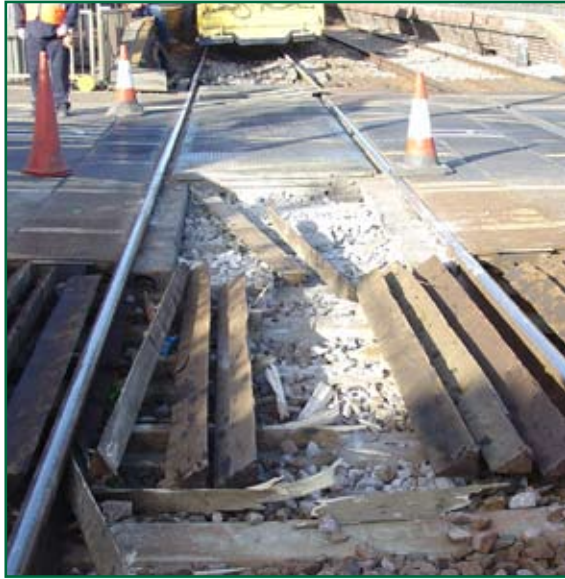
Figure 4: Trooperslane crossing with rear aspect of ballast regulator 7003

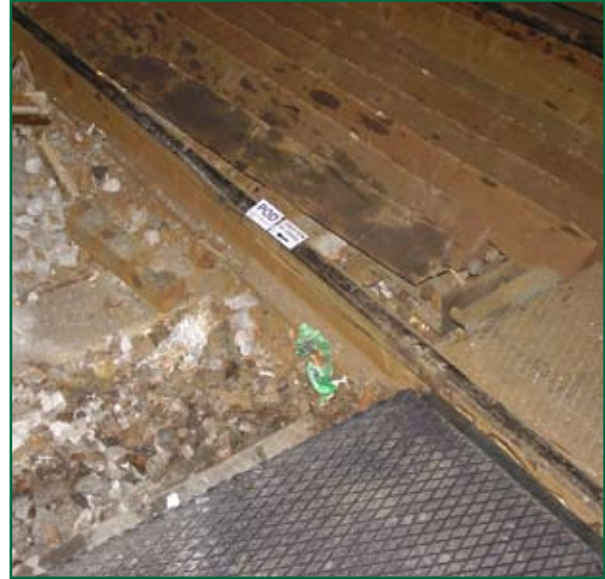
Figure 4a: Point of Derailment (POD) showing sleeper zero

- 121 The point of derailment was taken as a mark when the wheel dropped into the five foot. This was defined as sleeper '0'. This was preceded by a climb mark on the six foot rail at sleeper 2, followed by grooves on the sleeper caused by the derailed wheel flanges from sleeper -2 onwards (Figure 4a). Damage to the *Pandrol clips*, *rail pads* and sleeper damage into the six foot was also visible.

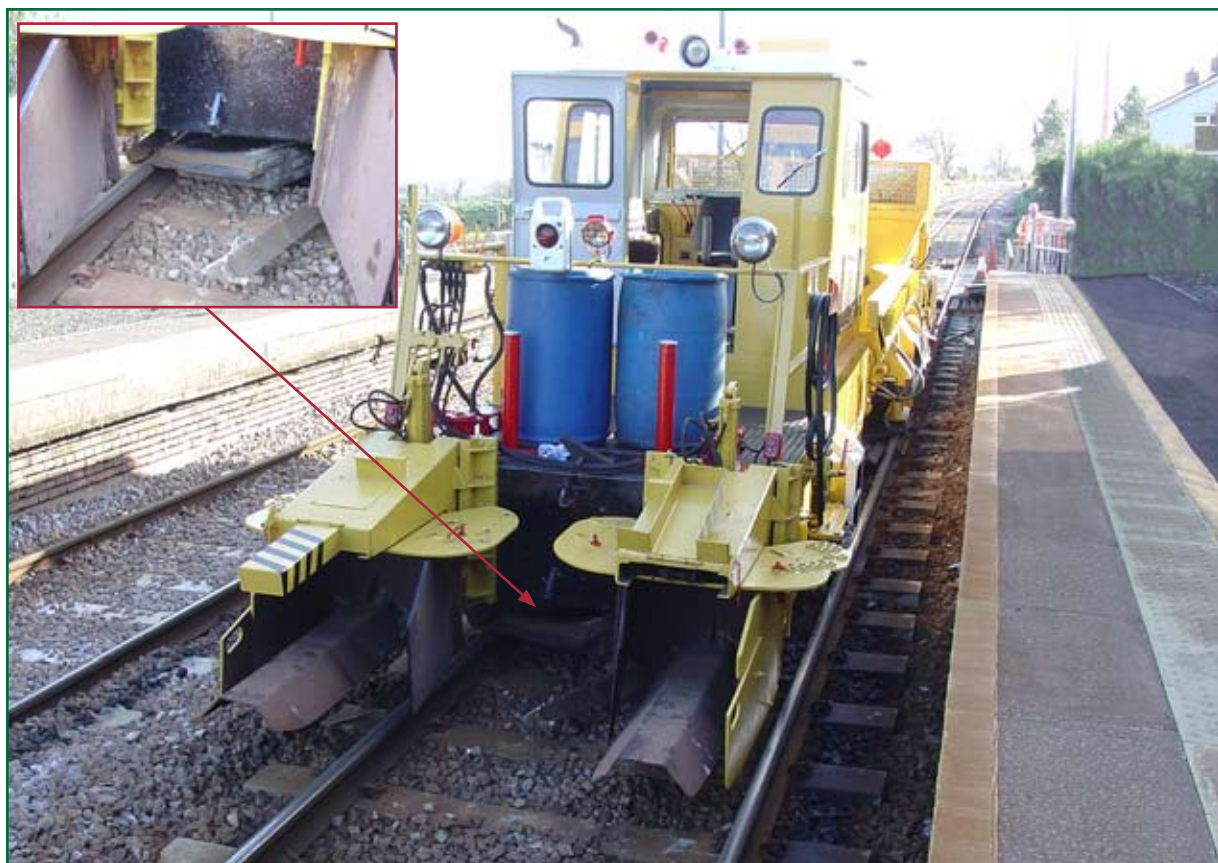
Figure 5: Ballast regulator 315 at Trooperslane station following derailment. The headstock on which both the towing brackets and anchor bracket are mounted is painted black (insert). A displaced road crossing block originating from the level crossing is shown in the background wedged beneath the vehicle

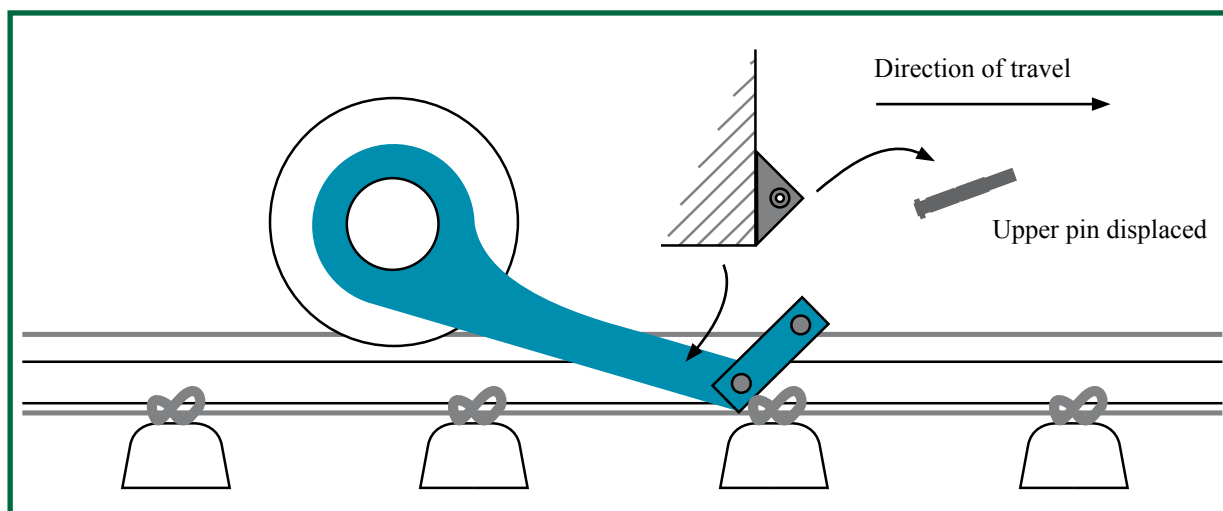
Figure 9: Schematic cross-section through regulator viewed from right in direction of travel showing torque reaction arm impacting on a sleeper following loss of the upper pin.

143 The train was en-route to a planned possession for ballast regulating documented in the WON issued on the 12 March 2006, from Whitehead to Larne Harbour and from Larne to Whitehead.

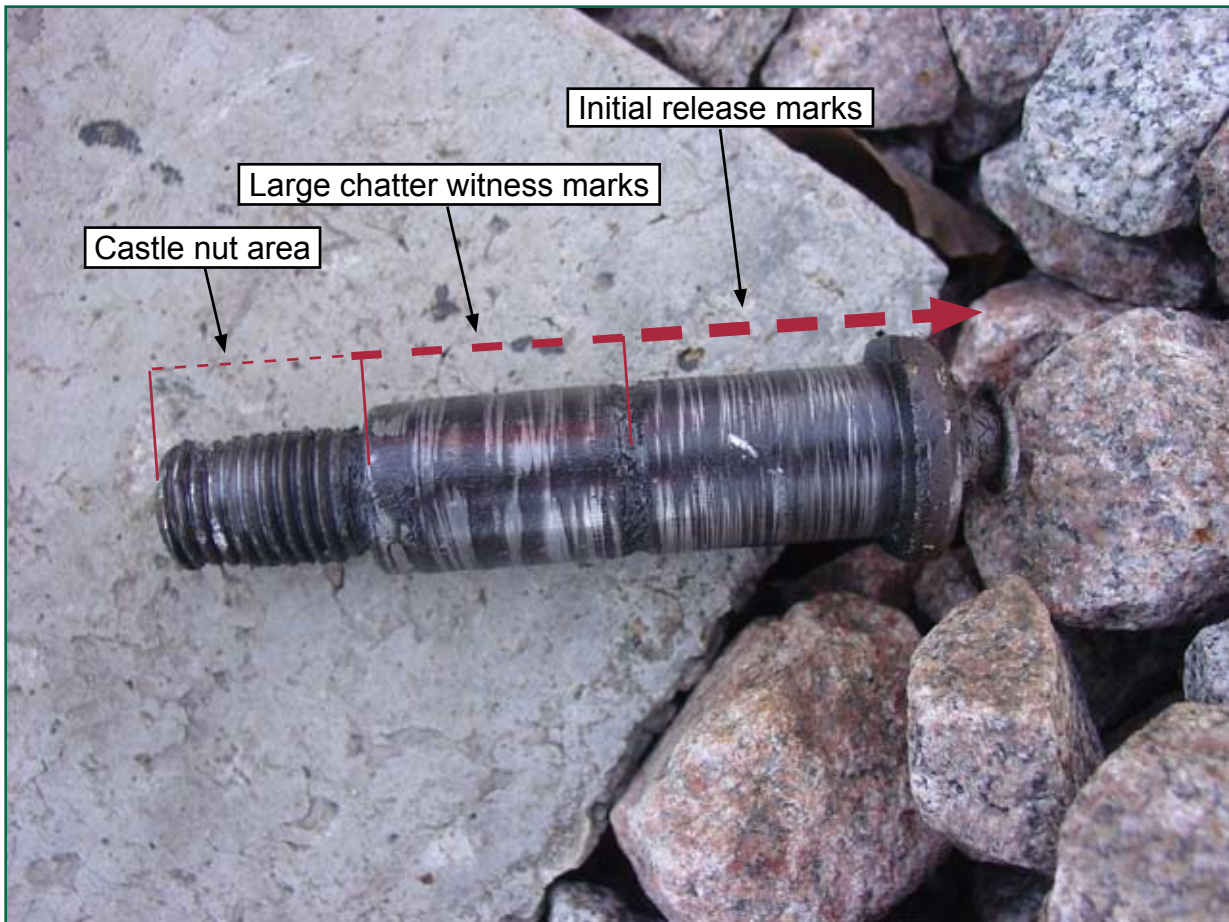
- 78 Evidence was gathered from a number of sources:
- examination of the site, rolling stock, the point of derailment and damage preceding the point of derailment from Greenisland Station to Trooperslane;

- interviews with NIR and Plasser and Theurer staff;
 - examination of the rolling stock and review of maintenance and refurbishment works of the ballast regulator at York Road depot;

106 The recovered pin was to specification and identified as the correct type for the torque arm assembly. Forensic examination of the site debris, the pin and the evidence recovered from the damaged torque arm found similar materials in all three, and indicated that this was the missing upper securing pin (see Figure 10).

Figure 10: Image of securing pin found on site

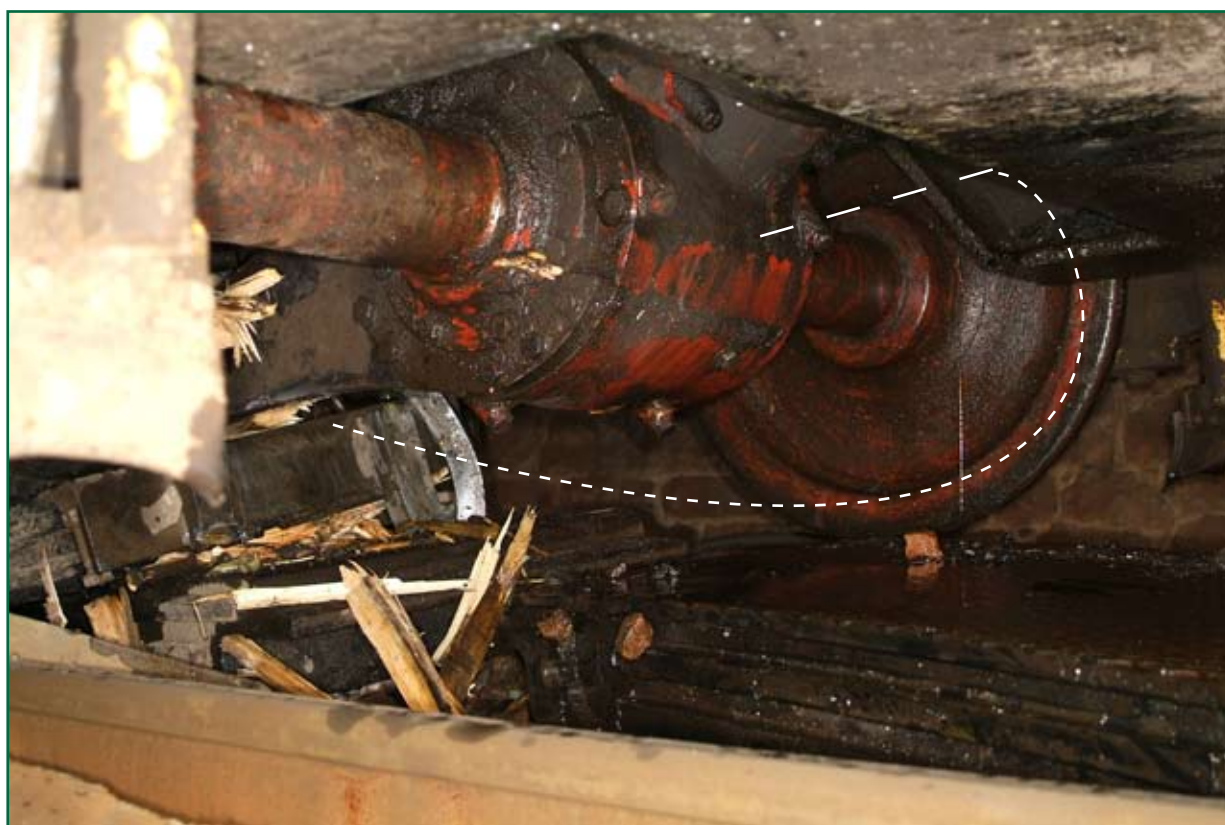
Figure 11: Torque arm damage seen when regulator lifted on site

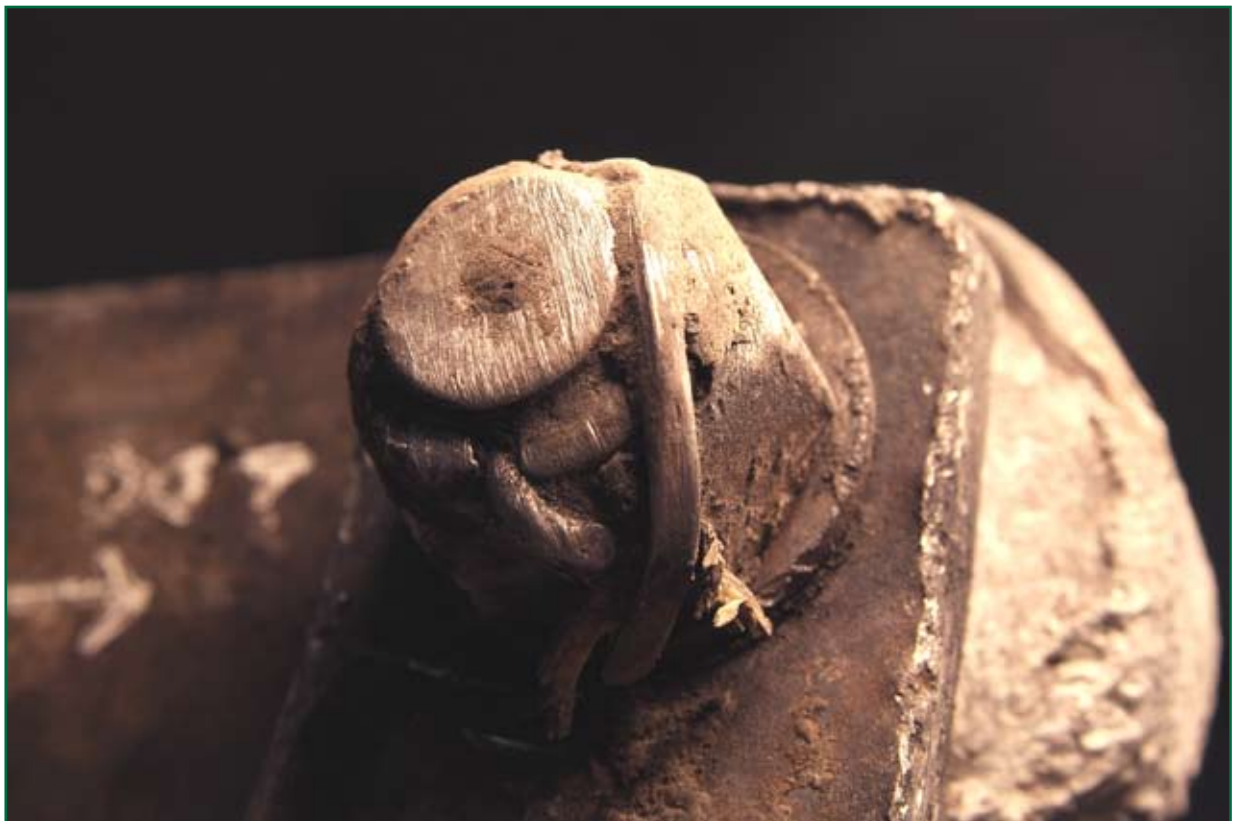
108 The torque arm and the lower securing pin were heavily damaged, with ballast, wood, grease and concrete debris visible on the end of the arm. The lower securing pin and castellated nut were damaged but secure and were to the correct specification. The split pin was in place and visible; it had been spilt in the correct fashion around the castellated nut.

109 Wood debris from the cattle grid stakes was visible in the crown of the lower castle nut. Fresh marks were visible around the mating surface of the holes of the upper bracket. The securing pin is slotted through the bracket and the headstock to secure the torque arm. The marks (Figure 10) indicated that the mating surfaces of the pin and castle nut had been in position for sometime before the incident and corroborate the pin being released just prior to UWC crossing X 301.

Figure 13: Lower torque arm fixing bolt with post incident damaged castle nut and split pin. Wooden debris from a cattle grid stake is also visible

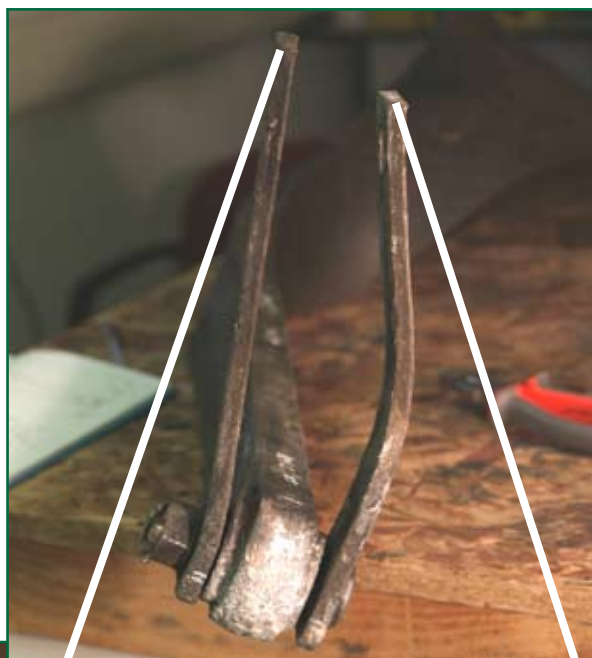
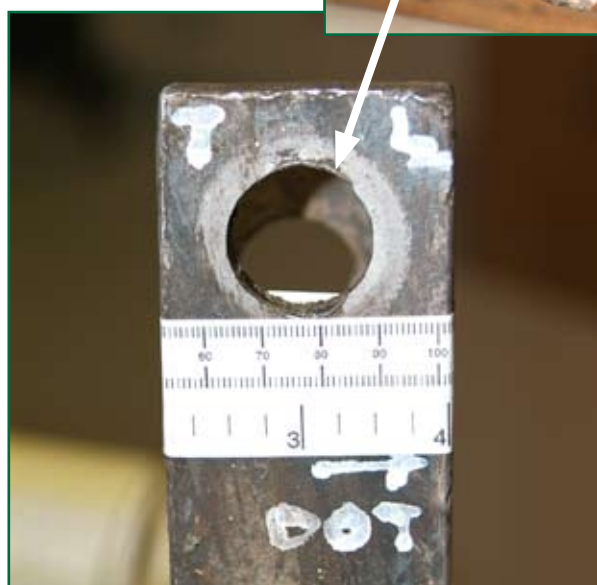
Figure 15: Torque support left side arm bracket (castle nut side)

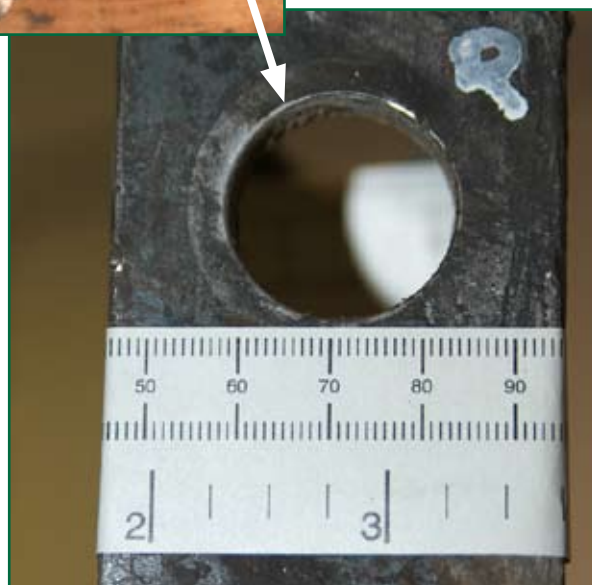
Figure 16: Torque support left side arm bracket (securing pin side)

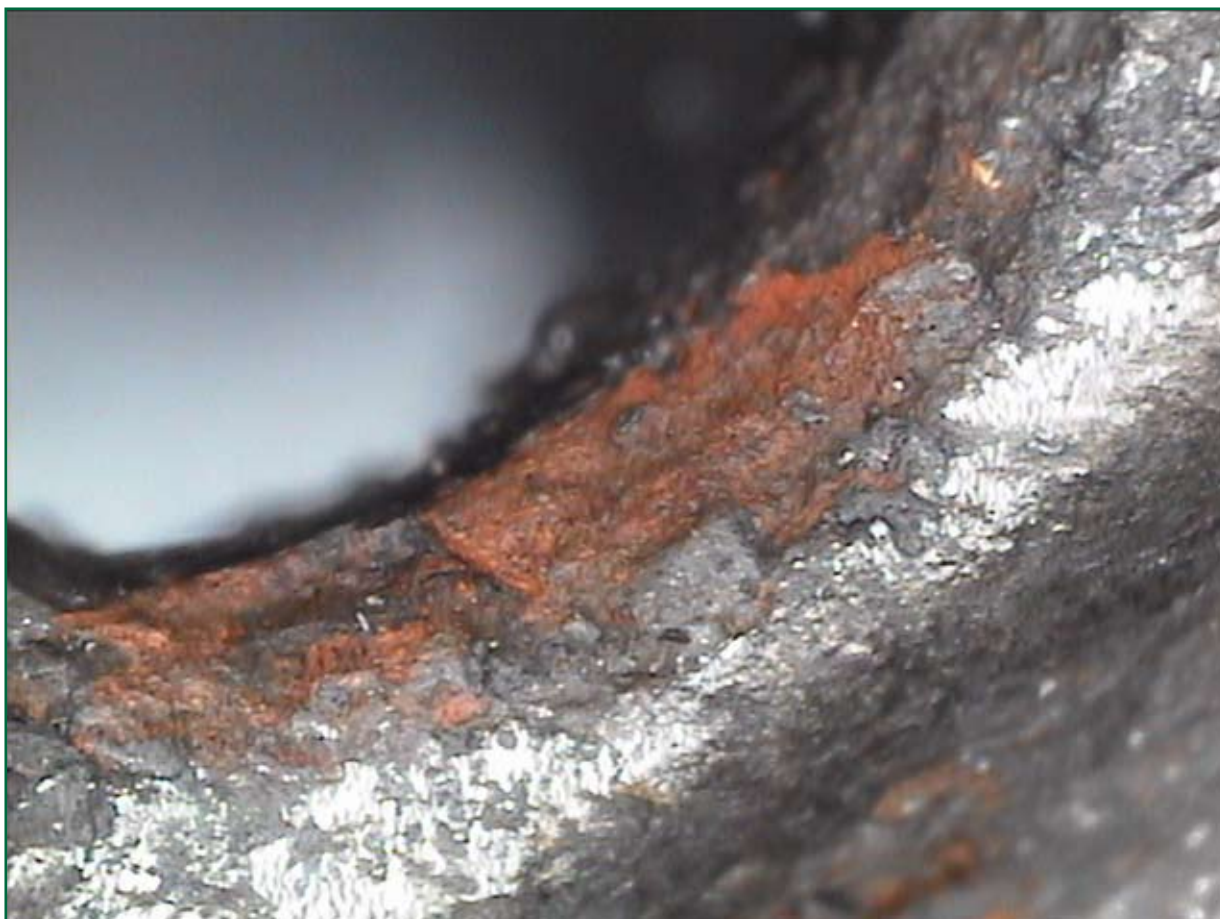
139 The WON information is compiled by the NIR Operations department and disseminated to all staff by the NIR Policy and Standards department. It includes the details of possessions.

Figure 17: Microscopic image (100x magnification) of split pin hole. Residual geological debris inside the hole and oxidisation indicate split pin has not been in place for some time prior to the incident
