Rail Accident Investigation Branch

Rail Accident Report

Derailment at Phipps Bridge on Croydon Tramlink 25 May 2006

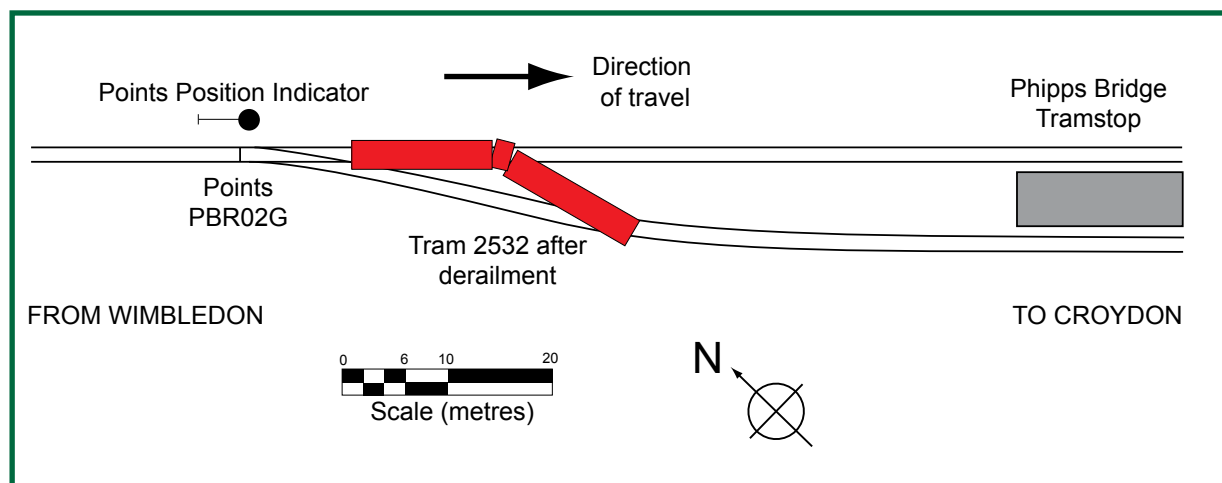
Figure 2: Site plan

- 17 The Wimbledon to Croydon line of the Tramlink system runs in a generally north west – south east direction throughout its 10 km length. It is double track from a short distance outside Wimbledon station for 2.13 km as far as Morden Road, where the line becomes single for 0.72 km. Double line resumes at points PBR02G, which are located some 90 m before reaching Phipps Bridge tram stop (Figure 2).

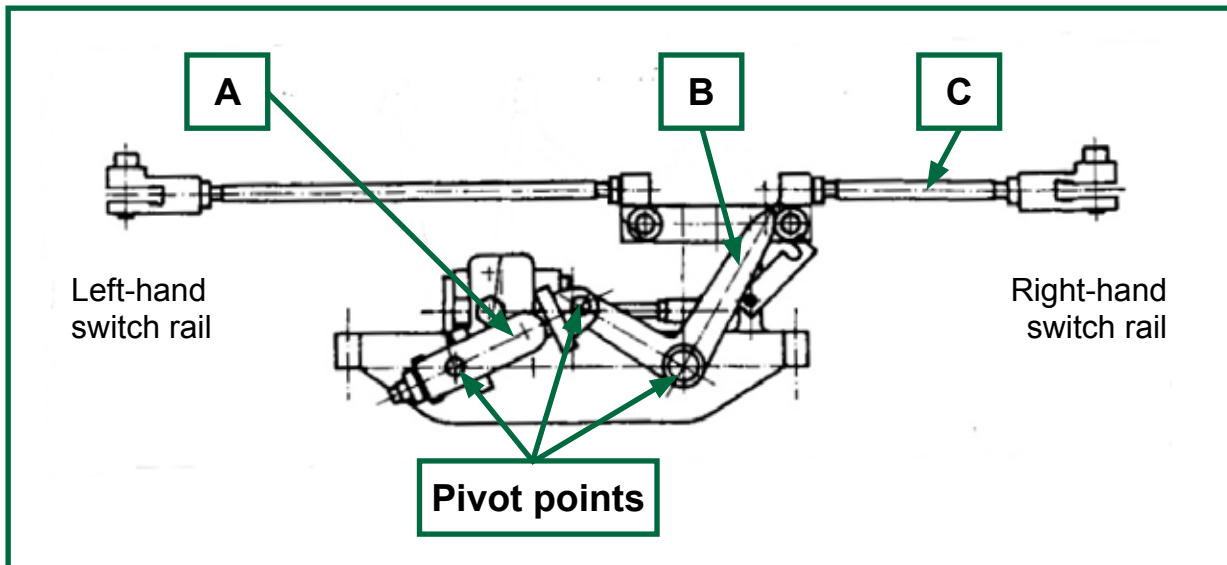
Figure 3: Hanning & Kahl spring point mechanism

- 20 The basis of the HW 160 mechanism is explained in Figure 3. It drives the switches via a lever running between rollers in the centre part of the *stretcher bar*. The compression spring, contained in the spring packet (A) acts through the linkage and the switch lever (B) to push the stretcher bar (C), and thus the switches, over to the right hand stock rail (as shown), setting the switches for the normal route.

- 23 A characteristic of this type of mechanism is that if the spring carrier is rotated sufficiently to line up all three pivot points in the linkage, it will reach a *dead-centre* position in which there is no turning moment to restore the mechanism to normal, and it will remain in that position until disturbed. In this position, although the spring is compressed to its greatest extent, the force required to disturb the mechanism is very low, and only a small impulse is required to cause the mechanism to spring back to the set position. As with all such mechanisms, whilst the theoretical dead-centre state only exists when all the pivots are exactly aligned, in practice the effect of friction in the pivot pins is such as to widen the range in which the mechanism can become stuck.

- 24 In normal operation, the movement of the stretcher bar (which is limited by the throw of the switches) should never push the operating lever into the dead-centre position. The dead-centre band is approximately 15° either side of the centre line (when the three pivot points line up as described in paragraph 23). To avoid this, the normal movement of the lever should be in the range 30° to 75° from the centre line, with the area from 15° to 30° allowing for wear or errors in setting. The manufacturer's instructions specify a maximum switch movement of 80 mm to achieve this. However, the length of the stretcher bar is adjustable using the threads at both ends of both portions, so it is possible for a wider range of movement to exist if the stretcher bar is not set up correctly. It is also possible to set the stretcher bar so that the throw is correct, but the range of movement of the operating lever (B) is asymmetrical.
