Rail Accident Report

**Derailment at Birmingham Snow Hill,
Midland Metro
29 January 2007**

Derailment at Birmingham Snow Hill, Midland Metro, 29 January 2007

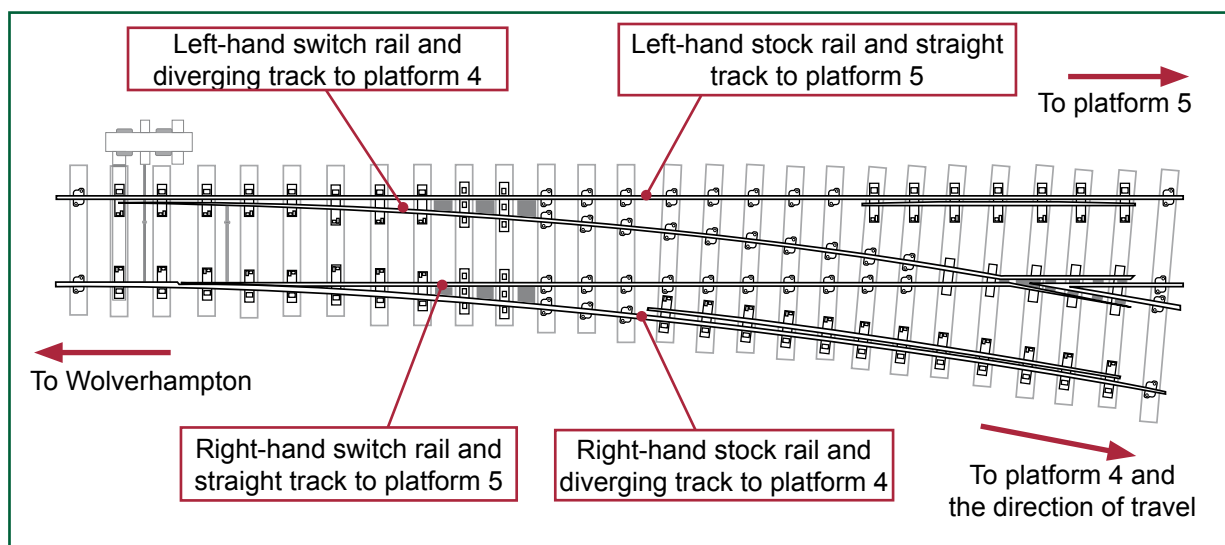
- 15 S&C *sidewear* is caused by interaction between the rail and wheel *flanges* and is most pronounced on the *switch rail* that causes a tram to change from the straight to the diverging track. A sidworn switch rail can usually be repaired, with lost material built up by welding and its as-designed geometry restored by grinding.
- 16 Travelling into Birmingham Snow Hill, the S&C diverging track is formed by the left hand switch and right hand *stock rails*. See Figure 5 for its layout. Between the Midland Metro commencing operation in May 1999 and December 2006, the left hand switch rail had been weld repaired on at least three known occasions. The dates of these repairs were November 1999, July 2001 and March 2004.

Figure 5: The S&C layout at Birmingham Snow Hill

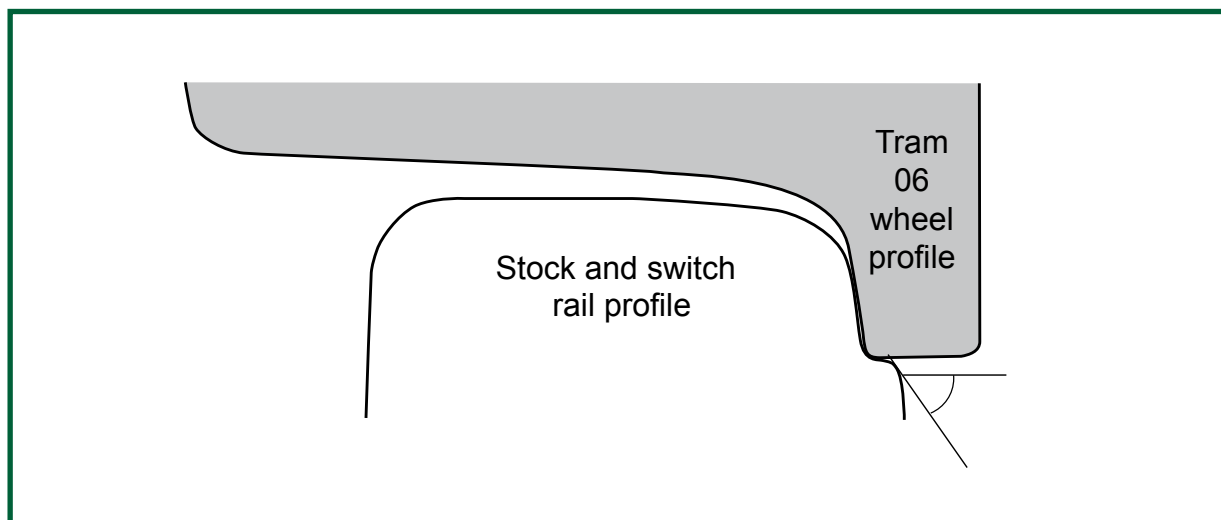
38 The repaired switch tip had a rounded and bulbous profile, was not chamfered to a 'knife edge' and did not undercut the stock rail. It was a derailment hazard as its profile was flatter than that of the stock rail and had an angle of less than 60° where indicated. See Figures 7 and 11. Contact marks from the passage of a number of wheels from trams 02, 12 and 06 can be seen in the *dye penetrant testing* material left from the welding repair. See Figure 12.

Figure 11: As repaired switch tip and tram 06 centre bogie leading left hand wheel

40 A causal factor was that the left hand switch rail had not been restored to its as-designed geometry following weld repair.

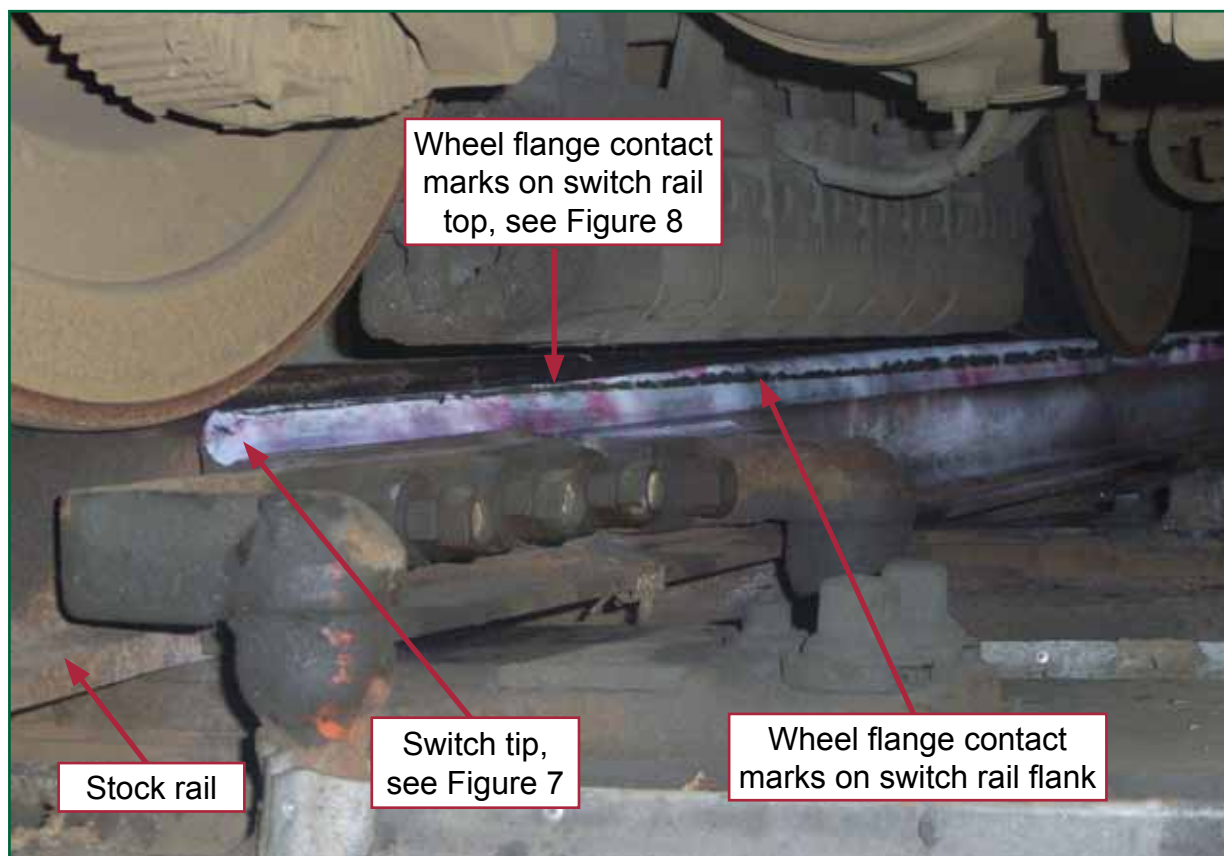
Figure 12: Wheel contact marks in residual dye penetrant material
