Rail Accident Investigation Branch

# Rail Accident Report

**Near miss involving a track worker at Tinsley  
Green Junction  
17 March 2007**

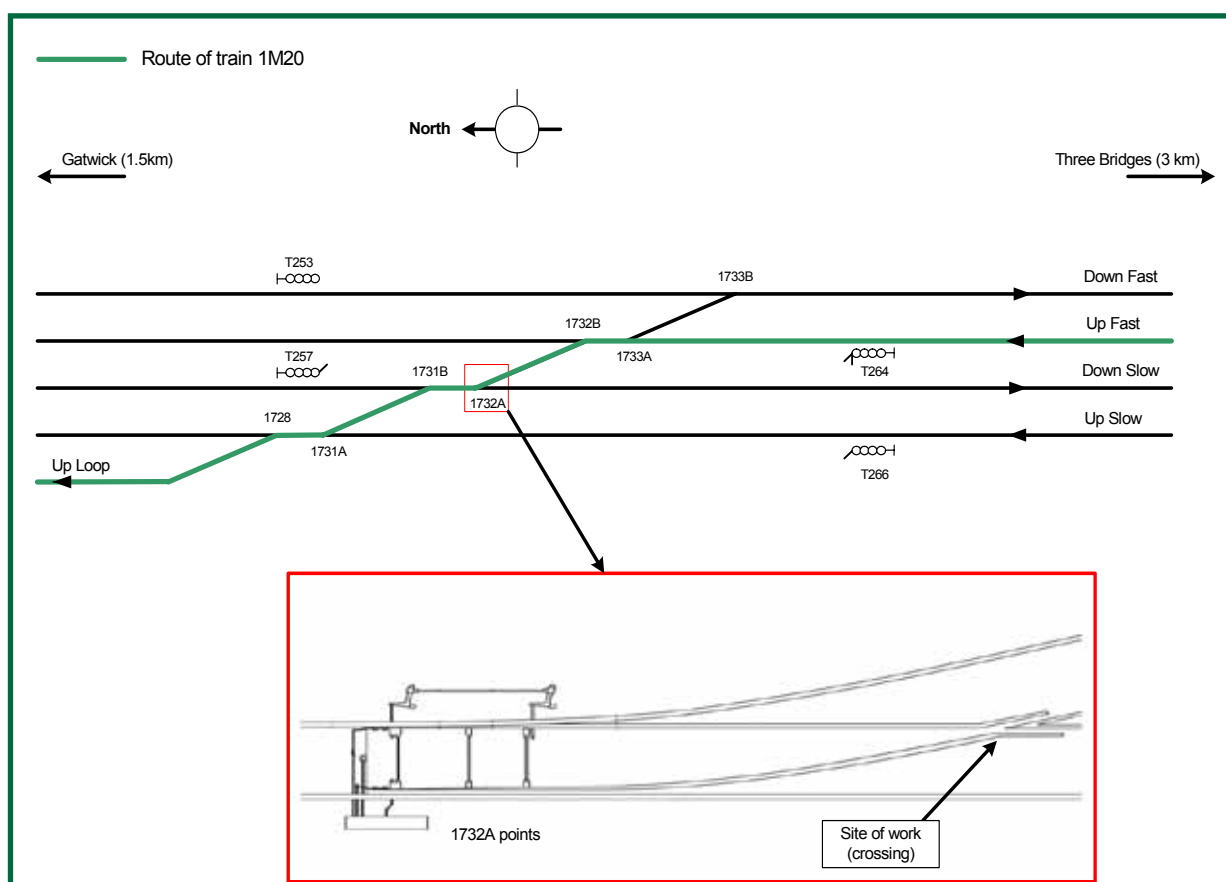
Figure 2: Track and signalling layout at Tinsley Green Junction, showing route of train 1M20

- 118 The briefing by the welder was silent on the method of protection from trains that might be routed from the up fast onto the up slow or up platform loop via 1732 crossover. No mention was made of the hazard posed by trains that might be routed via the crossover. No mention was made of any requirement for the lookout to observe the position of points.

165 The system of work established by the COSS appeared not to take the presence of the crossover into account. This occurred because the COSS did not perceive that trains approaching on the up fast line posed a hazard to him and his team. This misperception arose because of a combination of the following factors:

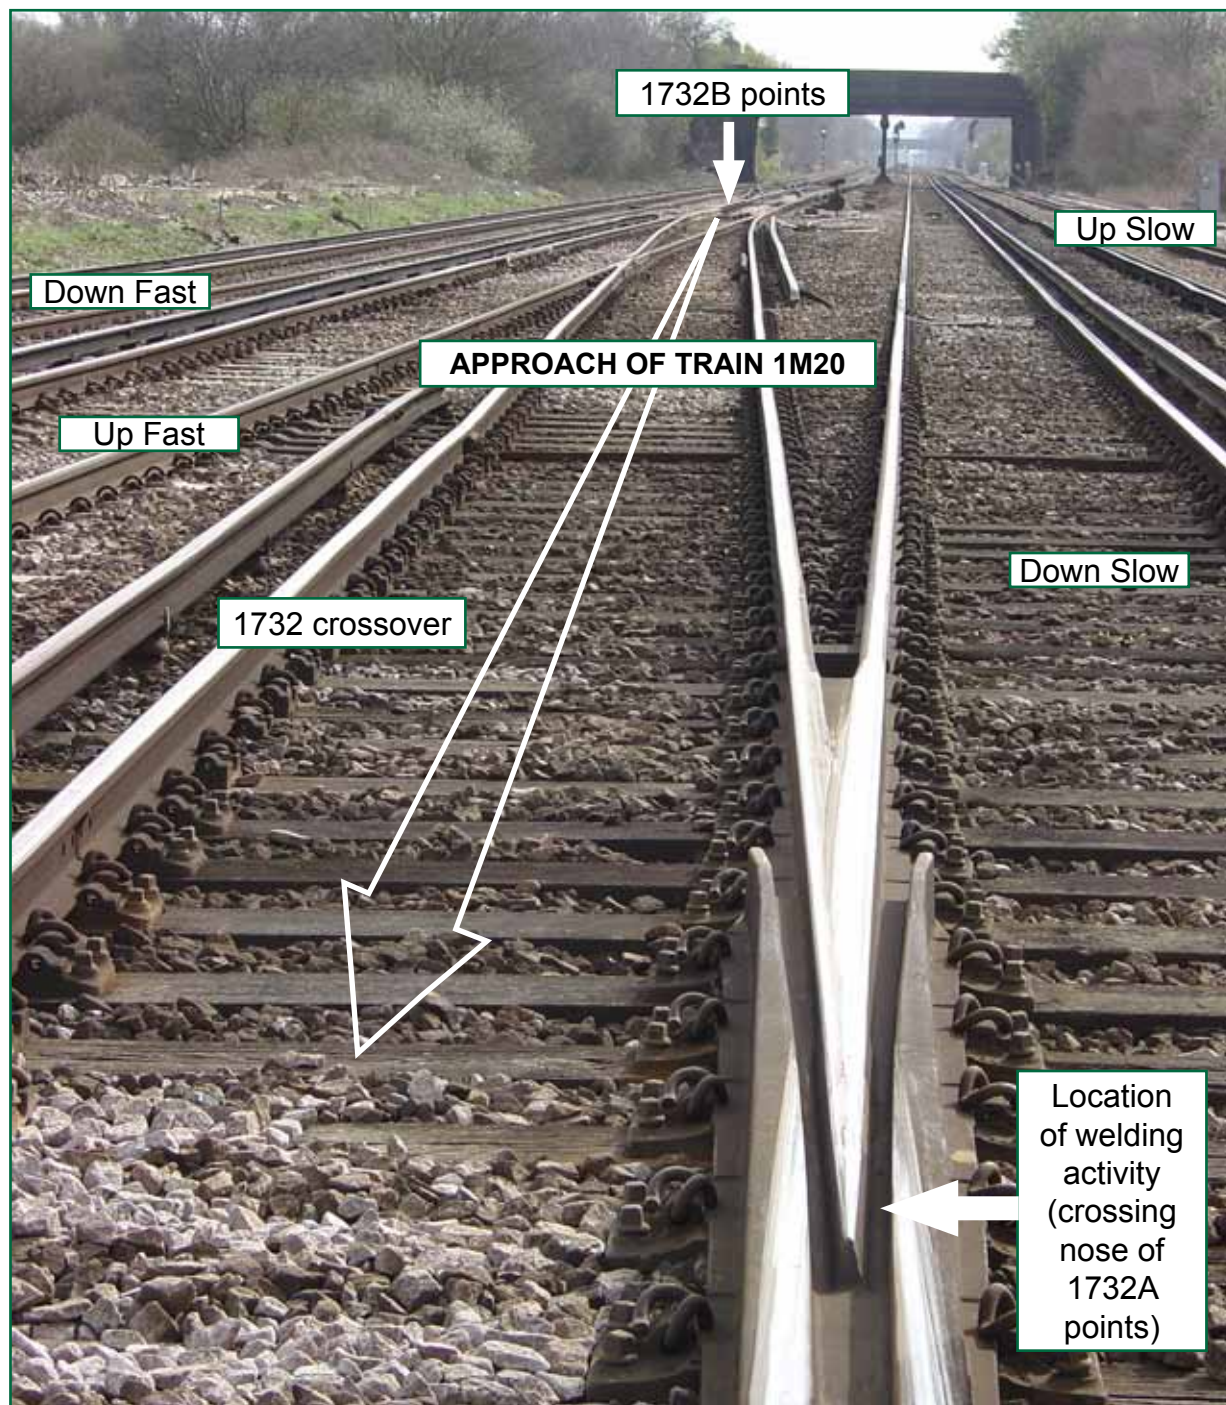
Figure 3: Tinsley Green Junction (looking south at the crossing of 1732A points)

- 91 The condition of the crossing nose of 1732A points was observed by the local track maintenance managers to be deteriorating in the early part of 2007. As a consequence repairs were planned to take place within an engineering possession during week 44 (Saturday 27 January 2007 to Friday 02 February 2007). These repairs did not take place because of a combination of defective planning and a lack of manpower.

- 92 By week 50 (Saturday 10 March 2007 to Friday 16 March 2007) the crossing had deteriorated further and the Assistant Section Manager decided that repairs were now urgent. He looked for a suitable engineering possession to permit the work to be carried out in the absence of service trains. No such possession was planned within the next few weeks and he decided to request that the work be done with service trains still operating (ie in the Red Zone).
