Rail Accident Investigation Branch

# Rail Accident Report

**Derailment in Hooley Cutting, near Merstham,  
Surrey  
13 January 2007**

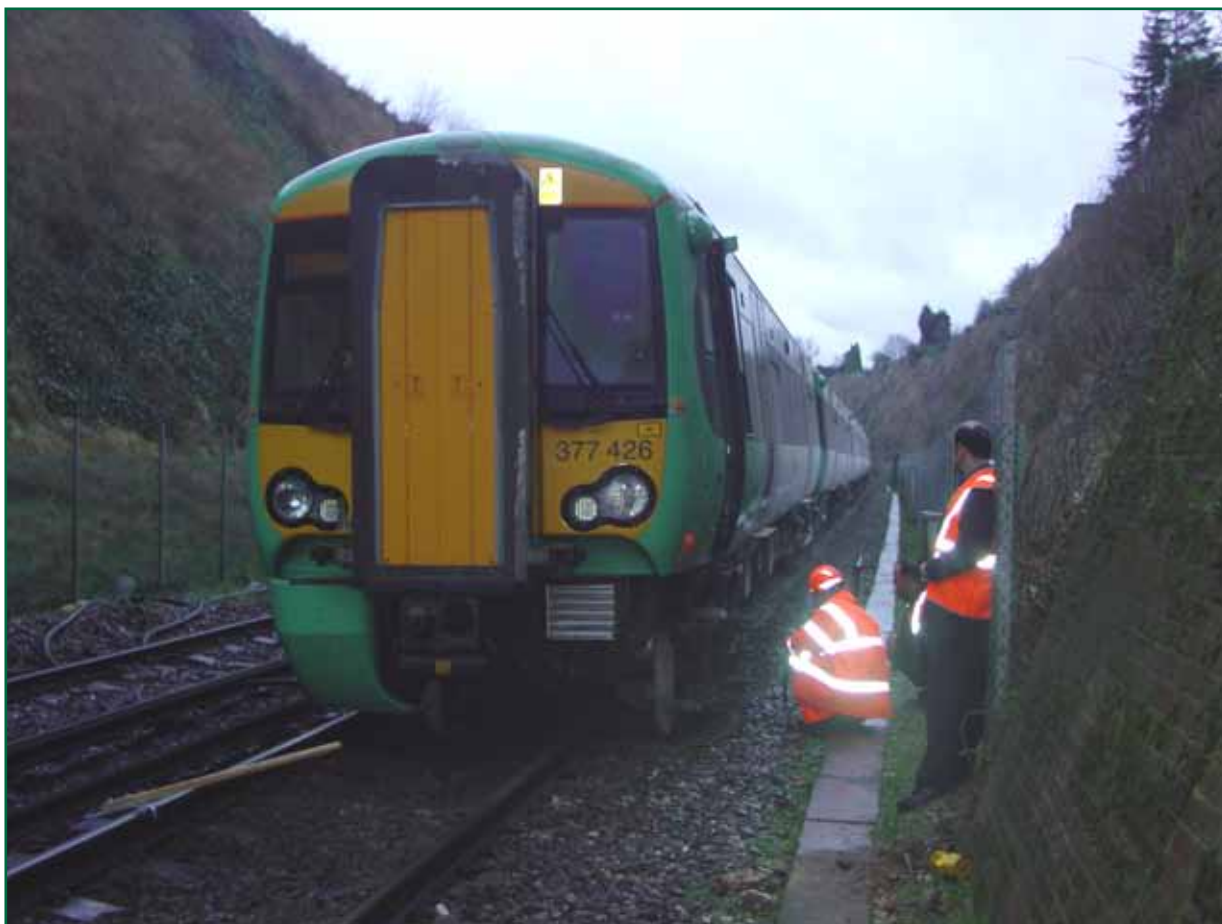
- 16 At 12:23 hrs the train emerged from Merstham tunnel into the deep Hooley cutting on the up Redhill line. The train was travelling at 83 mph (132 km/h). The driver, observing debris from a landslip on the line approximately 100 m from the tunnel mouth, immediately made an emergency brake application. The train hit the debris at approximately 70 mph (112 km/h) causing the leading wheelset to derail to the cess side of the track. The train remained upright and came to a stand after travelling another 320 m.

Figure 3: General view of the derailed train in Hooley cutting

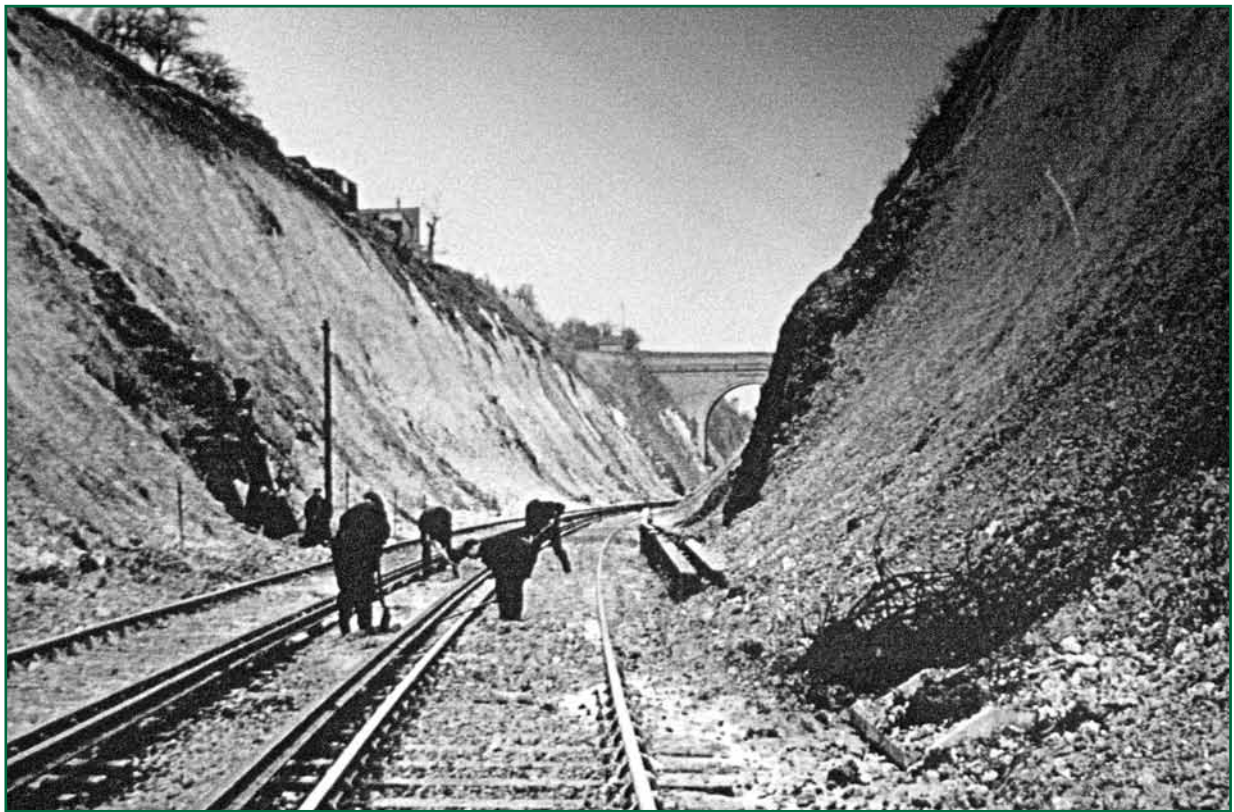
*Figure 5: A rock fall on the down side of Hooley cutting during the snows of 1947. The variable depth of gravel can easily be seen on the left side of the cutting (courtesy of Network Rail)*

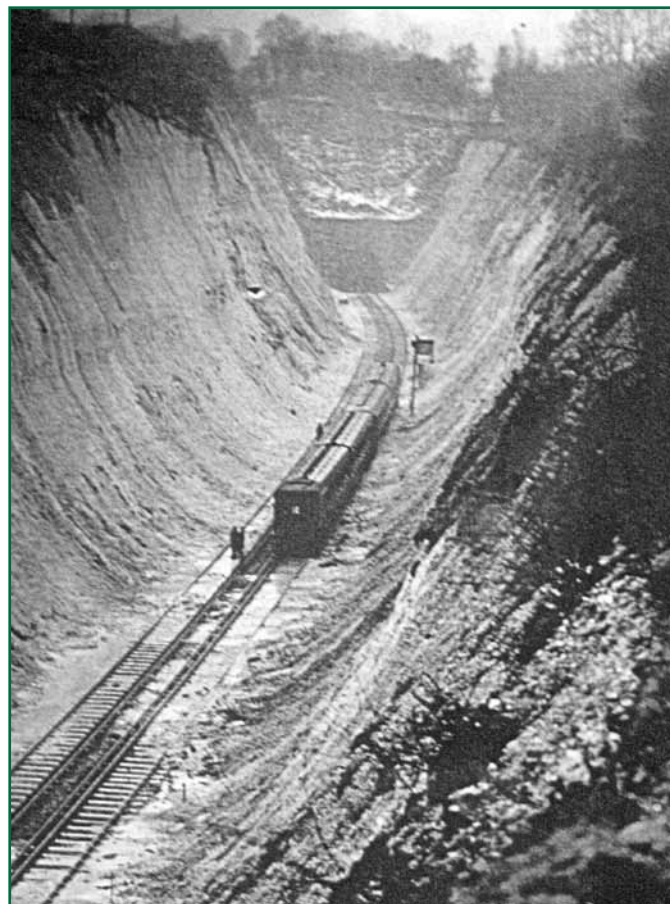
*Figure 6: Photograph taken in 1947 showing a rock fall on the up side of Hooley cutting (courtesy of Network Rail)*

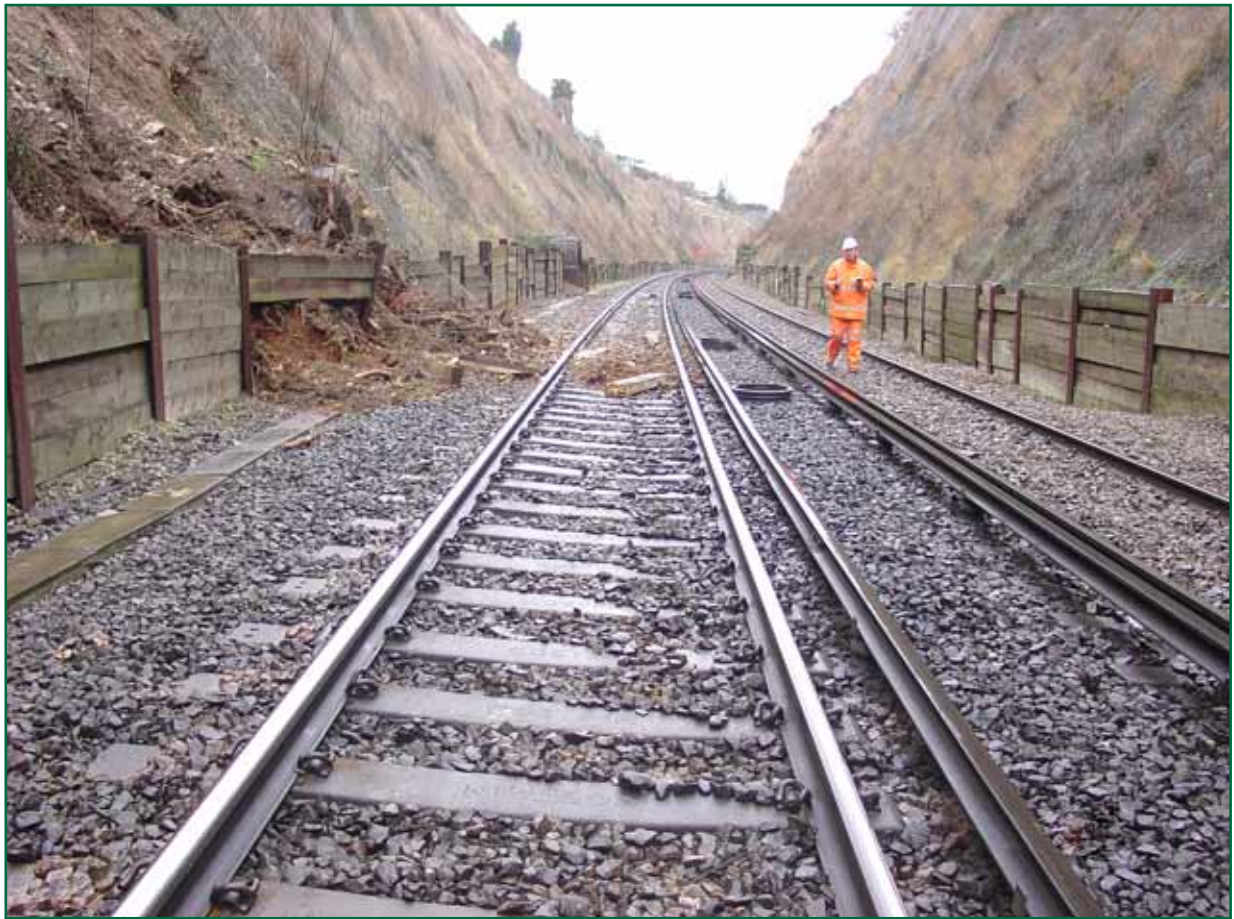
*Figure 8: Hooley cutting following the derailment showing the king post wall viewed looking towards London.*

38 Prior to train 1C23 emerging from the tunnel, a root ball from a previously felled tree (paragraphs 70 and 104) slipped down the cutting side approximately 100 m from the tunnel mouth. The root ball and ground material hit the king post wall, breaking the horizontal timber beams that formed the wall. Two of the beams were projected forward on to the up line (Figure 2), together with debris formed of gravel, clay, soil and small pieces of rock. The root ball was stopped from reaching the track by a vertical steel wall I beams. Most of the debris came to rest between the cess and the left hand rail (Figure 8).

- 93 The fall of the root ball was contained by the steel verticals forming the king post wall. The impact displaced some of the timber beams, several of which were buried under small amounts of debris. Two beams were thrown forward towards the track. These were found in a broken condition. It was not possible to determine whether they had been broken by the initial impact from the tree stump or subsequently by the impact from a train wheel.
- 94 One of the vertical steel I beams was displaced towards the track by the impact from the tree stump. It did not foul the *structure gauge* of the line.

- 104 The root ball came from a tree which had been felled sometime between 2001 and 2003. No records exist to determine the exact date although it is probable that it was felled in 2003 when most of the larger trees received attention. By 2007 the root ball had only rotted to a small extent. There were some small suckers growing from it indicating that it had not completely died. Most of the small roots that would have provided stability within the cutting side were missing (Figure 8).

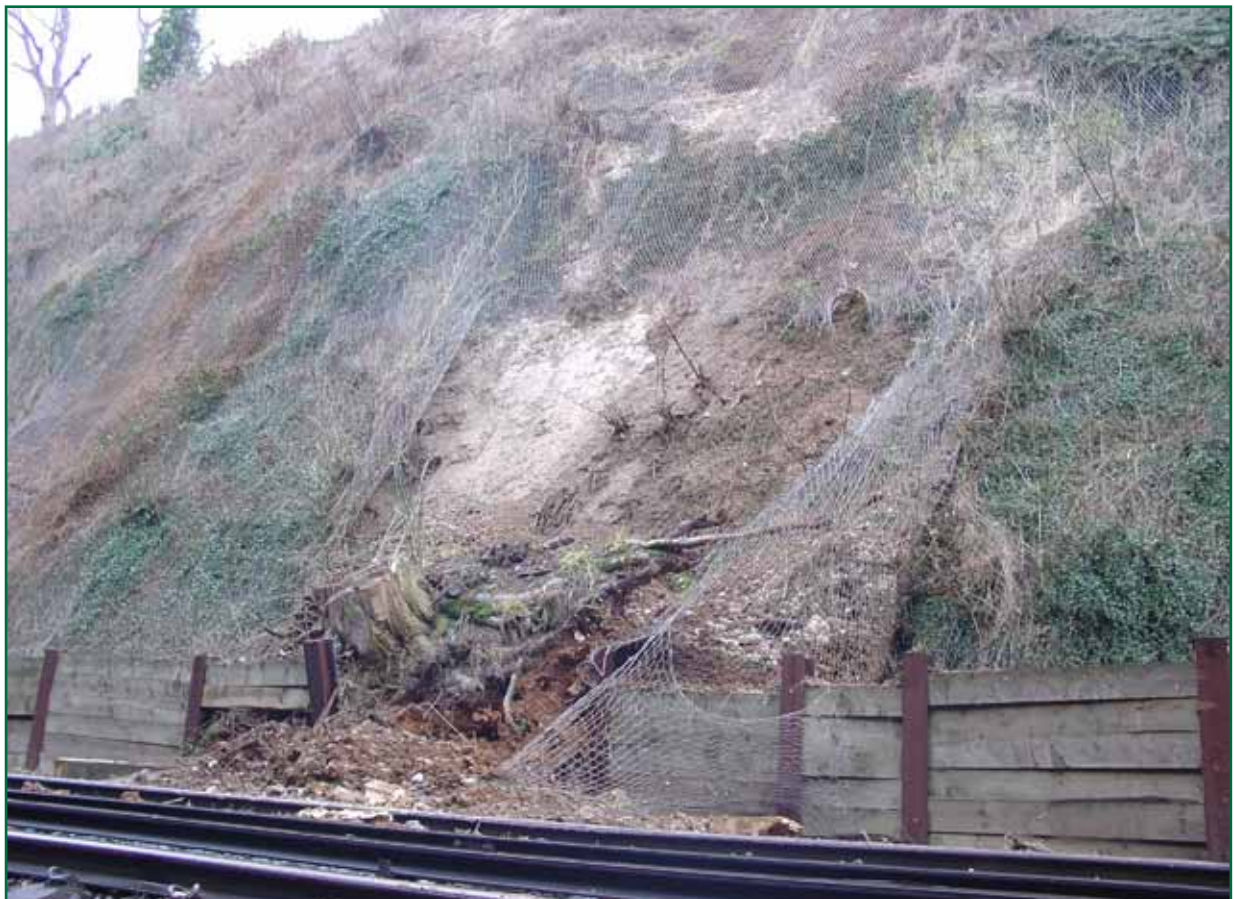
*Figure 9: Hooley cutting showing the landslide*

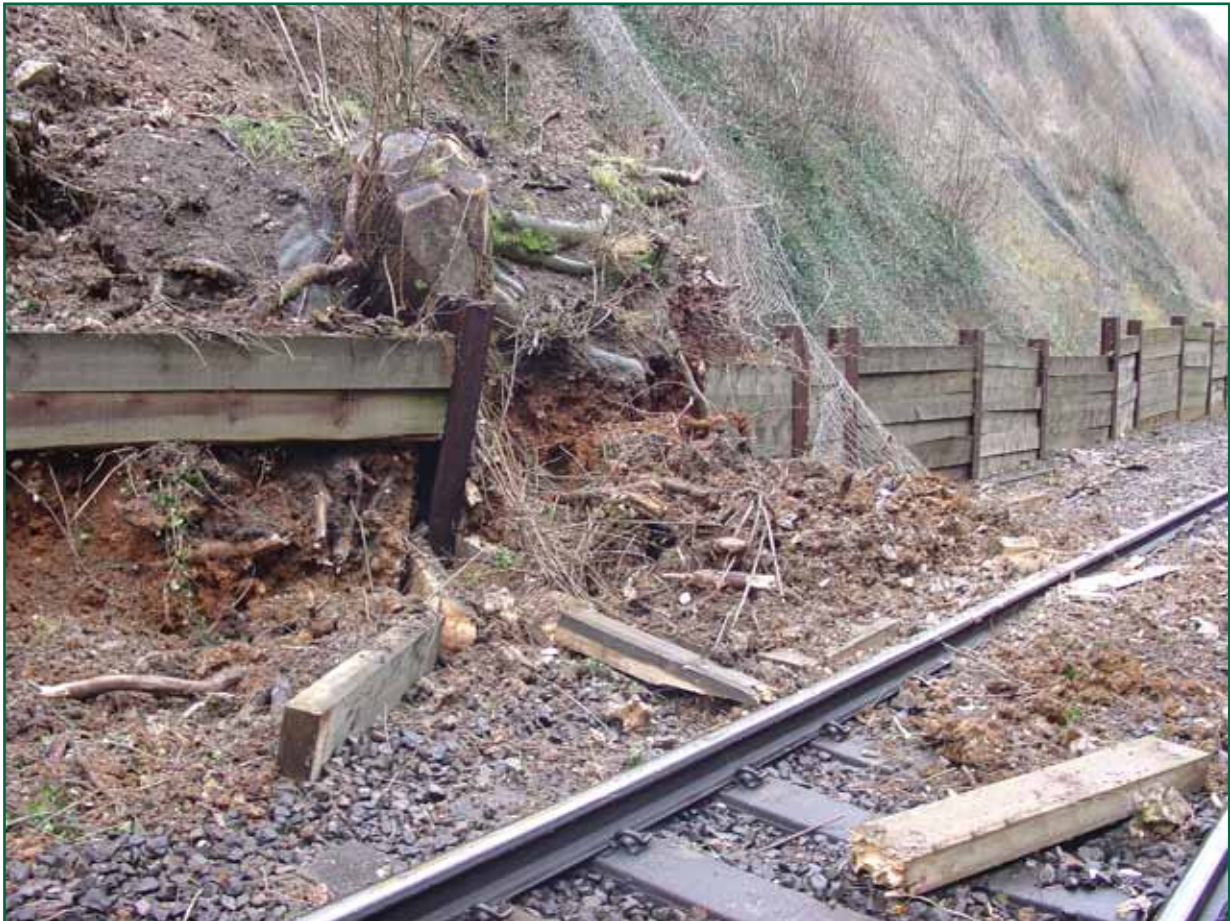
*Figure 11: Debris on the track following the derailment*

- 95 The debris blocking the line comprised gravel, clay, small pieces of rock, and broken parts of several timber beams from the king post wall. Most of the debris lay between the cess and the left hand rail. Only a small amount of debris lay between the rails. The 6 tonne (estimated) root ball had been contained by the wall; no part of it infringed the line, nor were any of the vertical columns displaced sufficiently to hit the train (Figures 8 and 9). Apart from the timber beams no material was present that was sufficiently large to derail a train.
- 96 The immediate cause of the derailment was an obstruction on the left hand rail formed by displaced timbers from the king post wall.

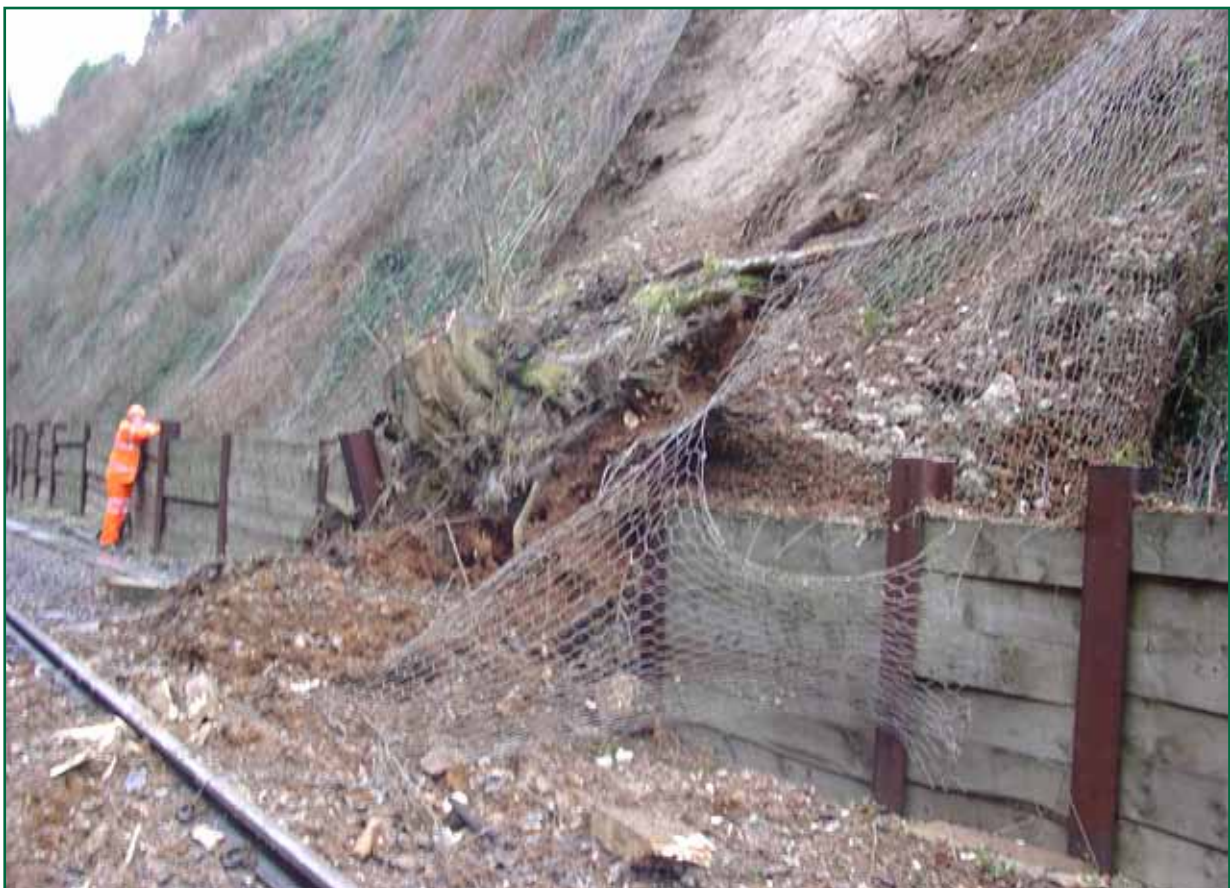
*Figure 12: Debris and rootball against the king post wall*

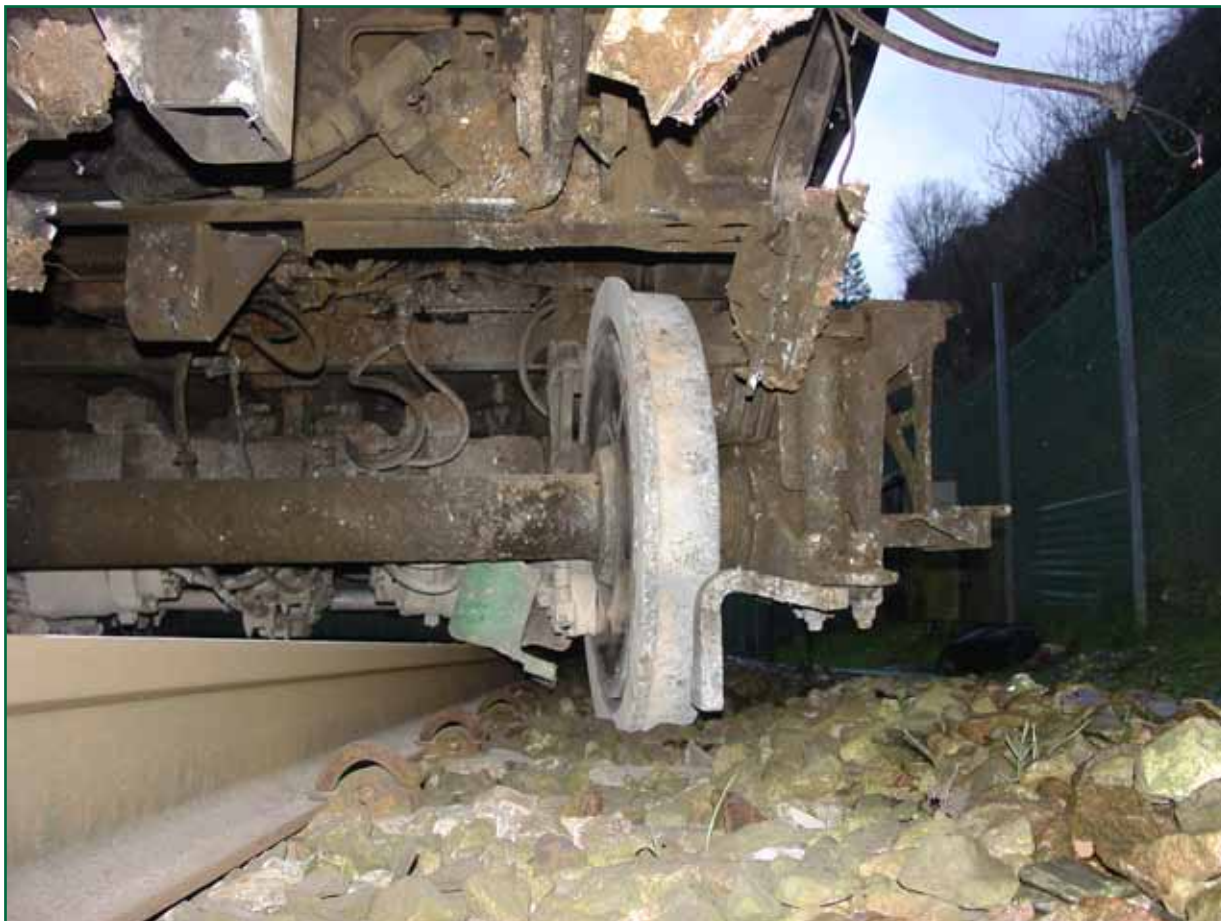
- 43 The leading wheelset derailed to the left (cess) side of the line and continued to run on the sleeper tops outside the Pandrol clips. Various items of train equipment were either detached or damaged by the debris or rails. In the derailed state the leading end of the front bogie ran approximately 200 mm lower than normal.
- 44 As they travelled over the sleepers the derailed wheels generated a large dense white cloud of concrete dust that obscured visibility through the side windows of the coaches. The train passed T466 signal before coming to a stand alongside Forge Bridge.

Figure 13: Damage to the front bogie of the train

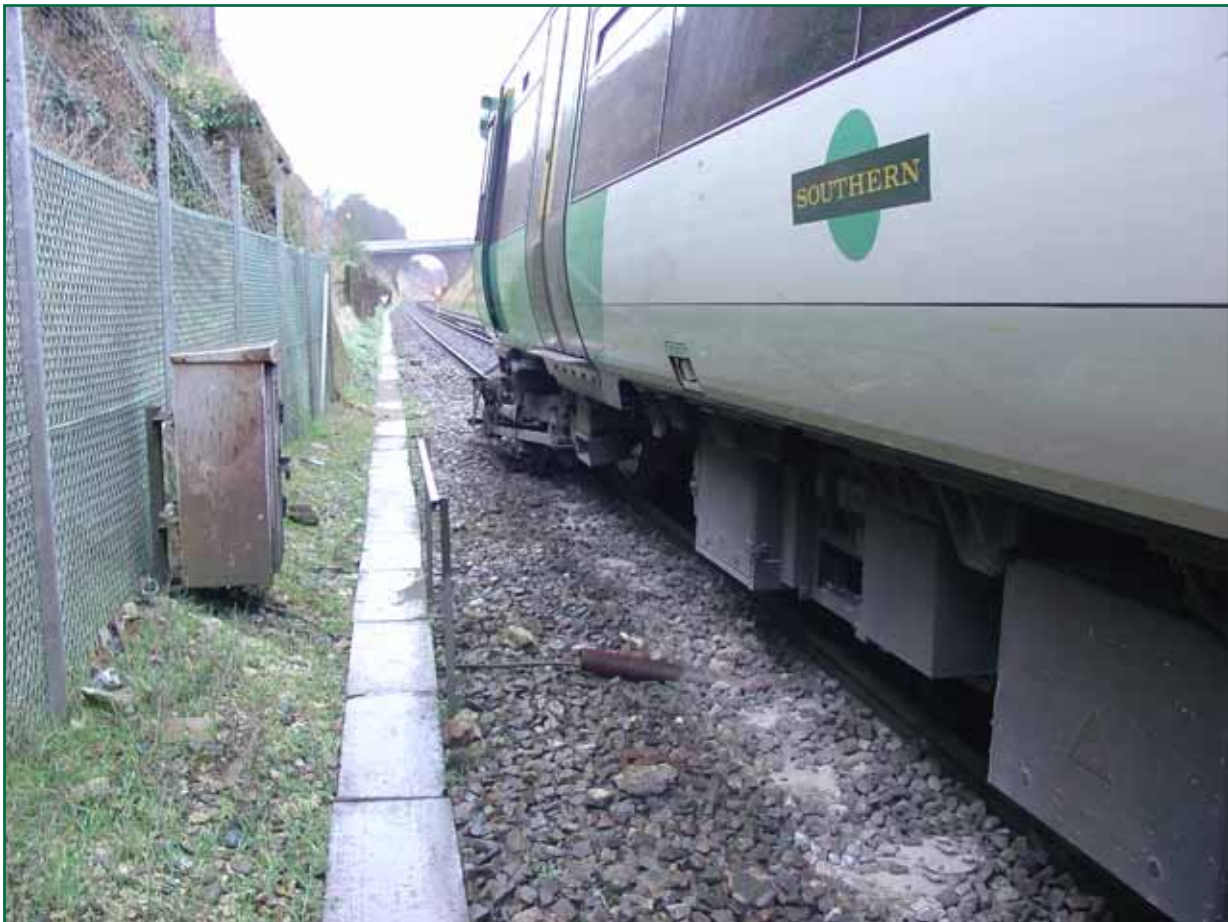
Figure 14: The derailed bogie and side of the train

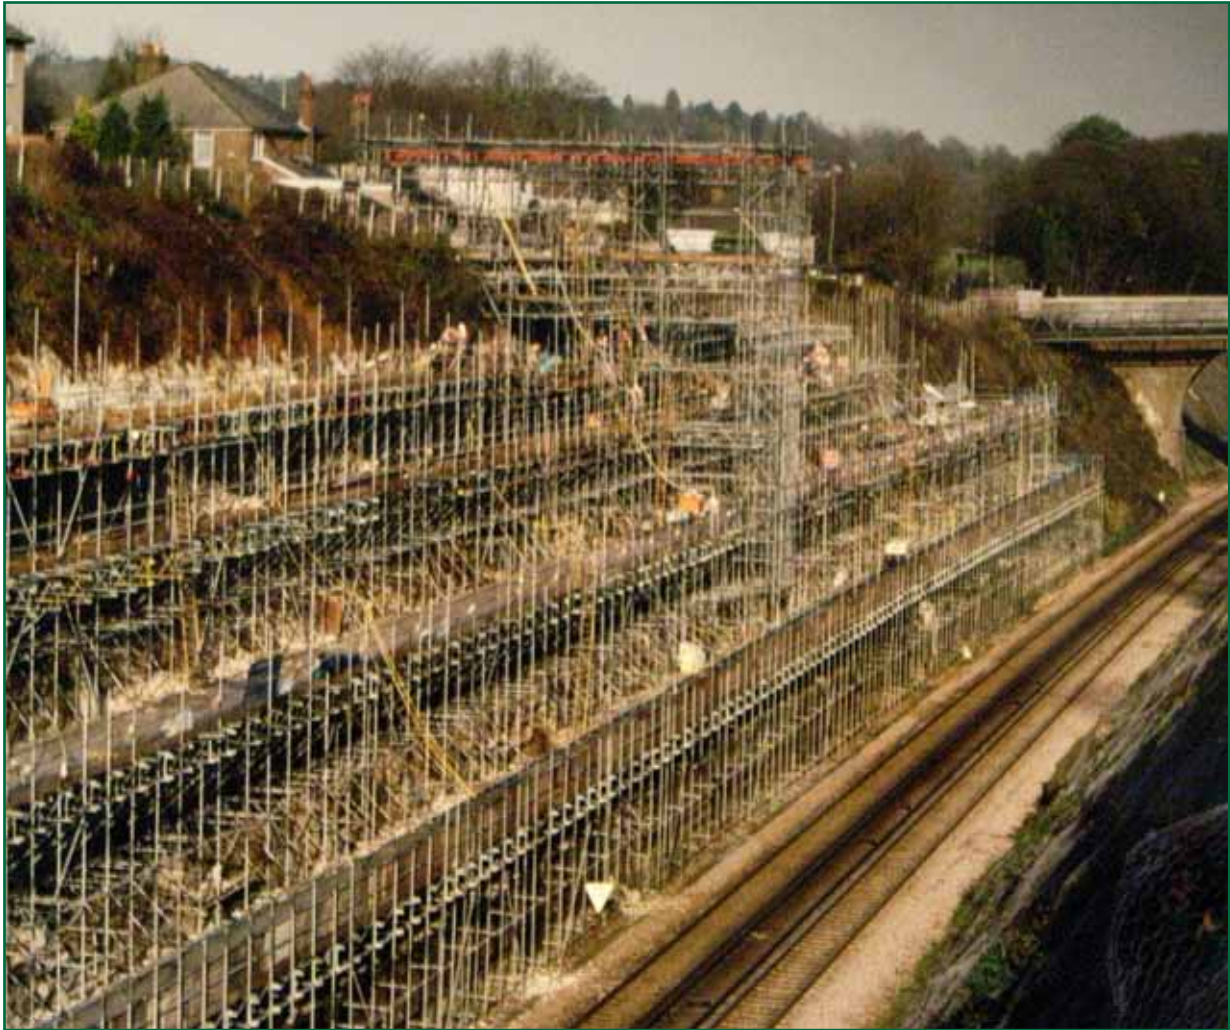
- 33 The train was fitted with a *cab secure radio* (CSR) that permits the driver to talk to the signalling centre. The driver used this system to report the derailment.

Figure 15: Photograph showing the stabilisation works of 2001 - 3 (courtesy of Network Rail)
