Rail Accident Investigation Branch

Rail Accident Report

Derailment of a passenger train near Kemble 15 January 2007

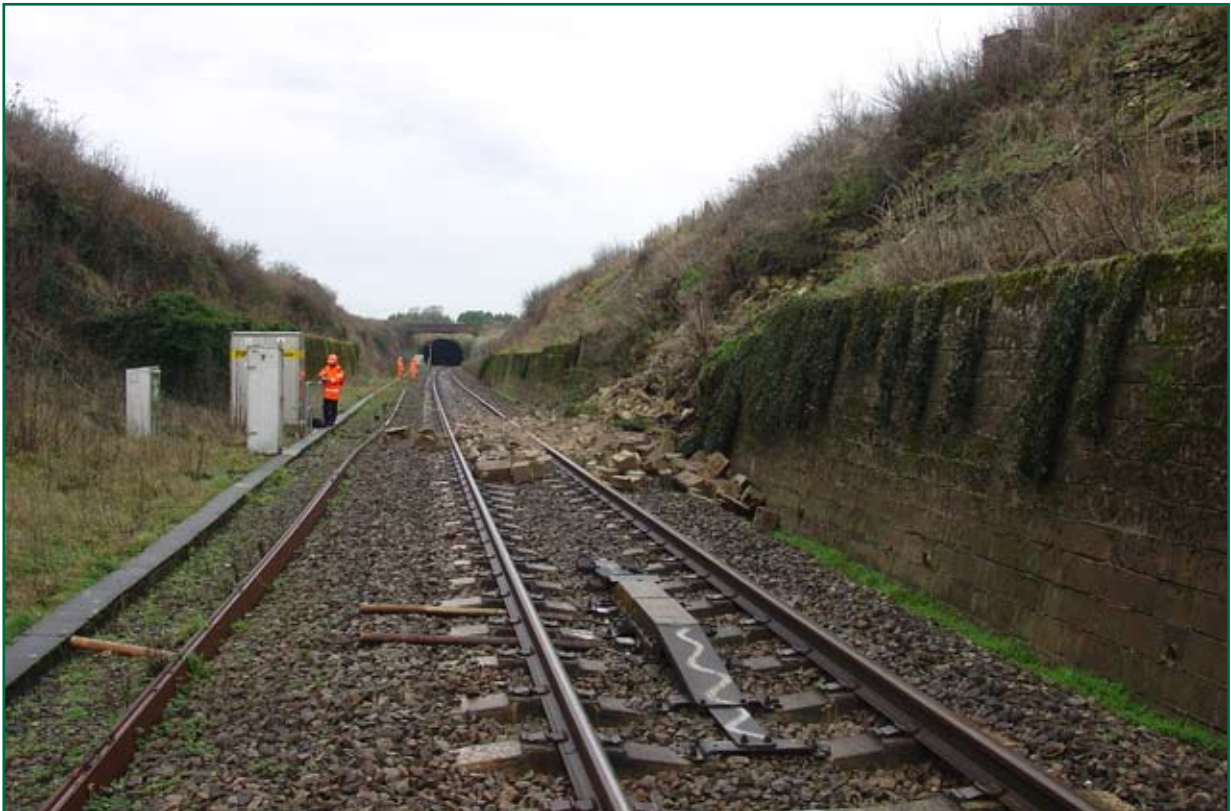
Figure 2: View of derailment site in the direction of travel

- 63 At the location of the cutting slip, the wall rises to a height of approximately 2.4 m above rail level. Its foundation is in the cess, set 2.4 m from the cess rail (Figure 2). The crest of the cutting rises a further 6 m above the top of the wall. The wall is constructed from a double row of hollow concrete blocks filled with a *lean-mix concrete* and has an overall thickness of approximately 450 mm. The face of the wall slopes away from the track at an angle of approximately 10 degrees.

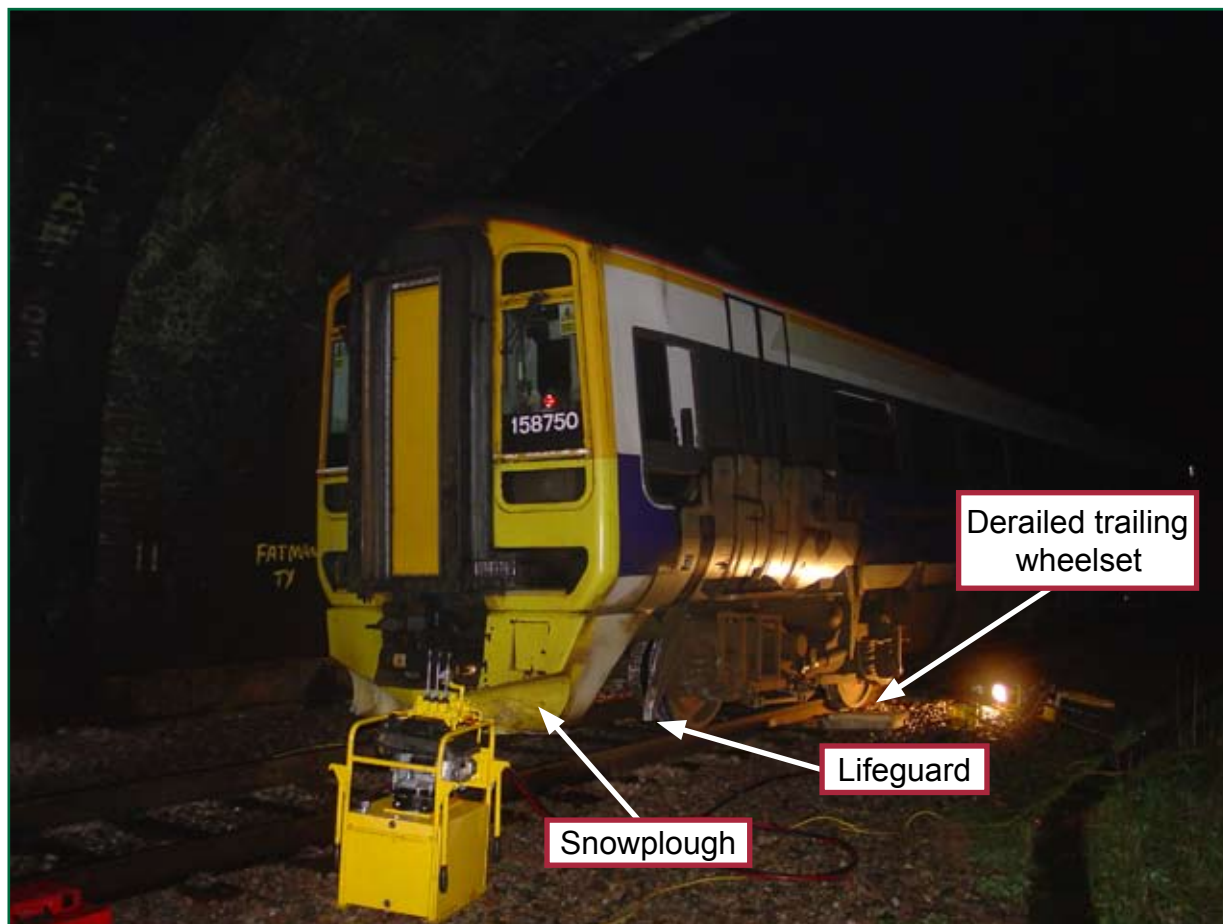
Figure 3: Leading end of Unit 158750 and derailed leading bogie

- 32 There was significant damage to the equipment on, and the wheelsets of the leading bogie. The leading vehicle sustained minor impact damage to the snow plough.
- 33 There was extensive damage to the track from the POD to the southern portal of the tunnel. Approximately 130 concrete sleepers and numerous rail fastenings were damaged. The left hand rail was broken at four positions where the derailed wheel had struck welded joints. The pile of concrete blocks, which had fallen from the collapsed wall and which were partially flattened by the train, covered the track over a length of 14 m (Figure 3).

- 91 It was not possible to determine the precise mechanism of derailment. The observed damage to the axle mounted brake discs and equipment attached to the bogie frame indicated that there were, very likely, upward acting vertical components of the impact forces, which could have unloaded the trailing wheelset. At the same time the bogie was probably forced to yaw to the right due to the greater depth of blocks and higher drag forces on this side. The right hand side of the bogie sustained greater damage than the left side.

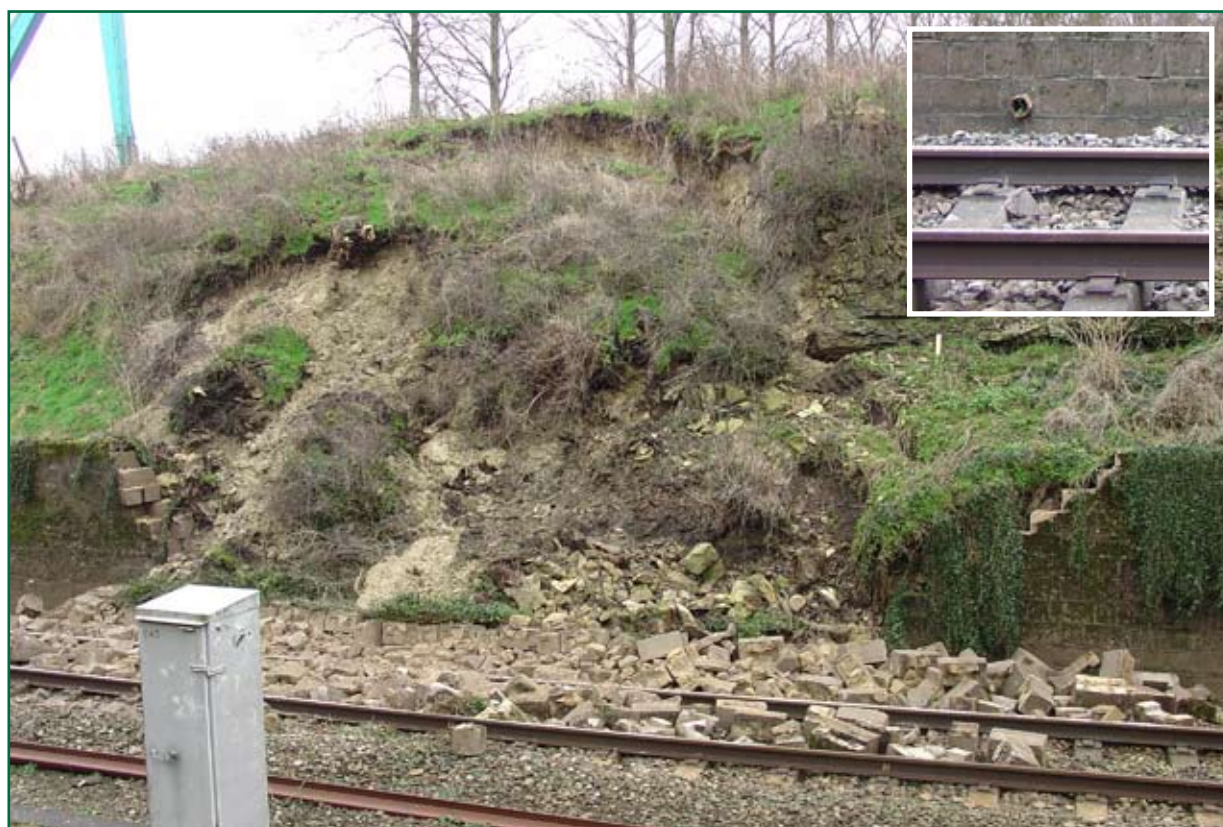
Figure 4: Derailed site showing cutting slips, state of backfill and typical weep hole (inset)

- 44 The cutting rises to a maximum height of approximately 9 m above track level and the *crest* is located 13 m from the cess rail. The geology of the cutting comprises soft limestone rock strata overlaid with a stiff clay. In places the clay has been weathered to a very soft, almost fluid, consistency. Towards the top of the slope, there was a primary slip (Figure 4) which had left a *scar* face approximately 10-14 m long and 1-1.5 m deep. Approximately half way down the slope, there was a secondary *slip*, approximately one third the size of the primary slip from which a soft clayey discharge, loose rocks and firmer clay layers had descended down the slope and run onto the back of the wall.

- 64 *Weep holes* were installed at the base of the wall, spaced approximately 3 m apart, to allow drainage of water from behind the wall. The weep holes in the portion of the wall that collapsed were destroyed. It was noted that the weep holes in the adjacent sections of wall, which remained intact, were clear at their exits but not discharging water as would be expected following the recent heavy rainfall in the area (paragraph 86), indicating that they were blocked. Such blockages are likely to cause a build up of water behind the wall, tending to destabilise it.

- 104 On the day after the derailment, it was noted that there was little or no water flowing from the weep holes in the vicinity of the failure although the clayey slurry which flowed out from behind the collapsed wall indicated there was a high water content. The weep holes were therefore probably blocked. The detailed wall inspection on 2 October 2001 noted the weep holes were blocked but there is no evidence of remedial action taken to clear them out. Therefore the blocked weep holes were a contributory factor in the collapse of the wall.

- 115 An initial programme of works was undertaken prior to removal of emergency speed restriction on 28 February 2007 to stabilise the slope by installing shear keys, regrading to reduce the slope, rock combing, removal of loose material behind the wall, removal of rock overhangs and pumping out of standing water. Watchmen were posted around the clock and instructed to walk the stretch of track between the overbridge and tunnel several times a day during these works:

- 116 Further works were then carried out to complete the stabilisation of the cutting and comprised completion of a crest line cut-off drain, demolition of a further section of wall (90 miles 28.5 to 33 chains) and removal of loose material behind the back of the wall, stabilising the rock overhangs along the cutting. To improve drainage material was removed from behind the wall and backfilled with granular material and additional weep holes were drilled in the wall. A number of other works were carried out between 90 miles 03 chains and the derailment site.
