Rail Accident Investigation Branch

Rail Accident Report

Runaway and collision at Armathwaite 28 January 2007

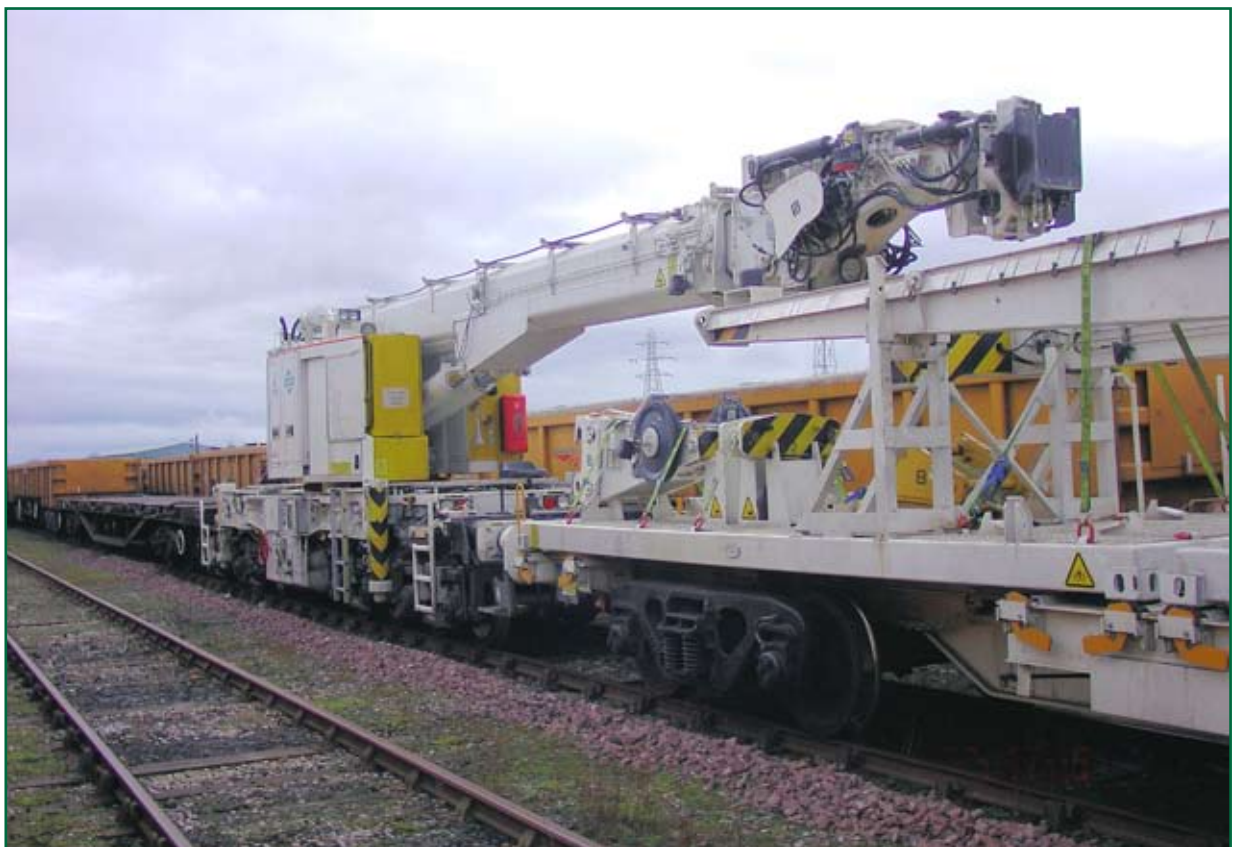
Figure 4: Kirow crane DKR81623 and its match wagon

- 61 The derailment of the crane caused only minor damage: two bolts securing the *keeper bracket* for the rearmost bogie sheared causing it to become detached; the speedometer sensor was damaged; and a leaf spring on the rear bogie was dislodged. This damage was repaired as described in paragraphs 44 – 45.

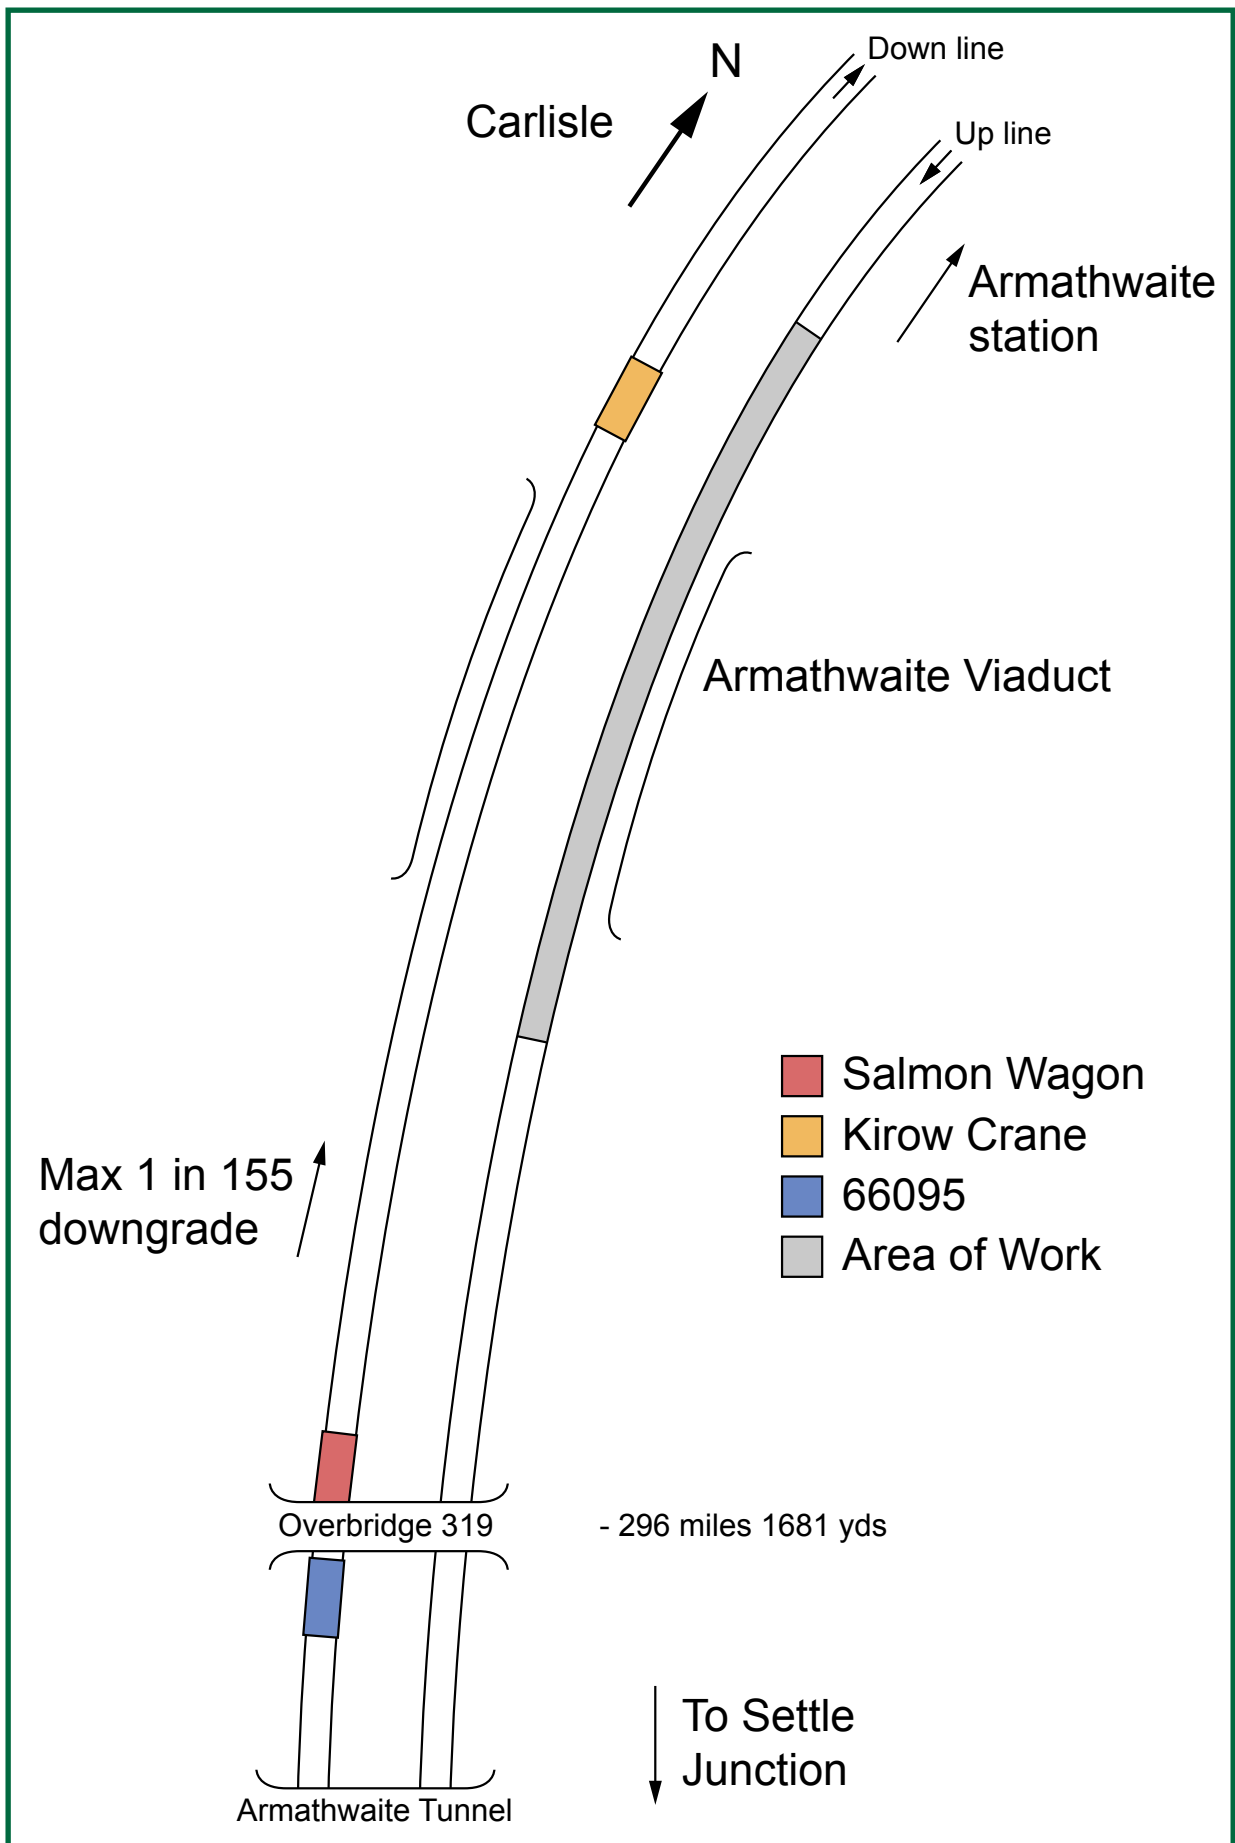
Figure 7: Location of vehicles at the worksite at the time the Kirow crane derailed

- 36 At 06:22 hrs on Sunday 28 February 2007, the crane derailed just north of Armathwaite viaduct. This was while it was lifting in new concrete sleepers and followed problems with the cant compensator system (see paragraph 58). Figure 7 shows the location of vehicles at the work site when the Kirow crane derailed.

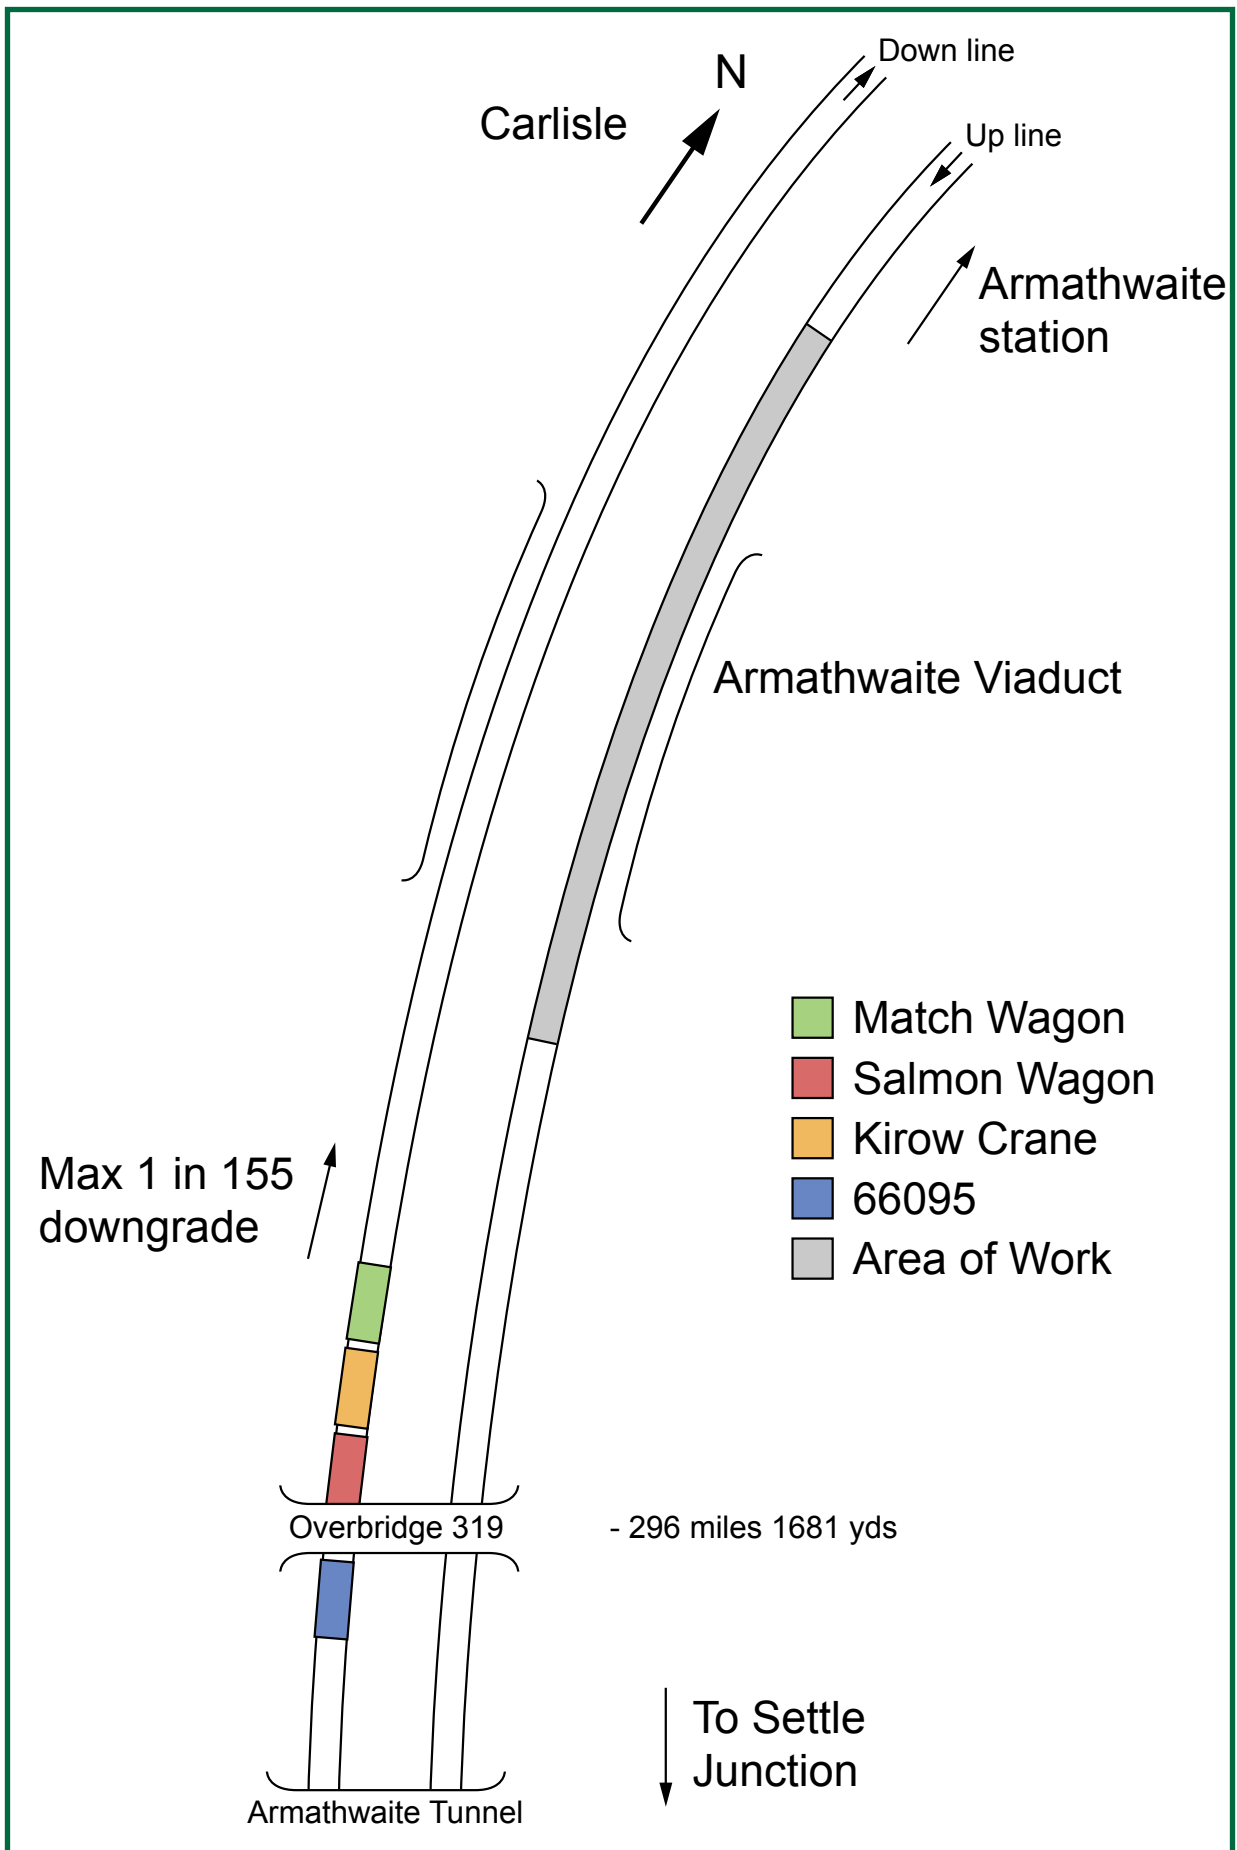
Figure 8: Location of vehicles at the time the crane was under repair

- 44 A few minutes later the First Engineering specialist engineer and another crane operator arrived at overbridge 319 on foot. At the same time, a First Engineering fitter, whose attendance had been arranged by the First Engineering specialist engineer, arrived from Glasgow with the parts necessary to repair the crane following its earlier derailment. Figure 8 shows the location of vehicles at the time the crane was under repair.

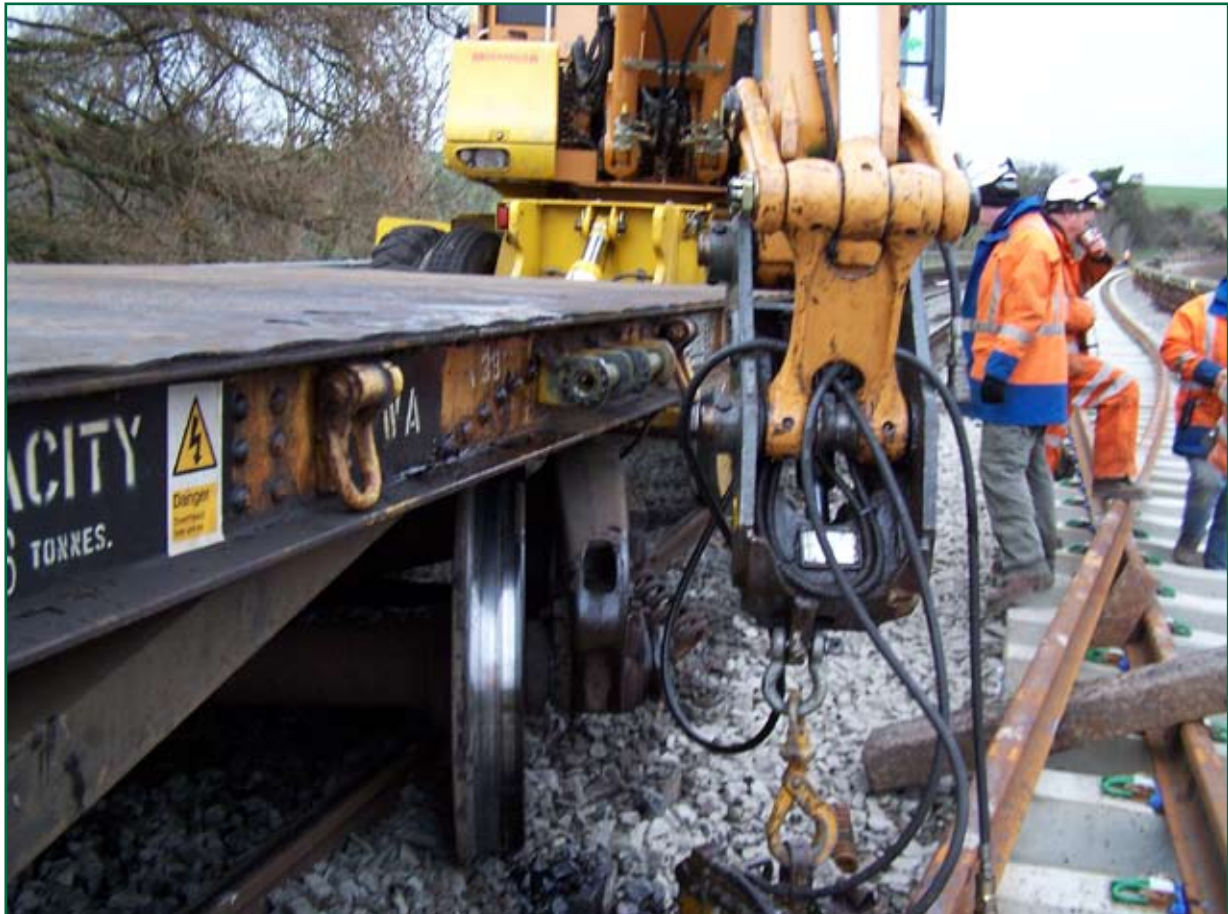
Figure 10: Consequences of the collision (by courtesy of Network Rail)

- 49 From both witness evidence and subsequent calculations carried out by the RAIB, the speed at impact is likely to have been around 27 km/h (17 mph).
- 50 The impact caused the leading bogie of the salmon wagon to derail and pushed the RRV back along the railway by about 3 metres (3.28 yds).
- 51 The RRV was only superficially damaged, but the thimble being used to position the new rail was broken. Minor damage was caused to the salmon wagon including a snapped off brake pipe *air cock* and lamp bracket, and bogie springs in the leading derailed bogie that had come out of position. Figure 10 shows the consequences of the collision.
- 52 The RRV operator who had remained in his cab, although not injured, was shaken up as a result of the collision.

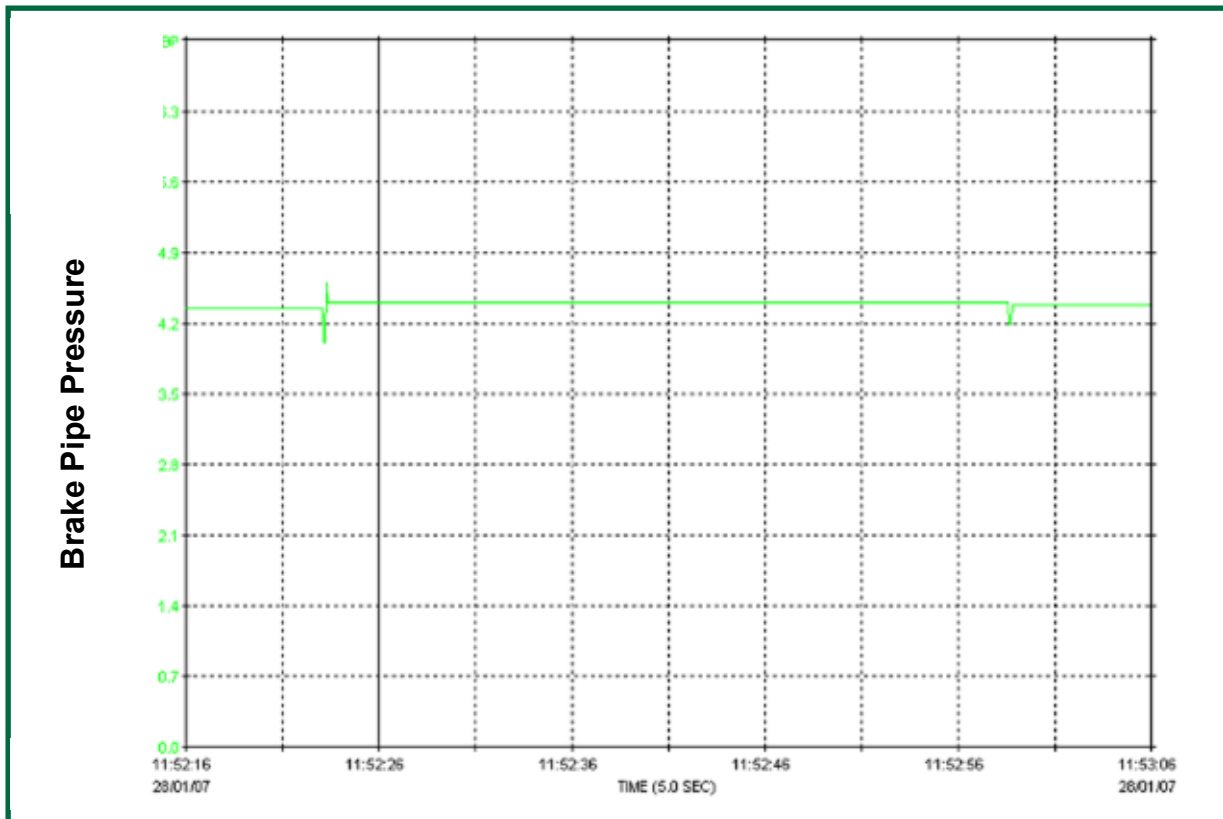
Figure 11: Extract from the download taken from the locomotive's OTMR

- 63 The OTMR output from locomotive 66095 showed two spikes on the locomotive brake pipe pressure trace at 11:52:24 hrs and at 11:52:58 hrs (see Figure 11). These are indicative of the crane's brake pipe being connected to the salmon wagon's brake pipe followed 34 seconds later by the salmon wagon's brake pipe being disconnected from the locomotive. It can be concluded from this, that at these same times, the salmon wagon was being coupled to the crane and uncoupled from the locomotive. The time between the two spikes on the brake pipe pressure trace is consistent with the time it takes to walk from one end of a salmon wagon to the other.

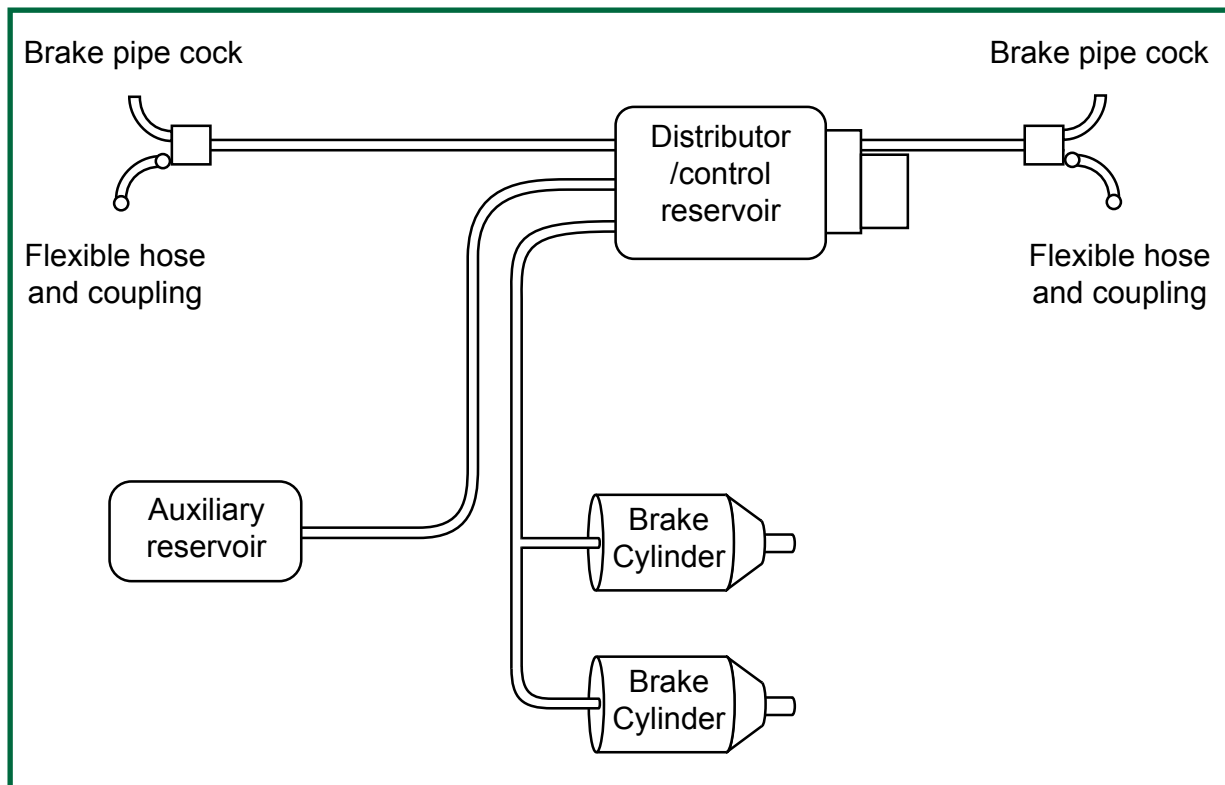
Figure 12: Salmon wagon braking system

- 64 A diagram of the brake system fitted to the salmon wagon is shown in Figure 12. The wagon is *single piped* and the air brake pipe runs the length of the vehicle. When the pressure in the brake pipe is reduced, for example through the action of the train driver applying the train's brake, the *distributor* causes air to flow from the auxiliary reservoir to the brake cylinders to apply the brake with a force (dependent on the pressure admitted) which is proportional to the amount of reduction of pressure in the air brake pipe. This proportionality is achieved by the variation in pressure between the brake pipe pressure and the pressure in the *control reservoir* which is normally maintained constant at 5 bar by the locomotive.

- 95 Therefore after the salmon wagon was uncoupled from the locomotive, there was a residual pressure of 4.4 bar in the brake pipe that had been delivered by the locomotive. At the same time, there would have been 5 bar of pressure (the normal running brake pressure) in the wagon distributor's control reservoir. Equalisation of these pressures causes the brakes to release.

- 96 The results of the brake tests on the salmon wagon (paragraph 65) showed that reducing the brake pipe pressure to 4.56 bar (equivalent to the 'initial' position of the train brake) resulted in brake cylinder pressures of 0.85 bar. The time taken for the cylinders to leak off from this pressure sufficiently to release the brake blocks from the wheels was between two and two and a half hours. Although the brake cylinder pressure would have been slightly higher than this (because the brake pipe pressure was actually reduced to 4.4 bar), once the salmon wagon was uncoupled from the locomotive (paragraph 41), the air in the brake cylinders leaked off in the period before it ran away (about 2 hrs 20 mins). This occurred while the crane was under repair, and subsequently when the salmon wagon was standing on the gradient uncoupled from any vehicle.

- 97 Neither of the two handbrakes had been applied to the salmon wagon, and no scotches had been fitted to the wheels. There was nothing to prevent the wagon running away once the air had leaked out of the brake cylinders. Therefore, the immediate cause of the accident was that the wagon had not been secured on the gradient. This led to its runaway and ultimate collision.
