Rail Accident Investigation Branch

# Rail Accident Report

## Collision with the gates at Lydney Town level crossing 15 August 2007

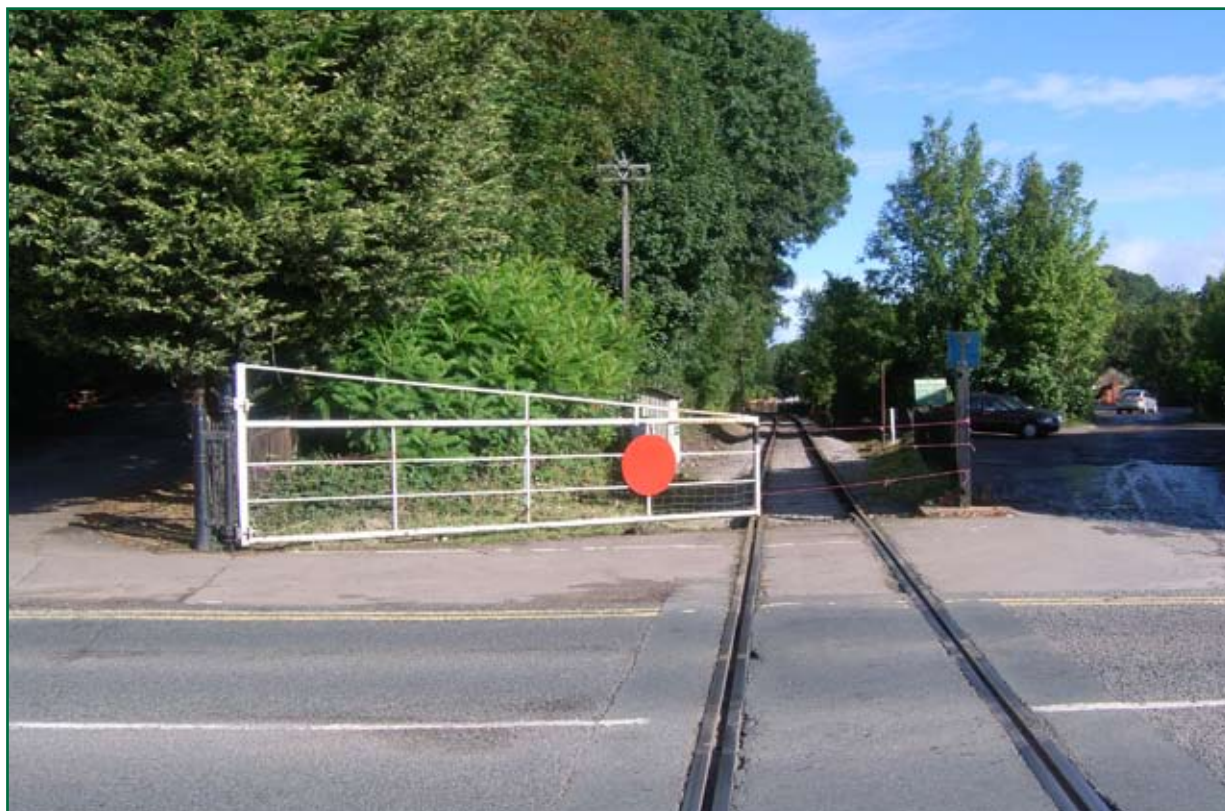
Figure 4: Lydney town crossing looking north (secondary gate missing following accident)

- 70 The rolling stock was recovered from site later in the day and taken back to Norchard for examination.
- 71 The crossing was taped over and the line closed for the remainder of the day. A replacement for the damaged gate has subsequently been provided.

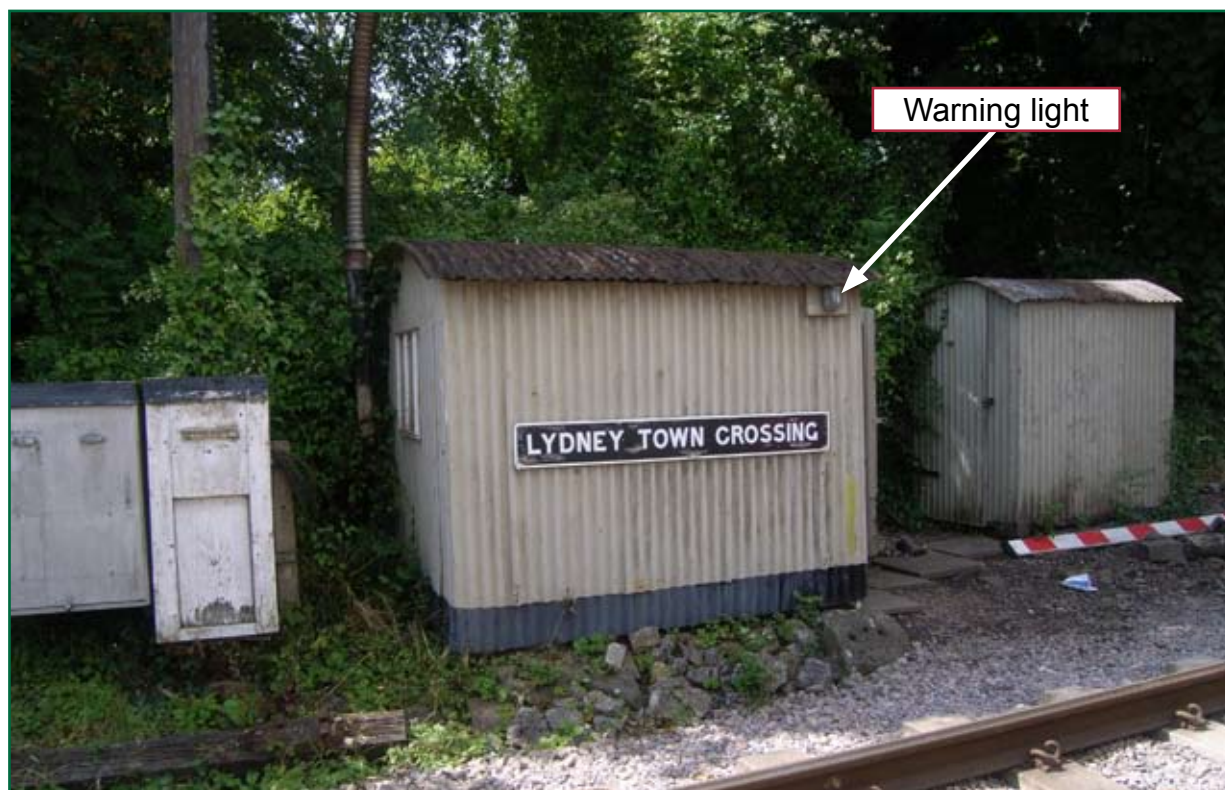
Figure 5: Crossing keeper's hut, showing warning light for approach of trains

- 84 Inspection of the system following the accident identified that the buzzer was faulty and not working at all. The treadle operated warning light was intermittent. The length of the warning given by the flashing light is a function of the train length and how long the treadle arm takes to return to the normal position once depressed by the wheel flanges of a passing train. The return motion is *damped* to extend the period of warning. At 20 mph, the wheels of the auto-train would depress the treadle arm for less than 3 seconds. If the arm is correctly adjusted, it should take between 6 and 8 seconds to return to its rest position. This gives a total length of warning of 9 to 11 seconds, which will be reduced if the arm is not set at the correct height (so that it is not fully depressed by wheel flanges) or if the damping not adjusted correctly.

- c. replaced the battery that powers the buzzer and the white light at the crossing;
  - d. moved the 'stop' board at Lydney Town to a greater distance from the crossing; and

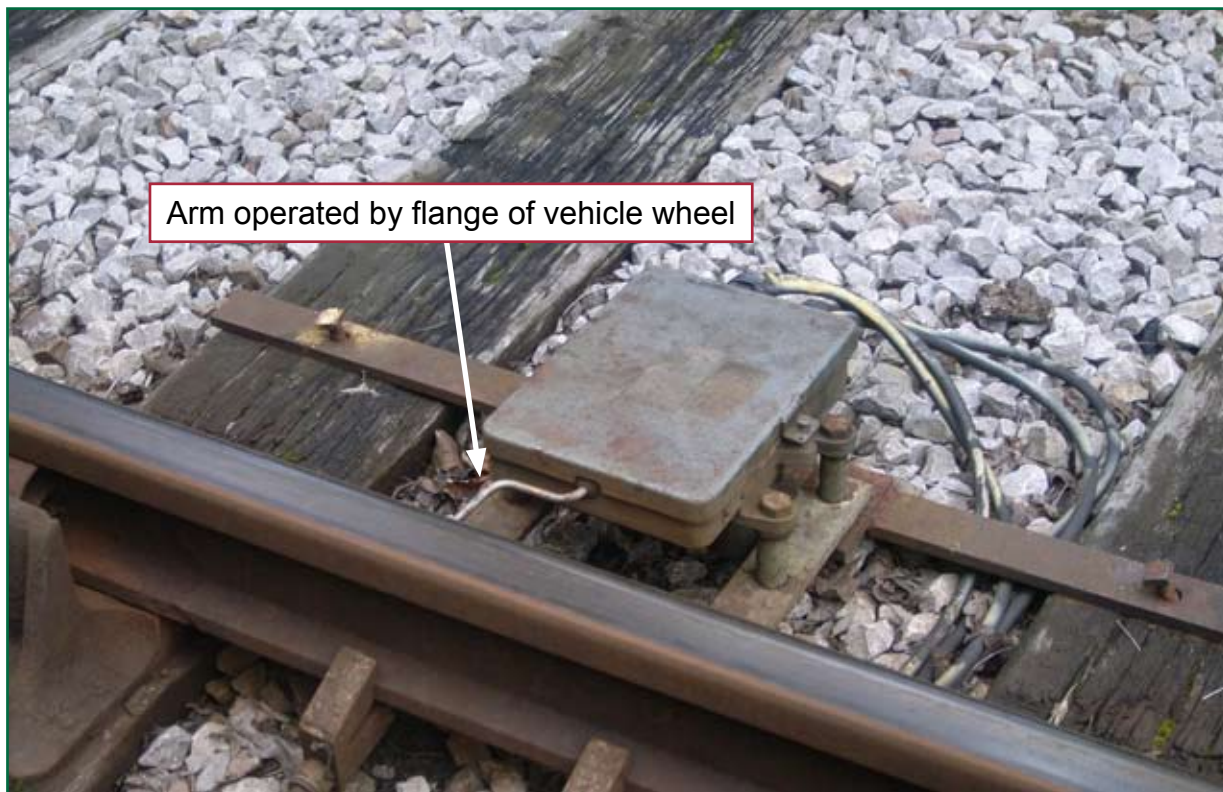
Figure 6: Treadle

- 32 In order to warn the crossing keepers of approaching trains there is a treadle placed 455 metres (500 yards) north of the crossing (Figure 6). Operation of this treadle by a train causes a buzzer to sound, and a light to flash, at the crossing keepers' hut.

- 46 There was no speedometer, and no on-train data recording system, fitted to the locomotive or the autococh. This was normal practice for rolling stock built before the second world war.

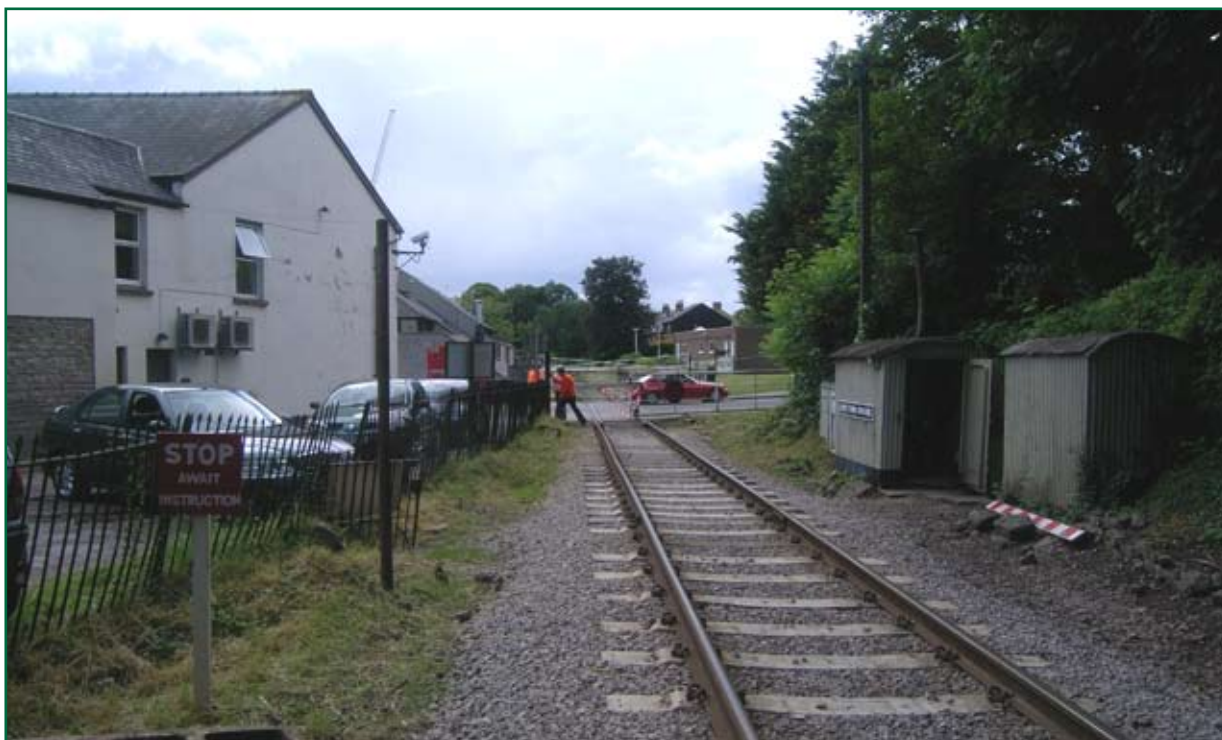
Figure 8: Approach to Lydney Town crossing, showing 'Stop' board

- Be prepared to stop at a board 24 metres before reaching the crossing, unless the crossing keepers give a proceed signal (Figure 8).

- 34 Vegetation to the left of the line obstructs the view of the stop board until the driver is some 40 metres from it, but for a train travelling at 10 mph on a dry rail this provides sufficient stopping distance.
- 35 Figure 9 shows schematically the position of the features in relation to the crossing gates.
