Rail Accident Investigation Branch

# Rail Accident Report

**Passenger trapped in a closed train door,  
Tooting Broadway, Northern Line,  
London Underground  
1 November 2007**

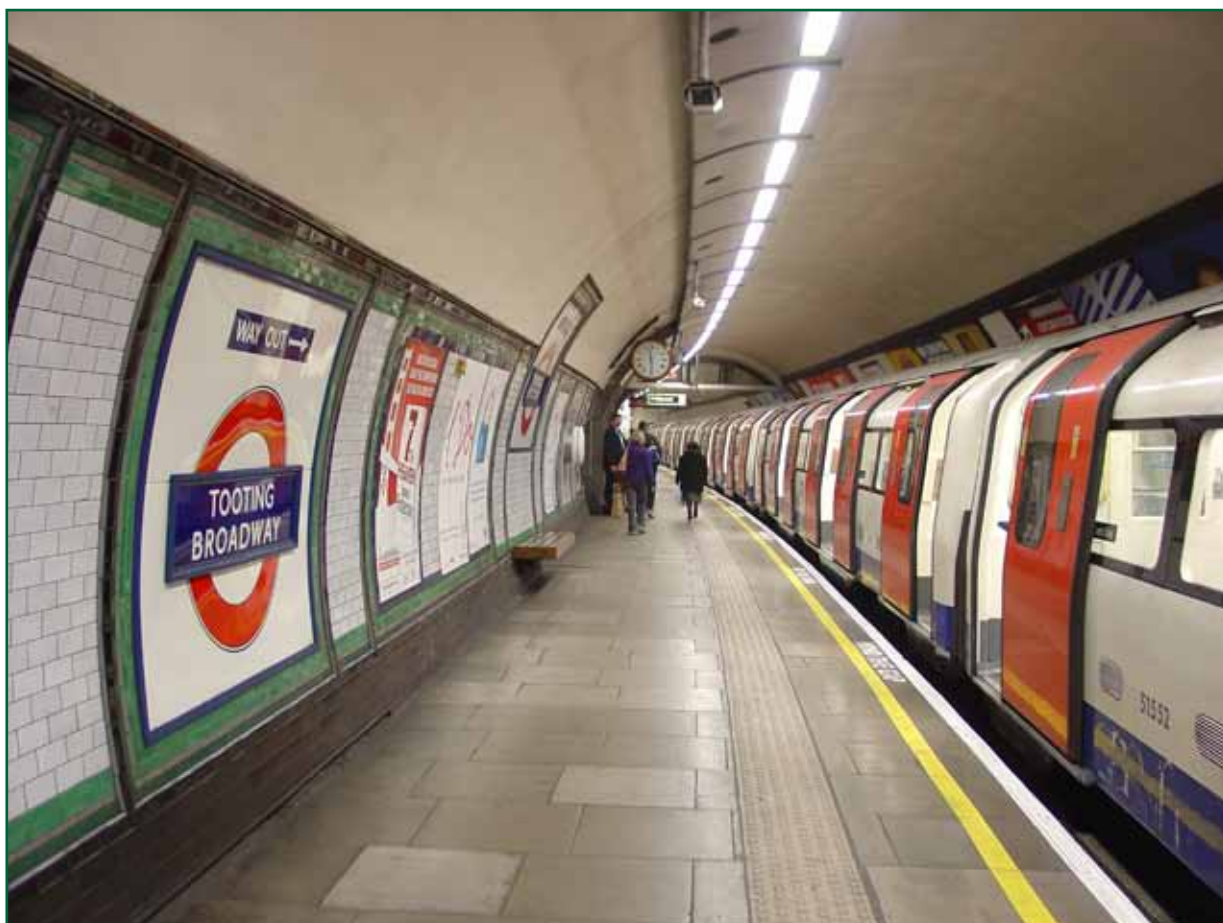
Figure 2: Southbound platform at Tooting Broadway, Northern Line

- 14 On 1 November 2007, at approximately 14:30 hrs, the hem of a passenger's coat was trapped in the closing doors of a southbound Northern Line train at Tooting Broadway as she left the train.
- 15 The passenger was not able to release herself from the coat until after the train began to move away. Although she fell to the platform while extracting the coat from the door, the injuries she sustained did not cause her to be detained in hospital.
- 16 The train was stopped as it left the station following the activation of the PEA by a passenger on the train. On completion of its journey to Morden it was taken out of service for examination.
