Rail Accident Investigation Branch

Rail Accident Report

Derailed at Grayrigg 23 February 2007

Derailment at Grayrigg, 23 February 2007

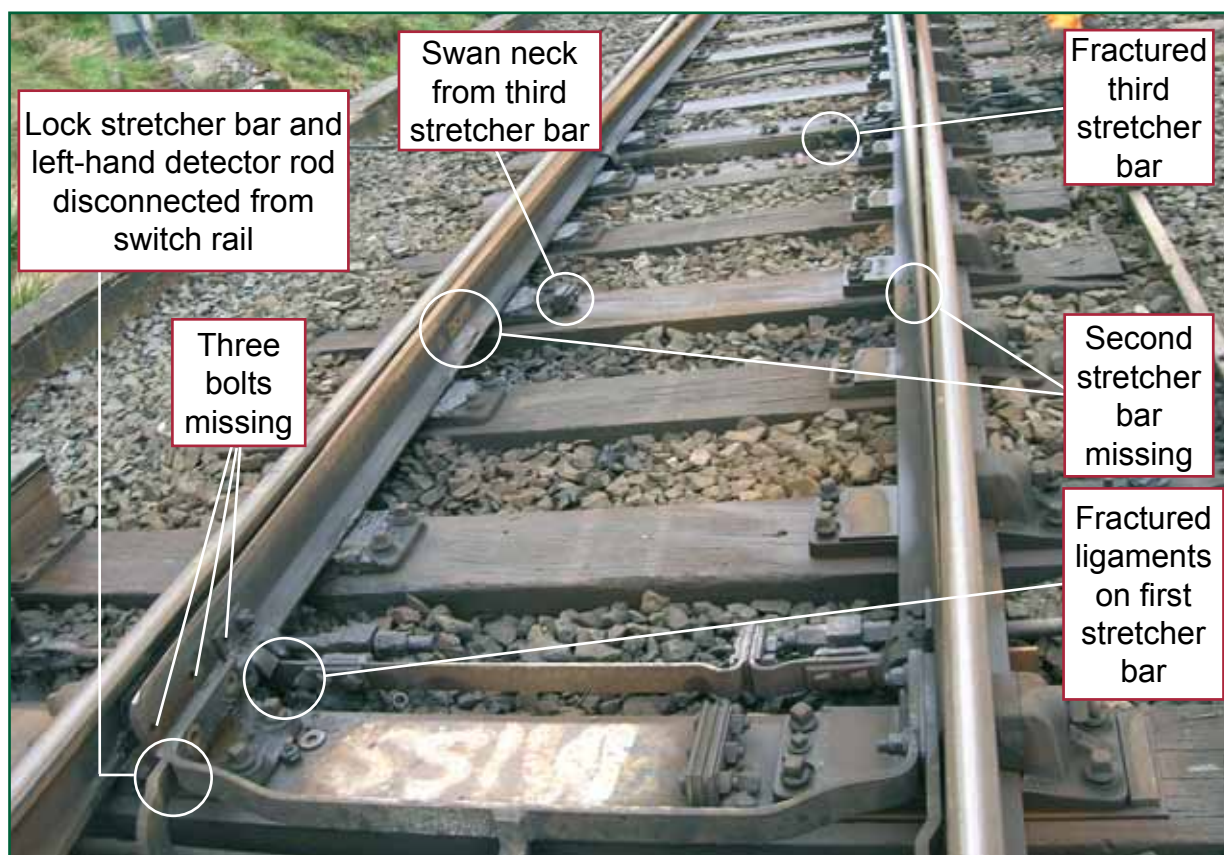
Figure 7: 2B points on 24 February 2007

111 Figure 7 shows the state in which the points were found immediately after the accident.

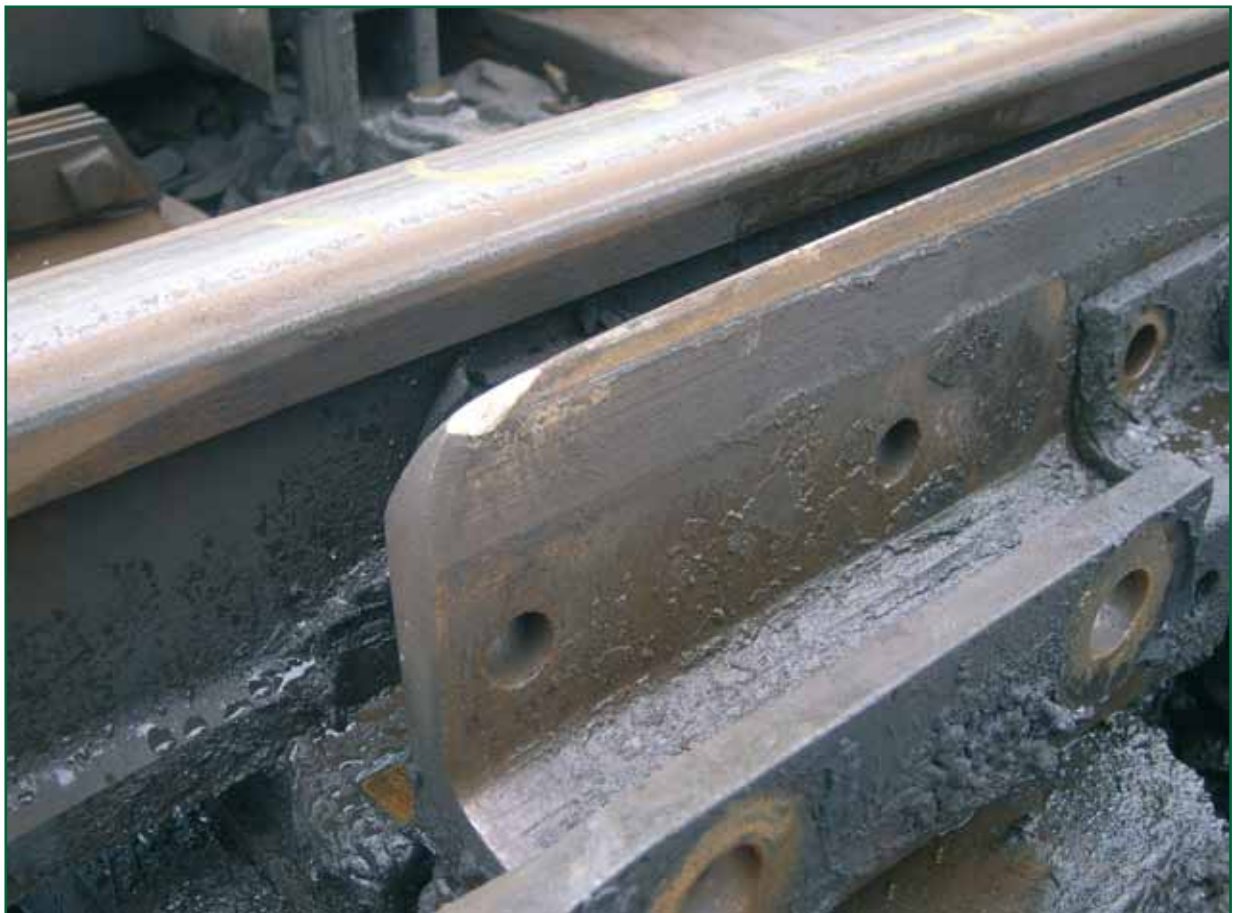
113 There was bruising on the tip of the left-hand switch rail (Figure 8) caused by impact with more than one train wheel as the wheels passed to the *gauge-side* of the left-hand switch rail during the derailment. There were wheel marks on the *field-side* face of the left-hand switch rail starting close to the switch toe and running along it, through to and beyond the third permanent way stretcher bar position (Figure 9). There were no marks indicating that any wheels had passed between the right-hand switch and stock rails from the toe to the third permanent way stretcher bar. There were flange climb marks on both switch rails in the vicinity of the third permanent way stretcher bar, and three of the left-hand *slide chairs* had fractured during the derailment because of forces tending to widen the gauge.

Figure 8: Bruise to the tip of the left-hand switch rail

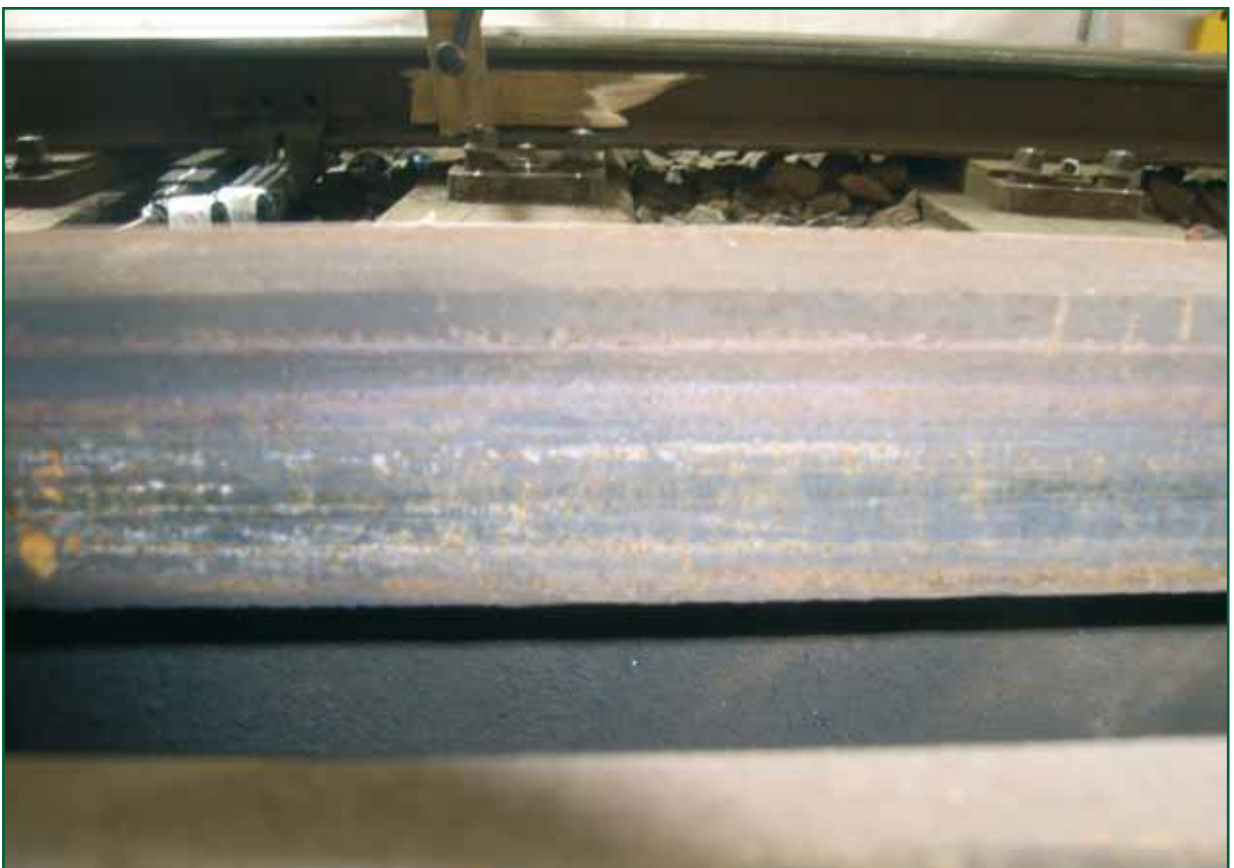
Figure 9: Wheel marks on the field side face of the left-hand switch rail

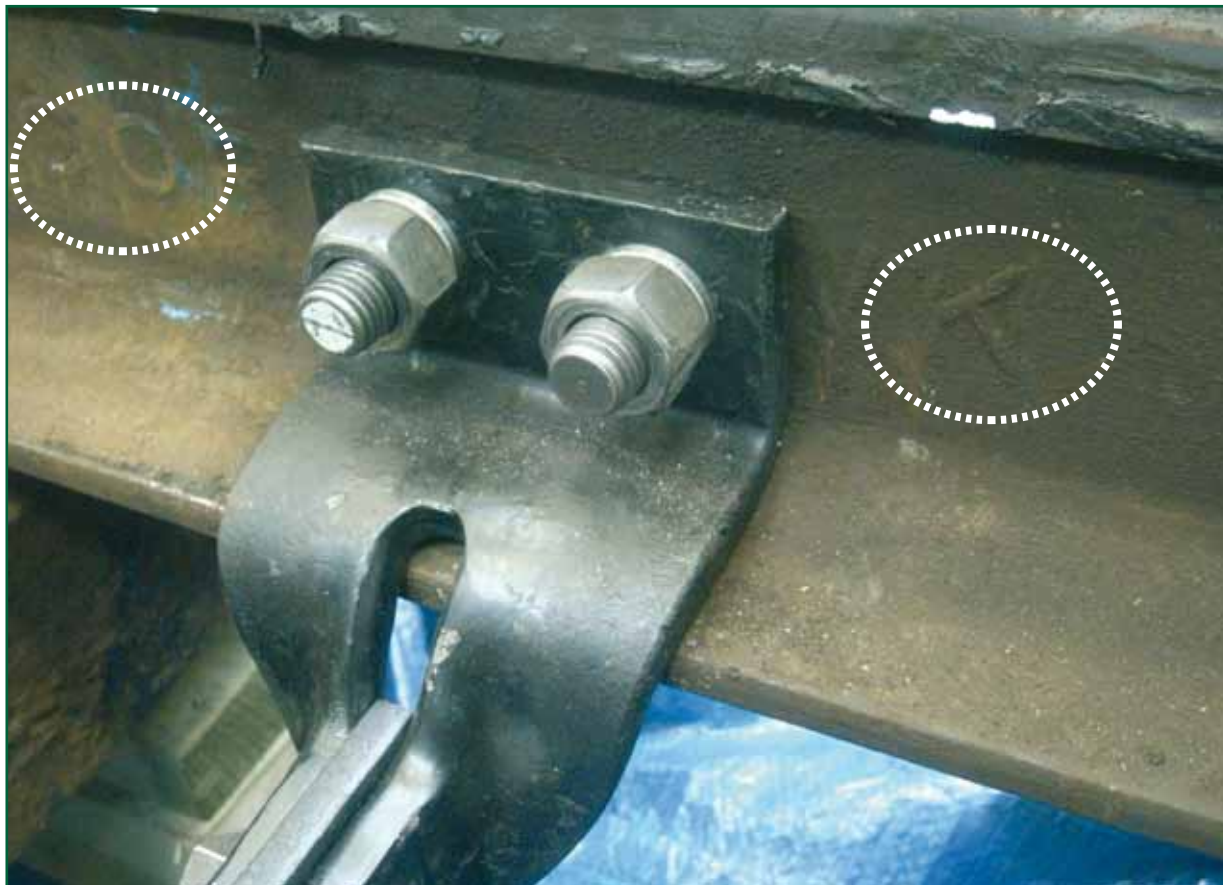
114 *Rail branding* was present on the *four-foot* side of the right-hand side switch rail where the second and third permanent way stretcher bar brackets had been attached (Figure 10). *Branding* was also present on the field-side of the left-hand switch rail where both bolt heads of the first permanent way stretcher bar and the north bolt head of the *lock stretcher bar* had been seated (Figure 11).

Figure 10: Rail branding on right-hand switch rail (Note: a new bracket has been added for testing purposes)

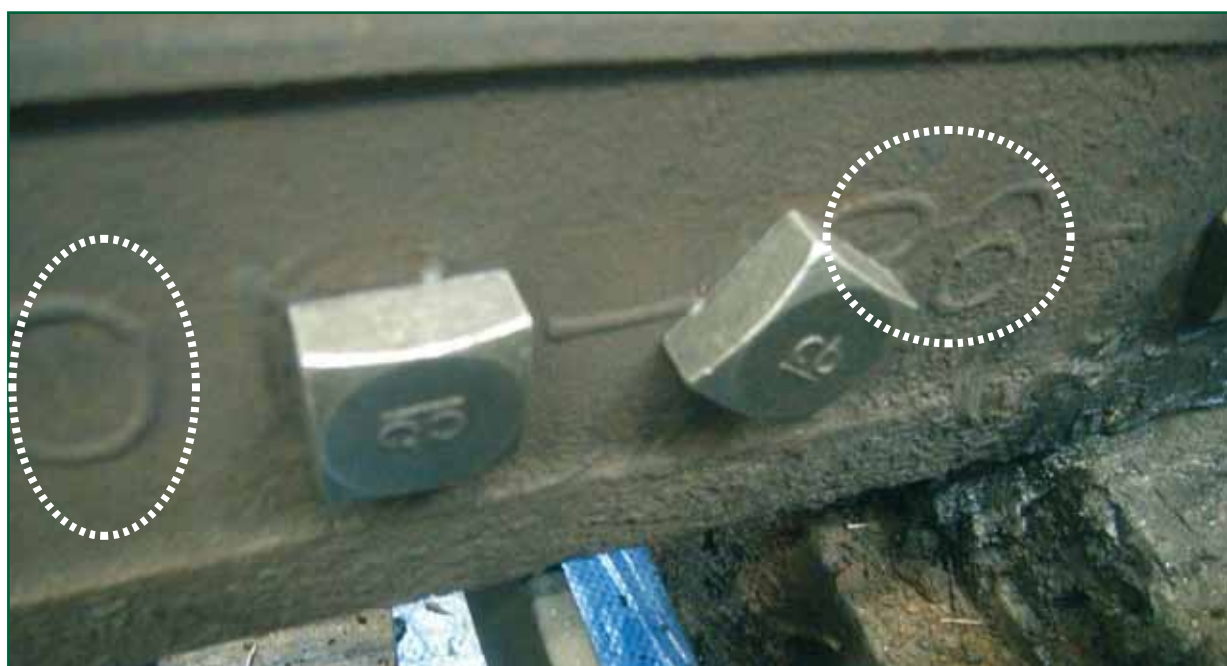
Figure 11: Rail branding on left-hand switch rail (Note: new bolts added for testing purposes)

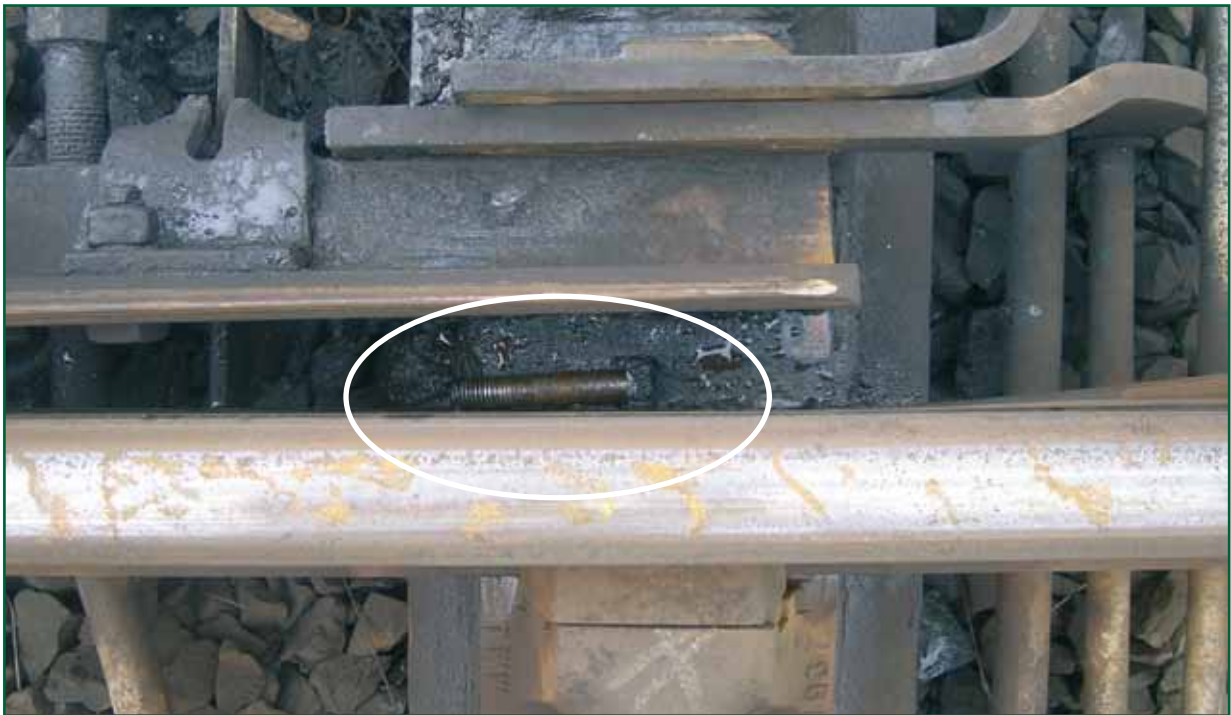
115 The lock stretcher bar was detached from the left-hand switch rail because the two fasteners were not in place. These fasteners were $\frac{3}{4}$ inch Whitworth bolts with *prevailing torque* nuts. The bolts were made from mild steel, equivalent to grade 4.6 to British Standard 3692:2001, commonly known as black bolts, in accordance with Network Rail's specifications. All of the detached fastener components were lying in the vicinity of the switch toes, with the exception of one of the bolts which, despite an extensive search, was not found. The other lock stretcher bar bolt was recovered from the left-hand slide chair at the point toes, between the left-hand switch rail and its adjacent stock rail (Figure 12). There were markings on the bolt head (Figure 13), and the feet of both rails, consistent with the bolt having been trapped by the closing of the left-hand switch rail.

Figure 12: Lock stretcher bar bolt between left-hand switch and stock rail at toe

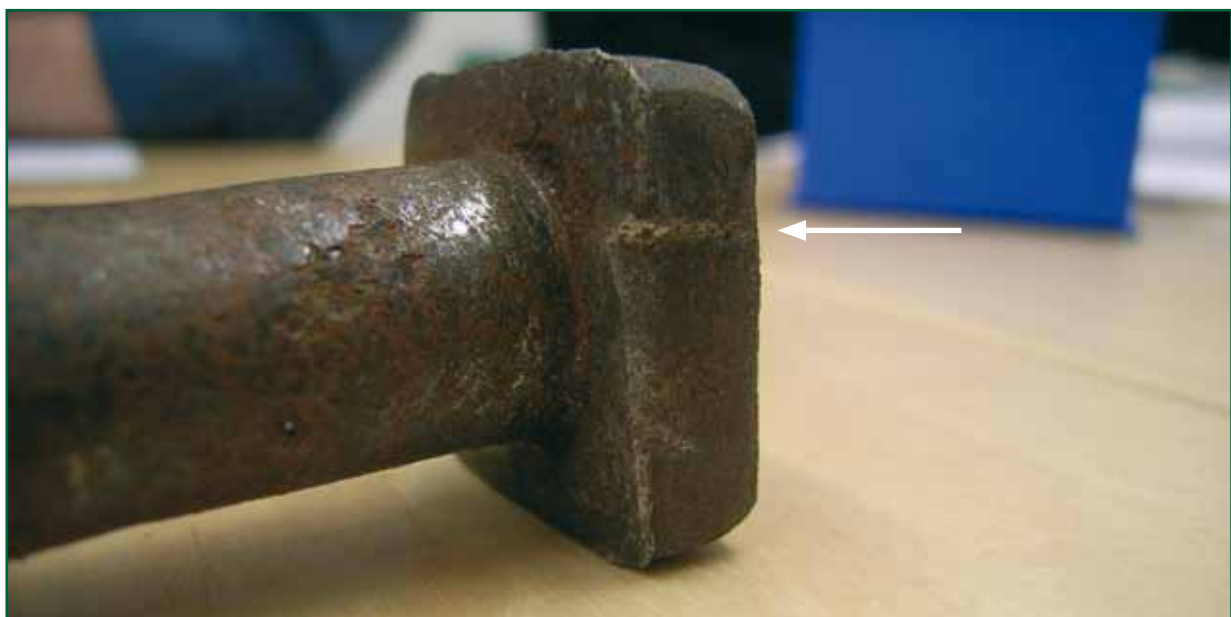
Figure 13: Indentation in lock stretcher bar bolt head

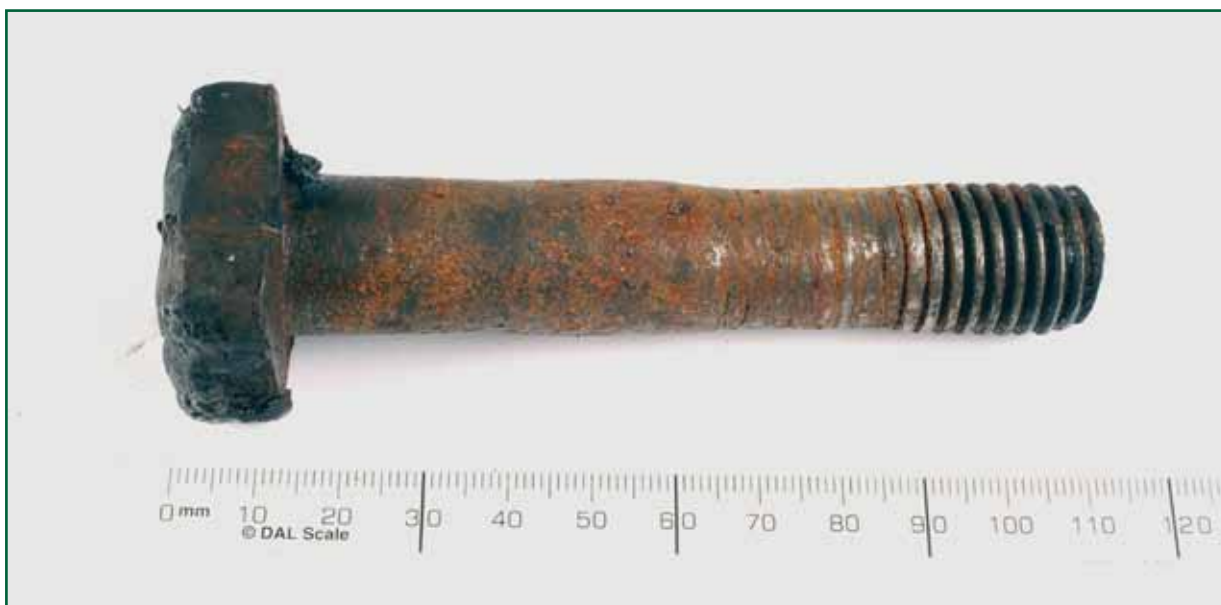
116 Examination of the one detached lock stretcher bar bolt (paragraph 115) indicated that the fastener had loosened and the nut had progressively wound off the bolt. The gradual unwinding of the nut is apparent from the decreasing flattening of the crowns of the threads towards the tip of the bolt (Figure 14).

Figure 14: Lock stretcher bar bolt showing progressive thread damage

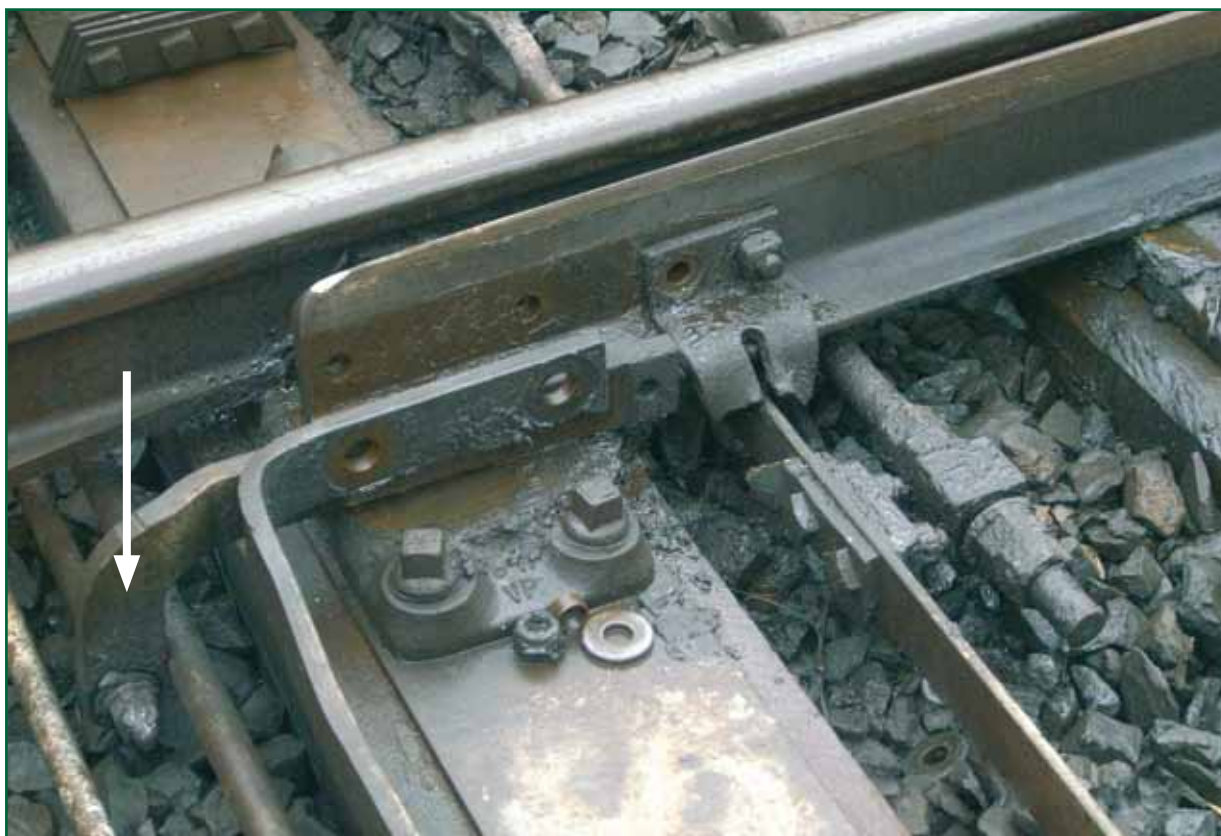
117 The left-hand *switch rail extension piece* (Figure 15), to which the *detector rod* was attached, was also detached from the left-hand switch rail because its fasteners were common with those of the lock stretcher bar.

Figure 15: Left-hand switch rail toe showing switch rail extension piece (arrowed)

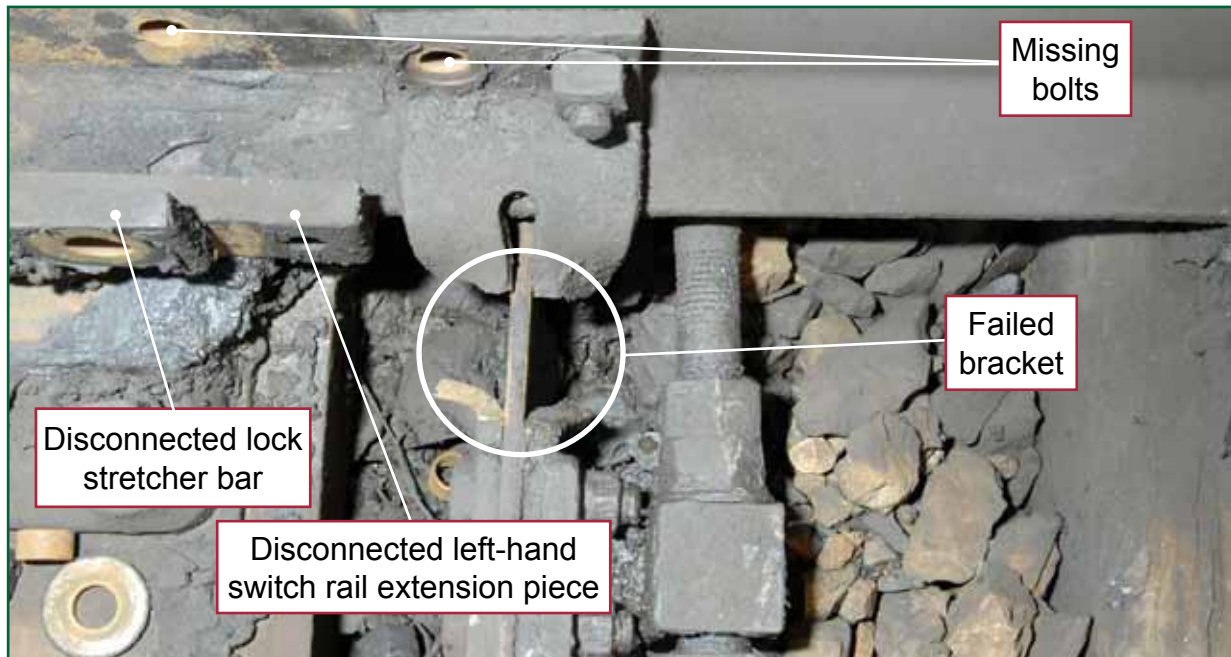
Figure 16: Failed bracket first permanent way stretcher bar

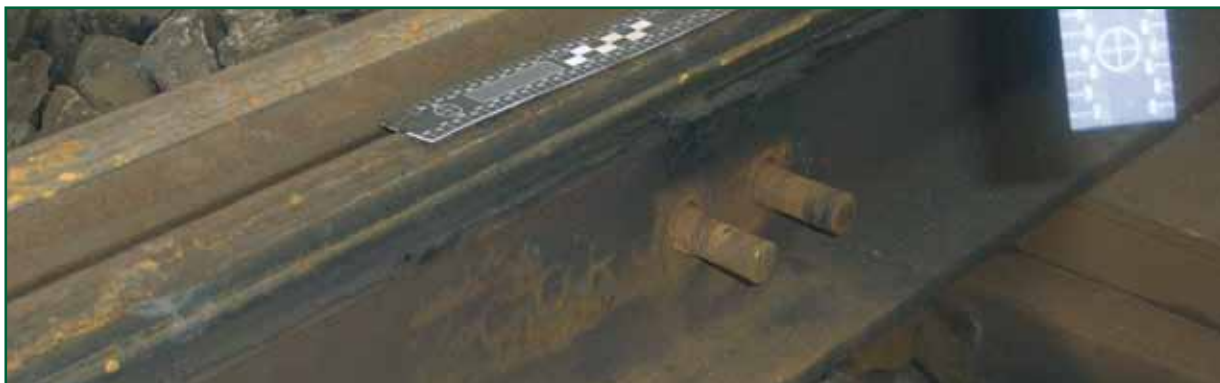
- 122 The second permanent way stretcher bar was missing from the points. All of its fastener components (bolts, nuts and spring washers) were present in the ballast in the vicinity of where the bar had been, with the exception of the right-hand switch rail bolts which were still within their attachment holes in the right-hand switch rail (Figure 17).
- 123 Two sections of stretcher bar (Figures 18 and 19) were found at two separate locations 50 metres and 150 metres north of 2B points. Their dimensions and metallurgy indicated that these were the sections of the second permanent way stretcher bar.

Figure 17: Right-hand switch rail at second permanent way stretcher bar position

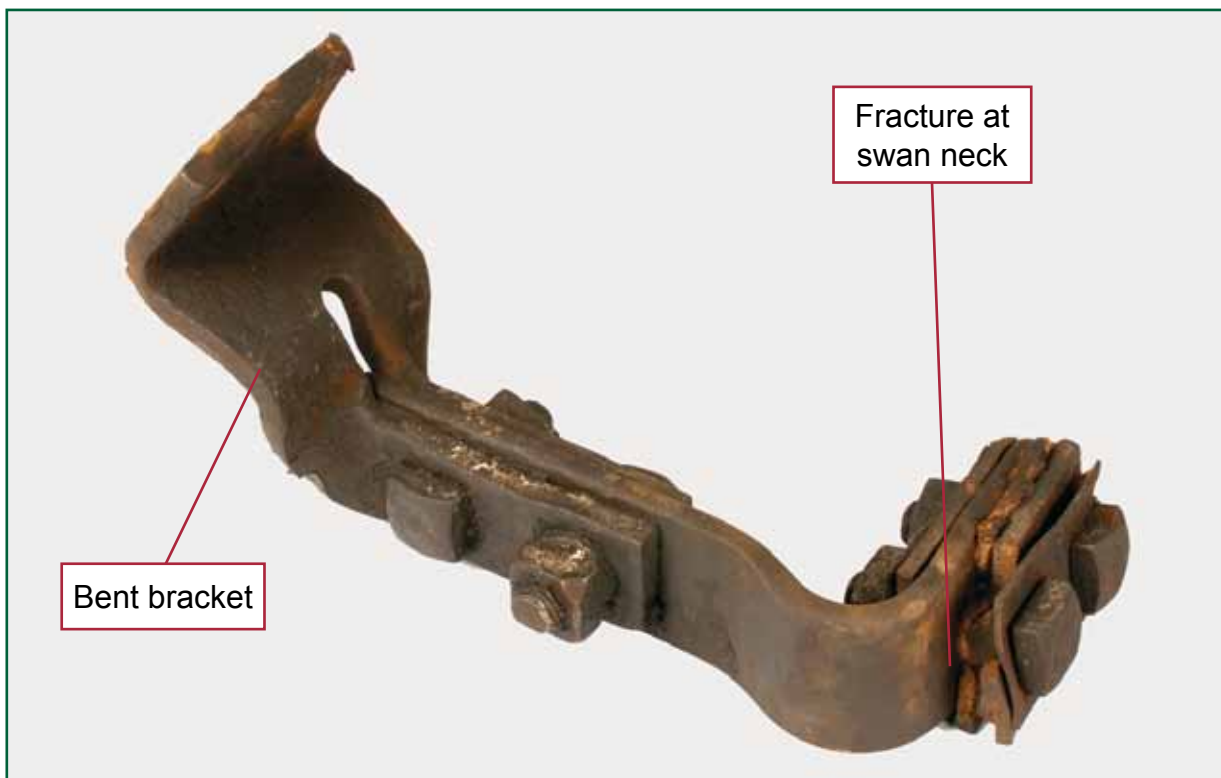
Figure 18: Short section of second permanent way stretcher bar

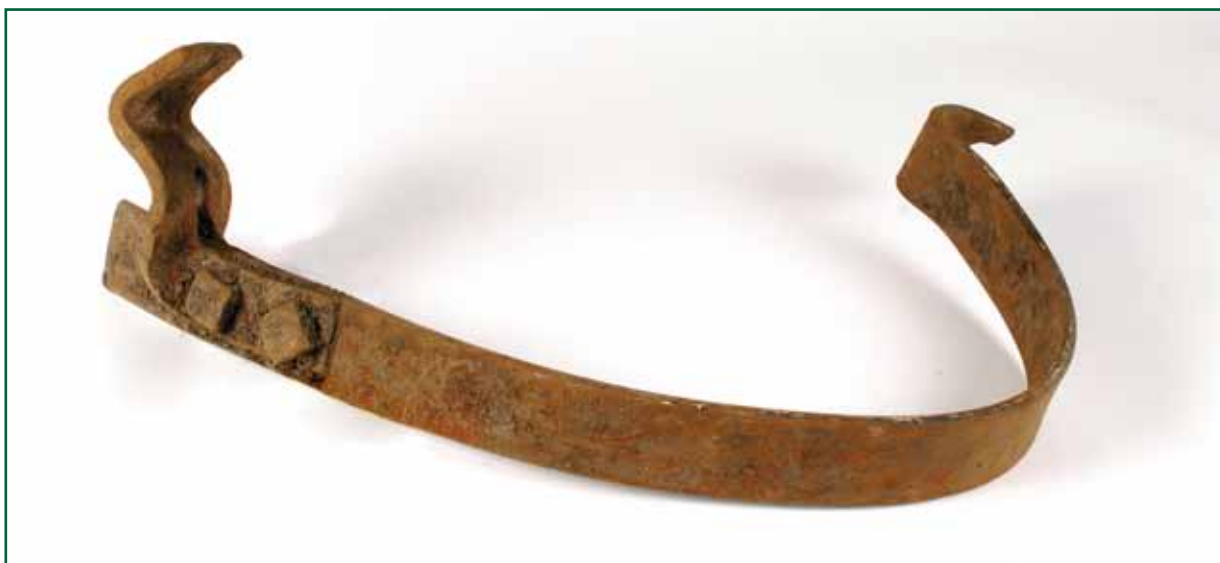
Figure 19: Long section of second permanent way stretcher bar

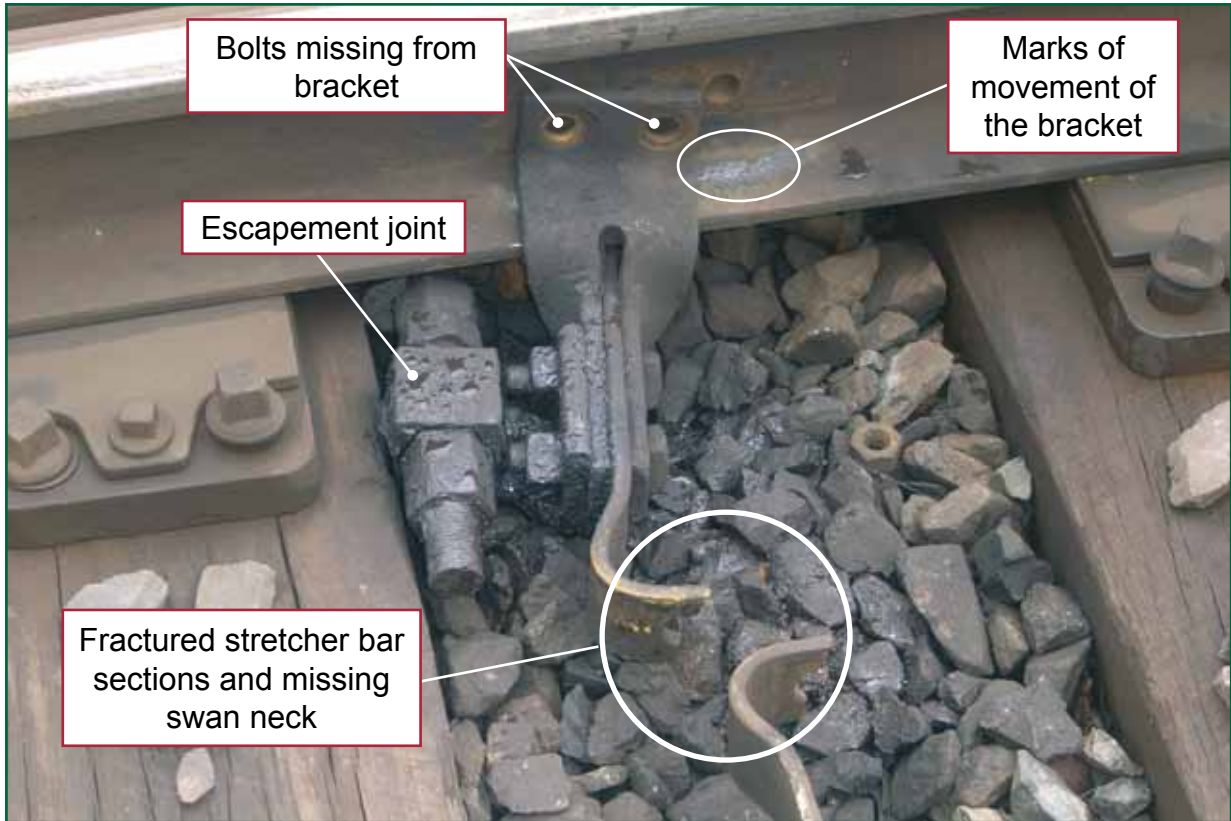
124 The third permanent way stretcher bar was found in place but broken in two places (Figure 20). The *swan neck insulation* assembly was found on the third *bearer* from the point toes in the direction of travel close to the left-hand slide chair (Figures 7 and 21).

Figure 20: The third permanent way stretcher bar

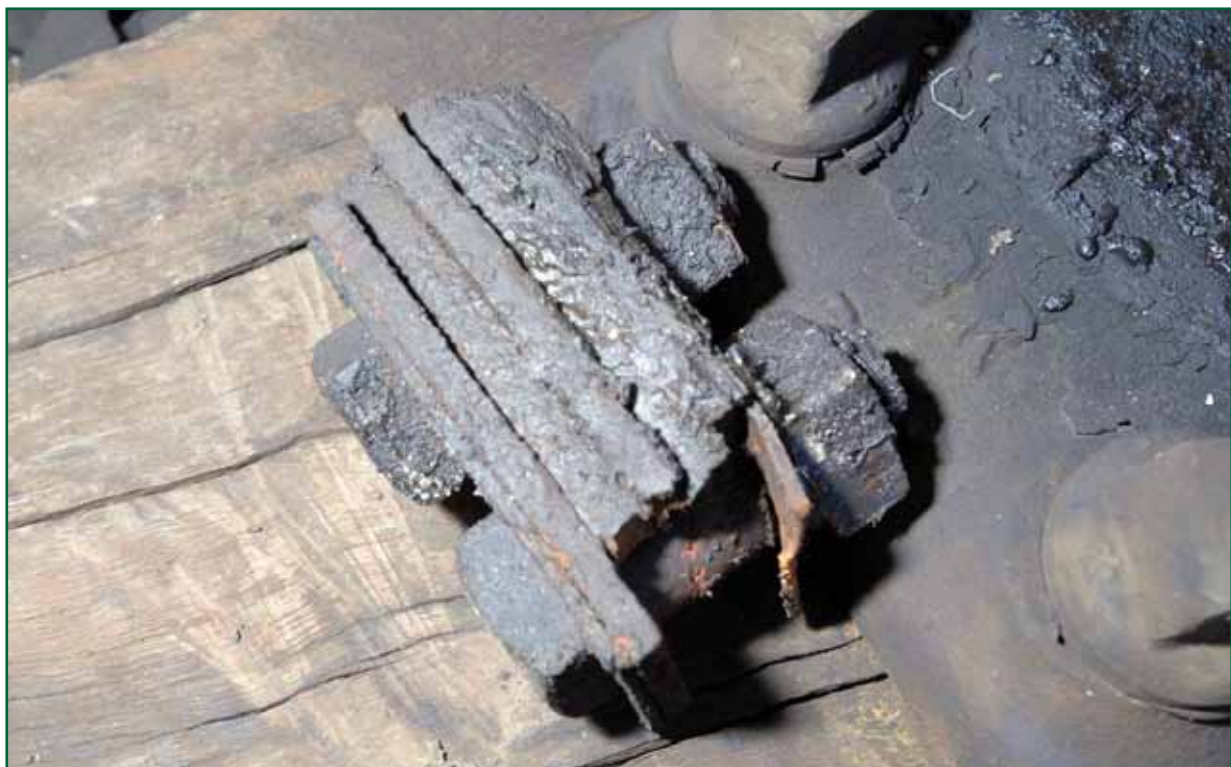
Figure 21: The third permanent way stretcher bar swan neck insulation assembly

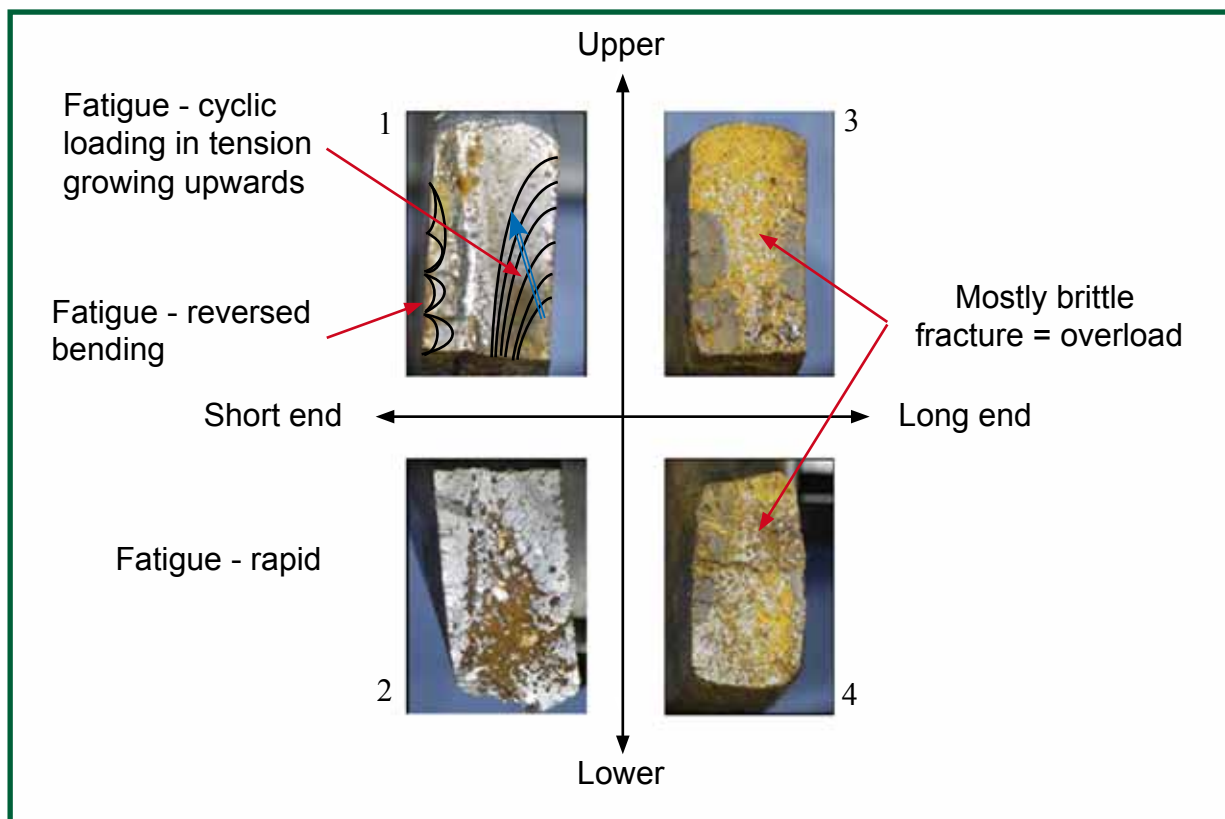
125 The broken components in the third permanent way stretcher bar swan neck insulation assembly had new, corrosion-free fracture surfaces. Additionally there was evidence of older fatigue. The four fracture surfaces in the swan neck insulation assembly are shown in Figure 22.

Figure 22: Fatigue surfaces within the swan neck assembly of the third permanent way stretcher bar

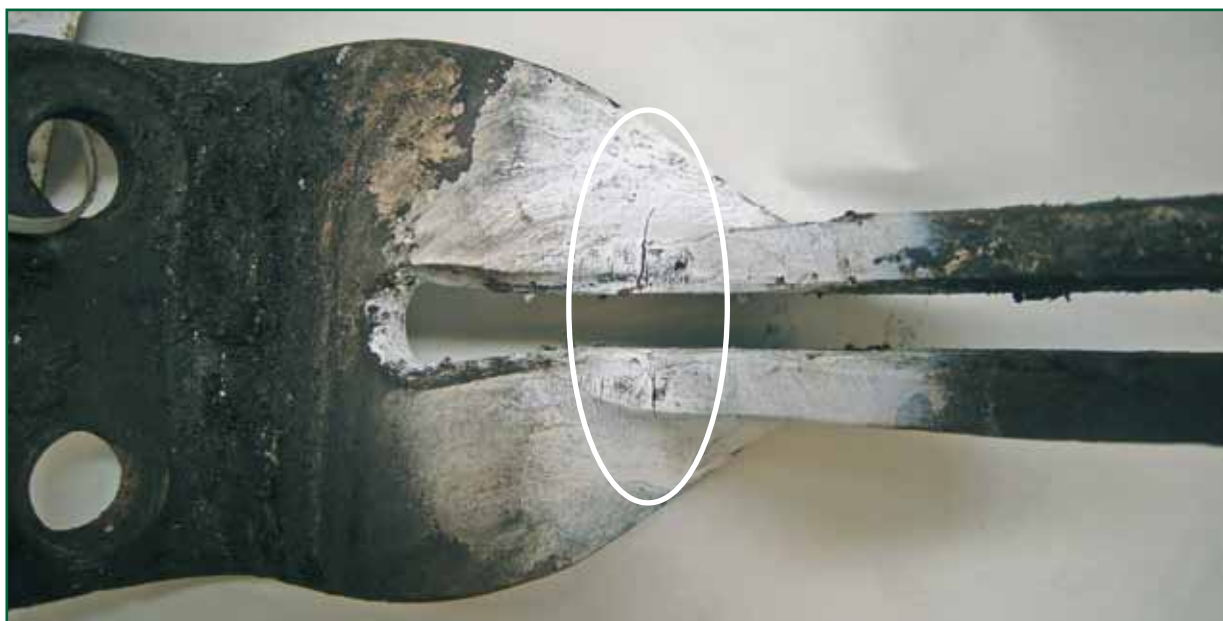
126 There were also cracks in the ligaments of both the left and right-hand switch rail brackets (Figure 23).

Figure 23: Cracks in the left-hand rail bracket of the third permanent way stretcher bar

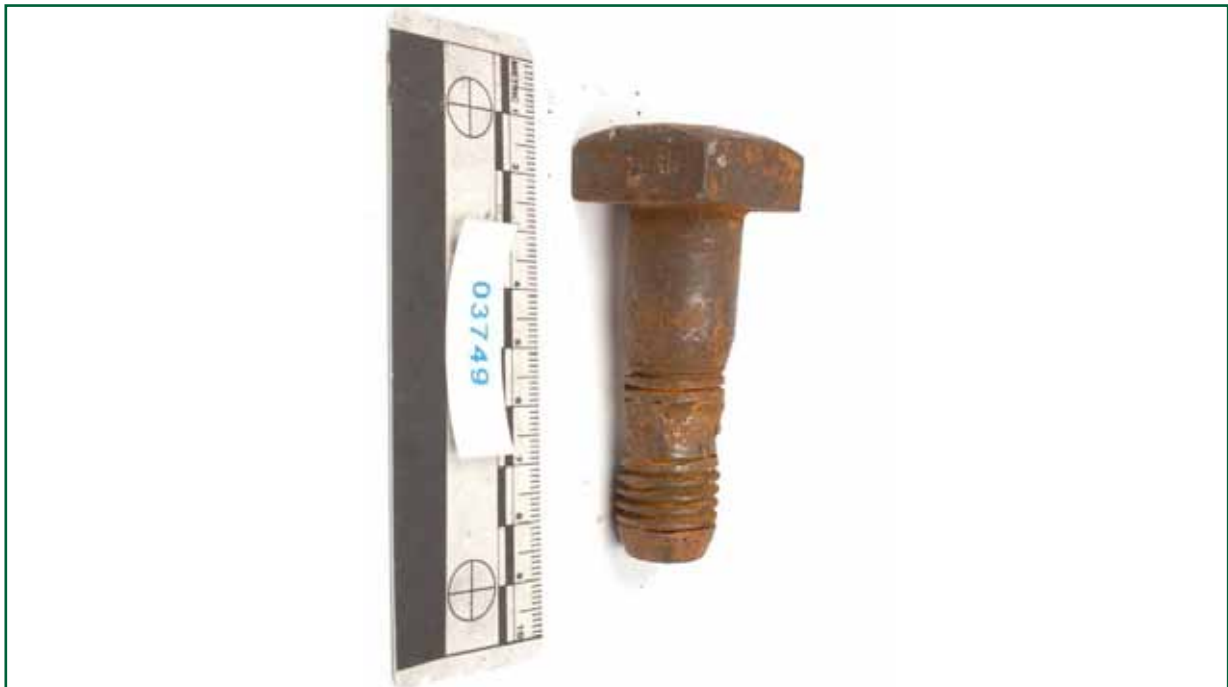
- 127 The right-hand bracket of the stretcher bar was detached from the right-hand switch rail and was supported only by its connection to the supplementary drive (Figure 20).
- 128 Four bolts and four nuts (all $\frac{3}{4}$ inch Whitworth) and two single coil spring washers were found in close proximity to the third permanent way stretcher bar. All of the bolts exhibited signs of damage consistent with being loosely held within the switch rail holes prior to working free. Three of the bolts had sustained damage consistent with being trapped for a while between the closed right-hand switch and stock rails before falling free (Figure 24).

Figure 24: Damaged bolt from right-hand end bracket of third permanent way stretcher bar

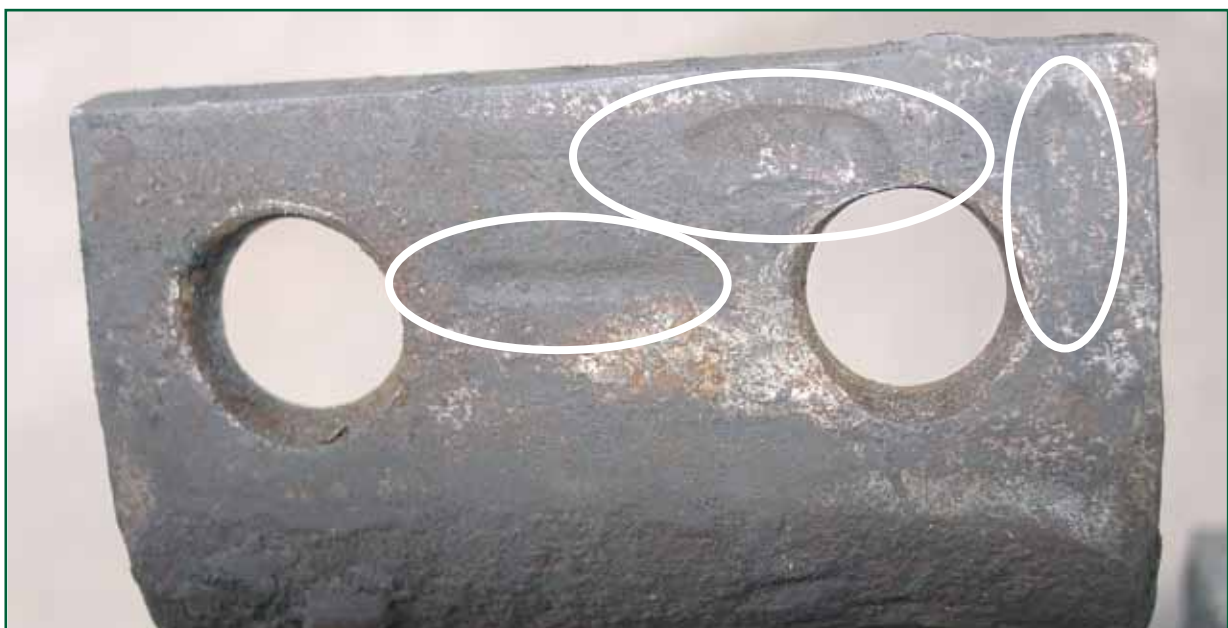
- 129 There were indentations matching the rail branding (paragraph 114) imprinted into the mating face of the right-hand stretcher bar bracket (Figure 25).

Figure 25: Indentations imprinted into the mating face

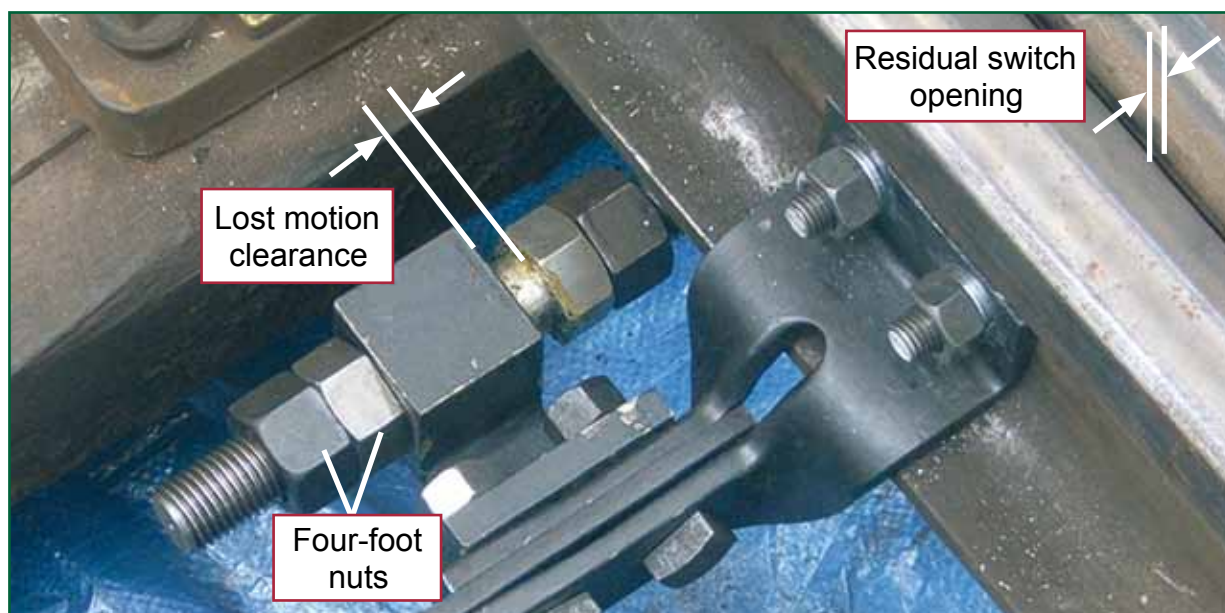
- 134 The position of the escapement joint's four-foot nuts was such that it allowed a residual switch opening in the range of 7 to 10 mm between the right-hand switch and stock rails.

Figure 26: Escapement joint on a reconstructed stretcher bar

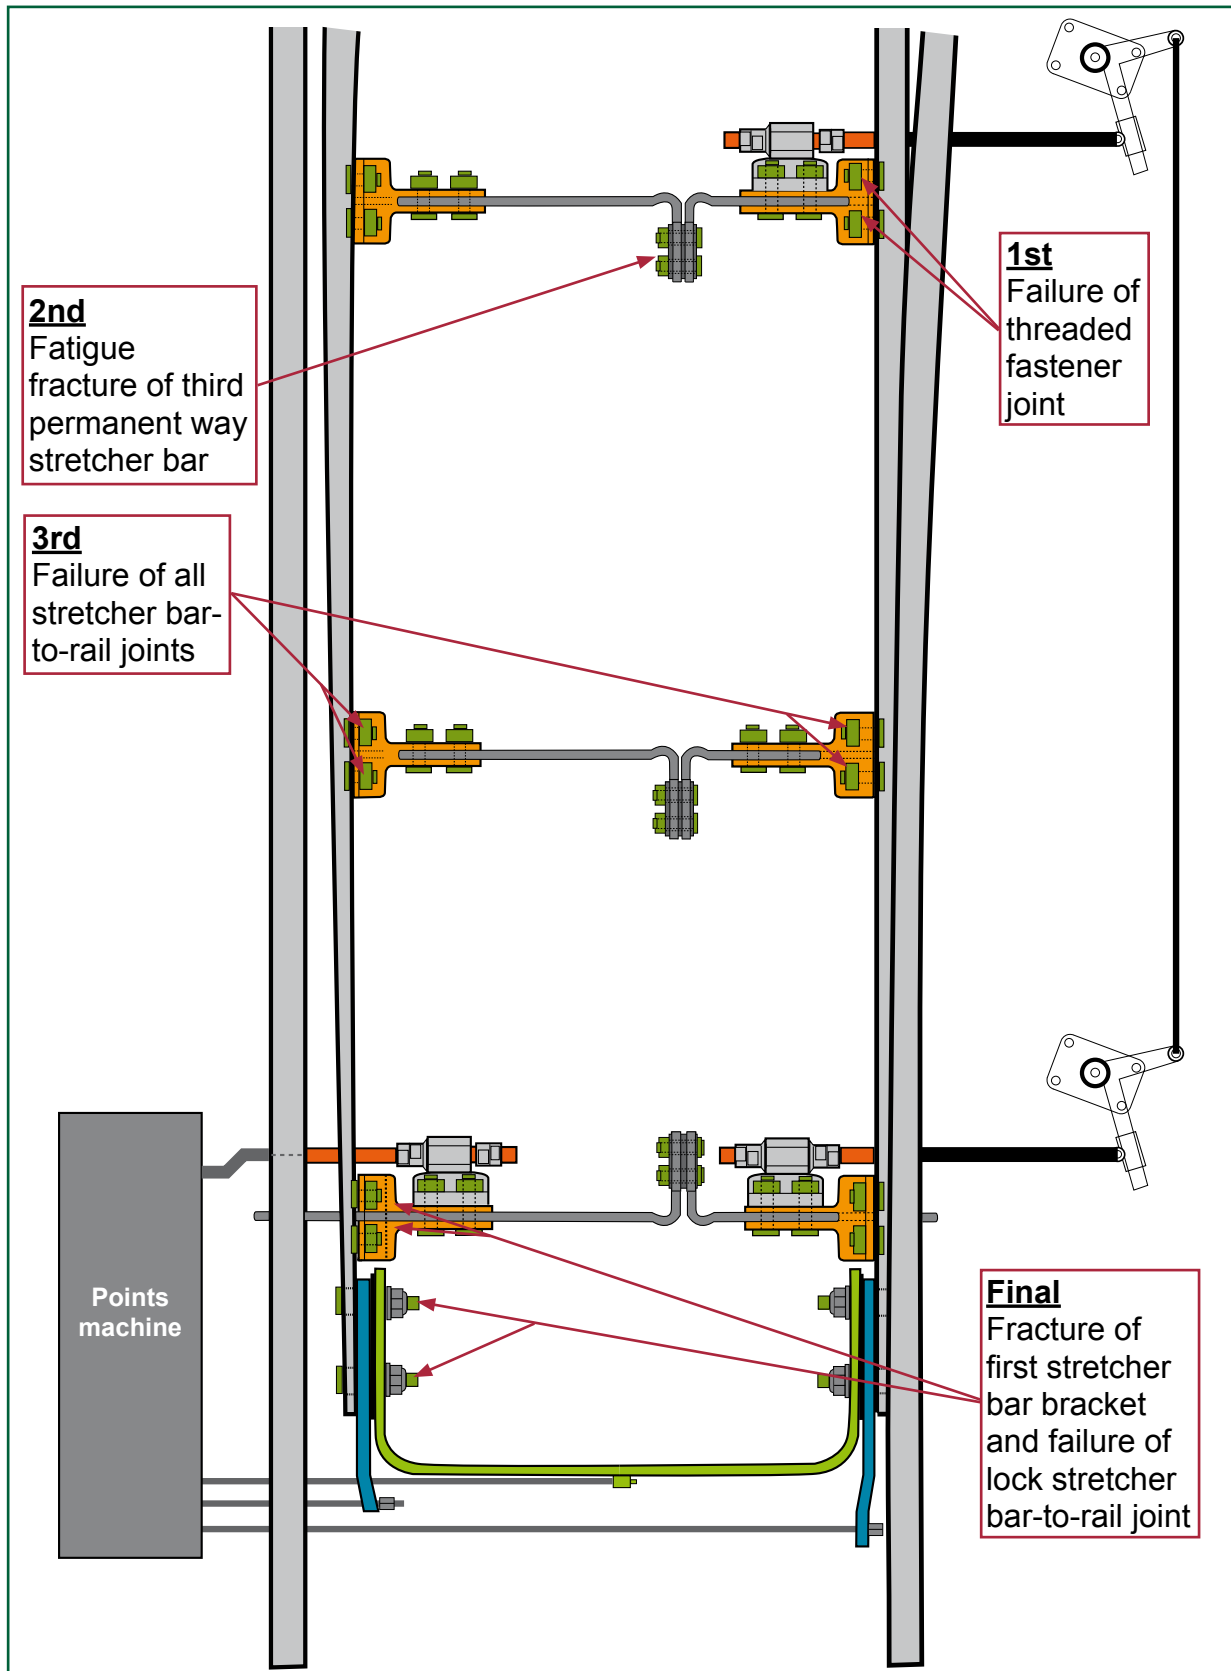
Figure 27: The sequence of failures - schematic diagram of points

- 13 The train derailed as it passed over 2B points which were in an unsafe state. A combination of failures of *stretcher bars* and their joint to the *switch rails* allowed the left-hand switch rail to move, under its natural flexure, towards the left-hand *stock rail*. The left-hand wheels of either the first or second *bogie* on the leading vehicle (it is not clear which) passed the wrong side of the left-hand switch rail and were forced into the reducing width between the switch rails. The wheels then derailed by climbing over the rails. All the other vehicles of the train derailed as a consequence. Figures 3 and 4 show the key details of the points.

- 15 The bolts holding the third permanent way stretcher bar to the right-hand switch rail became loose, and subsequently completely undone. As a result of this, and the excessive residual *switch opening*, the left-hand switch rail was struck by the inner faces of passing train wheels, giving rise to large cyclic forces. As a consequence, rapid deterioration of the condition of the remaining stretcher bars and their *fasteners* occurred. This led to the left-hand switch rail becoming totally unrestrained.

135 This section describes the probable sequence of failures within 2B points, as summarised in Figure 27, and their possible causes.

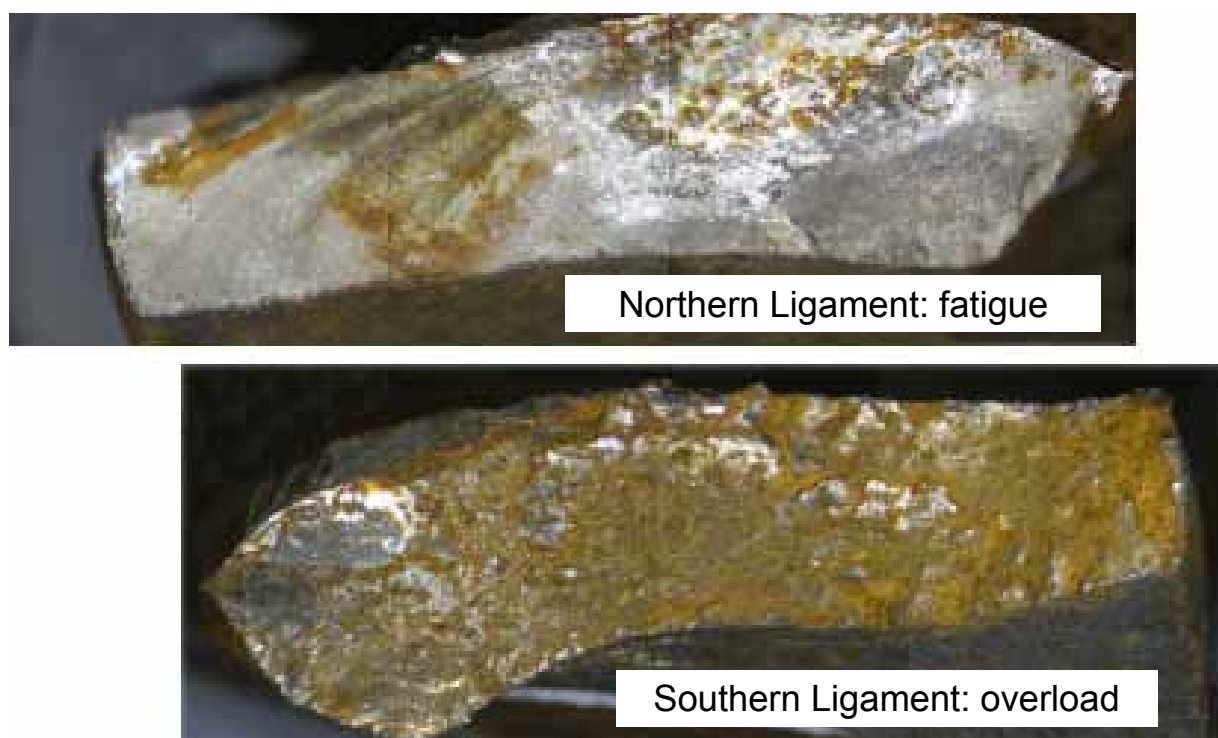
- 160 Testing in the laboratory demonstrated that the forces in the remaining stretcher bars increase following the loss of the third permanent way stretcher bar. Testing on the network and in the laboratory indicated that greater flange-back contact resulted in an increase in forces experienced by the remaining stretcher bars. The magnitude of these forces was sufficient to overcome the clamping force on both rail bracket joints on the second permanent way stretcher bar. The failure of these joints resulted in a further increase in flange-back contact to a level of up to 37 mm for a residual switch opening of 8 mm. This led to the failure of the left-hand joints of the lock and first permanent way stretcher bars. While the left-hand switch rail continued to be struck, the left-hand switch rail bracket of the first permanent way stretcher bar failed at both of the ligaments where it joins the stretcher bar itself. The northerly fracture was by fatigue and the southerly by *brittle overload* (Figure 29). The RAIB has not been able to determine the order in which the final failures occurred.

Figure 29: Fatigue and mechanical failure surfaces in ligaments of first stretcher bar bracket
