Rail Accident Investigation Branch

Rail Accident Report

Derailed at Grayrigg 23 February 2007

Derailment at Grayrigg, 23 February 2007

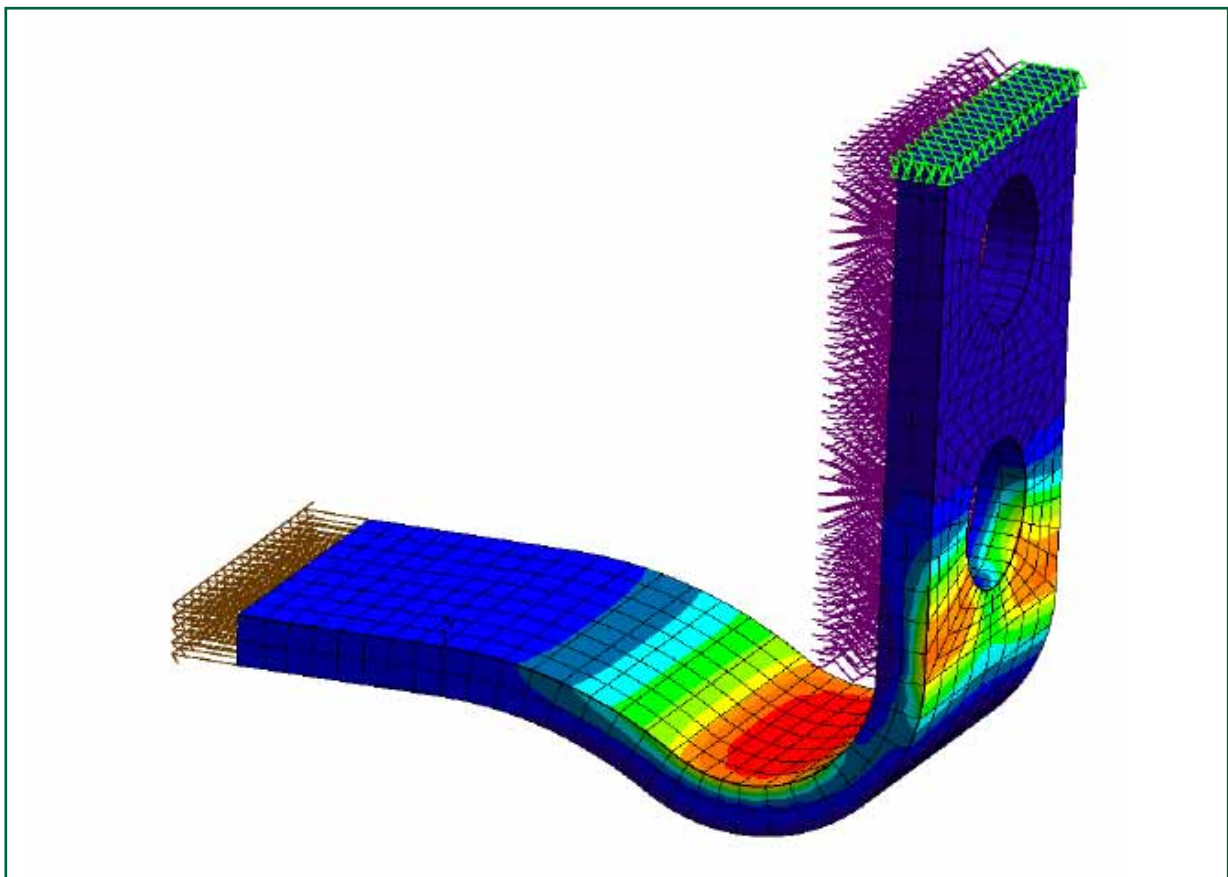
168 Separate computer modelling, commissioned both by Network Rail (paragraph 156), and by the RAIB, has shown that stretcher bars on correctly set points have a long, but finite, life when subjected to normal service forces (in the order of tens of years). The modelling has shown that even without flange-back contact there is a relationship between increased residual switch opening and a reduction in fatigue life to a value in the order of years, as increasing the opening leads to increased movement of the stretcher bar under traffic. The predicted areas of highest stress (Figure 30) include around the bolt hole, where the fractures in the third stretcher bar at 2B points occurred. Network Rail records indicate that 60 to 70 stretcher bars are replaced per month across all territories; some of these are repeat replacements.

Figure 30: Stress contour plot of swan neck assembly

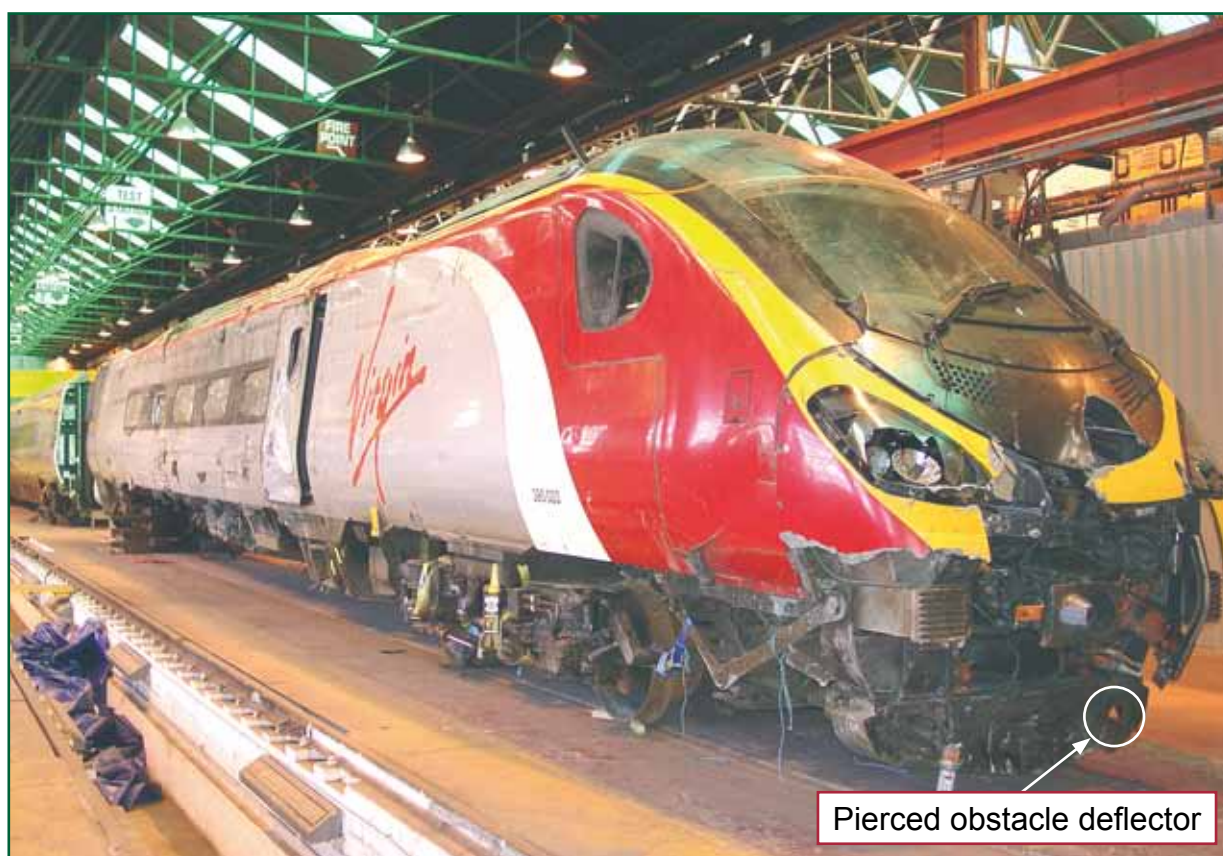
548 As a consequence of the derailment, vehicle one suffered damage to the leading and trailing ends and the right-hand body side, which was buckled and severely scored (Figure 37). The floor was distorted and underframe-mounted equipment was severely damaged. There were concentrated impact damage marks at the two positions along the right-hand cantrail where it had struck overhead line equipment masts (paragraphs 543 and 544) but there was no loss of survival space or penetration through the body structure. Damage to the left-hand side was confined to the leading door and underframe equipment.

Figure 37: Damage to the right-hand bodyside of vehicle one and obstacle deflector

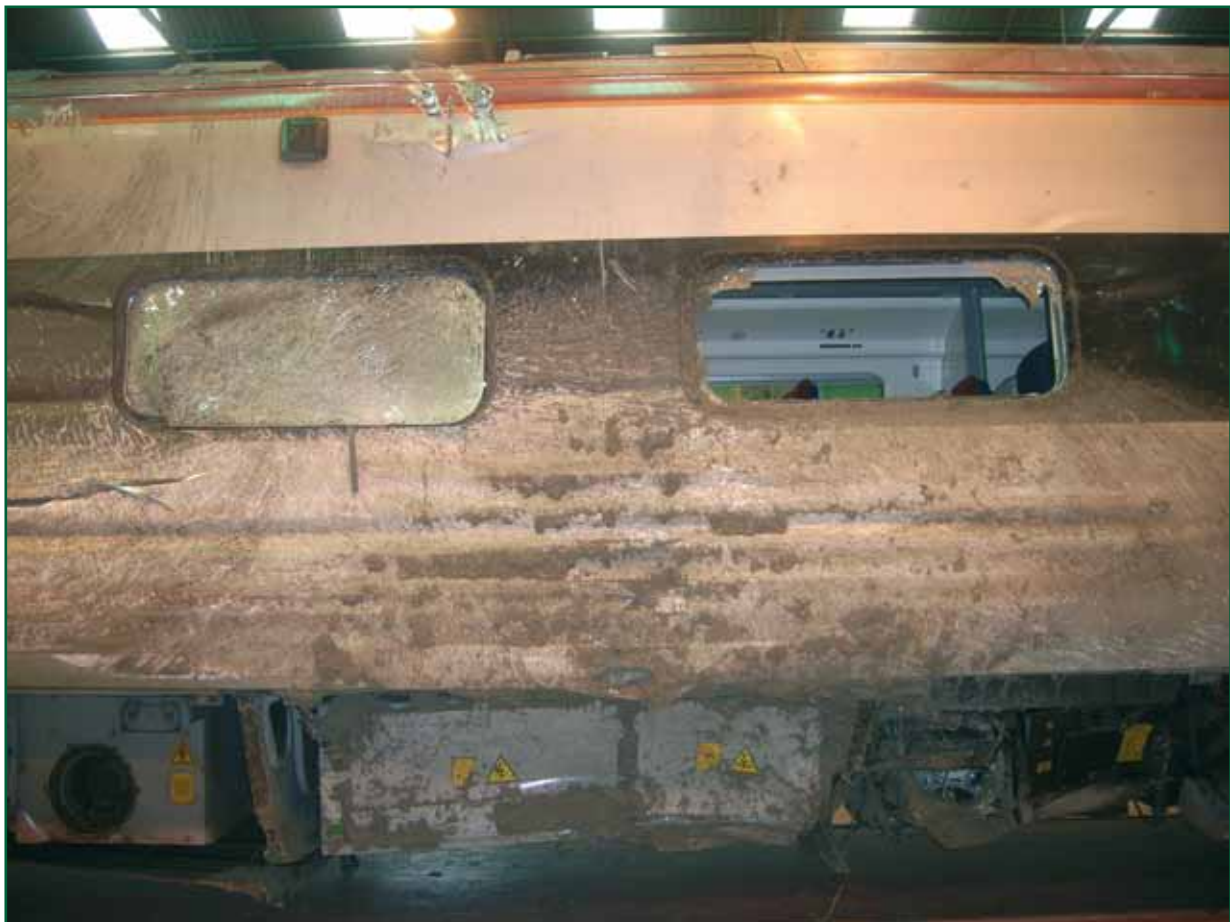
550 Vehicle two sustained damage to both leading and trailing ends, particularly at the left-hand corner of the trailing end which had been pushed in by approximately 320 mm. This localised damage probably occurred when it slid down the embankment on its side, at the end of its travel, and hit the ground before it came to rest. The left-hand side was severely scored by sliding on ballast and had been pushed in by approximately 160 mm at the central section (Figure 38). The right-hand body side was scarcely damaged. Three of the four external doors were jammed in the closed position but this did not hamper evacuation as explained at paragraph 565. Both bogies were damaged but remained attached to the body. The coupler attaching vehicle two to vehicle three had parted at its central connection.

Figure 38: Damaged central section of the left-hand bodyside of vehicle two

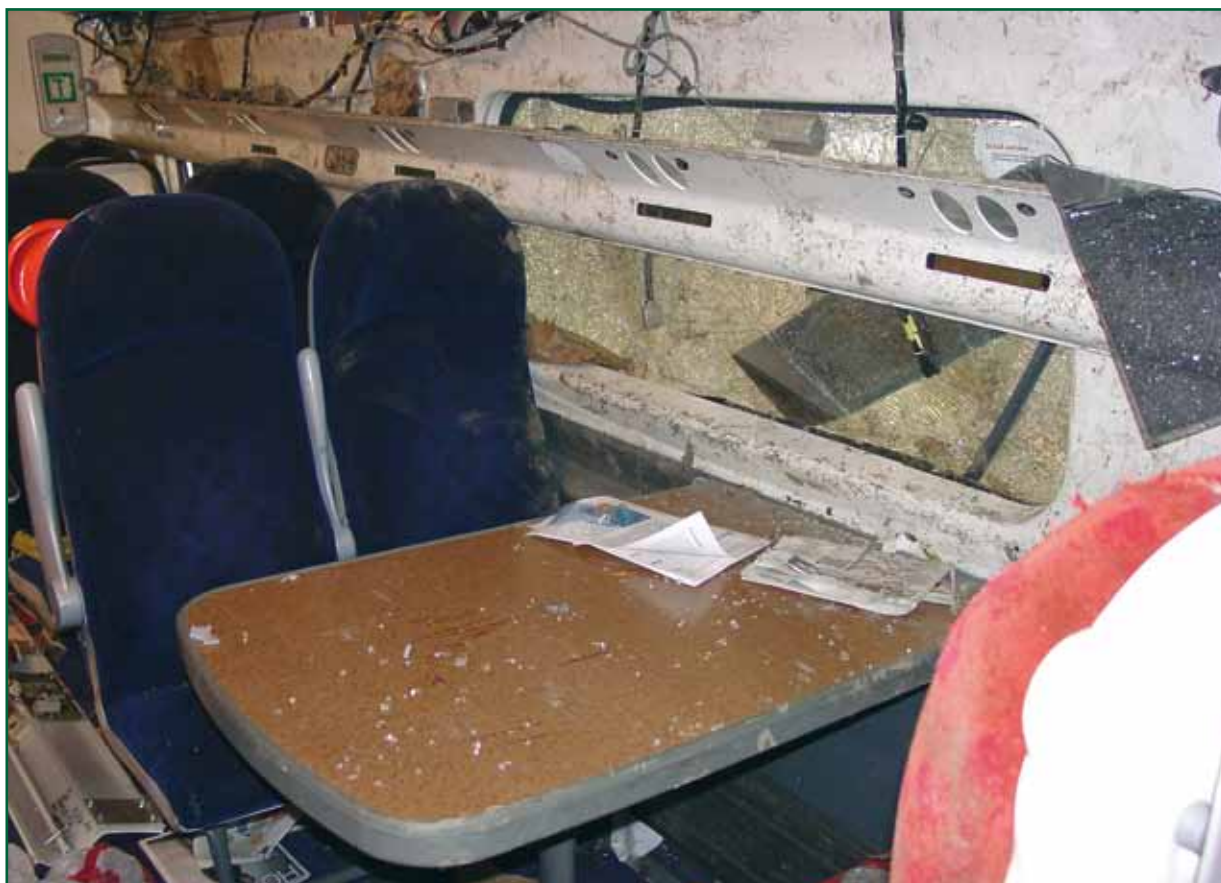
553 The interior of the passenger compartment in vehicle one remained largely intact except for the detachment of all six reading light panels from their mountings. The retaining locks, which secure the outboard edges of the panels to the interior of the bodyside, had distorted and allowed the panels to swing down on hinges mounted on the luggage racks. Five panels detached completely (Figure 39); the sixth remained attached by its hinges.

Figure 39: Detached reading light panels in the leading right-hand side of vehicle one

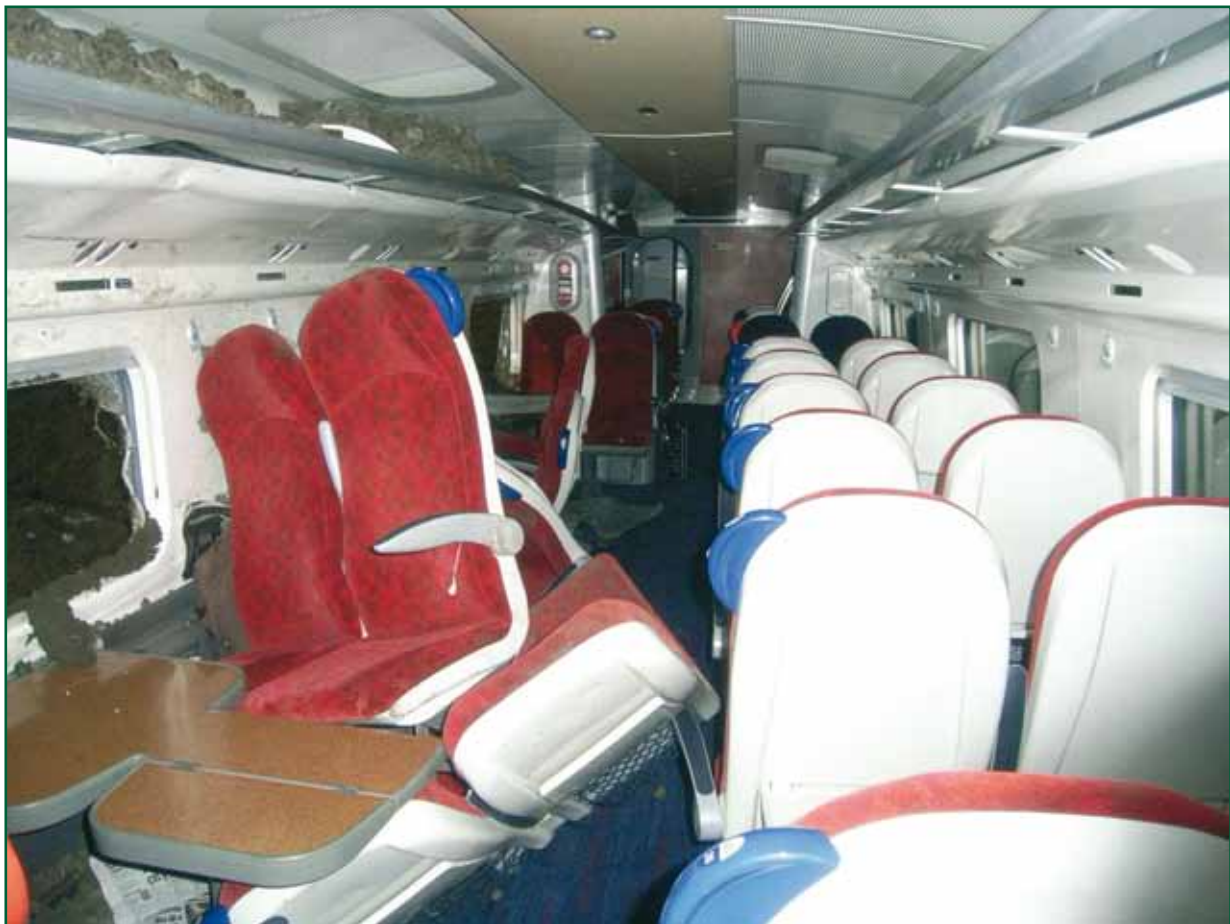
Figure 40: Detached seating on the left-hand side of vehicle two

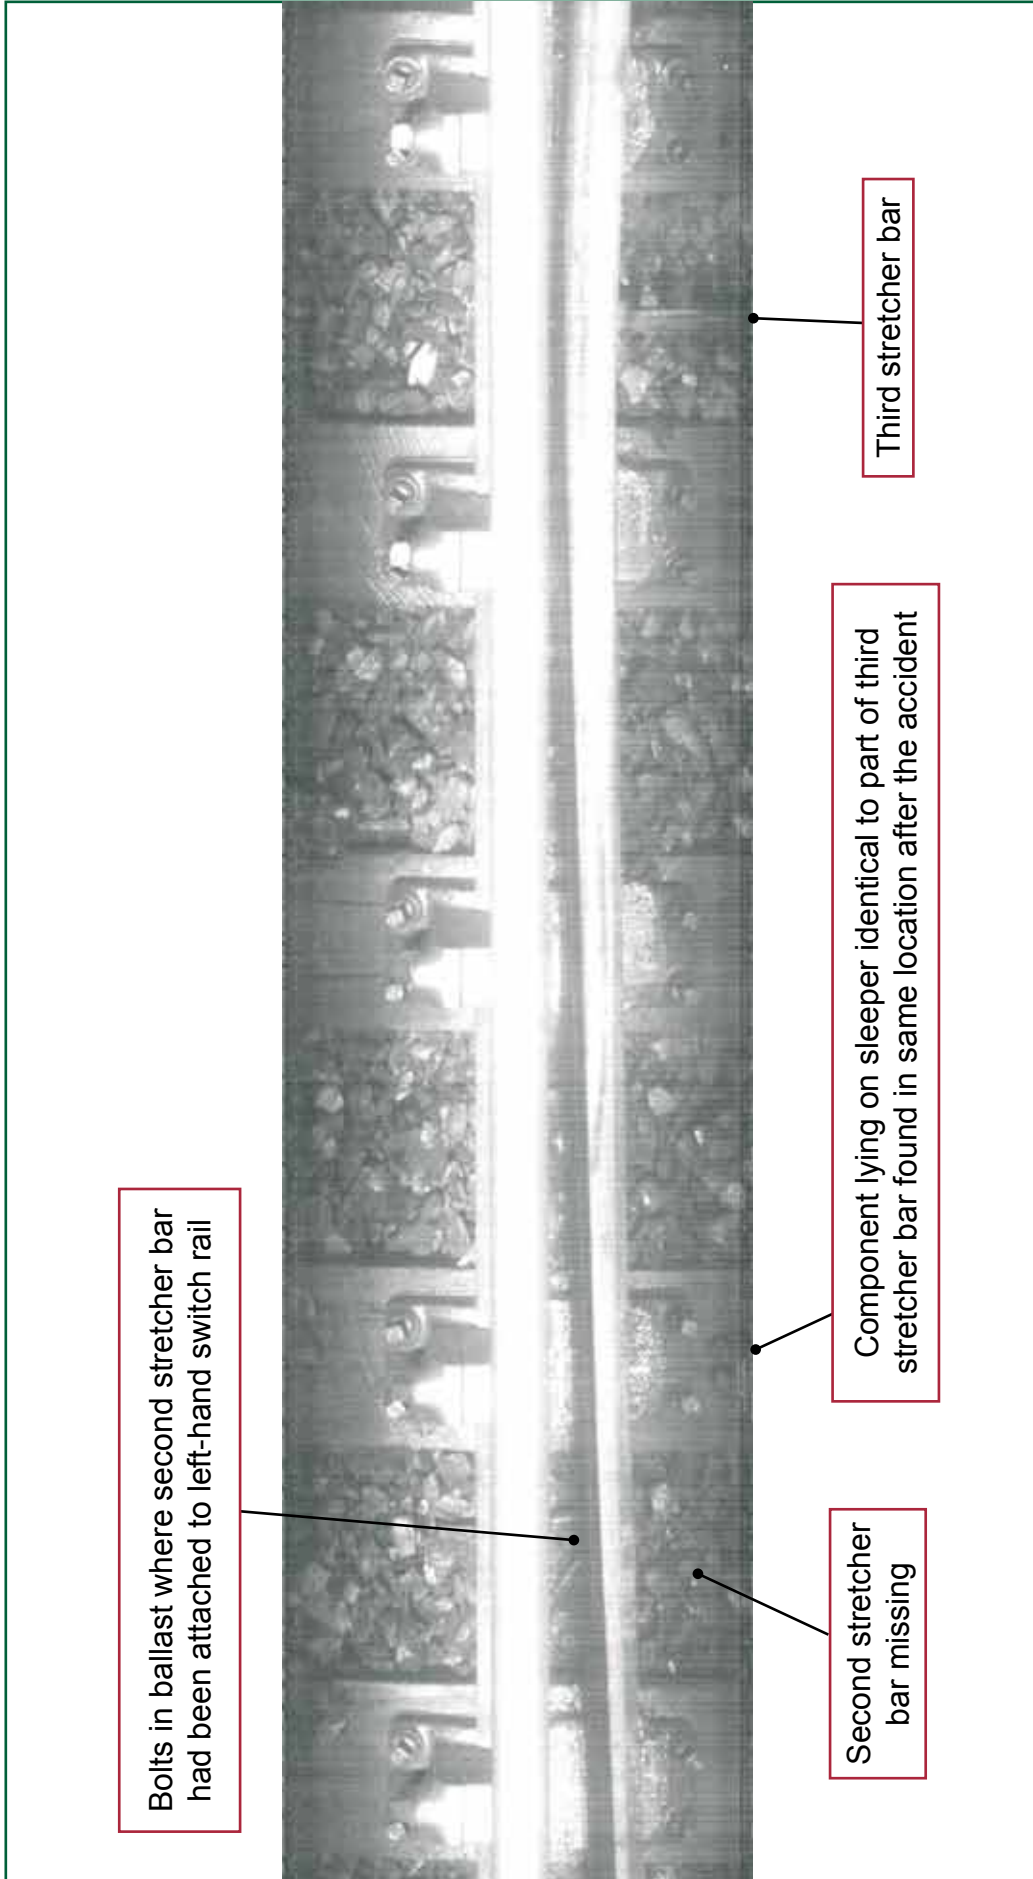
21 February 2007	Images from New Measurement Train showed 2nd Permanent way stretcher bar joints were missing - severe flange back contact.
between 21 February 2007 and 23 February 2007	Failure of 1st Permanent way stretcher bar and lock stretcher bar.
23 February 2007	Derailment.

Figure 49: Cybermétéx IVOIRE III image from NMT run on 21 February, showing part of left-hand switch rail
