Rail Accident Investigation Branch

# Rail Accident Report

**Train overspeeding through an emergency speed restriction at Ty Mawr Farm Crossing on 29 August 2007**

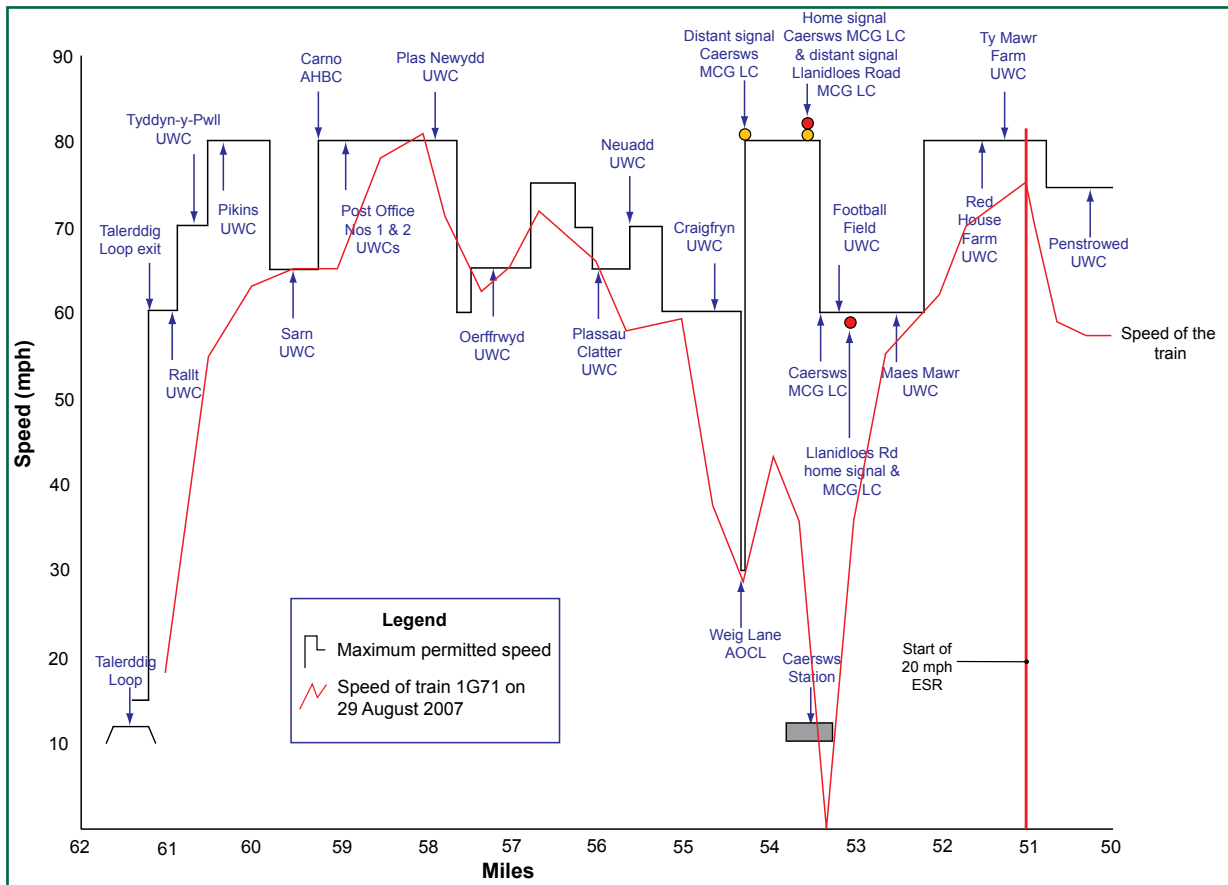
Figure 2: Variations in maximum permitted speed, location of level crossings and signals between Talerddig and Ty Mawr and speed of train 1G71 on 29 August 2007

67 The working timetable allows eight minutes for a train to run from Talerddig to Caersws (start to stop). Train 1G71 exceeded the sectional running time by approximately two minutes. Figure 2 shows the location of the speed restrictions over this section of route, the locations of level crossings and signals and the speed achieved by train 1G71 through this section on 29 August 2007.

- 90 The section of route between Talerddig and Caersws was modelled using the route driveability tool. One feature that is highlighted by the tool is the number of speed changes. Although this did not necessarily create conflicts for the driver (i.e. there were few examples of overload through simultaneous driver inputs and actions), the Network Rail human factors specialist observed that it did add a level of complexity to the driving task that increases the potential for the driver to forget other items of information.

- b. The characteristics of the route between Talerddig and Caersws in terms of the numbers of level crossings and frequent changes in permanent speed restrictions together with the working timetable allowance of eight minutes for the section (paragraph 91, Recommendation 3).

- 3 Network Rail should review the range of speed restrictions and the timings for trains between Talerddig and Caersws to determine whether rationalisation of the number of such restrictions and/or relaxation of timings could enhance the driveability of the route and reduce the potential for distraction and misunderstanding by train drivers under degraded operating conditions (paragraph 122b).
