Rail Accident Investigation Branch

Rail Accident Report

Network Rail's Management of Existing Earthworks

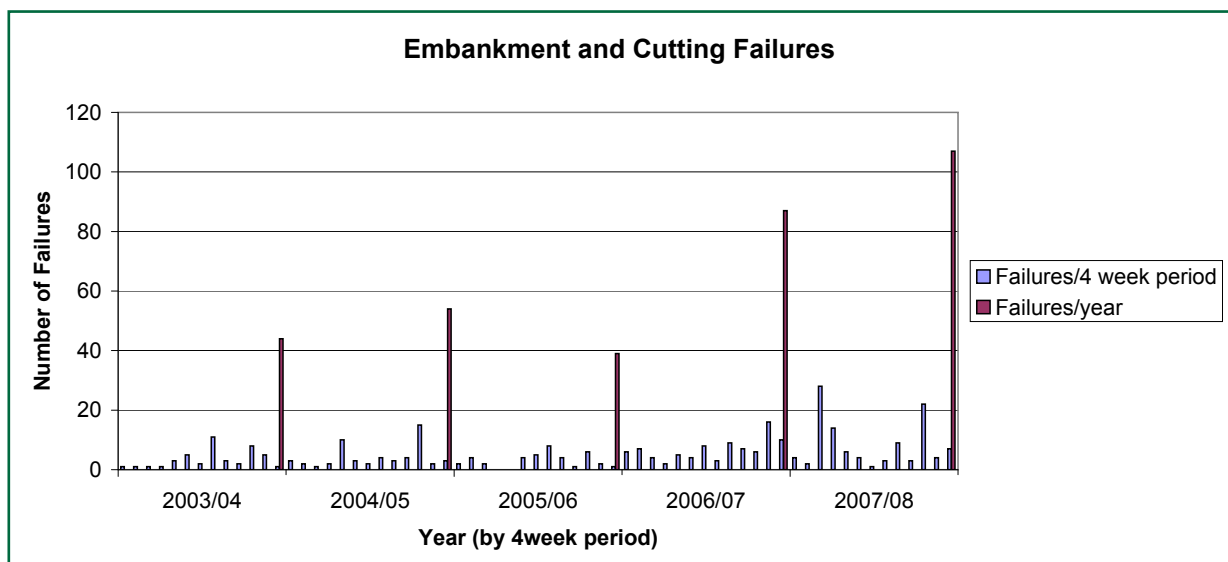
Figure 2: 2003 to 2008 Network Rail recorded earthworks failures

58 In the period covered by this data, train derailments attributed to earthwork failure were:

- 1 in 2003/4 – rock fall;
- 1 in 2004/5 – embankment slip;
- 2 in 2005/6 – 1 cutting slip and 1 cutting *washout*;
- 3 in 2006/7 – 1 cutting washout and 2 cutting slips; and
- 0 in 2007/8.

- 67 Earthworks failure data has only been collated in its current form since 2003, and witness evidence suggests that during that period the quality of reporting has improved. Whilst the limited data available indicates a slight increasing trend in the rate of reported earthworks failures and also in the trend of consequential derailments, the extent of the data does not permit meaningful analysis.
