Rail Accident Investigation Branch

Rail Accident Report

**Near miss involving railway staff and a train
between Bishop's Stortford and Stansted
Mountfitchet, Essex
20 January 2008**

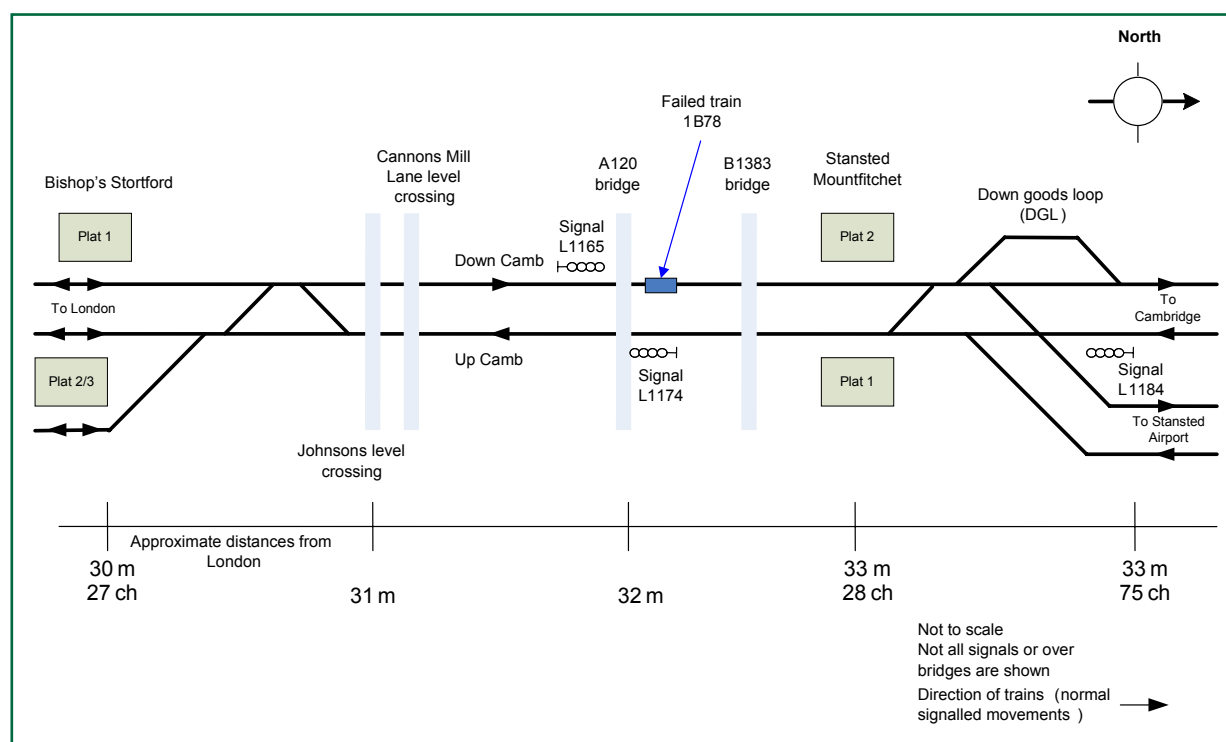
- 14 On 20 January 2008, train 1B78, the 14:25 hrs from London Liverpool Street to Stansted Airport (Figure 1), struck a wooden pallet that had been placed on the line by vandals. A valve on the underside of the train was damaged, and the brakes were automatically applied and could not be released. The train came to a stop about a mile and a half north of Bishop's Stortford station (Figure 2).

Figure 2: Track and signalling layout of area between Bishop's Stortford and Stansted Mountfitchet

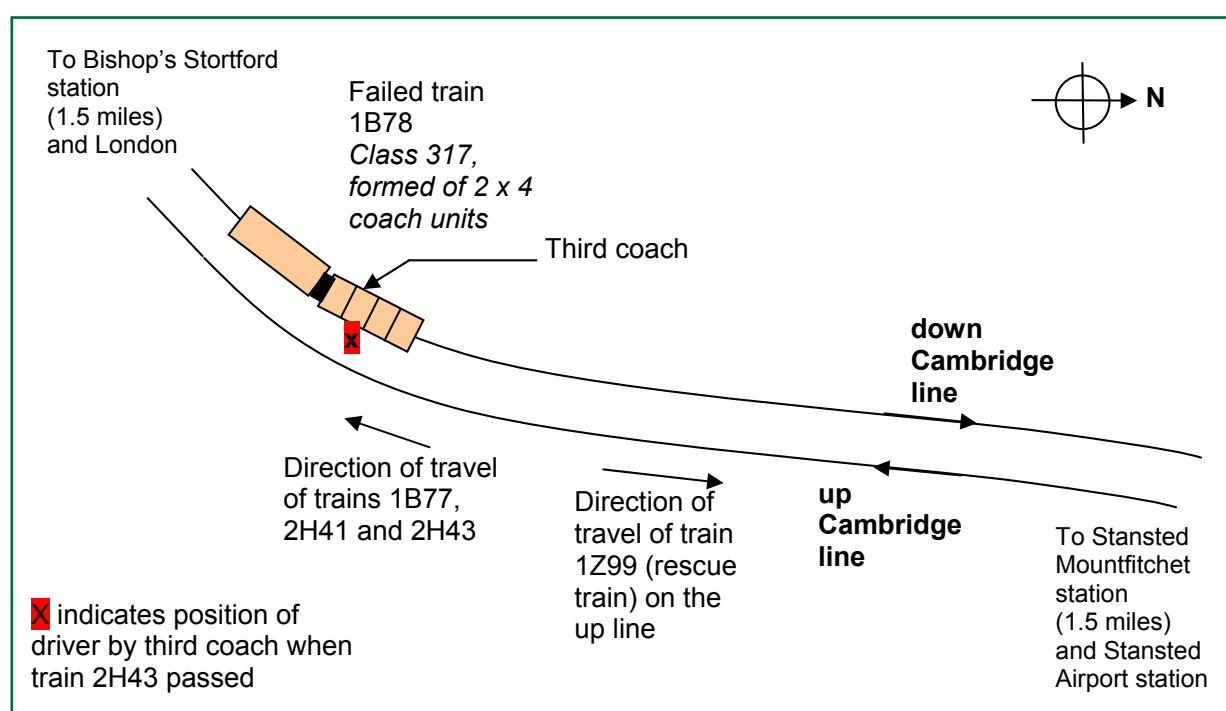
Figure 3: Plan of failed train 1B78 on the down Cambridge line

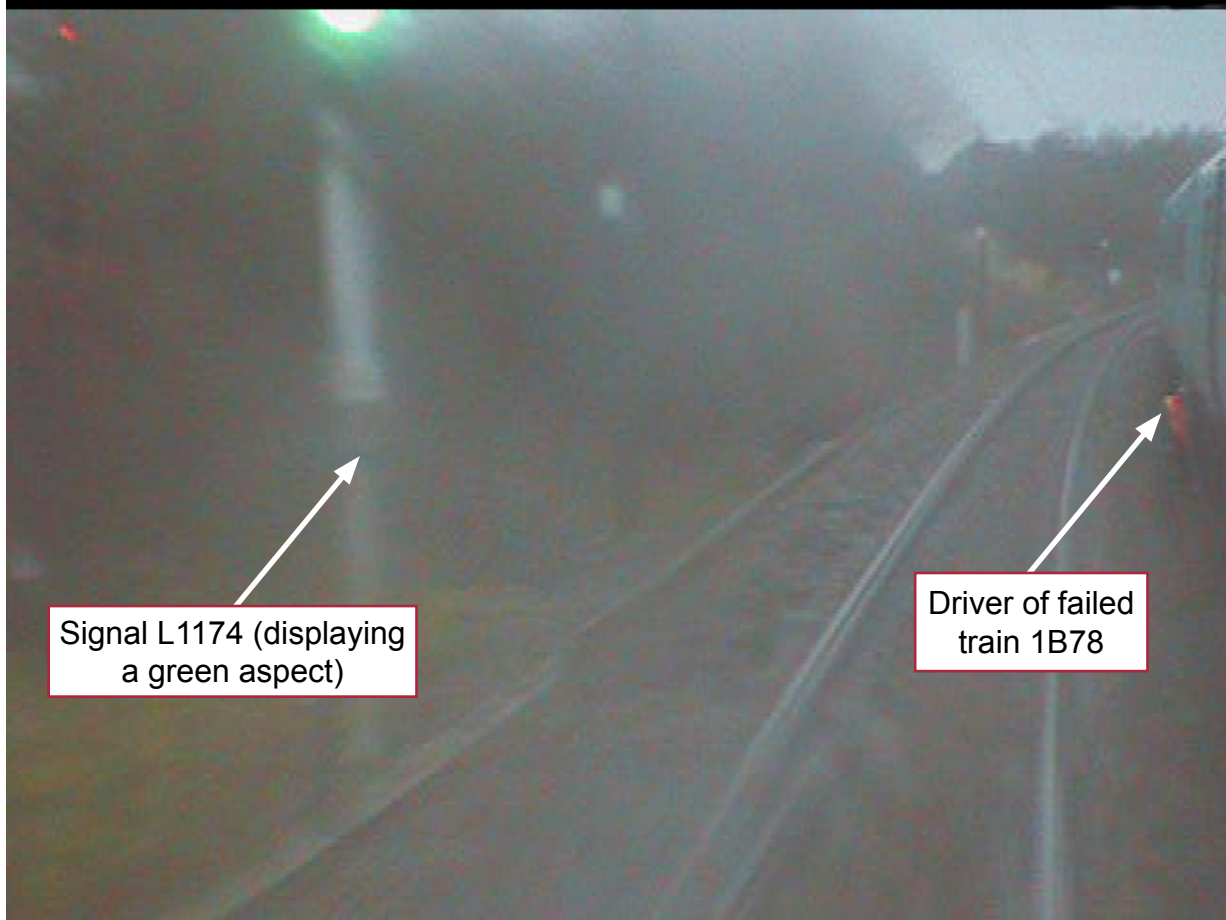
- 43 At 16:20:47, the driver of train 2H43 saw the driver of train 1B78 standing in the six-foot, by the third coach of his failed train, and another person underneath the failed train. Train 2H43 was now travelling at 70 mph (112 km/h). The driver of train 2H43 applied his emergency brake and sounded his horn and the train passed the driver of train 1B78, who lay down on top of the ballast to avoid being struck. See Figure 4.

Figure 4: View from the driving cab of 2H43 at the time of the incident
