# Rail Accident Report

**Fatal accident at Morden Hall Park footpath  
crossing  
13 September 2008**

Report 06/2009  
March 2009

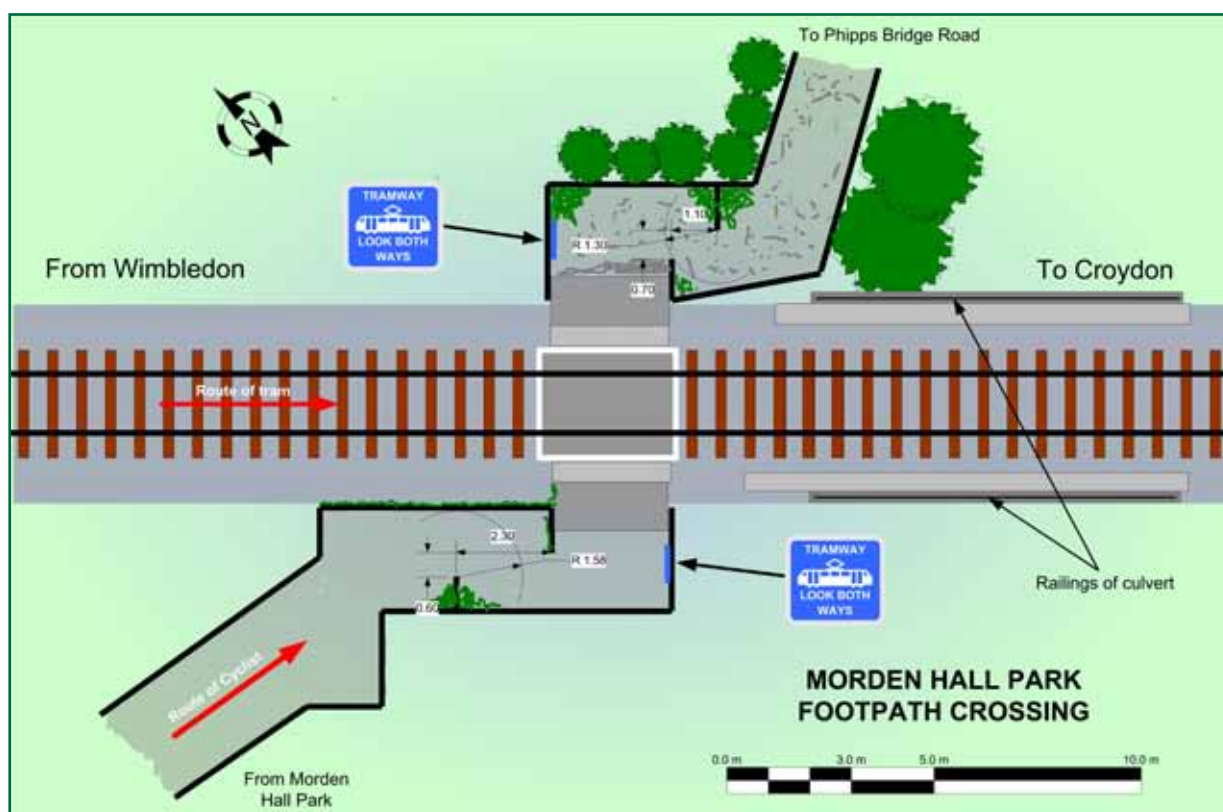
Figure 2: Layout of foot crossing

- 18 The crossing is approached through *chicanes* on both sides, constructed of wooden post and rail fencing about 1.25 m high. The chicanes on each side have quite different dimensions, but a common factor is that the barriers which form the chicanes do not overlap, but have a clear gap 0.6 m - 0.7 m wide between them, which gives a clear path width of at least 1.3 m through the chicane (Figure 2).

- 52 Mr Sivalingam cycled towards the crossing with his back to the tram. The design of the chicane at the crossing made him slow down, but did not cause him to stop or dismount. After passing through the chicane, he turned left to cross over the track, but he did not complete the turn (so that he was at right angles to the track), until he reached the centre of the track. The design of the chicane and crossing permitted him to approach the tramway without turning to be at right angles to the track, and hence he remained with his back to the approaching tram. If he had turned and seen the tram before moving onto the crossing, he would probably have been able to stop clear of the track.

- ‘Fencing or pedestrian guard rails should be provided where necessary to guide pedestrians to face oncoming trams before they cross the track.’
- 55 The chicanes at Morden Hall Park crossing were not effective in this respect because the distance between the chicane barriers and their orientation at right angles to the track, combined with the very short final approach to the crossing, did not force users, both on foot and on bicycles, to turn fully towards the tramway when passing through the chicane and before turning onto the track. This was a causal factor in the accident.

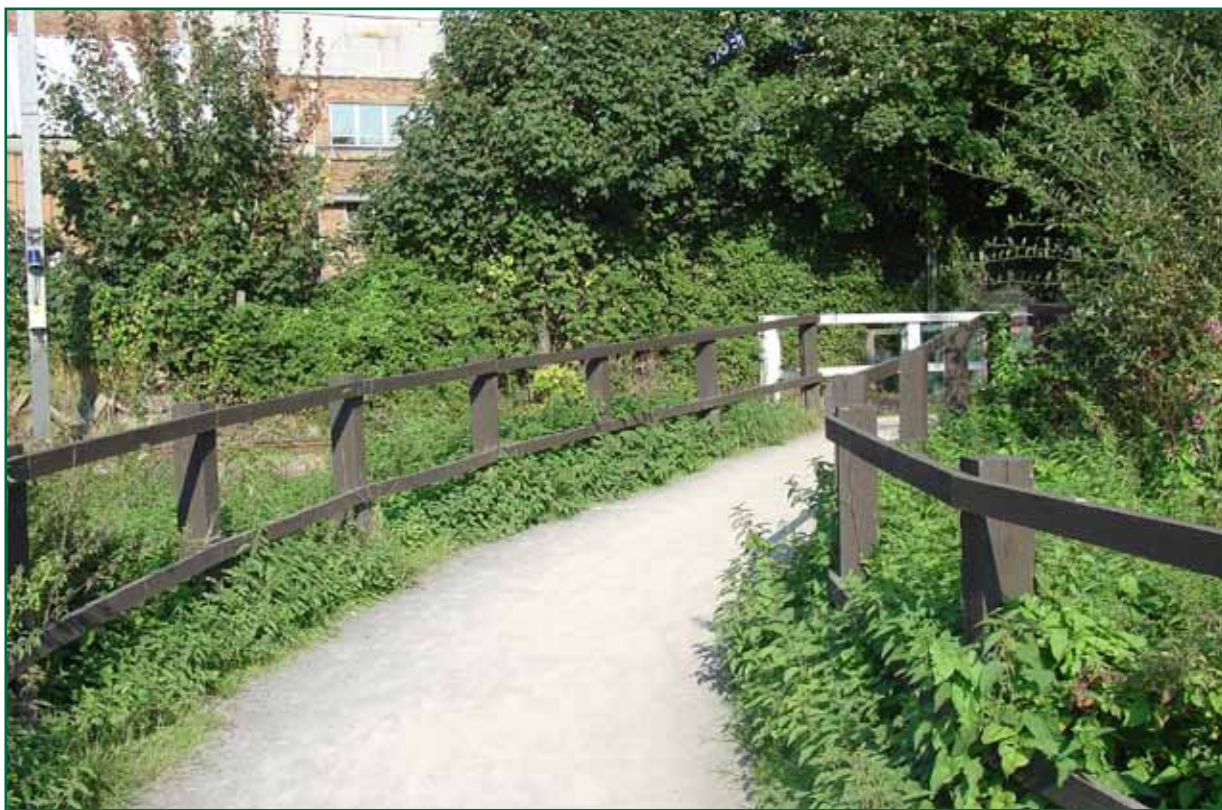
Figure 3: Approach to crossing from south-west

- 19 The approach to the crossing from the south-west is along a fenced, curving path 2.6 m wide (Figure 3). Before 2006, this approach was by a narrower path which ran directly towards the tramway at right angles to the track. In the winter of 2005/06 the layout of the approach paths was altered as part of a project to re-route the Wandle Trail around the edge of the wetlands which are an important feature of the park (Figure 4). The re-routed path curves round to approach the tramway at an angle of about 40°, and then bends sharply to enter the chicane, which is parallel to the tramway. Visibility along the tramway in both directions is unobstructed for several hundred metres in both directions from the point when a potential user reaches the centre of the chicanes (Figures 5 and 6).

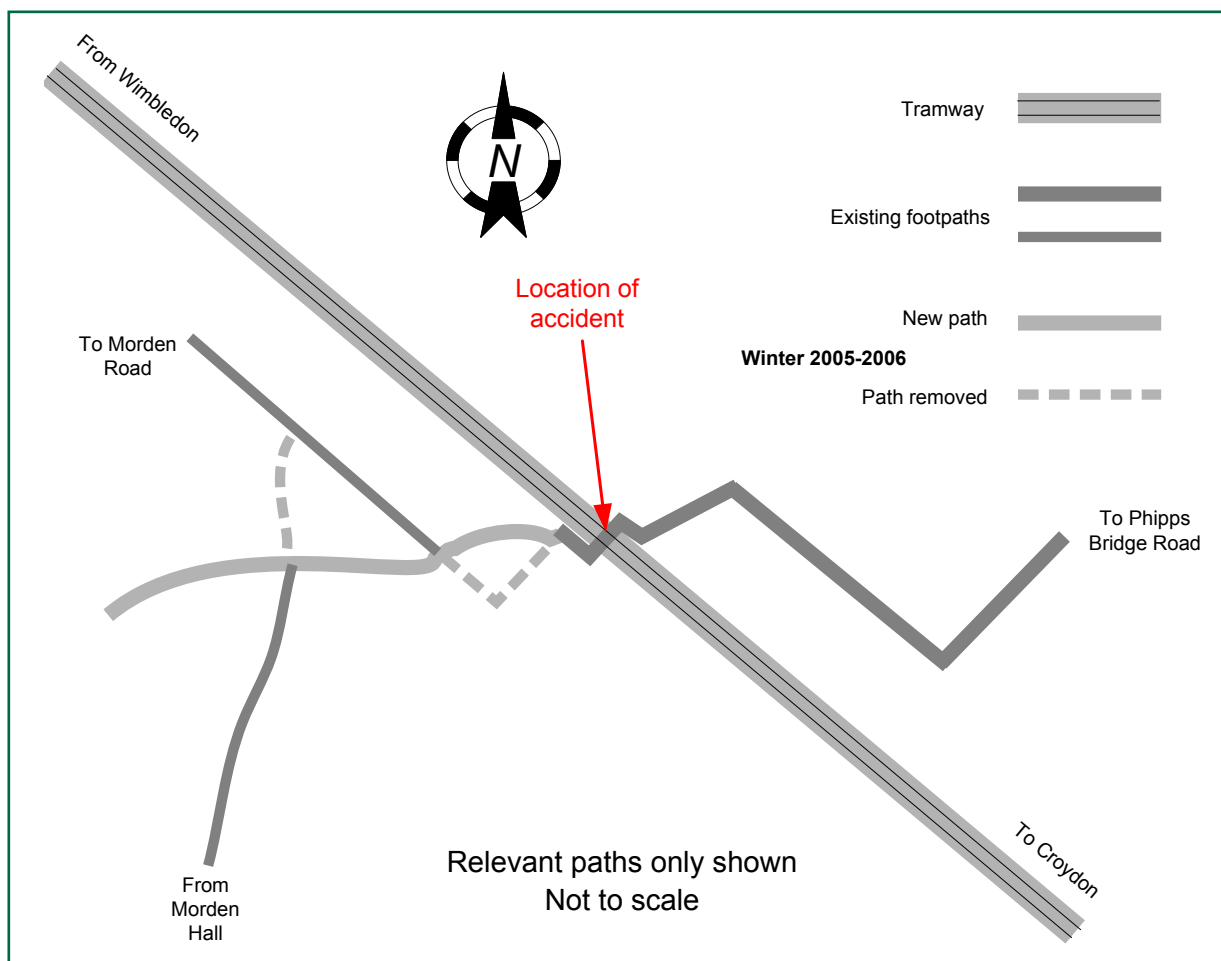
Figure 4: Footpaths near tramway crossing

- 60 The layout of the path on the south-west side of the crossing was altered over the winter of 2005-06 (paragraph 19 and Figure 4). As originally installed, the path approached the crossing at right angles, giving a user the opportunity to look both ways before turning right to pass through the chicane. The revised layout turns the user to the right gradually as they approach the crossing. This means that as they enter the chicane cyclists and pedestrians have their back to trams approaching from the Wimbledon direction, making it less likely that such people will become aware of trams unless they deliberately turn to look.

- 62 There was consultation between SWELTRAC, the National Trust and TCL before the work was done, but there is no evidence that the risk associated with the revised layout was identified by TCL. The change to the layout was a possible contributory factor in the accident.

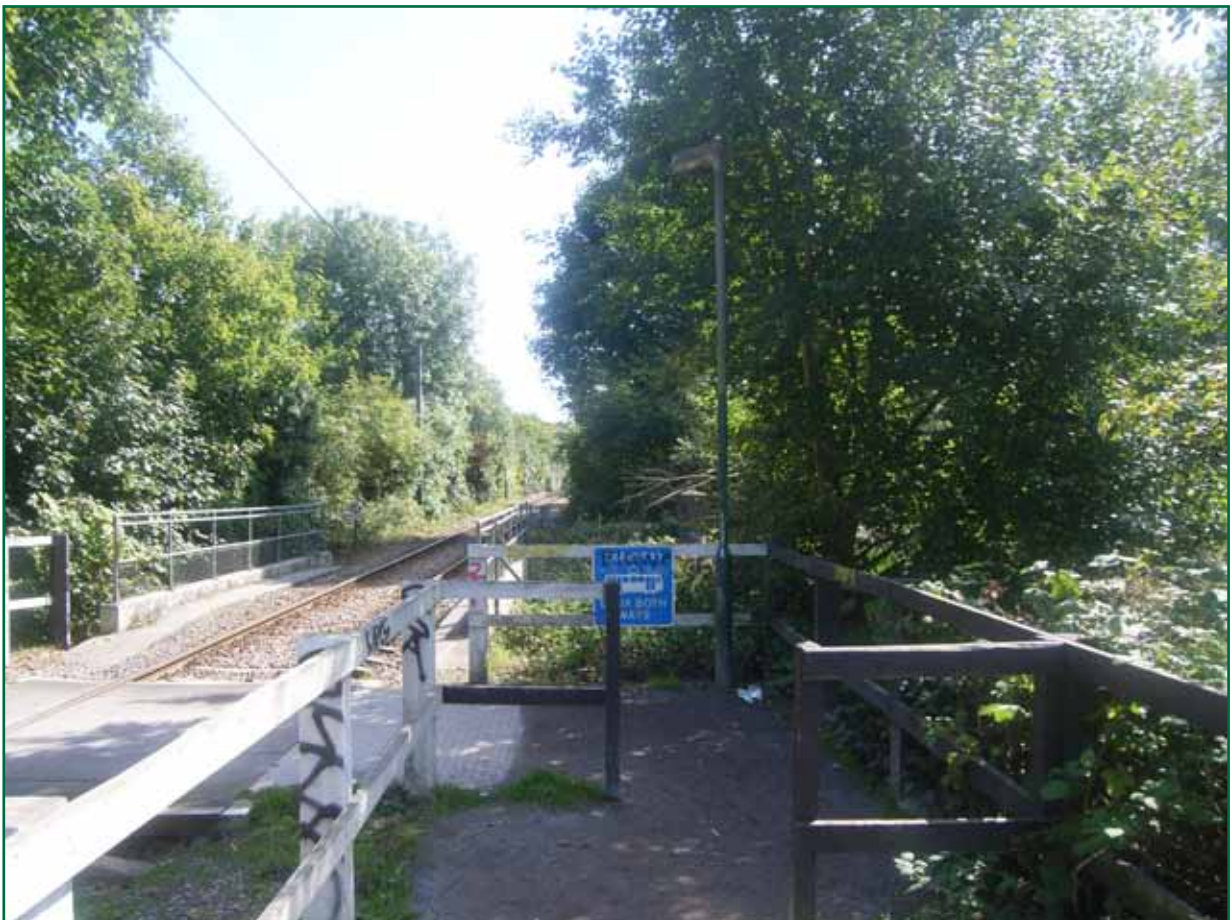
Figure 6: View towards Phipps Bridge, south-east from crossing

- 21 The crossing approaches are equipped with lamps on poles at both sides (one can be seen in Figure 6), but these were not lit at the time of the accident (which occurred during daylight), and, although this was not relevant to the accident, subsequent investigation found that they had not been maintained since installation and were no longer functional (paragraph 67).

- 58 The sign warning of the tramway was slightly obscured by graffiti (Figure 6). Mr Sivalingam was a local resident who is known to have been familiar with the crossing, and the condition of the sign and its position (paragraph 20) are not considered to have contributed to the accident.

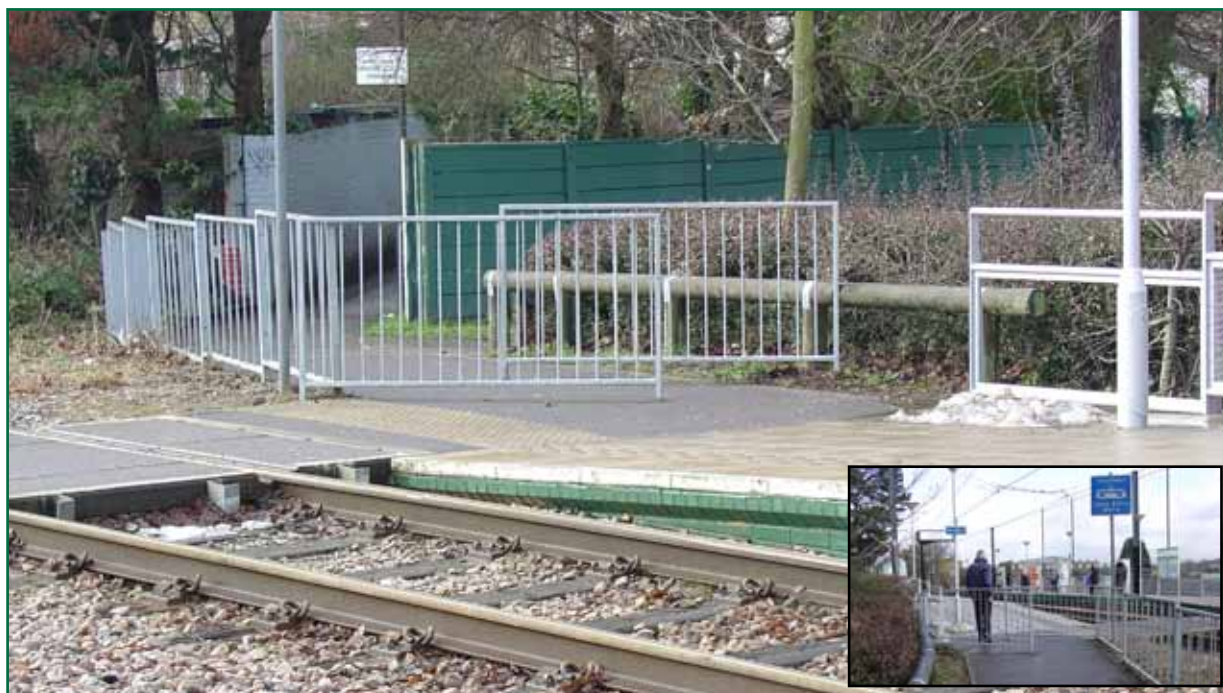
Figure 7: Chicane installed at Arena tram stop

- 70 An accident occurred at Arena tram stop on 23 August 2007 in which a pedestrian was struck by a tram. The pedestrian had run towards the tram stop along a path almost parallel to the tramway, and was concentrating on a westbound tram which he could see approaching and which he wished to catch. He did not notice an eastbound tram which was approaching from behind him, crossed the line just in front of it, and was struck and became trapped under the tram, but suffered only minor injuries.
- 71 Following this accident, additional fences were installed to form a chicane in the approach path at Arena (Figure 7). The design of these forces pedestrians and cyclists approaching along the path, who wish to cross the line, to turn to the right as they move onto the crossing. This makes it more likely that they will notice a tram coming from their right.

- 72 If the risks at other crossings on the network (including Morden Hall Park) had been considered at the time the chicane was introduced at Arena, and appropriate action taken, the risk of an accident might have been reduced. However, given the absence of any previous accidents at this location, it is possible that an assessment of this crossing would not have given a high priority to changes to the design of the chicane. The absence of an adequate risk assessment for the use of footpath crossings was a contributory factor in the accident.

- 74 These considerations mean that chicane barriers with the dimensions of those at Arena are unlikely to be suitable for use on the designated cycle track at Morden Hall Park. However, a design along similar lines, which would have the effect of turning a cyclist to face towards Wimbledon during their approach, might reduce the risk at this crossing.
