Rail Accident Investigation Branch

Rail Accident Report

**Derailment of a freight train near Moor Street
station, Birmingham
25 March 2008**

Report 07/2009
March 2009

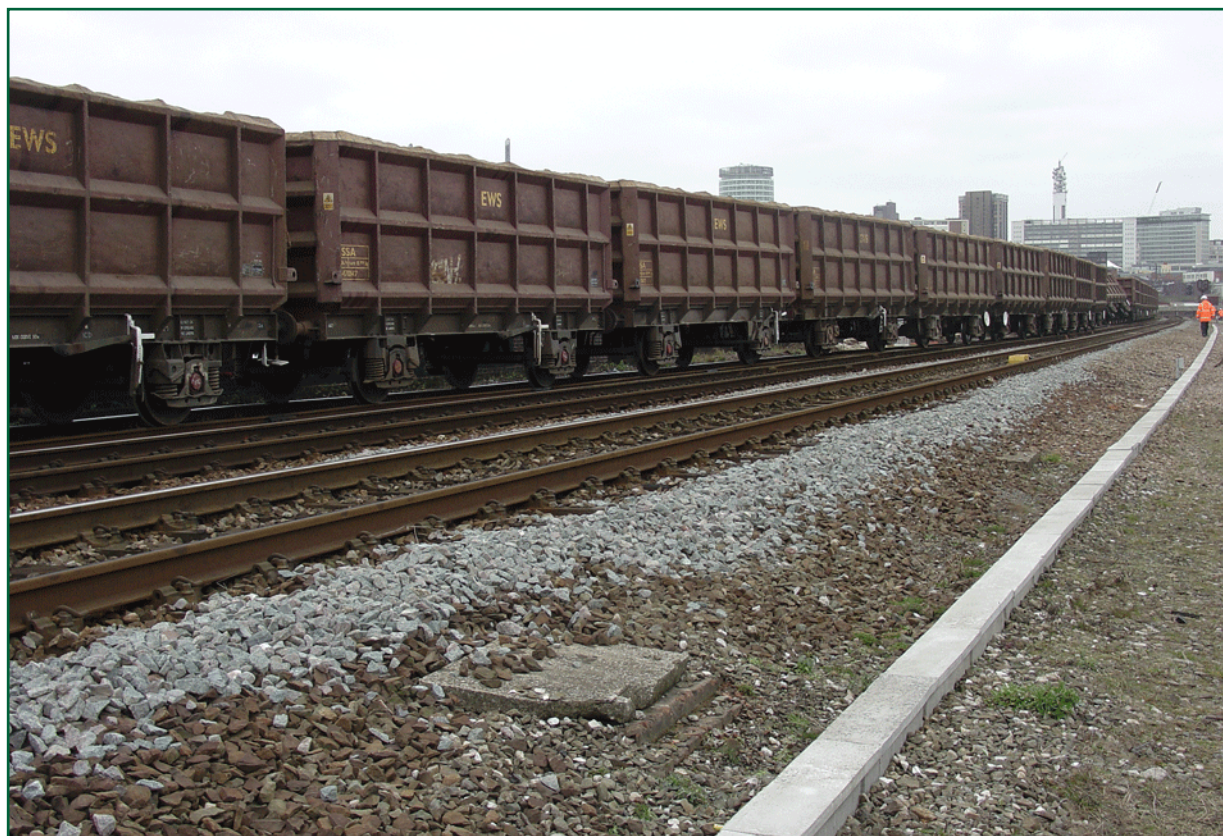
Figure 3: The incident site of the derailed wagons

- 9 There was significant damage to 677 points and some damage to 678B points, the operating equipment and *sleepers*, *baseplates* and *timbers* along the route of derailed running. A section of the adjacent viaduct *parapet* was demolished.
- 10 The 16th wagon suffered significant damage to its leading left-hand suspension assembly; the three other derailed wagons suffered less severe damage.
- 11 Rail traffic was initially stopped on all lines. The up Snow Hill line was released for *single line working* at 07:57 hrs. Repairs to the points equipment and track components were completed and normal operations recommenced on the down Snow Hill line and up Snow Hill line at 01:55 hrs on 26 March 2008.

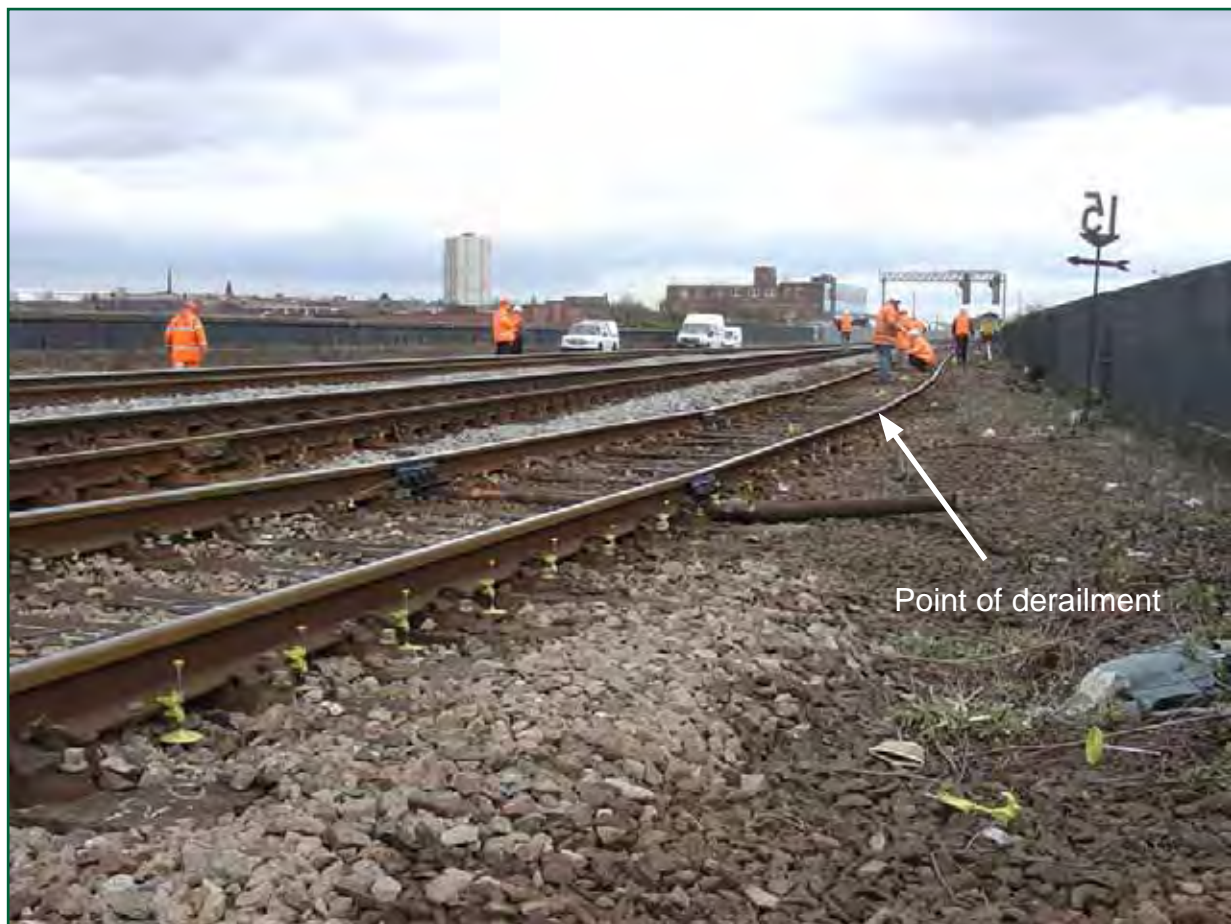
Figure 6: Track at the point of derailment

- 16 The initial *point of derailment* (POD) was identified as being on plain line 24 metres before the *crossing* of 677 points on the up and down goods line at approximately 128 miles 32 *chains*.

Investigation process and sources of evidence

- 84 The 3 metre dynamic track twist at the point of derailment was 40 mm (1 in 74). This is more severe than the immediate action limit to close the line of a 1 in 90 twist (paragraph 71). The 3 metre static track twist at the point of derailment was 25 mm (1 in 120). This geometry defect is more severe than the 1 in 125 threshold set in NR/SP/TRK/001 and requires attention within 36 hours of discovery (paragraph 72). The point of derailment also occurred at the start of a short right-hand curve, which would have increased the probability of contact with the left leading wheel flange. That the track geometry was non-compliant, and was not detected and remedied are causal factors.

107 The geometry defects at the point of derailment have been corrected.

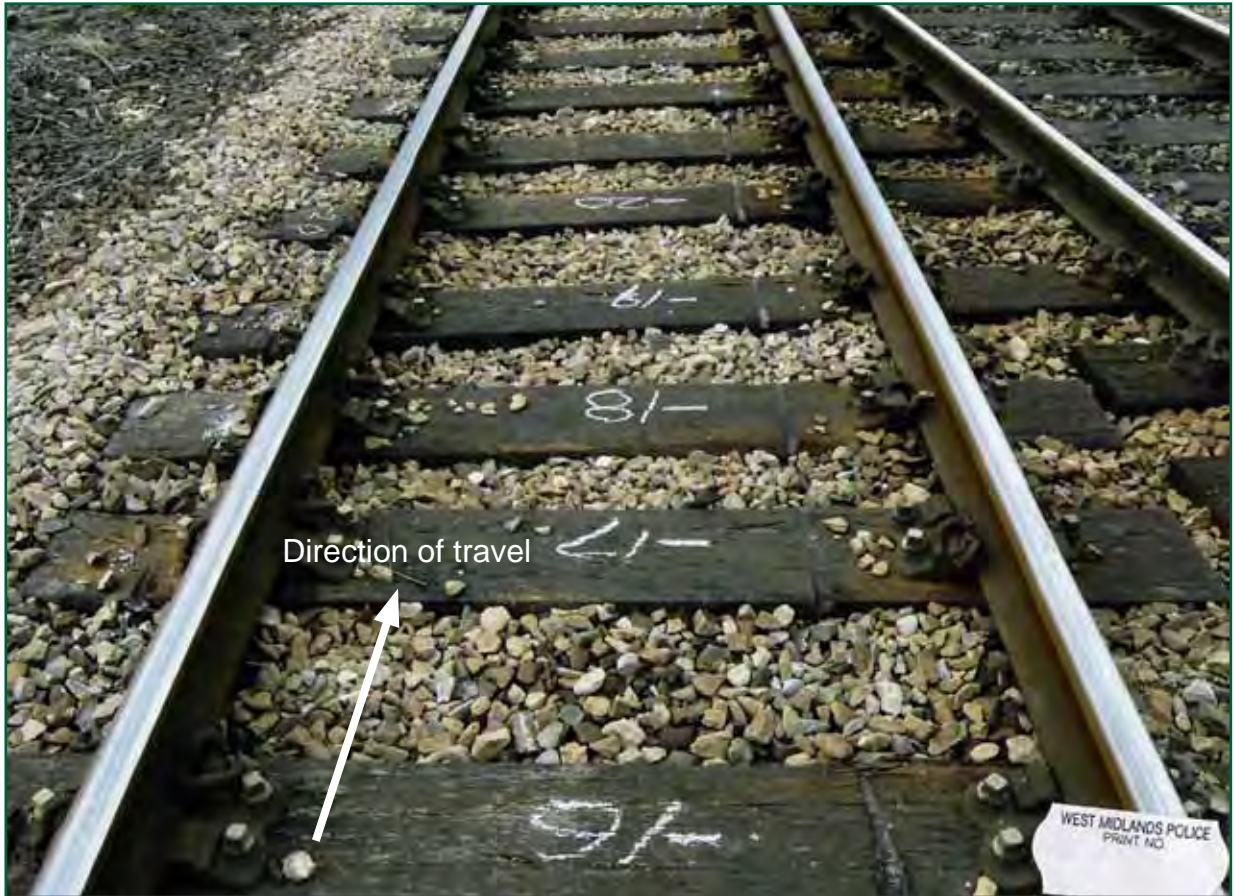
Figure 7: Damage marks (photograph courtesy of West Midlands Police)

- 30 Twenty four metres before the crossing of 677 points the left leading wheel of the 16th wagon, 470152, climbed onto the head of the left-hand rail. The wheel flange rode along the rail head for 3 metres before dropping outside the rail. Shortly afterwards the corresponding right leading wheel dropped inside the right-hand rail. Damage marks as a consequence of the derailment are shown in Figure 7.

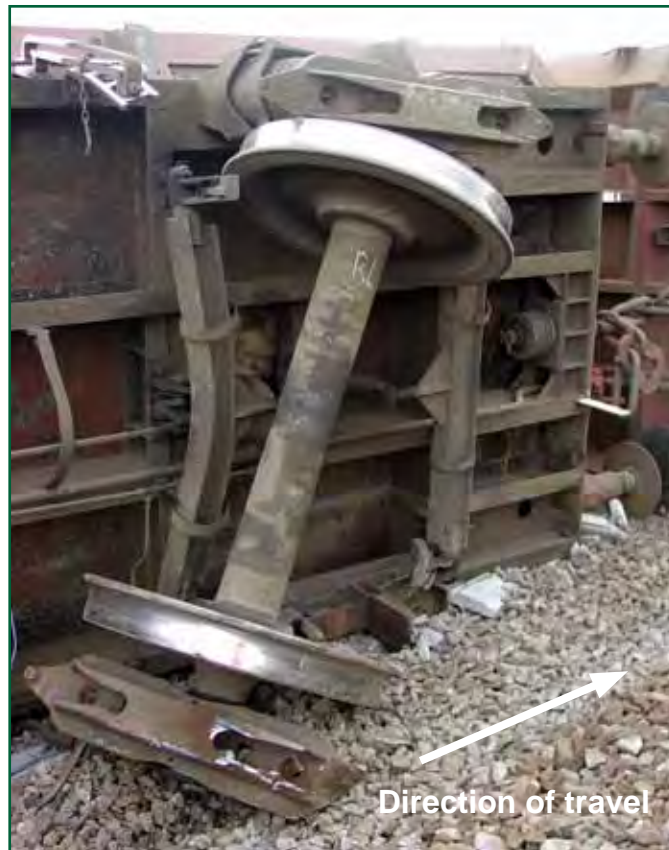
Figure 8: Damage to the left leading suspension of wagon 470152

- 34 Damage was sustained to the left leading suspension and wheel bearing of 470152 while running derailed (Figure 8). The suspension eventually failed with the springs coming adrift. The lower suspension and bearing of the left leading corner were ploughed into the ballast causing the wagon to yaw and diverge further to the left. The 15th and 16th wagons both overturned to their left-hand sides dragging the trailing end of the 14th and leading end of the 17th into derailment. During this time the *brake pipe* separated and the train brake was applied automatically.

- the 16th wagon, 470152, had significant damage to the left leading suspension, wheel and bearing and damage to other elements of its *running gear*.

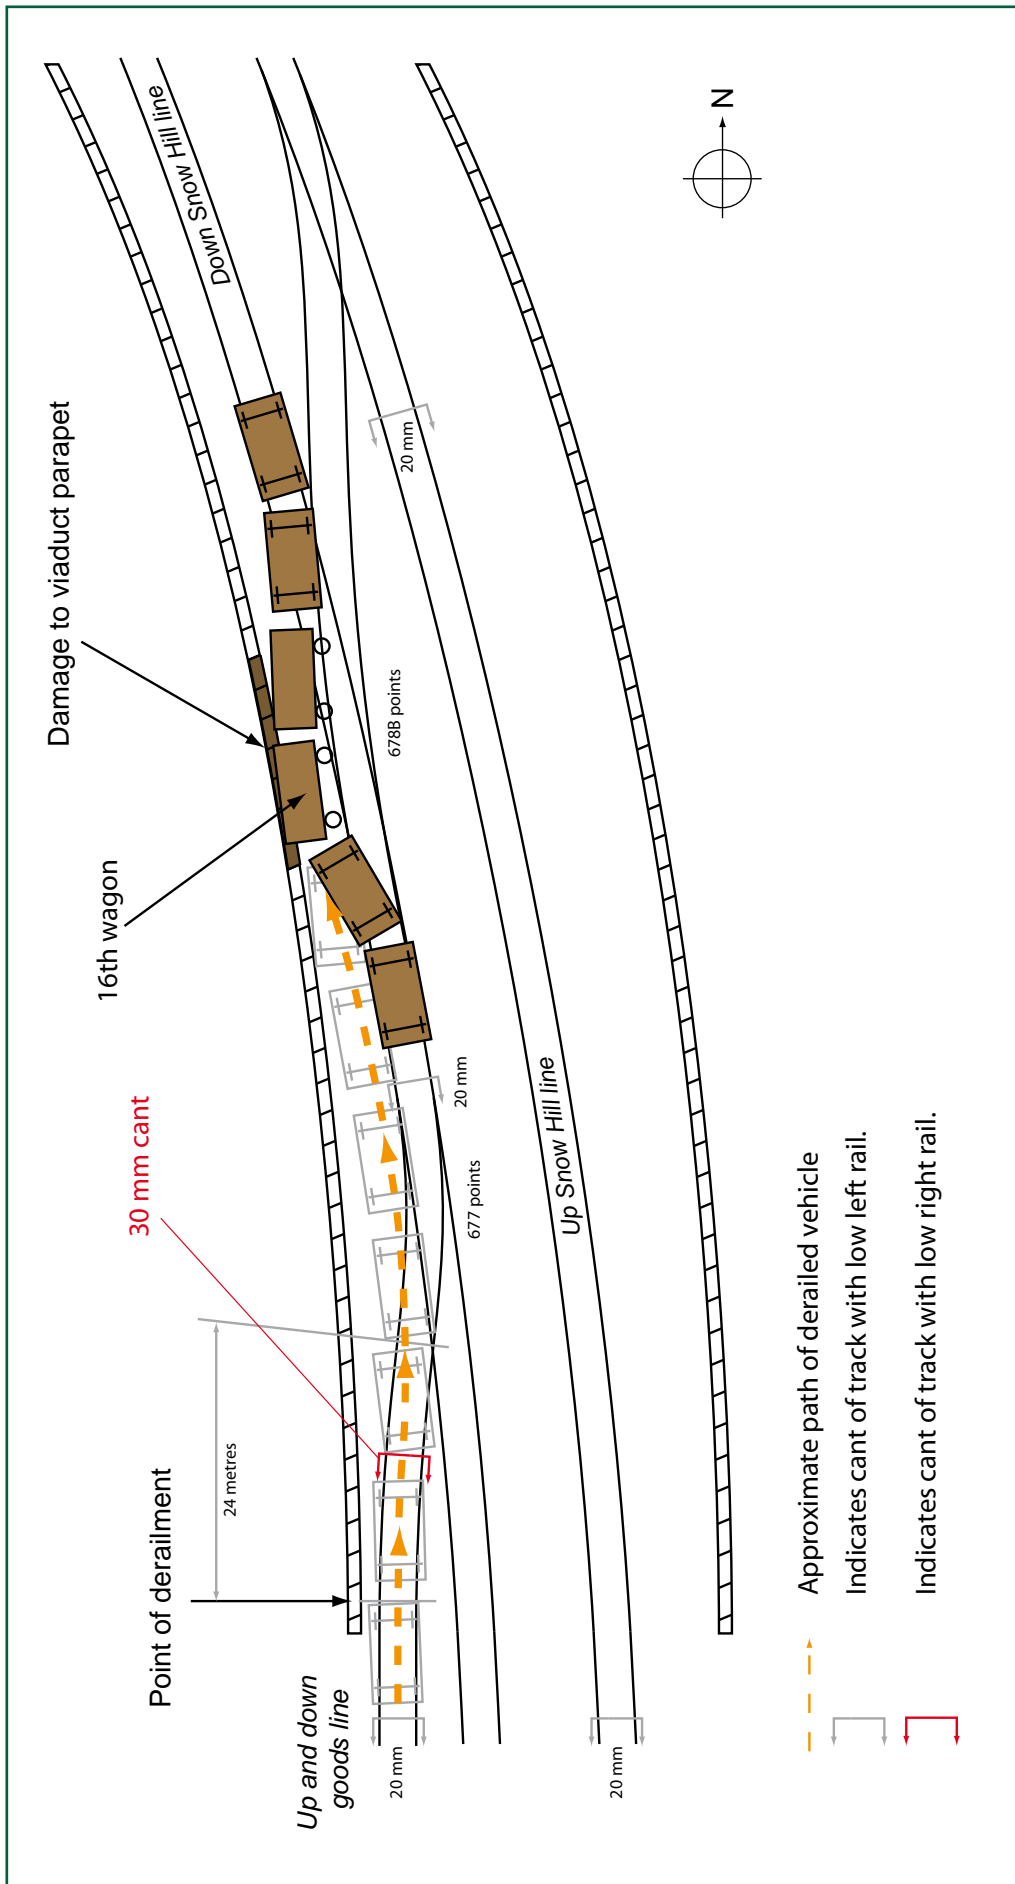
Figure 9: Diagram of derailment sequence

- 31 The wagon ran a short distance with its leading *wheelset* derailed until reaching 677 points. These points were trailing in the direction of travel and were set to allow the train access to the down Snow Hill line. The leading right-hand wheel struck the left-hand *closure rail* within 677 points and was deflected further to the left, crossing the left-hand *stock rail*. Its corresponding left-hand wheel was deflected across and outside of the left-hand *ballast shoulder* (Figure 9).

- 32 The deflection of the leading end caused the whole wagon to *yaw* to the left; this derailed the trailing wheelset. These trailing wheels were also deflected further to the left at the closure rail of 677 points.

- 33 The trailing end of the 15th wagon, 470153, was drawn to the left by 470152. When 470152 was deflected by the closure rail of 677 points the rear of 470153 derailed.

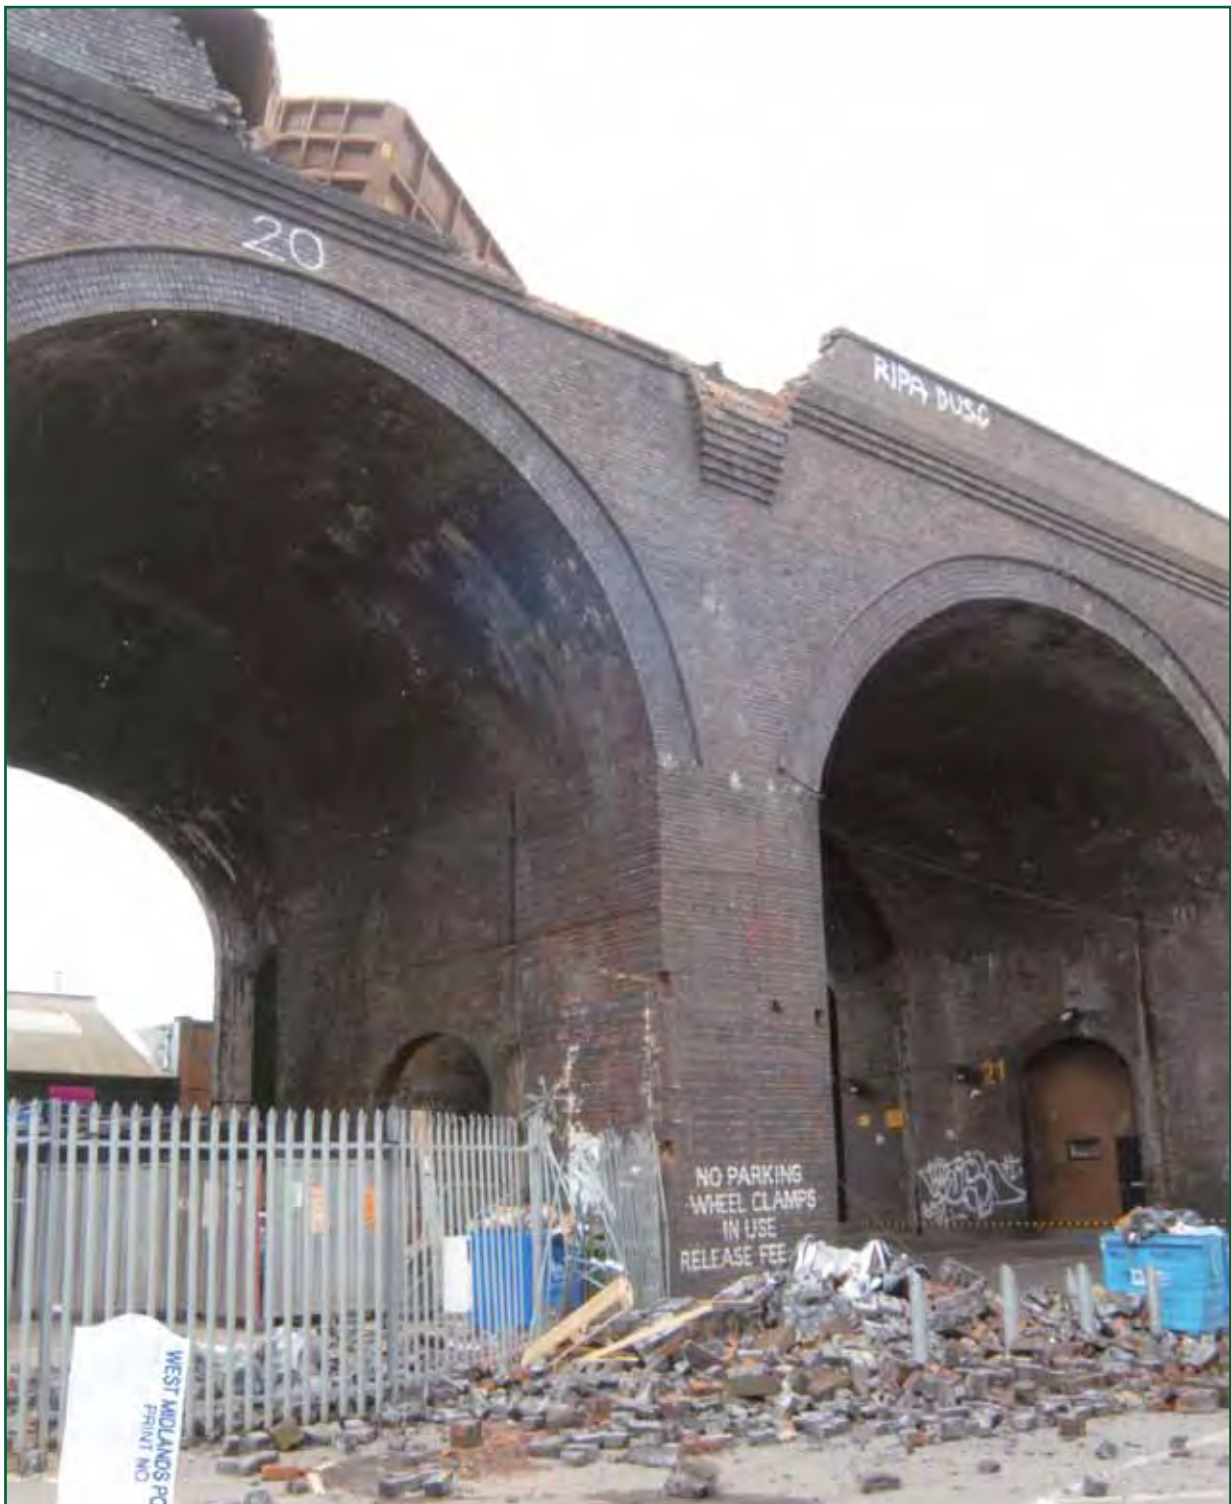
Figure 10: Fallen debris and damage to the parked car (image courtesy of West Midlands Police)

- 36 Just as the train stopped the upper trailing edge of the body of the 16th wagon, 470152, now lying and travelling on its left side, struck and displaced a 10 metre section of the brick parapet of the viaduct, which fell approximately 20 metres onto private ground below, severely damaging a parked car (Figure 10).

- 40 An unoccupied parked car was severely damaged by falling brickwork. The accident had potential for a more serious outcome, had there been any persons below the parapet.
