RAIB Bulletin 05/2009

Collision between a passenger train and the door of an open wagon

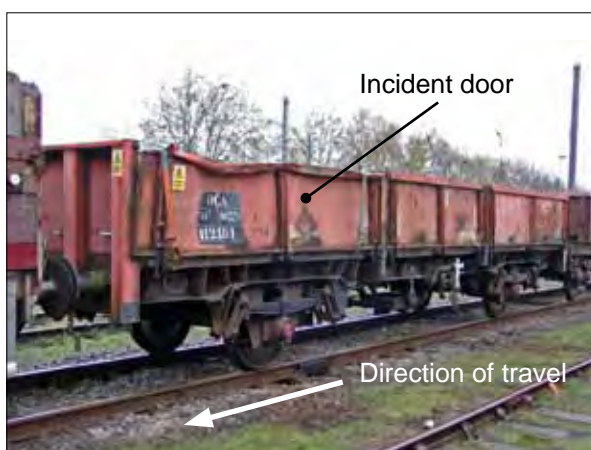
Figure 1: Damaged wagon

- 7 Damage to the incident wagon was restricted to the leading end, left hand side, door. The top edge of the door had been deformed downwards towards the hinges with both pins and chains missing.

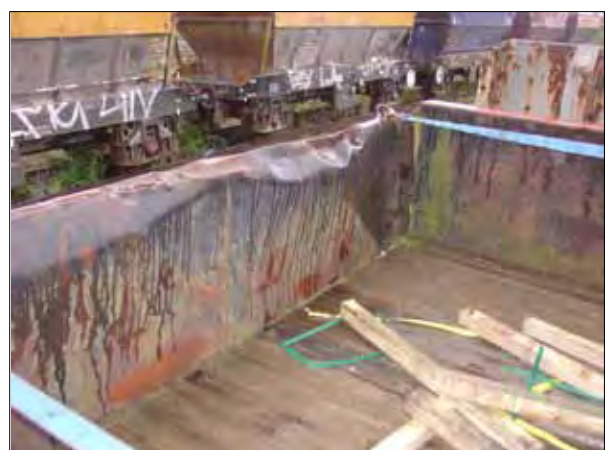
Figure 2: Incident door (held closed by straps) showing damage

- 8 The door damage was a consequence of the impact with the HST and the detached chain and pin that was found on the ballast is likely to have come from the trailing end of the damaged door.

- 9 Refitting the pin into the trailing end spigot of the incident door showed that it was bent and that it could not easily be inserted fully into the pin hole. There was evidence of previous head damage caused by multiple impacts. The pattern of damage was consistent with the pin being hammered into position.

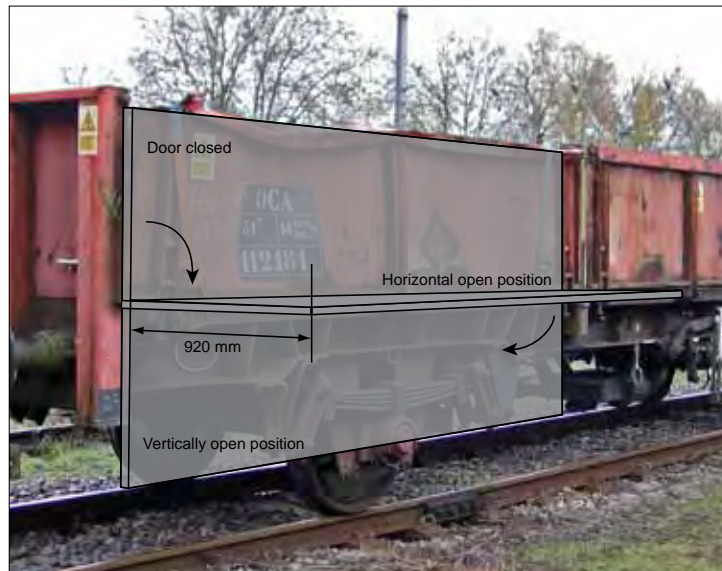
Figure 3 - Door orientation

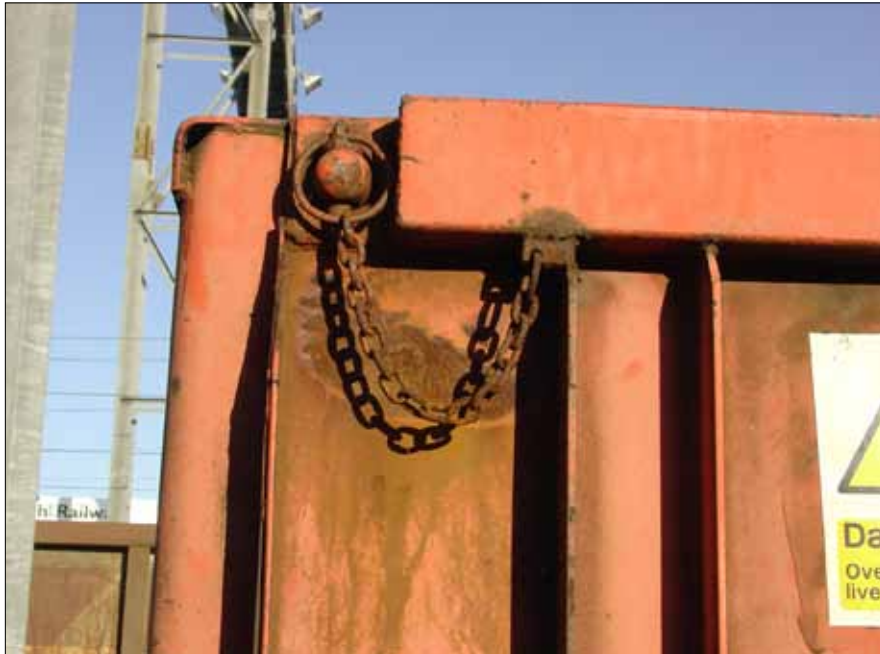
Figure 4 - Typical example of the type of securing pin

- Some of the securing pins and door frames had been distorted such that the full insertion and extraction of the pin would have to be done using a tool or hammer. In addition, some of the locking rings were significantly distorted, thus preventing them from effectively locking the securing pin in place. It is therefore important that freight operators ensure that staff responsible for inserting pins are provided with suitable tools, and that these are correctly used to avoid damage to the securing pin system.

- 14 The operator of the engineer's train has undertaken a number of actions, on similar drop down door wagons, to reduce the likelihood that a door will drop down in traffic. These are:
 - detailed examination of the drop down doors and component parts, including locking pins and the chain assembly;
 - painting the locking pins and chain assemblies yellow;
 - replacing damaged pins and chain assemblies with yellow painted longer pins and chain assemblies; and
 - if doors are to be removed, the hinge pin holes, bell crank and connecting links are to be checked for wear.
