# Rail Accident Report

**Fatal accident at Tackley station level crossing,  
Oxfordshire  
31 March 2008**

Report 09/2009  
March 2009

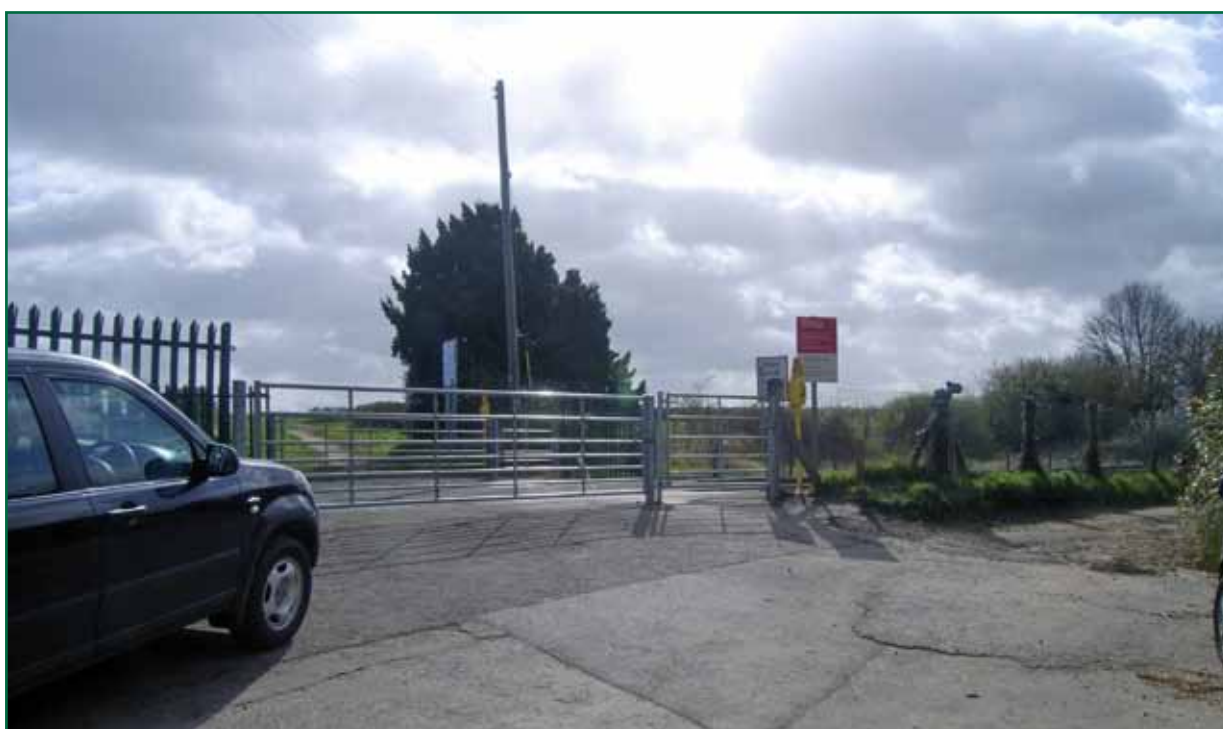
- 26 Tackley crossing is *user-worked* with separate vehicular and wicket gates, the vehicular gates normally being kept locked (Figure 2). The crossing provides three types of access:
- it is an *accommodation crossing* giving access for Tackley Estate, who are the only *authorised users*, and can use the crossing for farm vehicles in connection with managing and using the Estate;
  - it allows a footpath and bridleway to cross the railway, and forms part of an on-road cycle route promoted by the National Cycle Network; and
  - it is the only means of access to the up (London bound) platform of Tackley station from the village.

Figure 2: Approach to Tackley crossing from the down (ie village) side

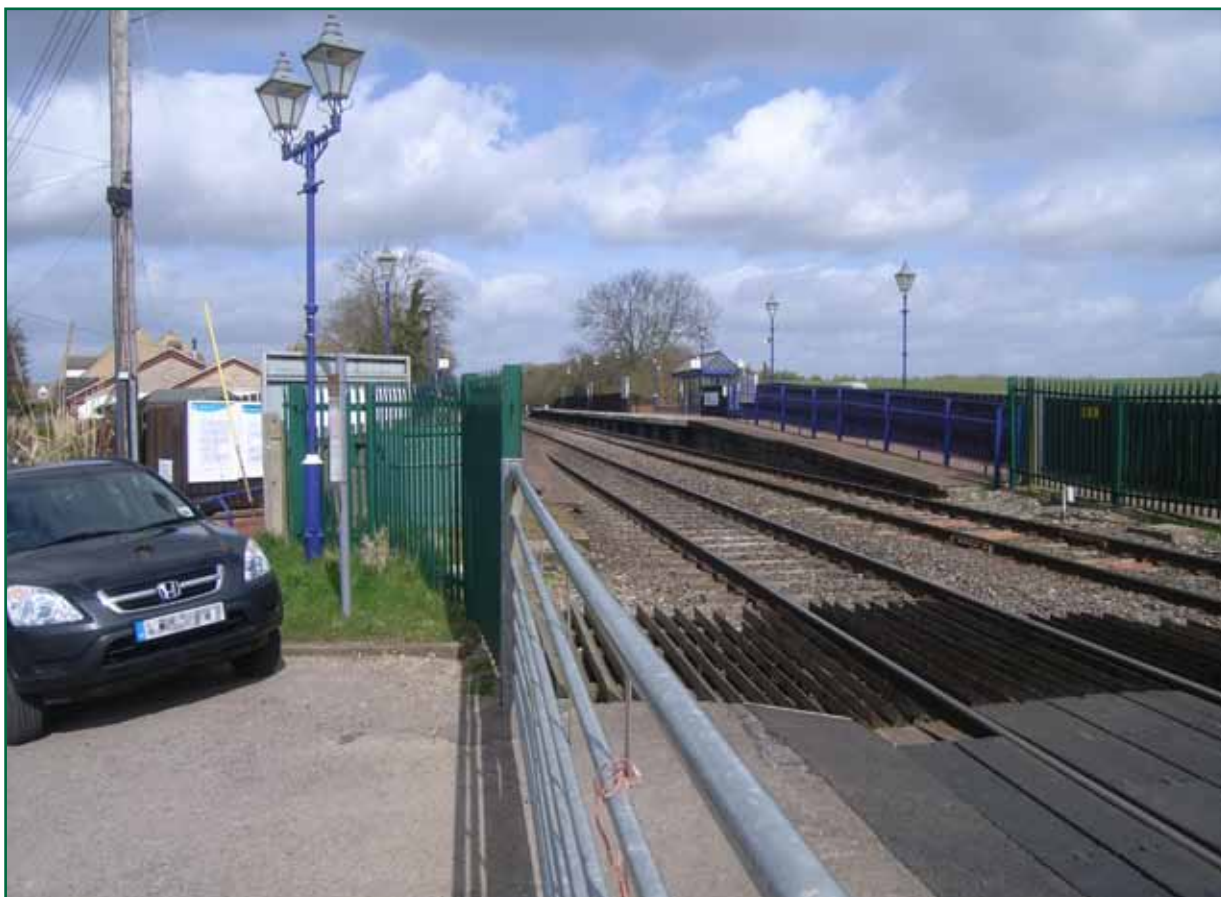
- 88 From the down side of the crossing, observing trains travelling on the up line (ie approaching from the north):
- Just outside of the railway boundary (ie wicket gate): 120 metres, equivalent to 3 seconds at 90 mph (145 km/h). The palisade fence at the north-west corner of the crossing obstructed visibility from this position (Figure 3).

Figure 3: Visibility from the down side of the crossing to the north, photographed from outside of the railway boundary

- 116 The palisade fence reduced the visibility of trains approaching on the up line to 120 metres from outside of the wicket gate. This represents three seconds travelling time for a train travelling at 90 mph (145 km/h) and was inadequate to assess whether it was safe to cross. Adequate sighting could be obtained from within the wicket gate (paragraph 88b).

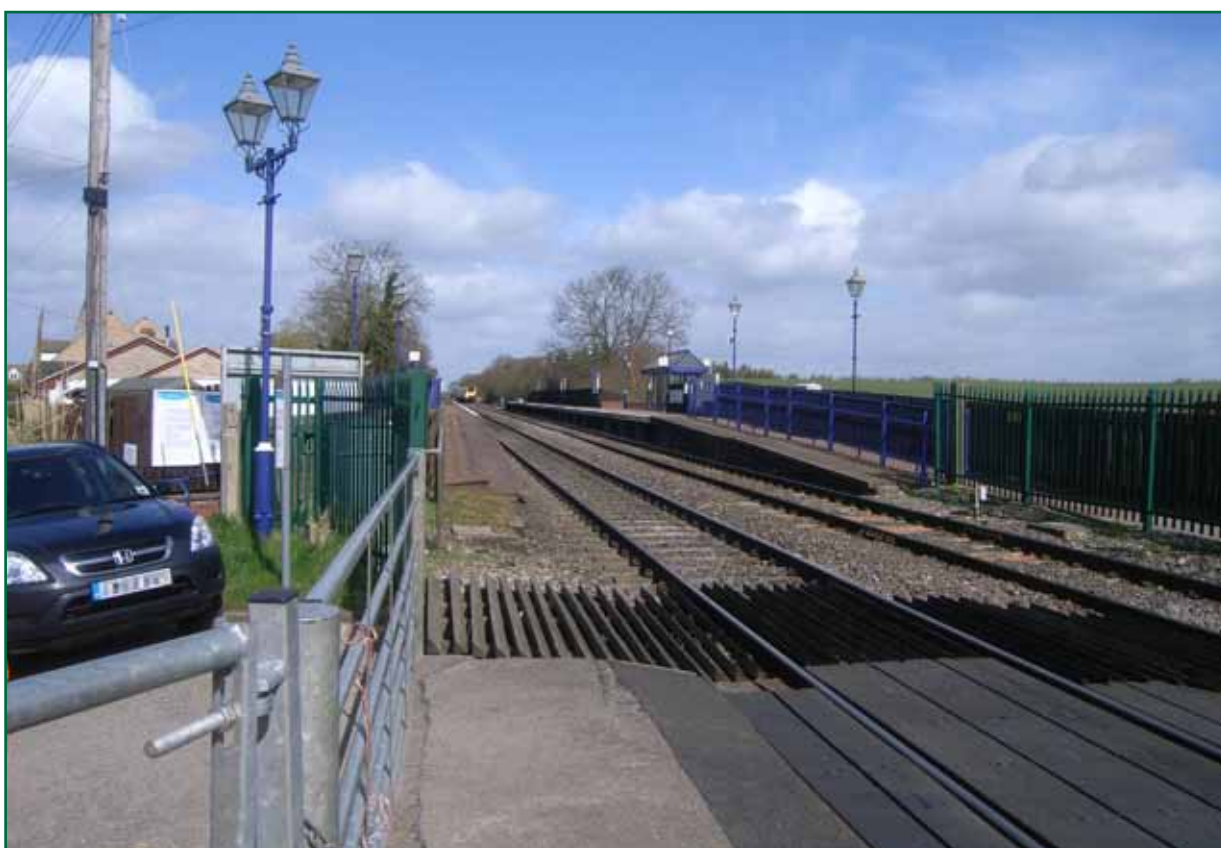
- Inside of wicket gate and approximately 2.2 metres from the running rail: 600 metres, equivalent to 15 seconds at 90 mph (145 km/h). This is the maximum possible distance due to curvature of the track and applies to sighting from both sides of the crossing (Figure 4).

Figure 4: Visibility from the down side of the crossing to the north from within the wicket gate

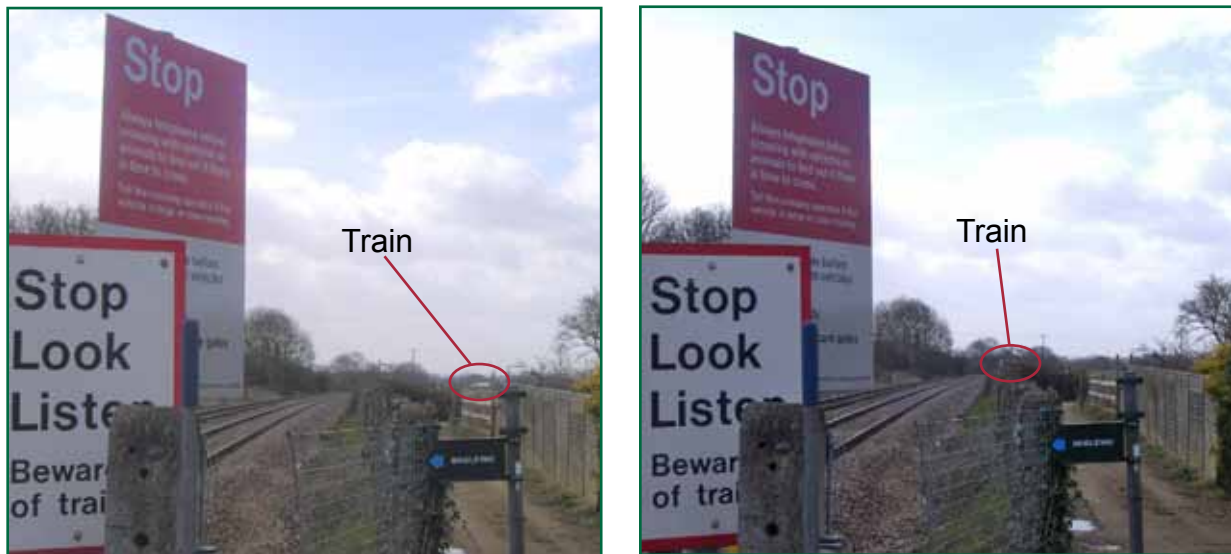
- 89 From the down side of the crossing observing trains approaching on the down line:
- Just outside of wicket gate: 925 metres, equivalent to 23 seconds at 90 mph (145 km/h). Approaching trains were visible across a field due to the curvature of the track.
  - Inside of wicket gate: 300 metres, equivalent to 7.6 seconds at 90 mph (145 km/h). Visibility from this position was restricted by vegetation on the inside of the curve growing on raised ballast, and by signs at the crossing. The roof of an approaching train was just visible above the vegetation as it passed the whistle board, 350 metres from the crossing (Figure 5) but this may not be apparent to all crossing users.

Figures 5 & 6: Train approaching on the down line, viewed from the down side of crossing outside of the wicket gate. The train is visible in the distance (Figure 5), but becomes hidden by vegetation as it approaches the crossing (Figure 6)

- 142 Sighting of trains approaching on the down line from the down side of the crossing was restricted by vegetation, some of which was growing on mounds of ballast deposited beside the track (paragraph 89, **Recommendation 6**).

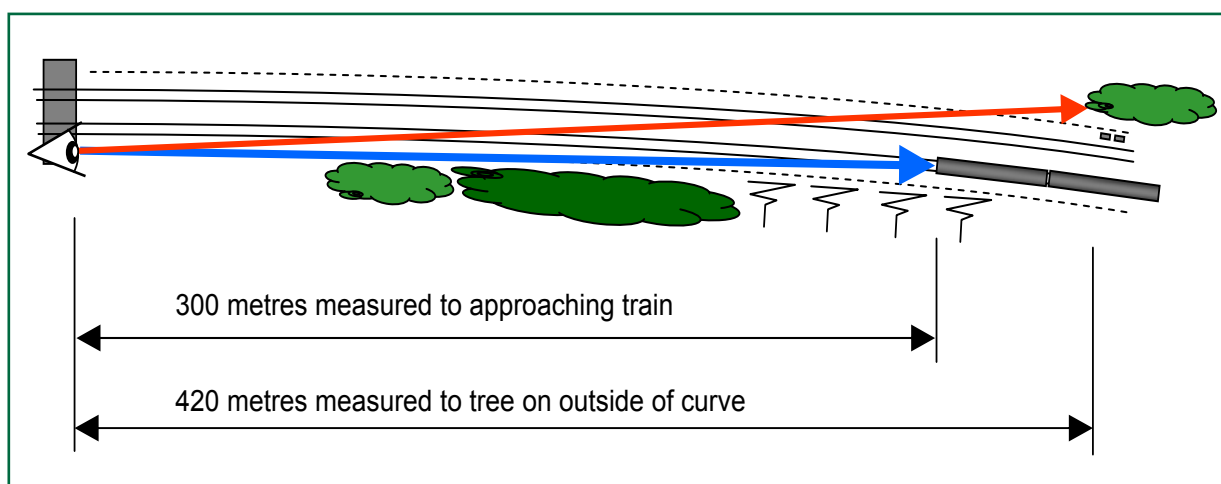
Figure 10: Schematic diagram showing over-measurement of sighting distance on a curve

129 The difficulty in accurately assessing distances using range-finder equipment is evidenced by the April 2007 ALCRM assessment and December 2007 crossing inspection reports. Specifically, the ALCRM assessment used the distance to the outside of the curve, giving a sighting distance of 420 metres, 40 % greater than that calculated by the RAIB by observing approaching trains and using a stop-watch (paragraph 89b). The December 2007 level crossing inspection report gave a sighting distance from the up side of the crossing of over 800 metres, which is 30 % greater than that which is possible for trains approaching on the up line due to a curve in the track. The methods currently in use result in unacceptable variations in the measurement of sighting distances which could compromise the safety of crossing users.

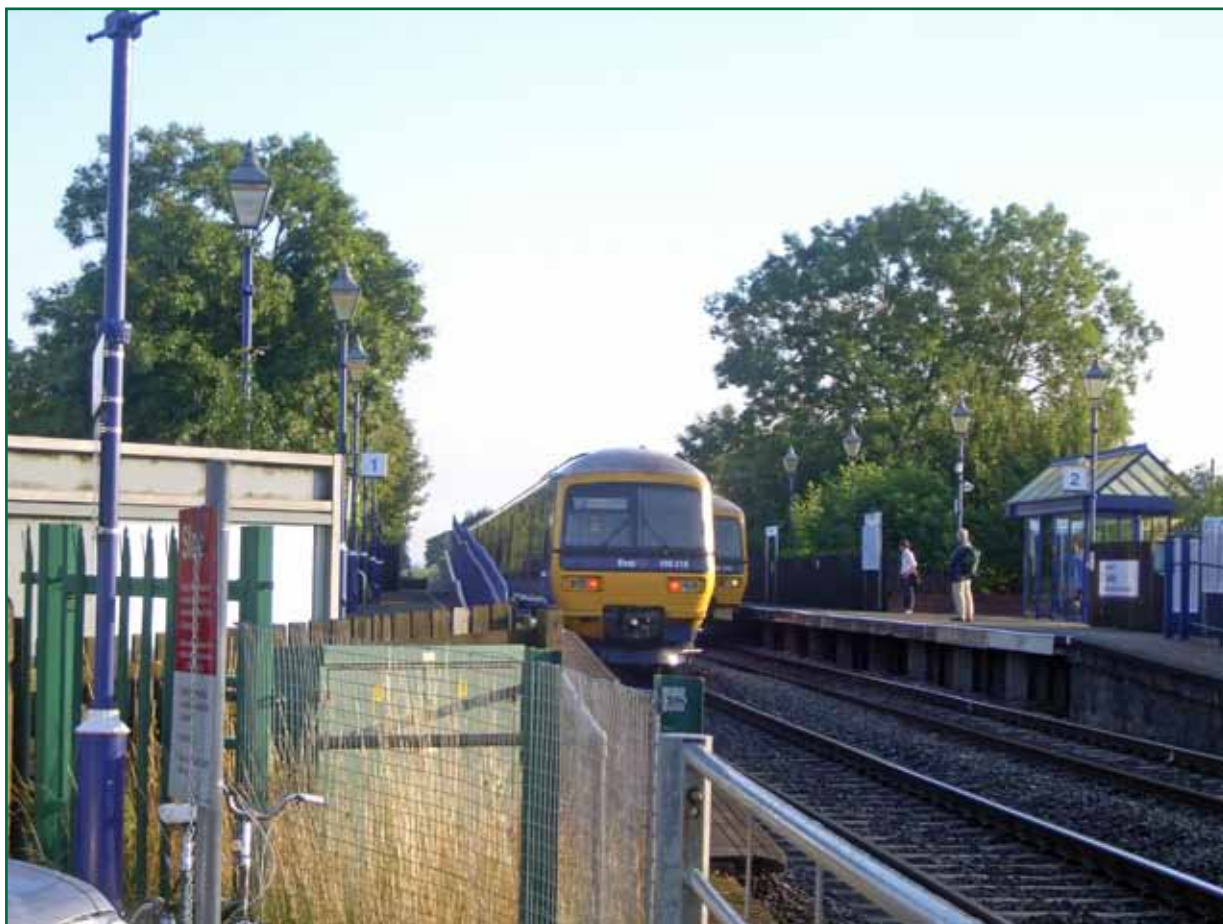
133 The visibility and audibility of trains approaching on the up line from the down side of the crossing is reduced when a train is stationary at the down platform. The respective layout of the station platforms and crossing means that a train travelling at 90 mph (145 km/h) becomes fully visible less than three seconds before it reaches the crossing. Network Rail refers to this phenomenon as a 'hidden train factor' (Figure 11).

*Figure 11: Photograph of train in down platform, in August 2008, illustrating the 'hidden train factor'. Note that the green palisade fence has now been removed, but that sighting is still affected by fencing on the platform*

134 This risk to crossing users is not identified by warning signs as the crossing is defined as a road to which the public have access, and all signs are required to comply with the traffic signs regulations. In these circumstances, the whistle board performs a vital function.

- 144 Fast trains approaching on the up line are visible for less than three seconds before they reach the crossing when a second train is stationary in the down platform. This risk is not identified to crossing users (paragraph 134, **Recommendation 1**).
