Rail Accident Investigation Branch

Rail Accident Report

**Detachment of containers from freight wagons
near Cheddington and Hardendale
1 March 2008**

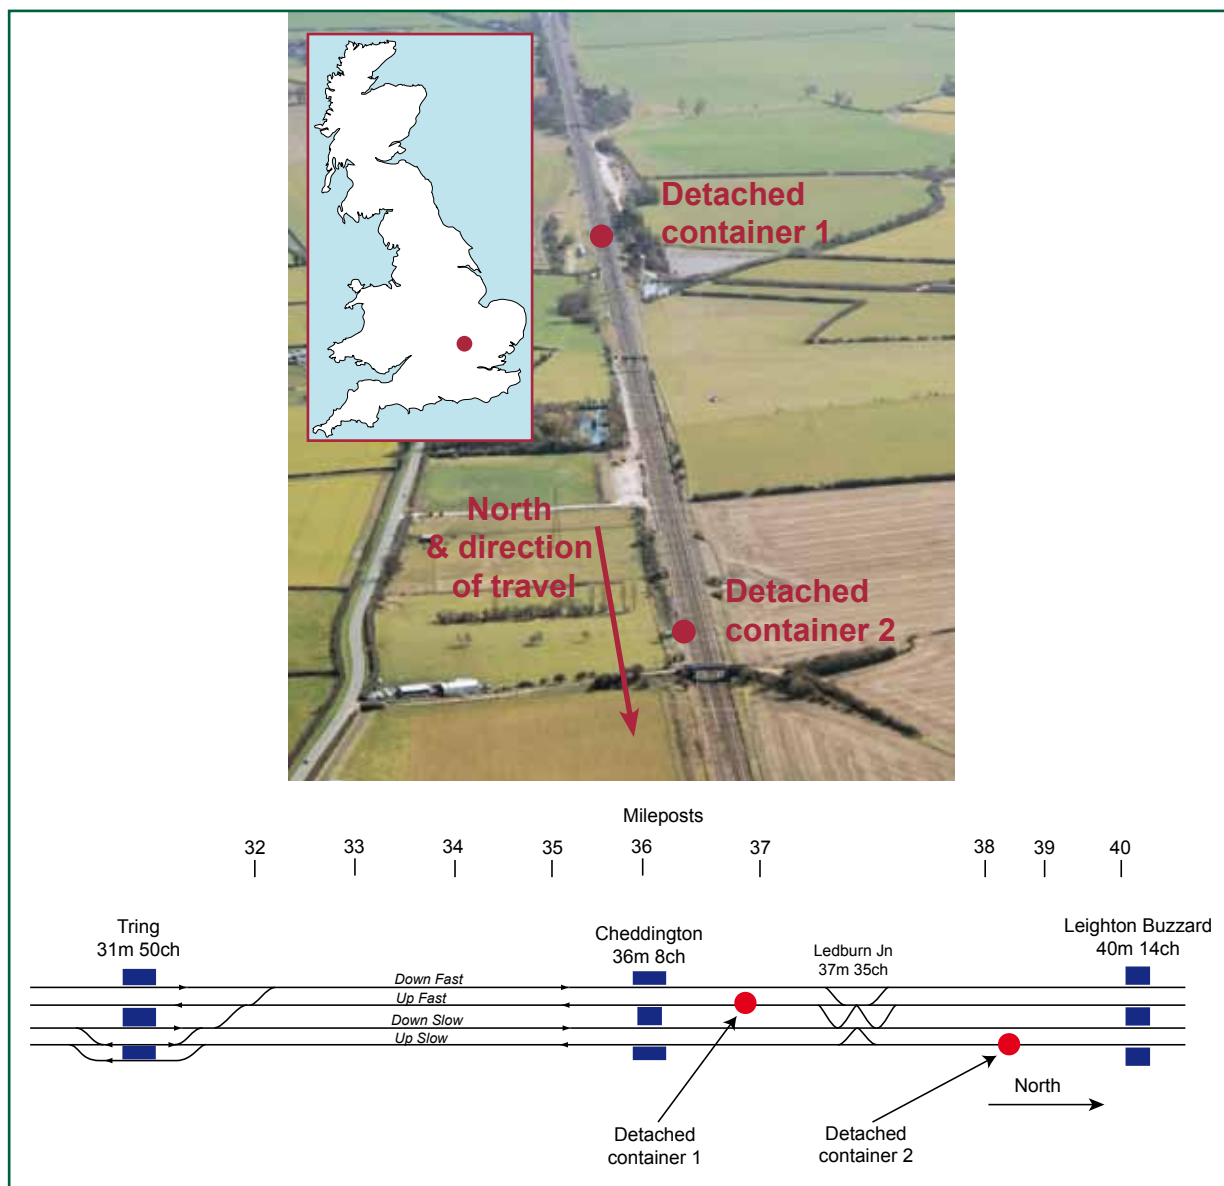
- 17 On 1 March 2008, at approximately 02:24 hrs, two empty 20 ft containers were blown off freight train 4E90, which formed the 00:07 hrs Isle of Grain to Doncaster. The train, which consisted of a Class 56 locomotive hauling 20 FEA-B flat wagons, was travelling north on the Down Fast line of the WCML just north of Cheddington (Figure 1) at approximately 75 mph (121 km/h) in windy conditions.
- 18 The detached 20 ft containers blocked the Up Fast and slow lines at two locations, approximately 1.4 miles apart (Figure 1), and caused damage to OLE and to the track. The line was closed for repairs until the evening of 1 March 2008.

Figure 1: Incident site near Cheddington

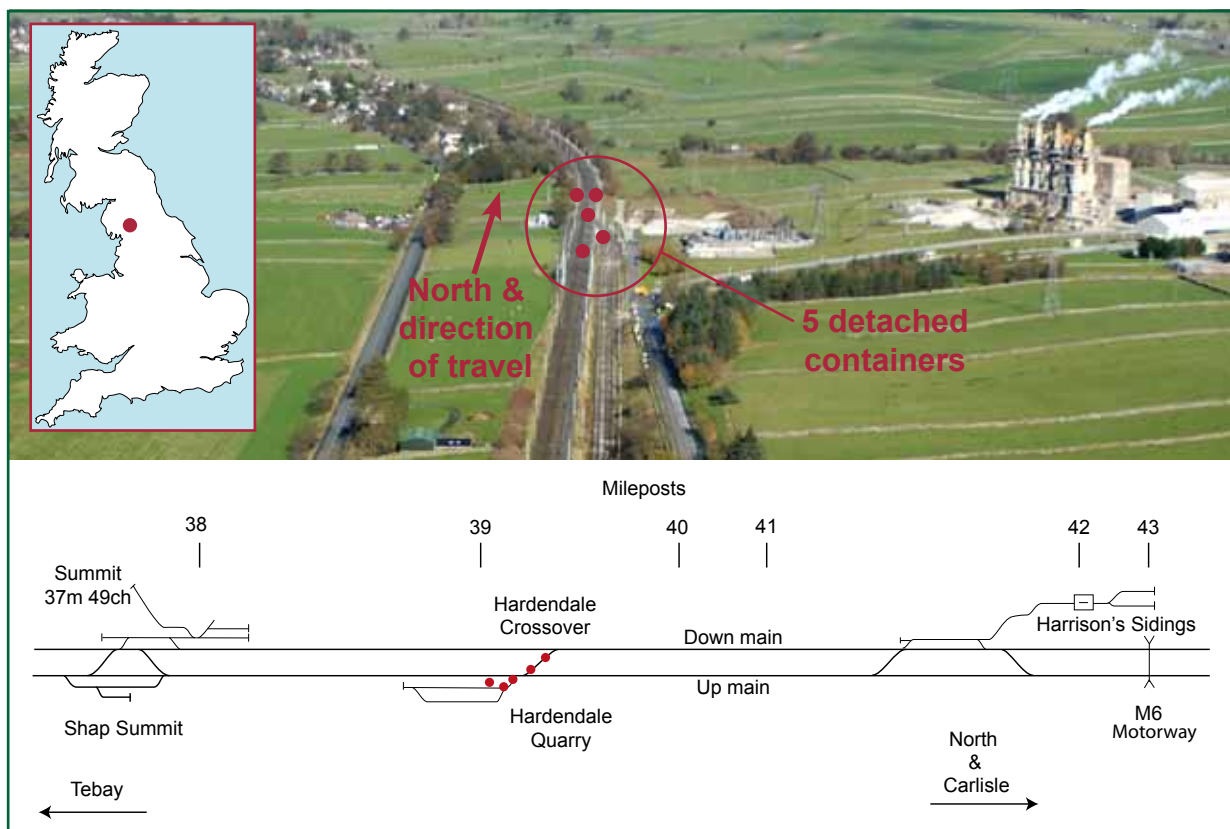
- 19 On the same morning, at approximately 03:15 hrs, five empty containers were blown from another freight train, 4S83, which formed the 18:28 hrs Tilbury to Coatbridge. The train, which consisted of two Class 86 locomotives hauling 20 flat wagons of mixed types including ten FEA-B wagons, was also travelling north on the Down line of the WCML adjacent to Hardendale Quarry (Figure 2), located between Tebay and Penrith in Cumbria. The train was also travelling at approximately 75 mph (121 km/h) in windy conditions.
- 20 The detached containers, which comprised three 20 ft, one 40 ft and one 20 ft tank, were blown from the rearmost four FEA-B wagons of the train. They came to rest blocking the Up and Down lines and caused significant damage to OLE and the track. The line was closed until the early hours of 3 March 2008.

Figure 2: Incident site near Hardendale Quarry

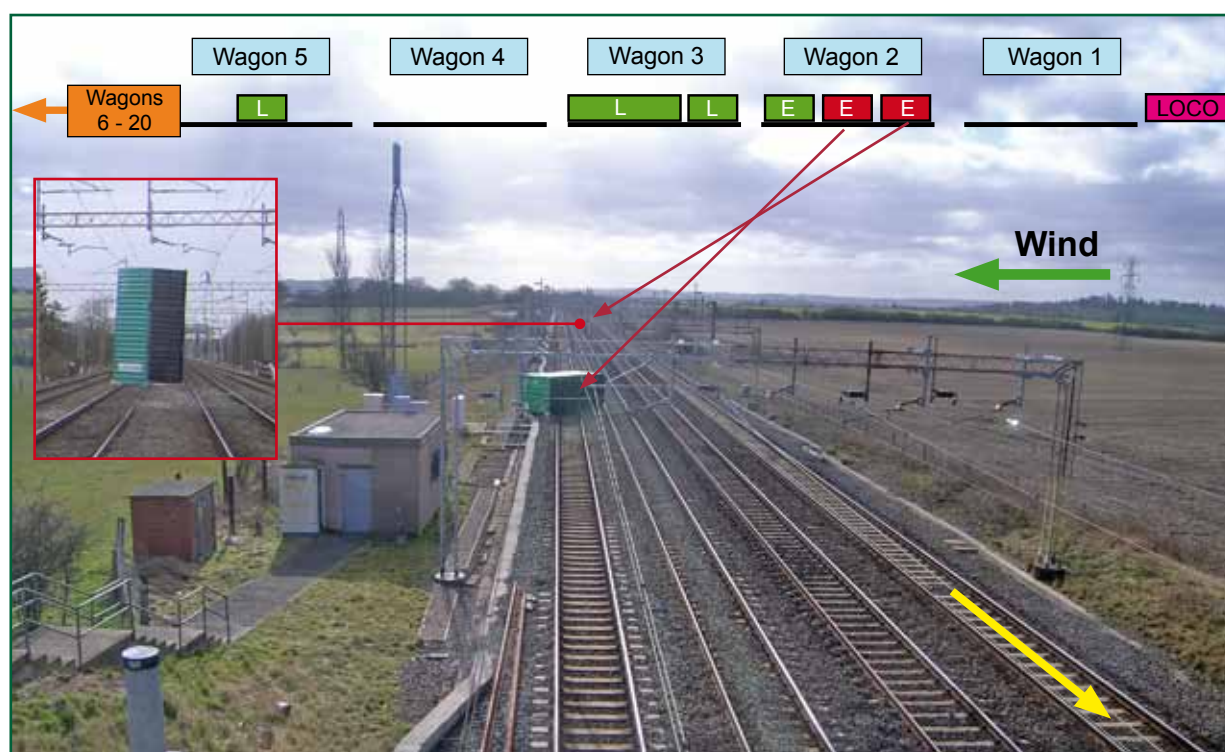
- 28 The site of the first incident was on a section of straight track on the WCML between the stations at Cheddington (36 miles 8 chains) and Leighton Buzzard (40 miles 14 chains) (Figure 1). The railway here consists of four running lines aligned in a generally north-south direction. From west to east these lines are the Down Fast, Up Fast, Down Slow and Up Slow. The first detached container was found on the Up Fast line at 36 miles 74 chains and the second container was found on the Up Slow line approximately 1.4 miles (2.2 km) further north at 38 miles 27 chains. Figure 3 shows a general view of the track, the detached containers and their original positions on train 4E90.

Figure 3: Detached containers near Cheddington and their original location on train 4E90

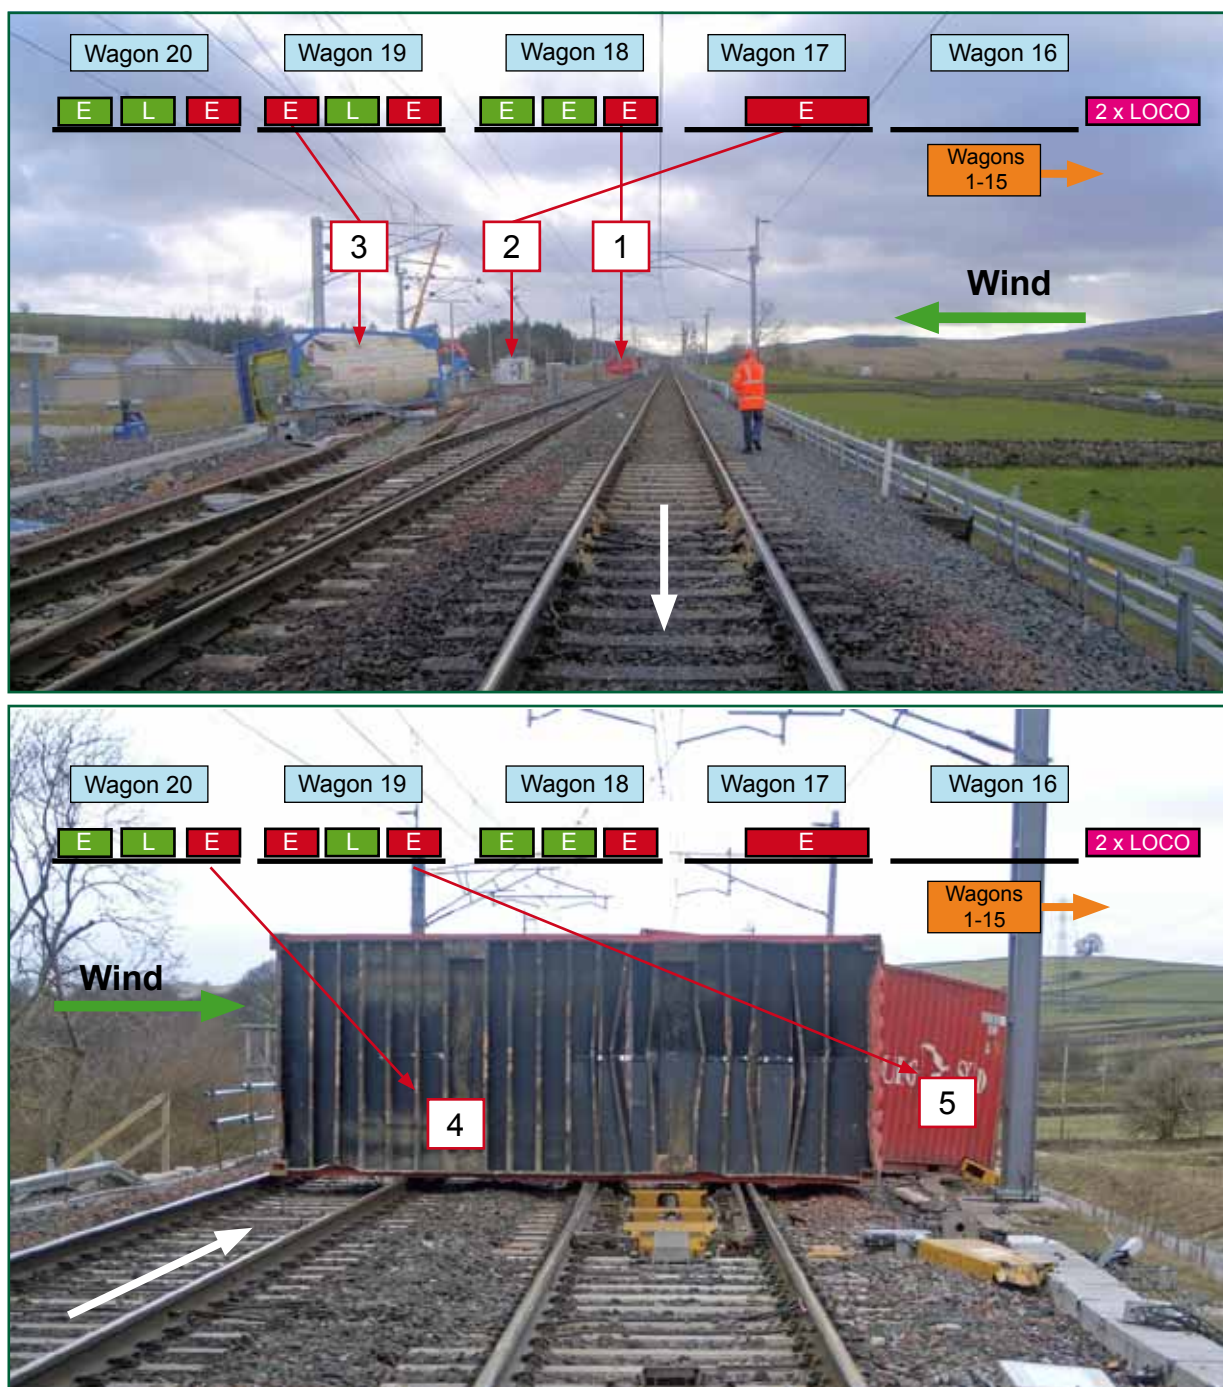
Figure 4: Detached containers at Hardendale and their original location on train 4S83 (white arrows denote direction of travel)

- 59 At Hardendale, the five detached containers came to rest over a distance of approximately 175 metres (Figure 4). The southernmost 20 ft container was fouling the Up line. The 40 ft container and 20 ft tank came to rest in the sidings and did not block the Up line. The two 20 ft containers at the northern end of the site fouled both the Up and Down main lines. Other containers on train 4S83 were also damaged but there was no significant damage to any of the wagons on the train.
- 60 The damage to the infrastructure at Hardendale was significant. Three OLE stanchions were severely damaged and required replacement, and the overhead wires required repair. There was damage to the rails, sleepers and points on the Up Fast line and Hardendale sidings. Signal CE141 and a location cabinet were completely demolished and various signalling cables were severed.

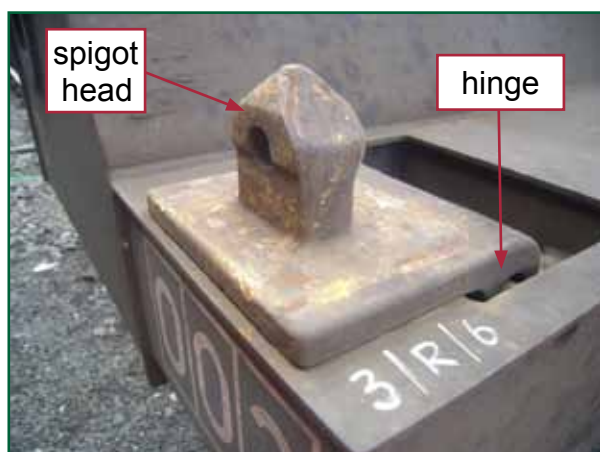
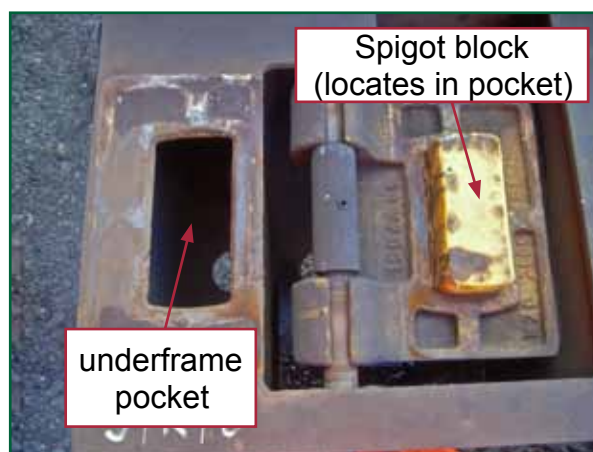
Figure 6: Fold-down spigot with inboard hinge, as fitted to FEA-B wagons, deployed (left), stowed (right)

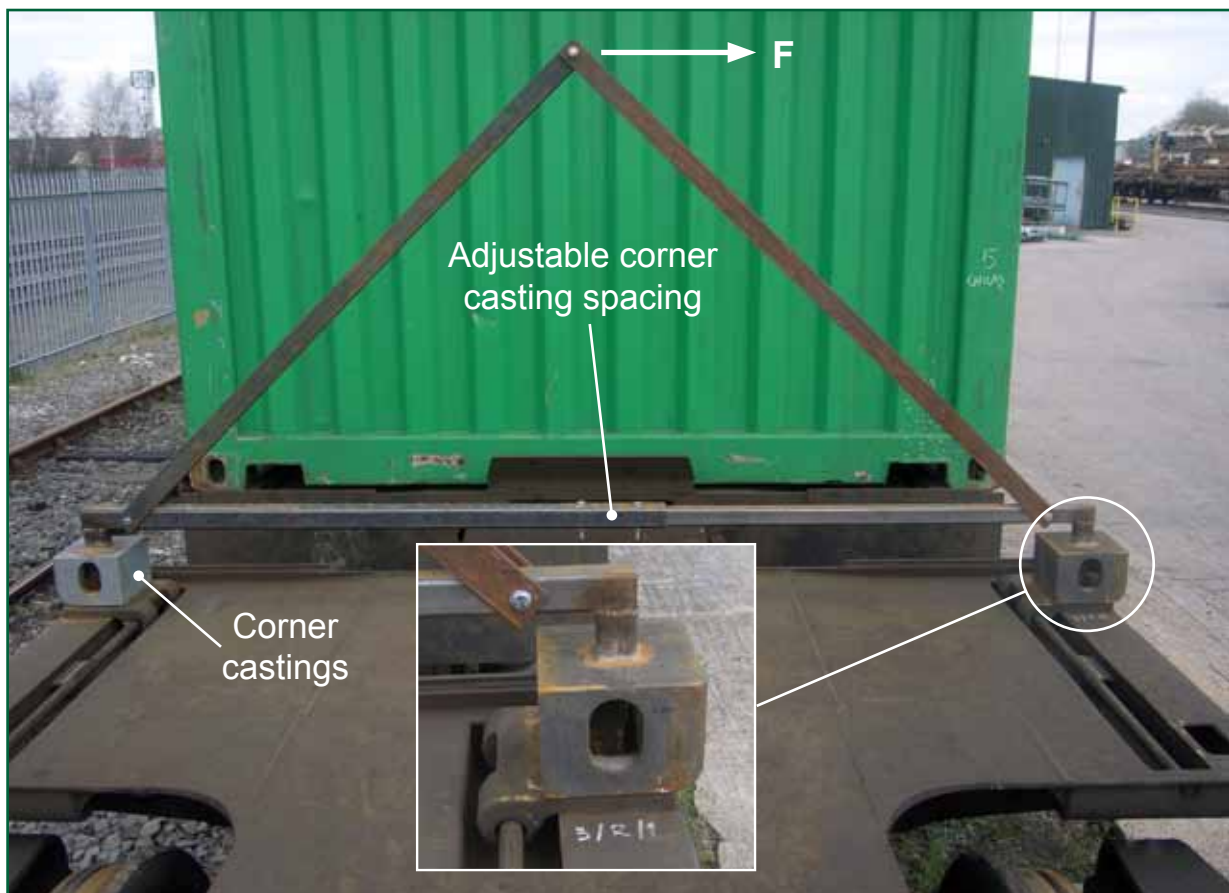
120 Tests were carried out on wagon 643003 (from Cheddington) to check the functionality of the spigots. A test rig, developed by Fastline for this purpose, was used for the tests. It comprises a full size container corner casting at each end of an adjustable A-frame as shown in Figure 11. It can be used to simulate the effects of wind loading on a container by manually applying a horizontal force at the apex of the A frame. If the frame is not restrained by the spigots when loaded at the apex, this indicates that a full size container will not be restrained.

Figure 11: A-frame used to test container overturning on Fastline FEA-B

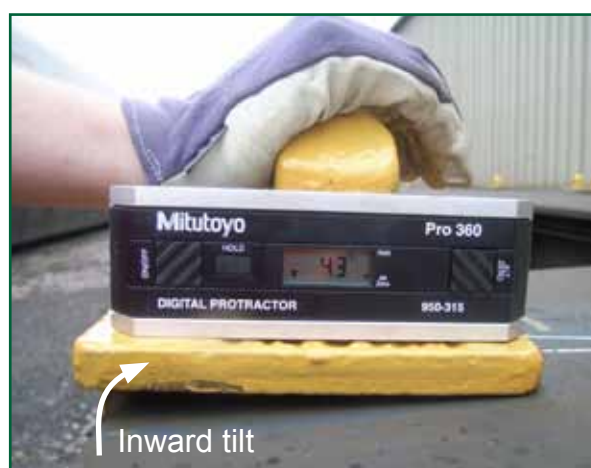
- Fixed spigots (Figure 12) which are compliant with UIC 571-4 provide overturning restraint, those that are not compliant do not provide reliable restraint.
- Fold-down spigots with inboard hinges, as fitted to the FEA-B wagons do not offer any overturning restraint, even if the spacings are complaint, because the spigot rotation follows the rotation of the overturning container on the windward side.
- Fold-down spigots with outboard hinges (Figure 13), as fitted to most wagons with UIC spigots, may not reliably restrain overturning containers if there is sufficient play in the hinges to allow them to initially rotate inwards, pivoting about the inboard edge as shown in Figure 14. During testing, inward rotations of up to 4.5 degrees were measured; the maximum specified in the UIC 571-4 is 2 degrees.

Figure 14: Inward rotation of fold-down UIC spigot with outboard hinge, due to play in hinge

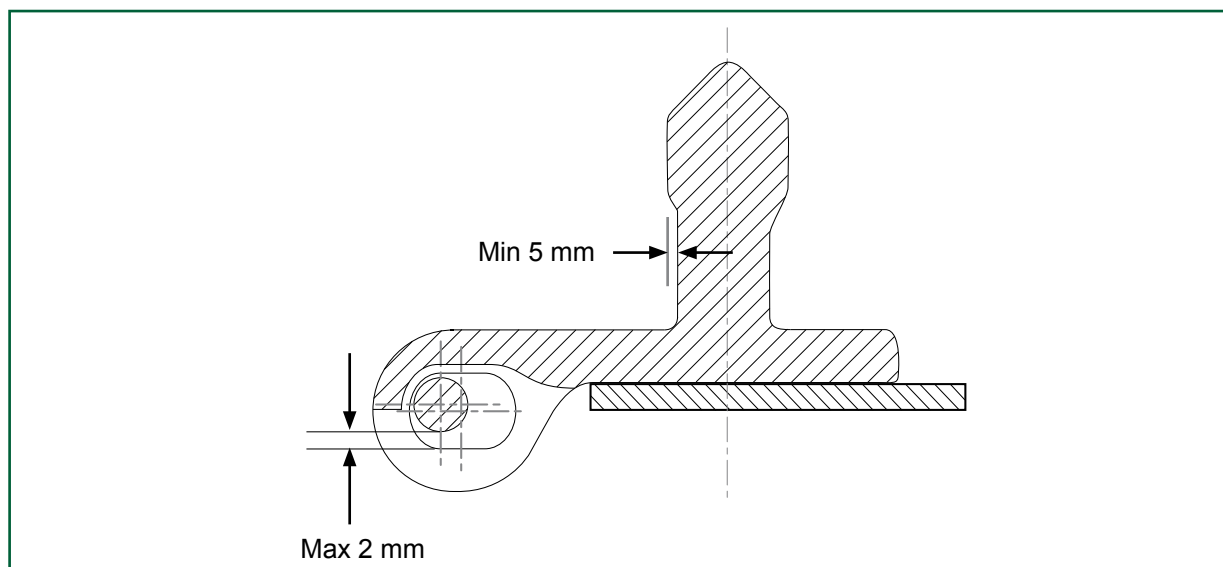
Figure 15: ‘Limits of Wear’ as set out in the FEA-B maintenance plans

149 Neither of the maintenance plans specified the dimensional checks required by UIC 571-4 to ensure the correct operation of the spigots. In the case of the Freightliner plan this was because of an oversight and in the case of the Fastline plan, Marcroft Engineering, who prepared the document, believed that wagons built solely for domestic UK traffic, were not required to fulfil the requirements of UIC codes.
