Rail Accident Investigation Branch

Rail Accident Report

Road-rail vehicle runaway incidents at Brentwood, Essex and at Birmingham Snow Hill 4 November & 31 October 2007

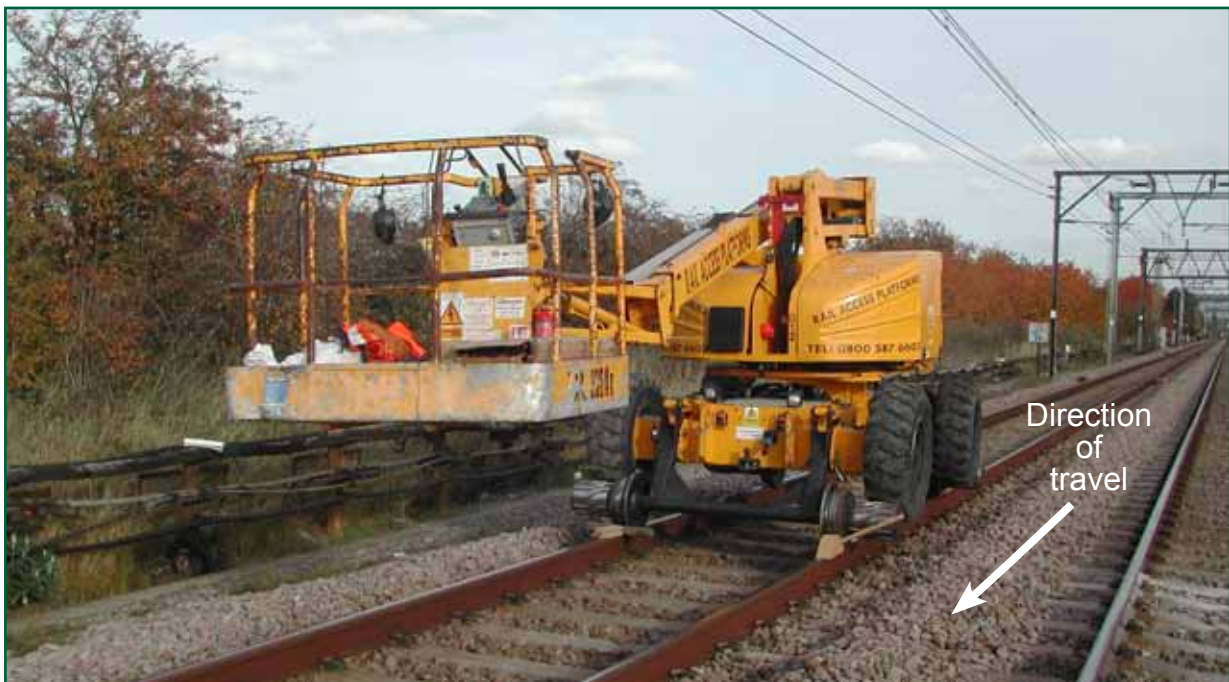
Figure 3: The Basket 14 RRV stopped west of Romford station after the runaway

- 22 The machine ran for a total of seven miles - three miles of which were outside the possession arranged for the renewal work - until staff, from the Romford OLE maintenance depot, stopped it west of Romford station (12 miles 30 chains), Figure 3. There was no material damage.

- 23 The machine had started to slow down as it passed Harold Wood station (14 miles 76 chains), and the operator jumped clear as it left the possession on its approach to Gidea Park station (13 miles 41 chains). He sustained injuries requiring hospital treatment, but he was not detained overnight.

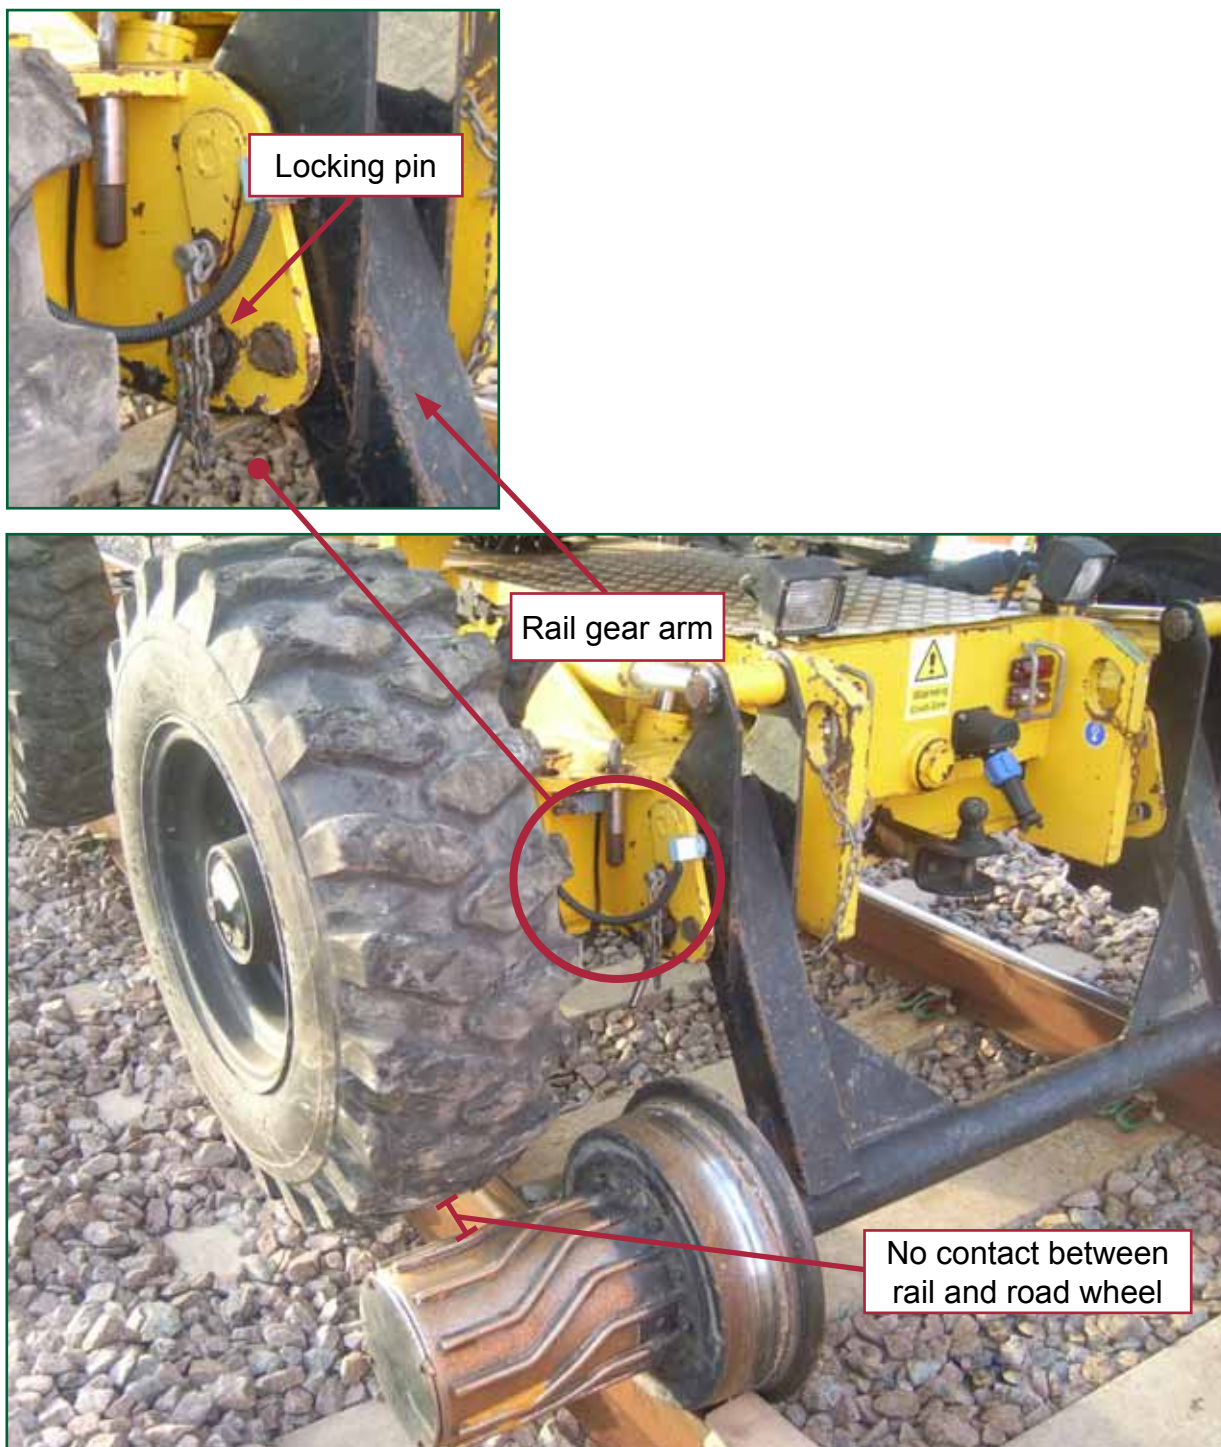
Figure 6: Basket 14 RRV locking pins and rail gear as found at Romford after the incident

- 70 The RAIB, with ETI's assistance, examined the Basket 14 RRV and found that:
- all rail wheels were on the track;
 - the rail gear arms, at both the fixed and the steered-ends, were in hard contact with locking pins; this was preventing the rail wheels contacting the road wheels, Figure 6;
 - the emergency stop button on the ground control panel was depressed and had been operated; and
 - the brakes and rail gear operated satisfactorily.

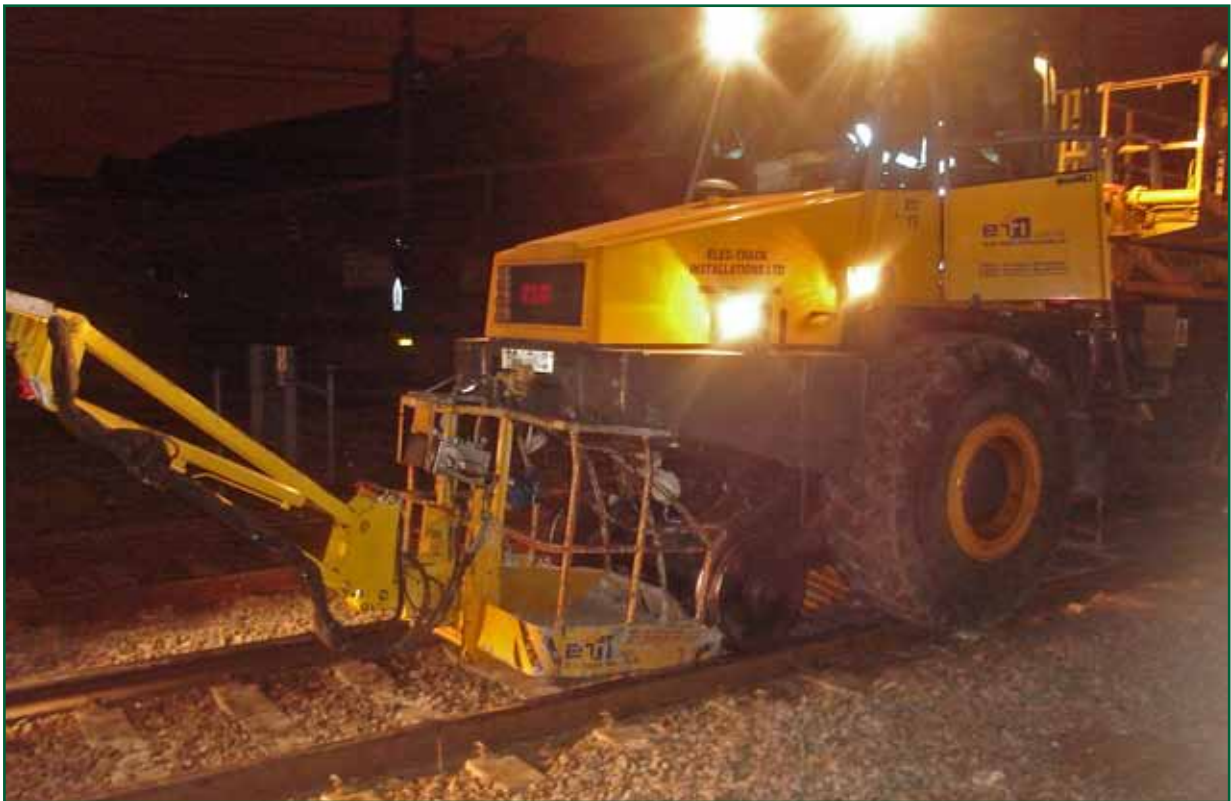
Figure 7: Damage as result of the TD-18 RRV colliding with the Basket 14 RRV (Photograph courtesy of Mouchel Rail Ltd)

- 71 At around 02:30 hrs on 31 October 2007, a TD-18 RRV was being off-tracked at a road-rail access point near Birmingham Snow Hill station (129 miles 36 chains). Mouchel Parkman Rail, a contractor working for Network Rail, had been using the machine for the routine examination of tunnels and other railway structures in the area.
- 72 As the machine was being off-tracked, it ran away towards the work basket of another RRV, a Basket 14 RRV, parked 10-15 metres away. There were two persons in the work basket of the Basket 14 RRV when the runaway started, and another was in the driving cab of the TD-18 RRV. They all managed to get clear before the cab collided with the work basket.
- 73 The work basket suffered damage, Figure 7. There were no injuries.

- 99 No-one was injured and material damage was limited to the parked Basket 14 RRV.
- 100 The loss of survival space as result of the damage to the work basket of the Basket 14 RRV (Figure 7) shows that, if they had not managed to evacuate quickly, those on and near the machine were at risk of serious injury.
