Rail Accident Investigation Branch

Rail Accident Report

Trackworker struck by train, Stevenage 7 December 2008

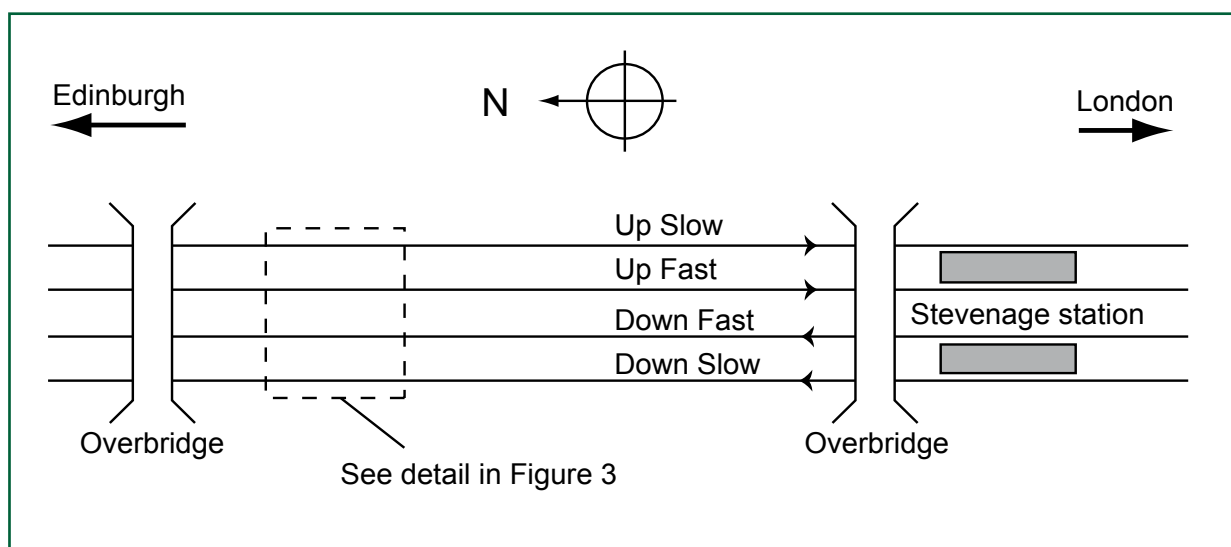
Figure 2: Diagram of the lines at the location of the accident

- 63 Where the accident occurred the railway is straight. During normal running of the railway there is clear visibility of the approach of trains.
- 64 The distance between the adjacent rails of the up lines at this location is 3.1 metres.

- 100 In this case the distance between the adjacent rails of the up fast and up slow lines was 3.1 metres. Therefore any work under Separated Green Zone conditions on the up fast line could not take place more than 10 cm from the outer edge of the rail adjacent to the up slow line, unless a Site Warden or fence were to be provided.
