Rail Accident Investigation Branch

Rail Accident Report

Accident at Falls of Cruachan, Argyll 6 June 2010

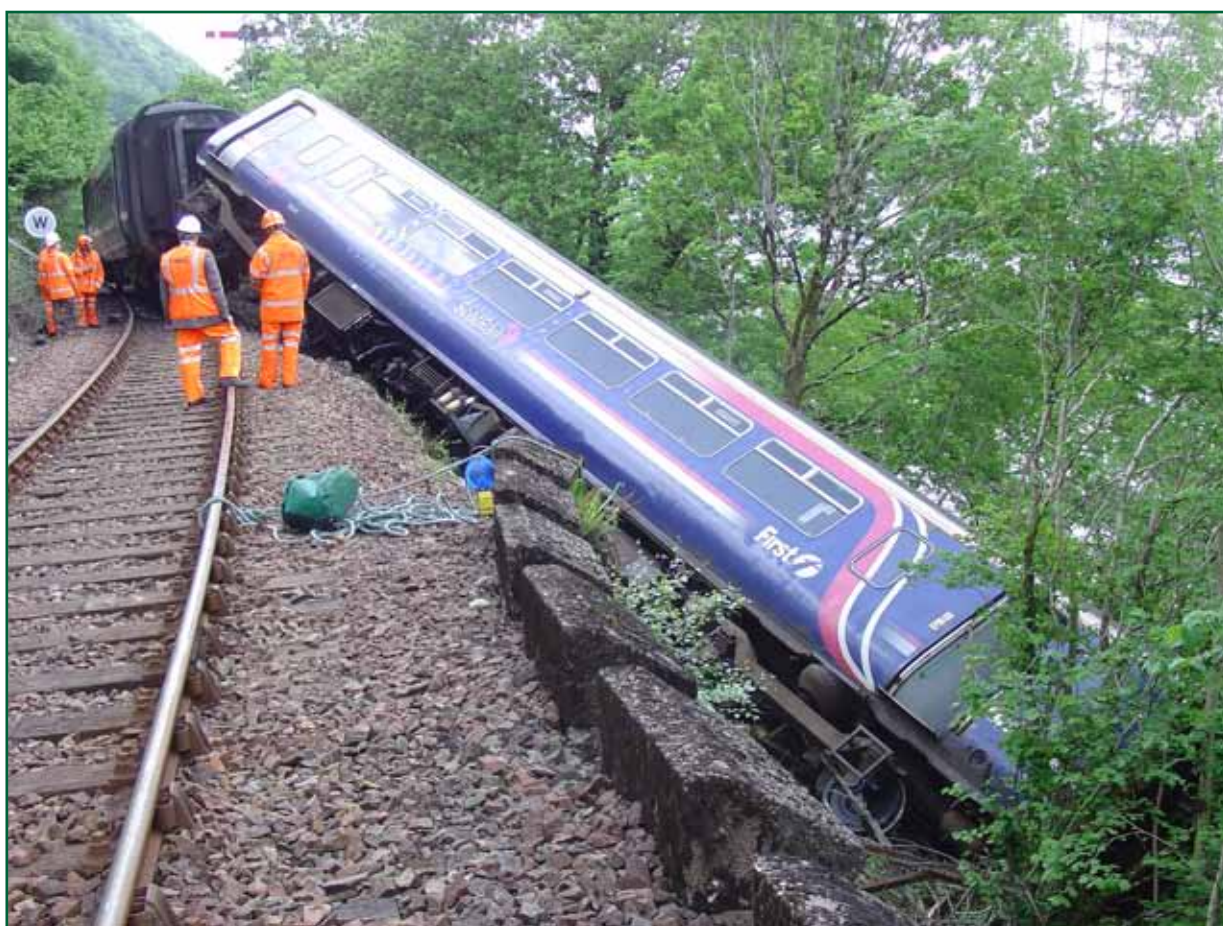
Figure 1: The derailed train following the accident

- 6 At 20:55 hrs on Sunday 6 June 2010 train 1Y27, the 18:20 hrs from Glasgow Queen Street to Oban, struck a boulder that had fallen onto the track just west of the station at Falls of Cruachan, in the Pass of Brander, on the line from Crianlarich to Oban. The boulder had fallen onto the track from its position on the slope within the railway boundary because of *root jacking* and soil erosion.
- 7 The evidence from the site of the accident was that the train, consisting of a 2-car class 156 *diesel multiple unit*, drove over the boulder, which lifted up the front car and derailed it to the left and down an embankment (figure 1). The leading bogie of the rear car ended up supported by the boulder with the rear bogie still on the track (figure 2).

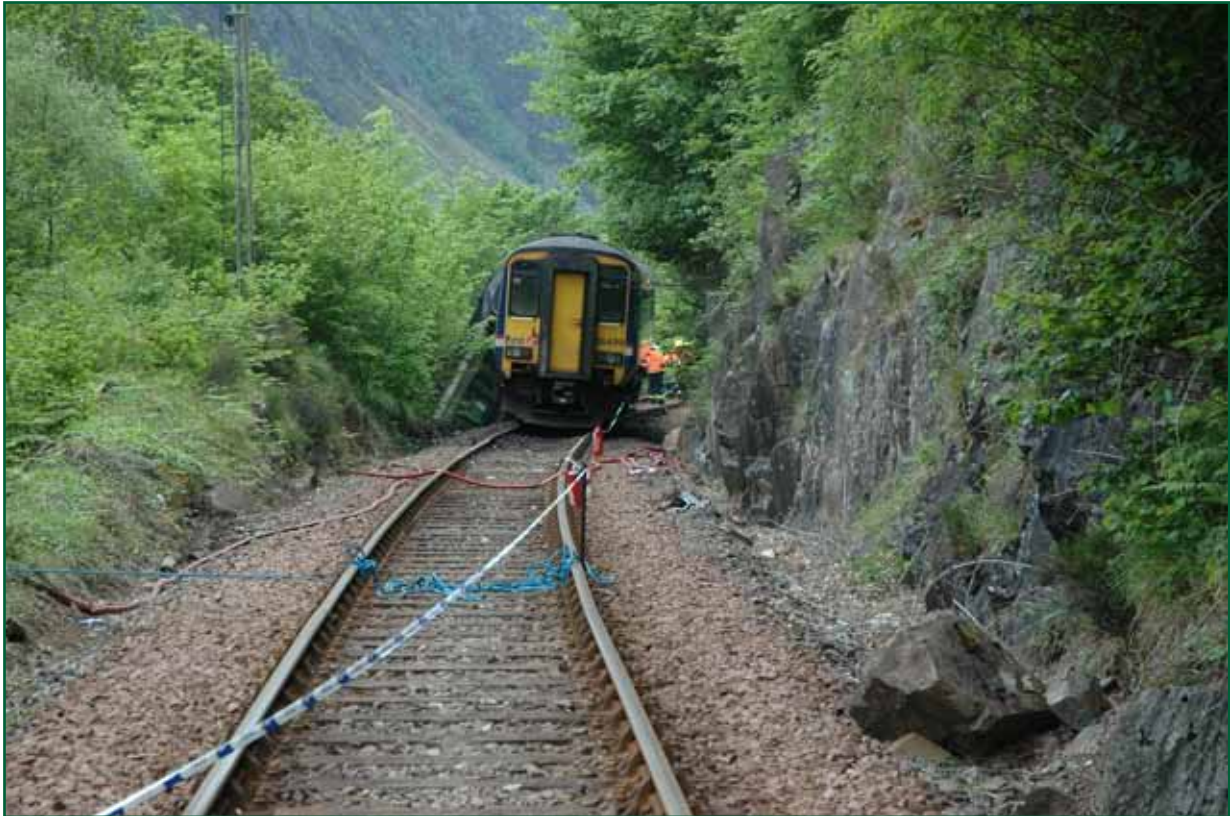
Figure 6: Exposed rock face area of the slope showing blocks

- 19 As a result, the slope on the north side of the railway comprises:
 - areas of exposed rock face with *blocks* that could potentially fail and break away from the face (failed blocks seen beside the track were evidence that this had occurred) (figure 6); and, above and between these rock faces,

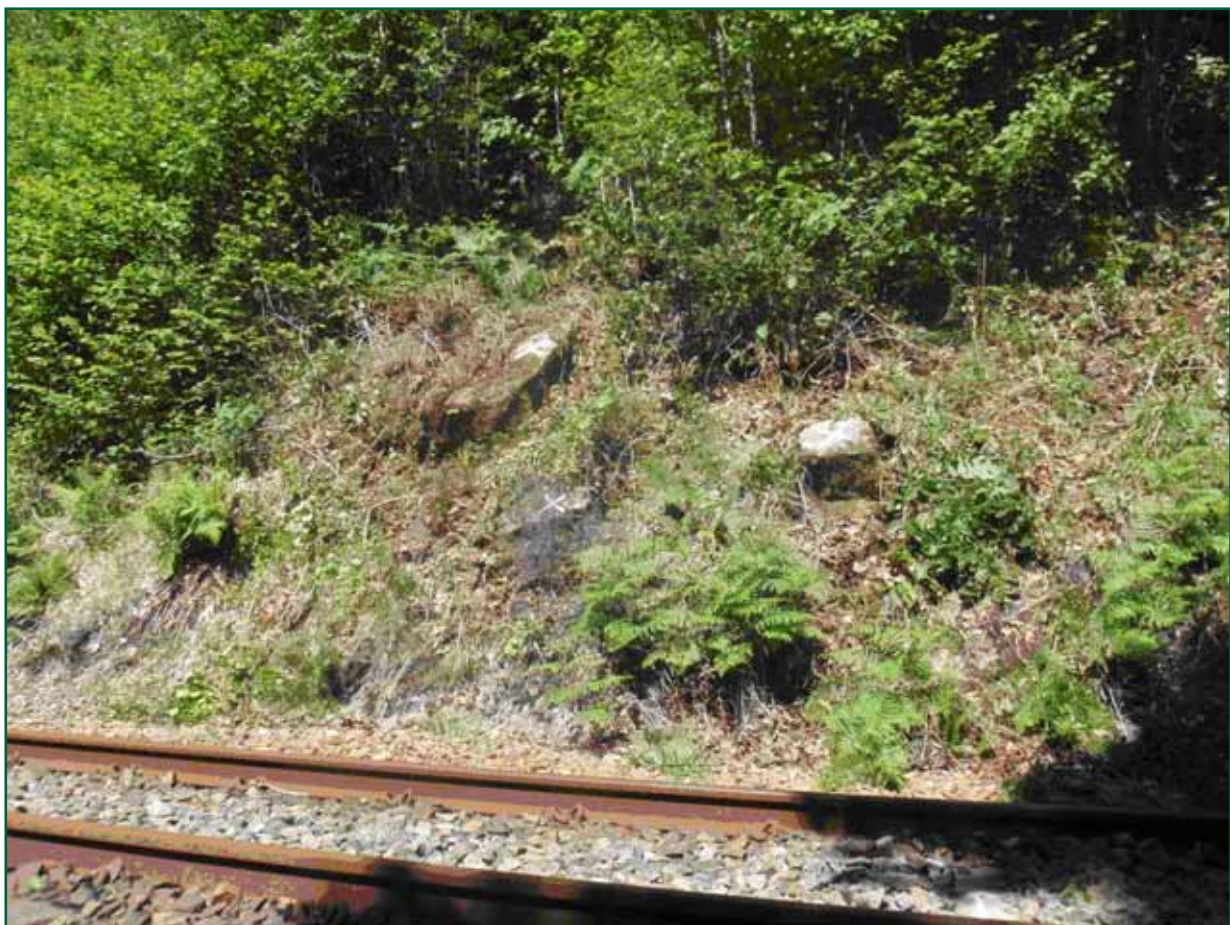
Figure 7: Area of soil slope containing isolated boulders (following post-accident de-vegetation) (image courtesy of Network Rail)

- areas of soil slope dotted with isolated boulders (figure 7).

103 Post-accident vegetation clearance close to the accident site revealed a significant number of boulders on the soil slope within the railway boundary, including some which were removed immediately as they posed a threat to railway safety. The combination of vegetation cover and poor access prevented examiners, and those who carried out the evaluation, seeing the boulder that caused the accident, or other loose boulders which should have alerted them to soil slope risks.

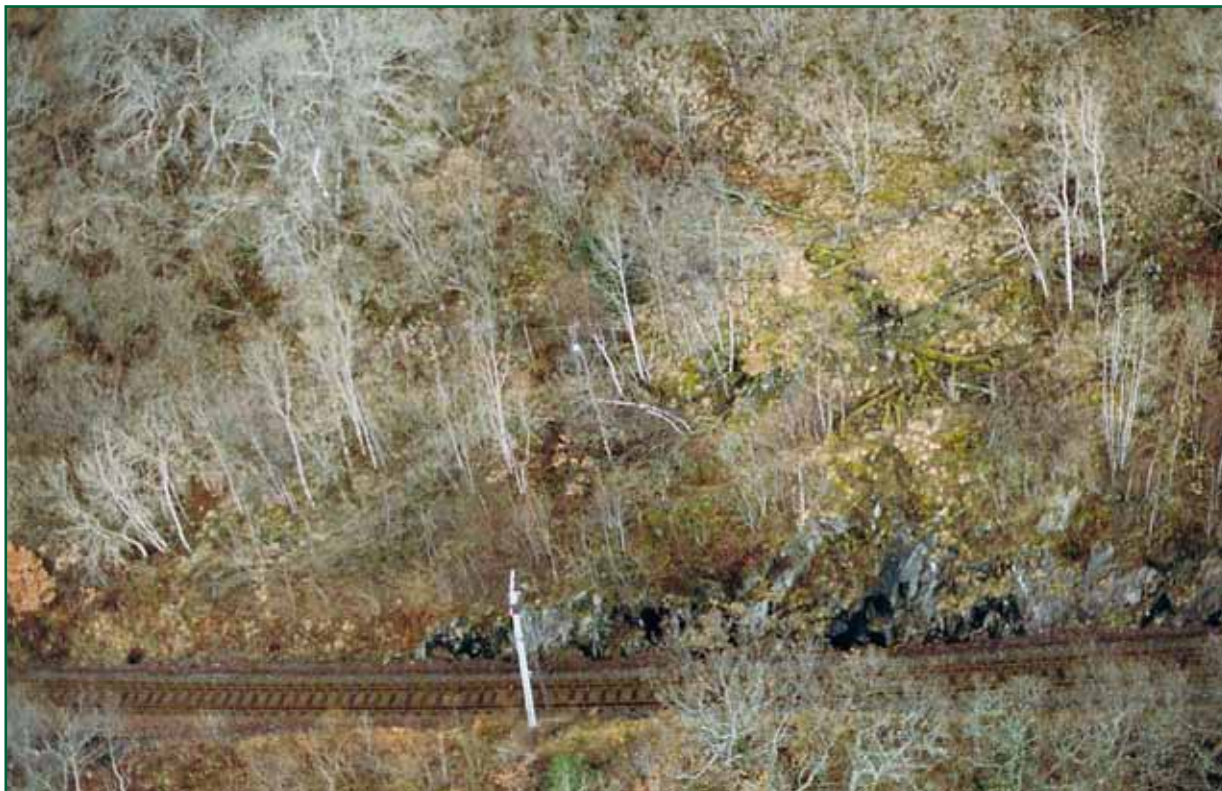
Figure 8: Winter's view of the slope in the Pass of Brander (image courtesy of Network Rail)

- 20 The areas of soil slope between the northern boundary fence and the railway line and top of the rock faces was covered with a dense growth of heather, bracken and trees, even in winter, when much of it dies back (figure 8).

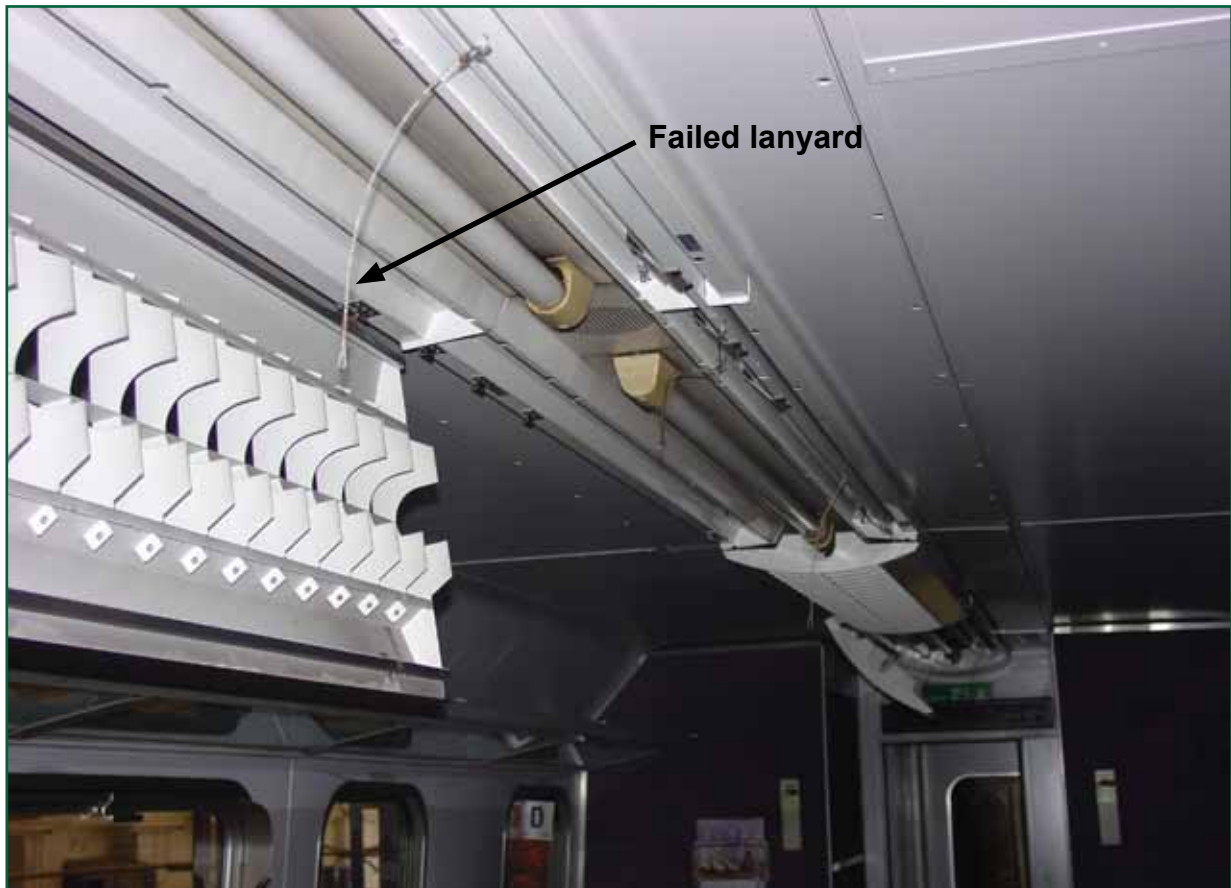
Figure 11: Lighting diffusers hanging down as a result of the collision

- 40 Most of the *budget locks* securing the lighting diffusers in the leading car failed to retain the diffusers when the impact with the boulder occurred. This resulted in lighting diffusers swinging down on their hinges either to a point where they were stopped by the wire lanyards used for *secondary retention* (figure 11), or completely in cases where the lanyard also failed. Six lighting diffusers came free from their hinges and fell to the floor. They could have caused serious injury to those on board in view of their weight (5.7 kg each) and sharp edges. However, the RAIB found no evidence that anyone on the train was hit by a detached lighting diffuser. Only three diffusers remained in place. These diffusers had budget locks that were defective and cable ties had been used to secure them.

A further recommendation has been made relating to the prevention of lighting diffusers and other saloon panels on rolling stock becoming displaced during accidents.

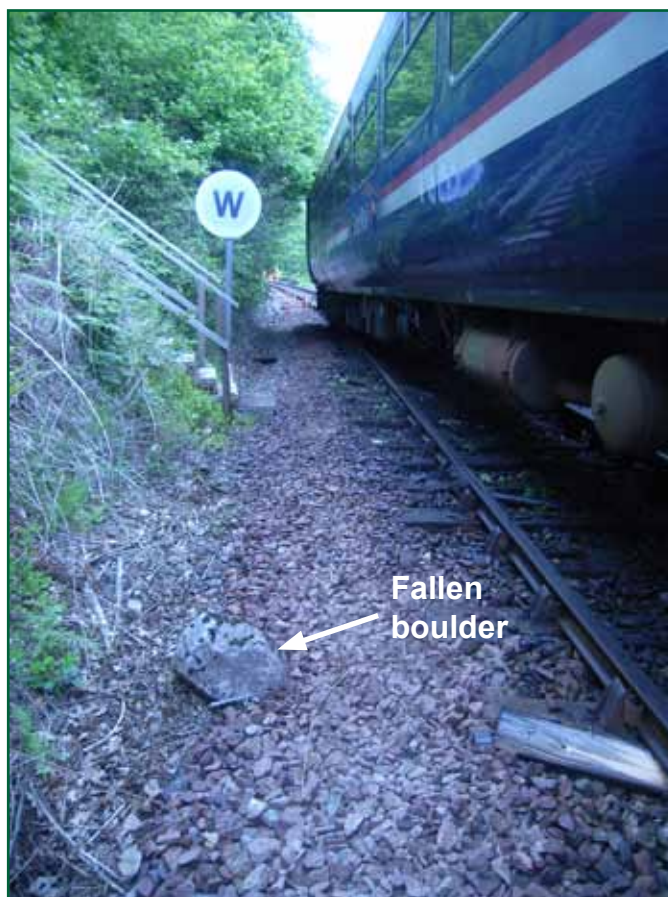
Figure 12: Previous fallen boulder from the soil slope

- 76 Close to the accident site, the soil slope below the railway boundary fence extends right down to the railway and is the same in character as the soil slope between the rock face and the boundary fence. Post accident investigations close to the accident site found loose boulders on the areas of soil slope after the partial removal of vegetation.
- 77 A photograph in the examination report dated 11 February 2007 shows a boulder in the cess which was not reported by the examiner. The boulder had apparently fallen from a soil slope and was still present when the accident occurred (figure 12).

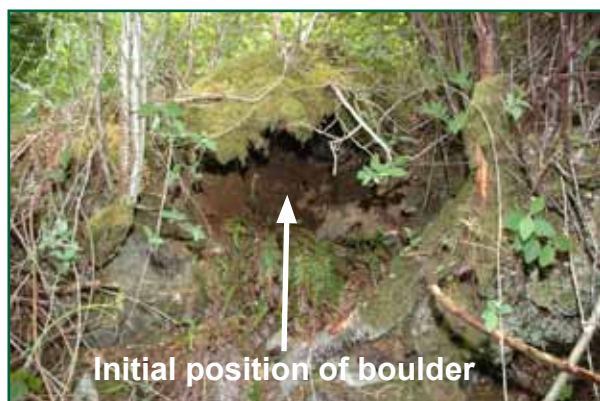
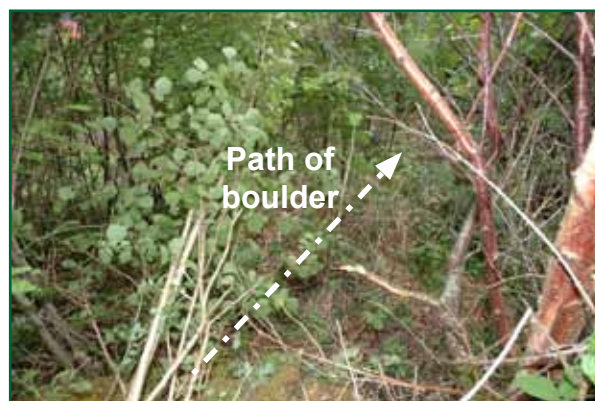
Figures 13a and 13b: Initial position of and subsequent path of the boulder onto the railway

- 92 **The immediate cause of the accident was that a boulder, within the railway boundary, became dislodged from the cutting slope on the north side of the railway and fell into the four-foot. The train struck the boulder causing it to derail.**
- 93 Inspection of the site after the accident identified the original location of the boulder and its path onto the railway (figures 13a and 13b).

97 The boulder had been located in a socket surrounded by soil and tree roots and its path onto the railway track was apparent from damage to vegetation. The RAIB observed on site that the socket was surrounded by tree roots positioned in a manner likely to have prised the boulder from its socket; a process that would have been exacerbated by erosion of the surrounding soil through normal rain fall. The potential for root jacking to cause instability on the soil slopes was not identified as a risk because of shortcomings in the examination and evaluation system (described in paragraphs 98 to 115).
