**Report on the runaway manually propelled  
trolley between Larkhall and Barncluith Tunnel  
2 November 2005**

# Report on the runaway manually propelled trolley between Larkhall and Barncluith Tunnel 2 November 2005

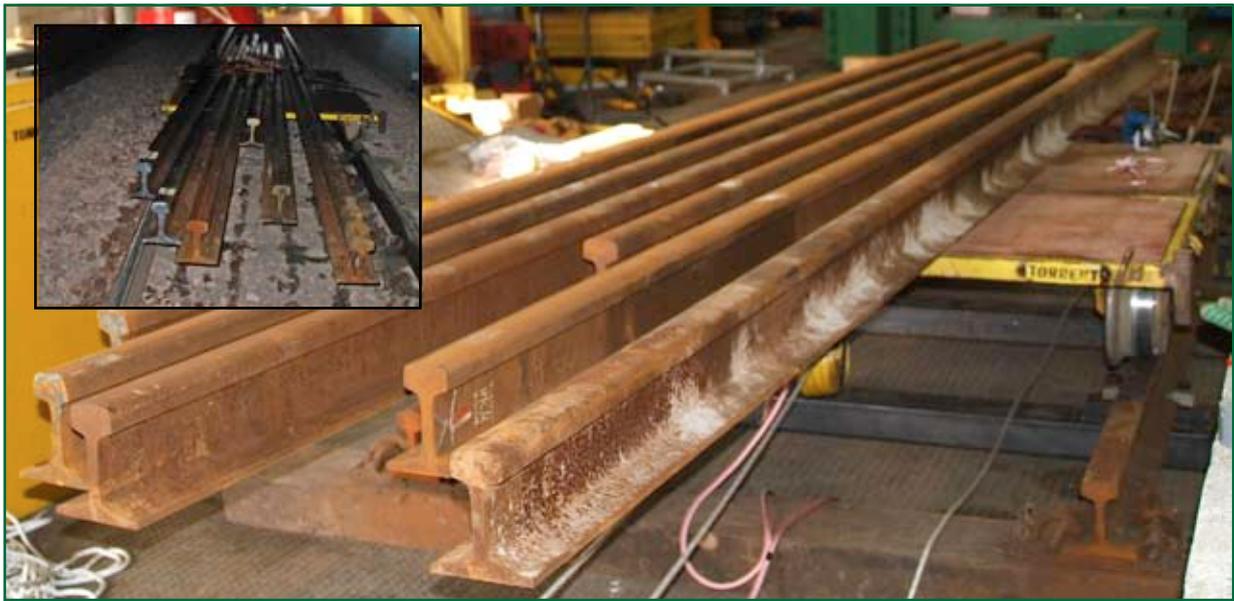
Figure 6: The incident trolley showing rails and relationship to 'as found' condition in Barncluith Tunnel

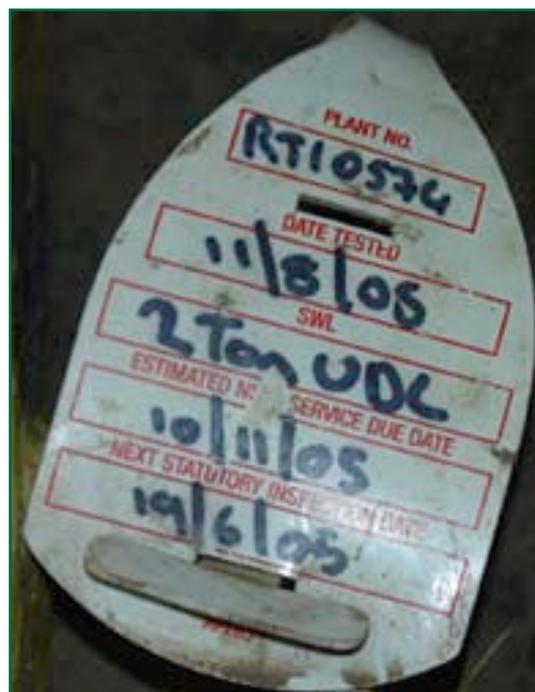
Figure 7: Bull tag on the incident trolley. This correctly indentifies the 3 month service date and incorrectly shows the annual inspection date as 2005

65 The trolley that was used had contaminated brake linings (see paragraph 124) and had an inspection bull tag giving the date of next annual service as June 2005, ie before the date of the incident.

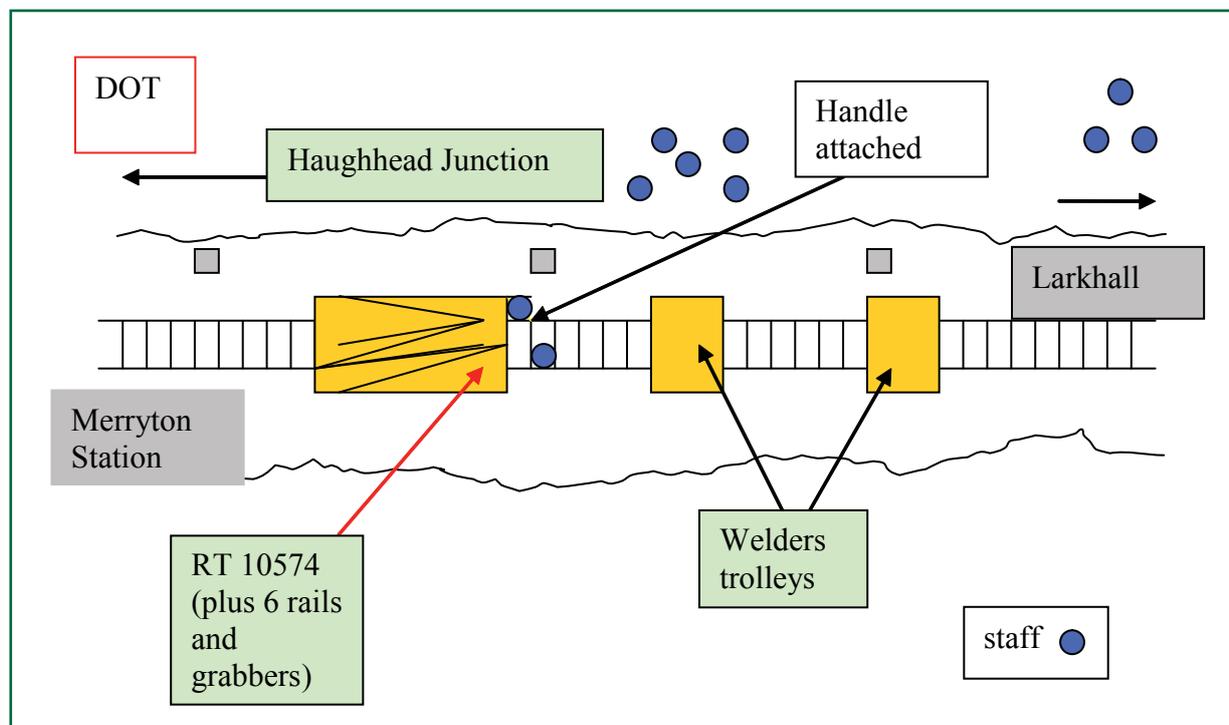
Figure 8: Merryton Worksite

64 The area near Merryton where rail recovery was undertaken was on a gradient of 1 in 48. The Railway Rule Book and Carillion ISM section I.01 both prohibit using a trolley on a gradient steeper than 1 in 50 unless specially authorised by local instructions. A load limit of 2 tonnes is painted on the trolley. There were no special or local instructions contained or referenced within the generic method statement that would have directed the COSS to a process that would enable the work to continue using a trolley. The decision to continue work was taken by the Carillion SS.

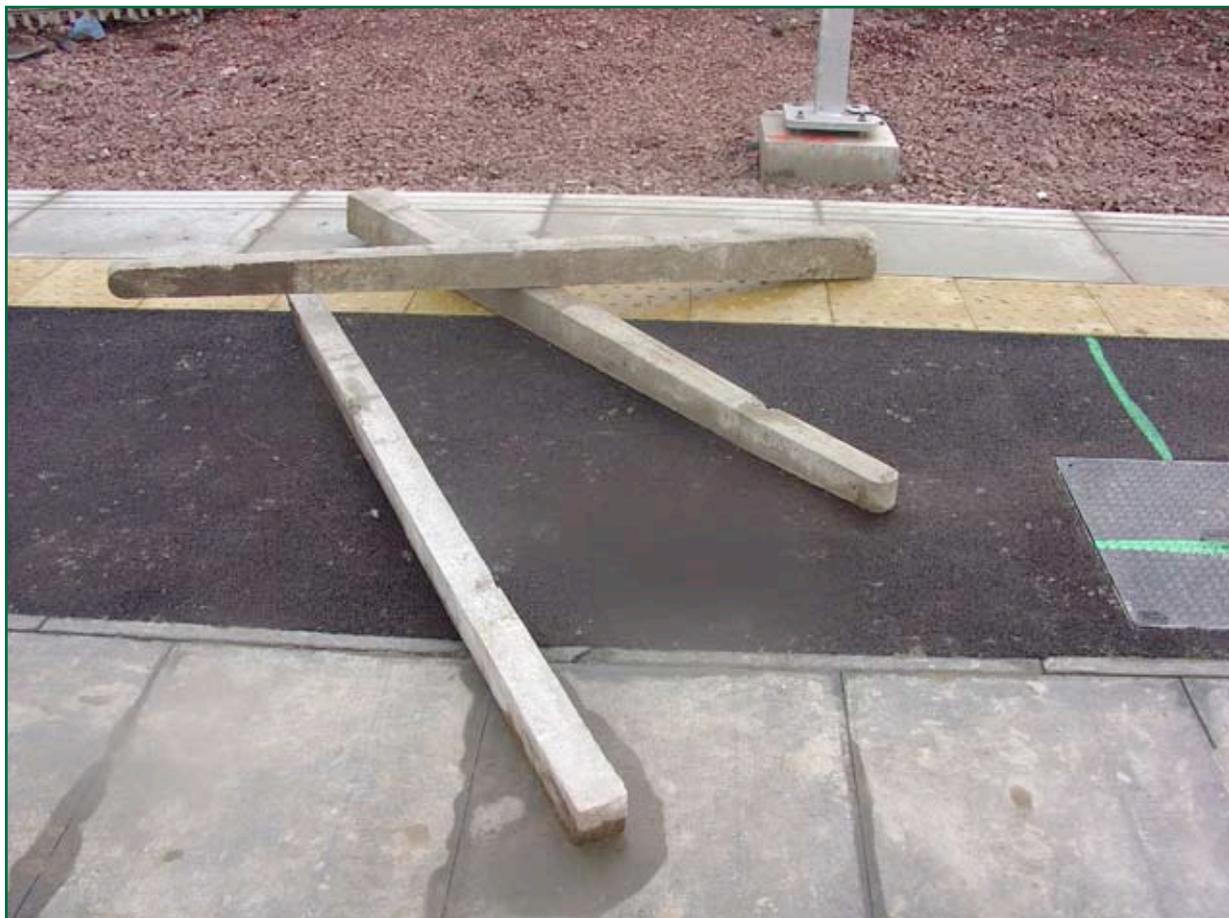
87 Skyblue and Carillion staff had by this time made their way to Chatelherault station. Three fence posts were thrown onto the track in an attempt to derail the trolley and prevent it from proceeding down the line. Unknown to these members of staff, the trolley had already passed this location. The fence posts were later removed and placed on the station platform.

Figure 11: Image of fence posts thrown onto the running line in an attempt to prevent the trolley passing through Chatelherault station

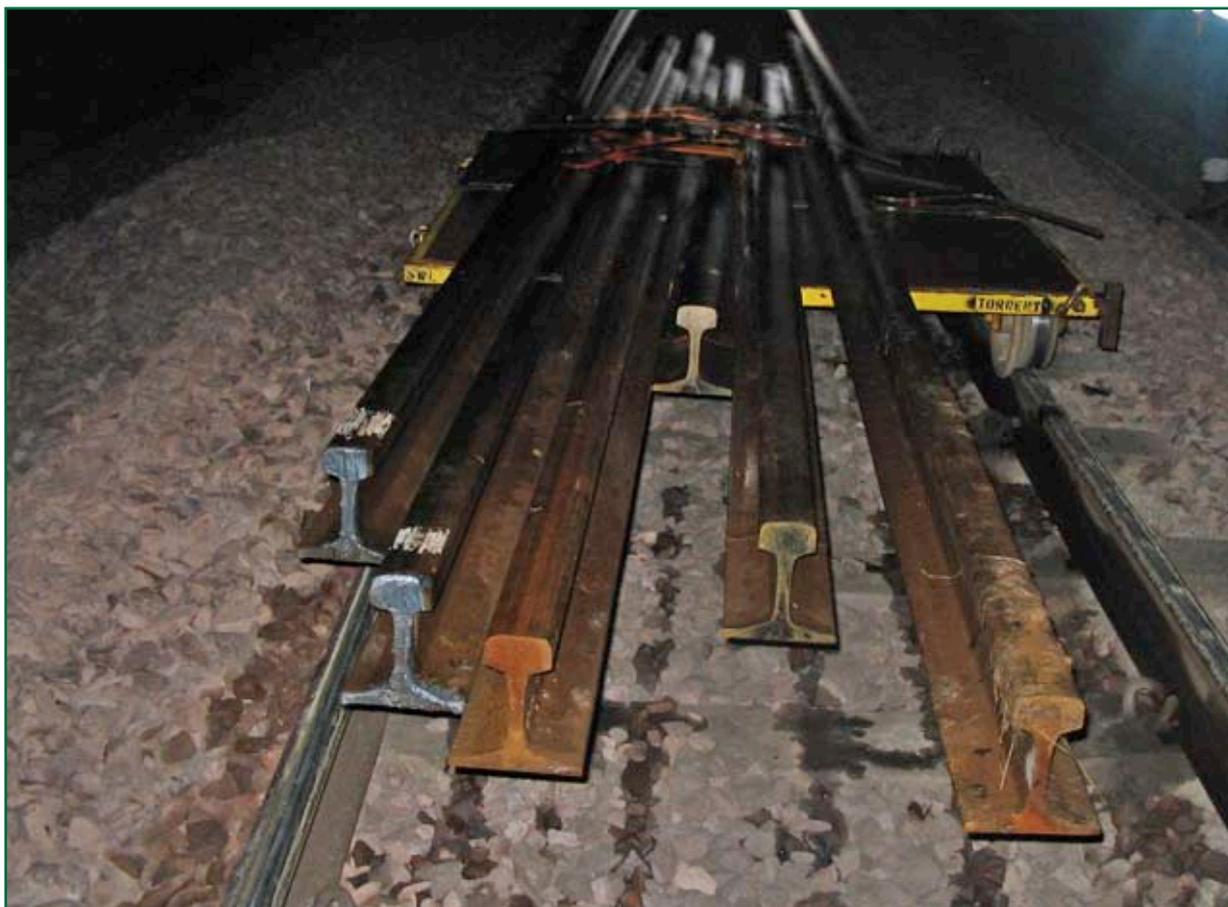
Figure 12: Image taken by the RIO from within Barncluith tunnel

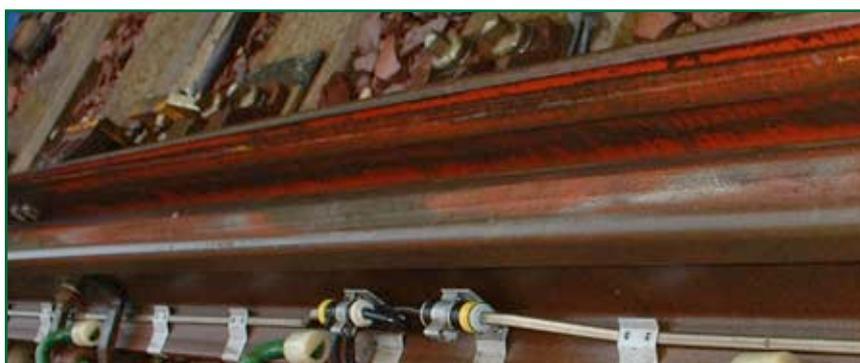
Figure 13: Image of flange climb marks from RT10574 wheel and number 50 points blade at Haughhead Junction

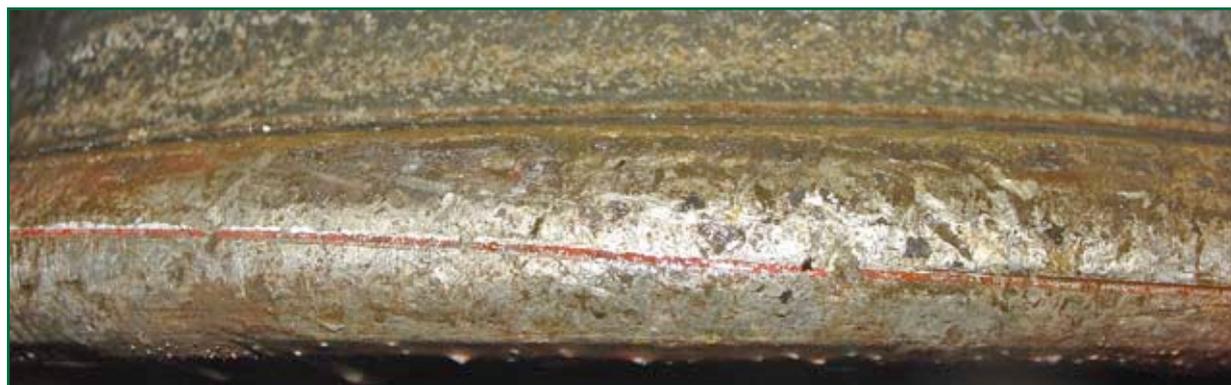
Figure 14: Cross contamination samples and flange climb marks (shown in red) on trolley wheel and Haughhead Junction number 58 points blade

104 Although there was evidence of 'swarf' from the aluminium wheels of trolley on the switch blades of number 58 points, no damage was sustained by the rails, stretcher bars or point mechanisms. The points were examined and authorised for immediate use by Network Rail engineers. No remedial work was required.

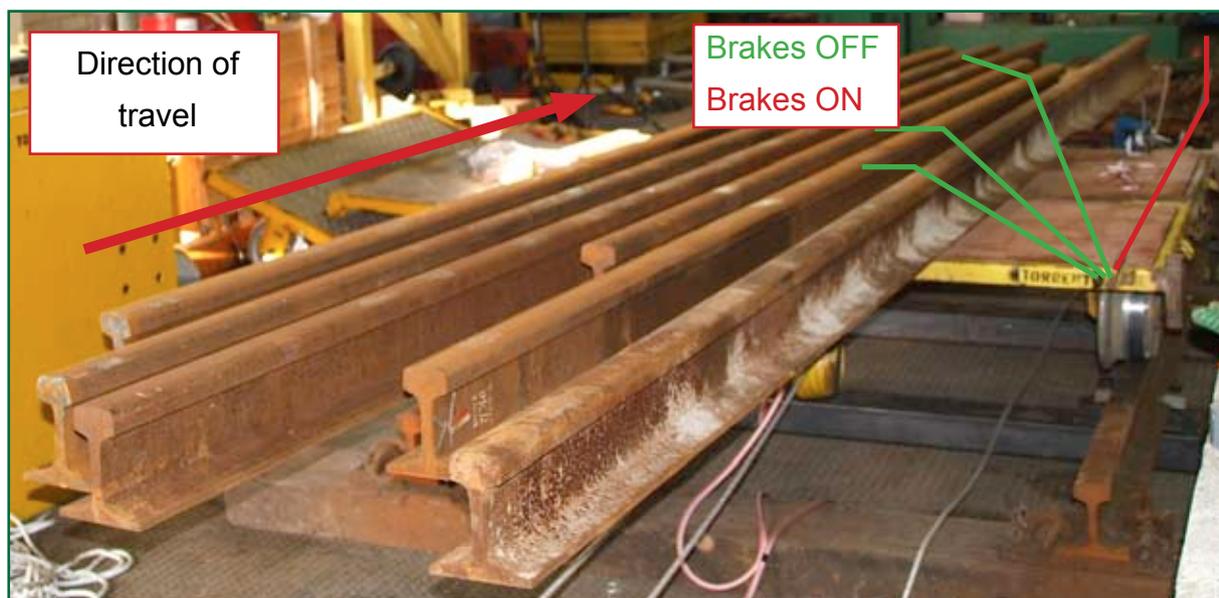
- 84 The trolley continued to Haughhead Junction. It ran through number 58 points which were set for the main line. As it hit the switch rails (see Figures 14 and 15) the lurch from *running through* the points caused the brake handle to become dislodged. The handle bounced forward into the cess in the direction of Barncluith tunnel where it was later discovered.

Figure 15: Image of incident trolley RT10574 showing incident rails in position and handle positions

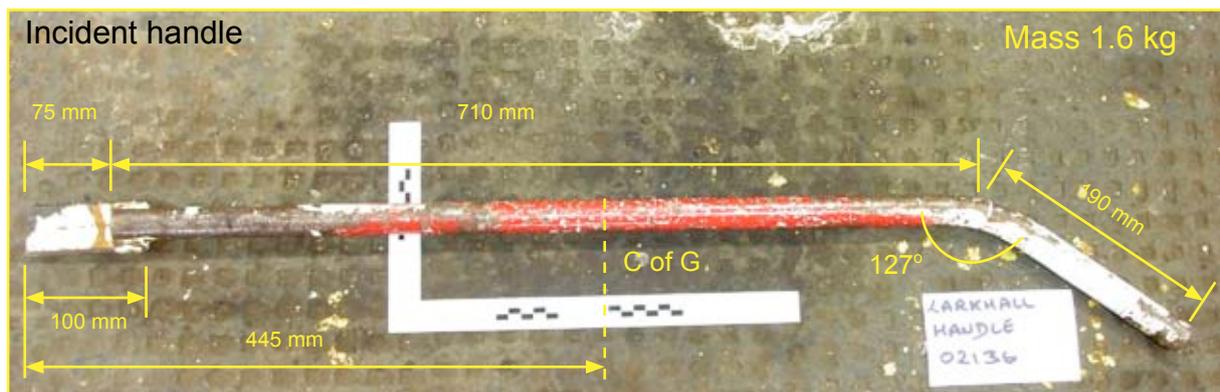
175 The handle found at Haughhead Junction (see paragraph 111) was identified as that used on the incident trolley. However it was not supplied for use with a Type B Permaquip trolley (Figure 10), but for use with a *Link* trolley also known as a Type A (Figure 12).

177 The Type B handle is designed specifically to activate and release the ‘fail safe’ brakes on the Type B trolley. The design of the spigot does not prevent ‘predictable misuse’ in that any tube-like handle of an appropriate diameter can be used. The Link type handle is designed to engage through the spade shaped end of the handle, but turning it end to end permits the handle to be fitted over the spigot of a Type B trolley. Such misuse will affect the load applied to the spring on the trailing brake mechanism in the ‘applied’ position. The Link type handle will apply a turning moment due to its position in that it will lie in a lower position, and there is an increase in the moment caused by the weight of the ‘spade’ which is some distance from the pivot when applied in this manner.

Figure 18: Link handle found in vicinity of Haughhead Junction number 58 points in rear of the runaway trolley. Identified by witnesses as the incident handle.

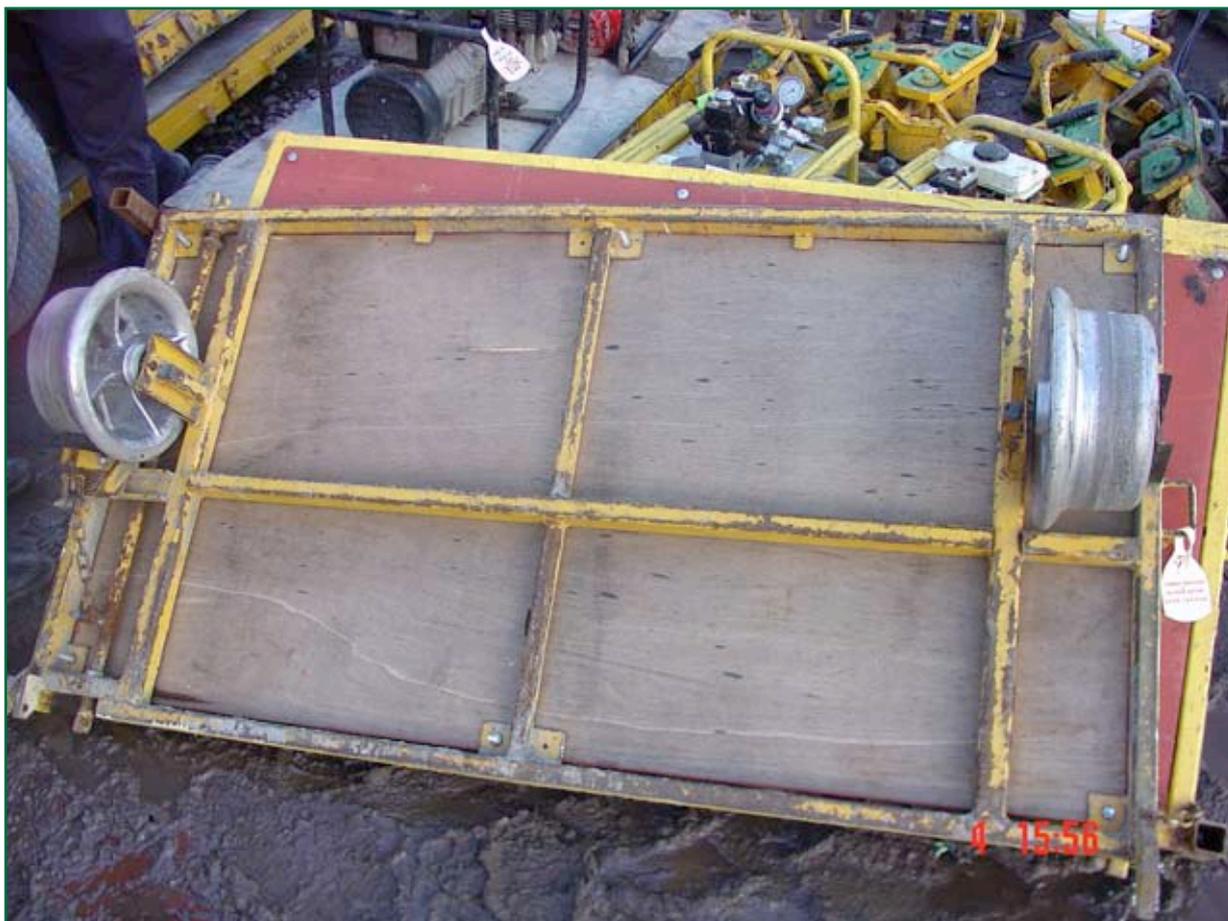
- 219 Examples of both Link type and Type B of trolleys were stored at the depot in an area where contamination was evident. The incident trolley was based at the depot, on lease, over the previous four weeks. Evidence gathered indicates that the trolleys were regularly stored in areas where geological contamination had been in contact with the brake mechanisms. It is thus likely that the contamination of the brake block lining material on the incident trolley occurred here.

- 220 Contamination of the brake lining reduces braking performance, as demonstrated by the RAIB’s tests (see paragraphs 125 and 126). The contamination of the brake lining of the trolley due to its use and storage was causal to the runaway.

Figure 21: Area at Lanark Road where manual trolleys were stored

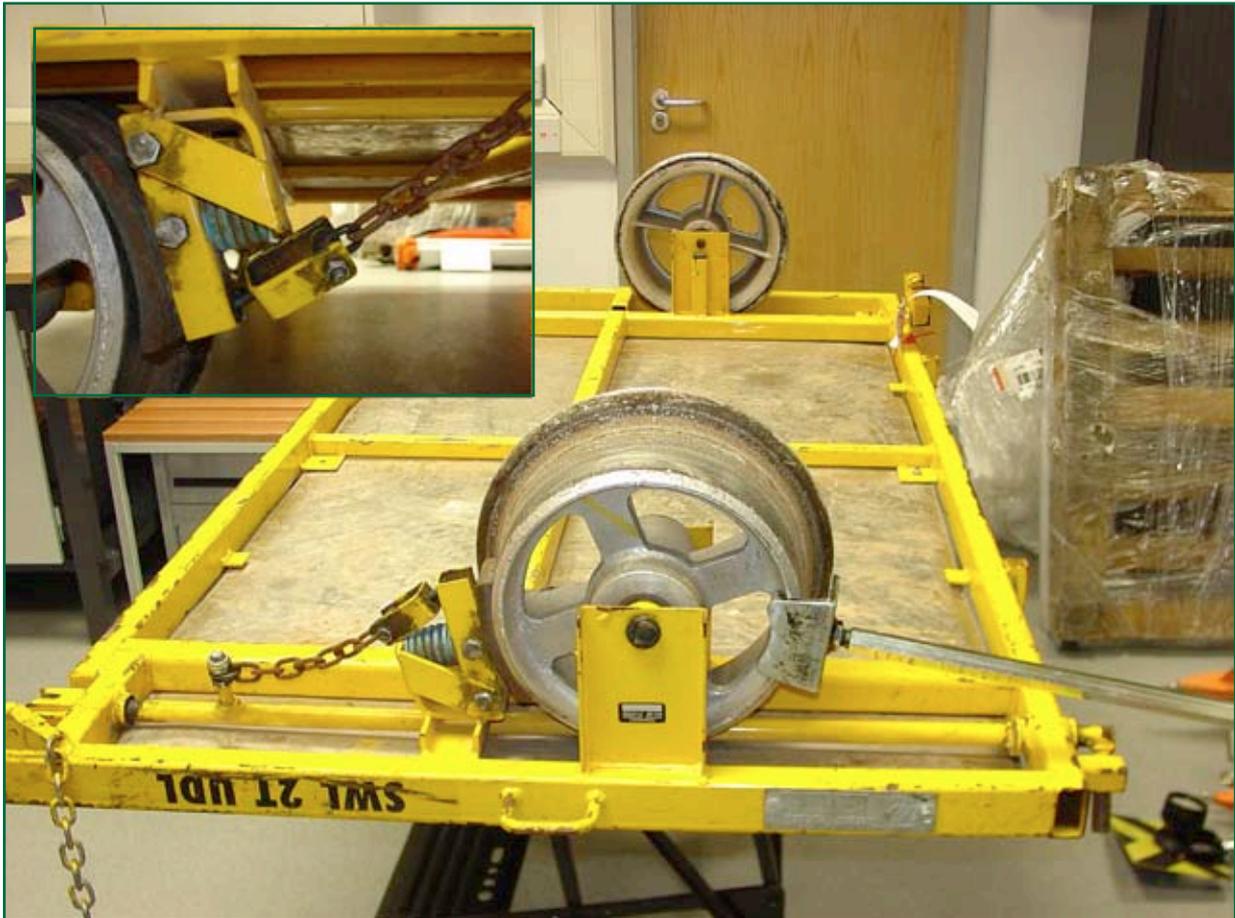
Figure 23: Image showing trolley, brake block and associated linkage (reference trolley)
