Rail Accident Investigation Branch

Rail Accident Report

Derailment at Starr Gate, Blackpool 30 May 2006

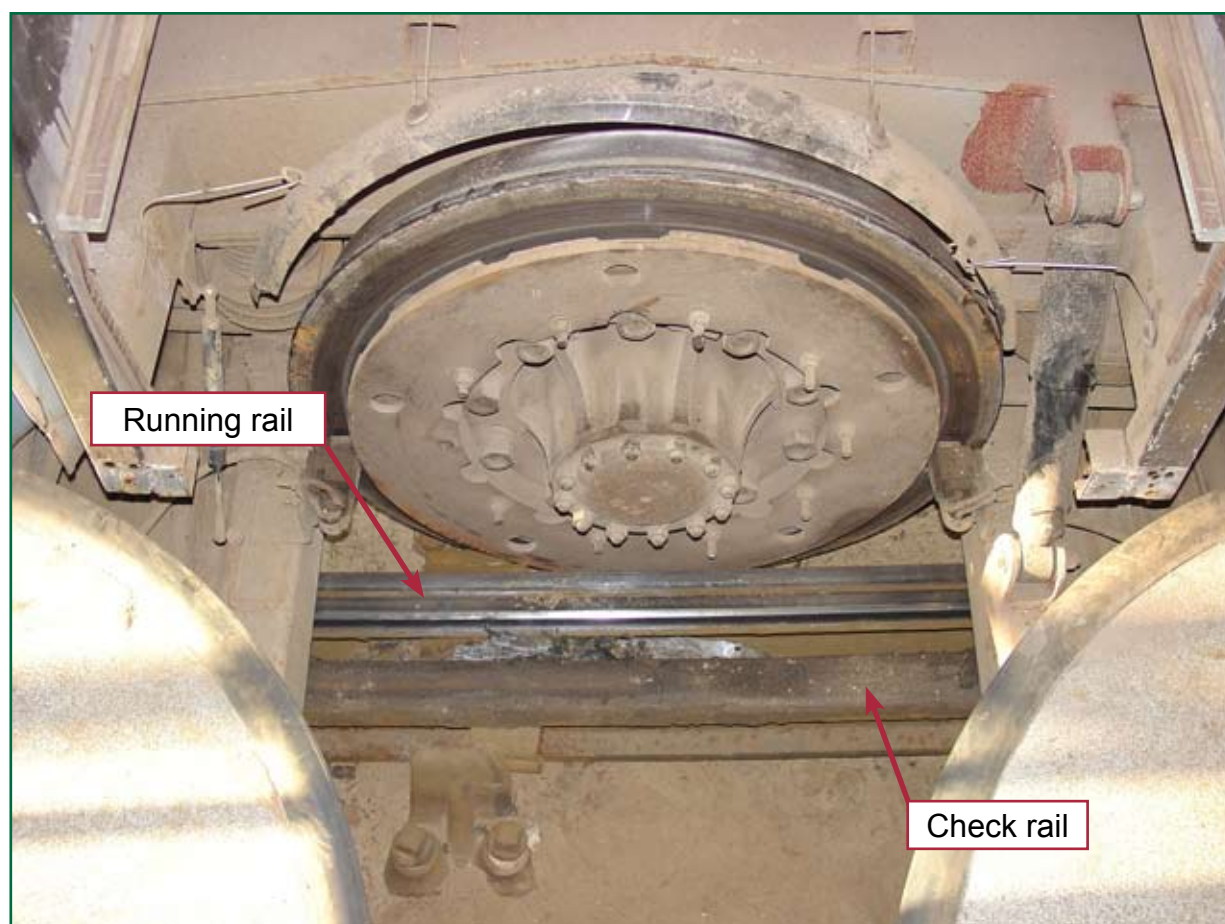
The Incident

Figure 3: View from inside the articulation module showing the location of the inner derailed wheel

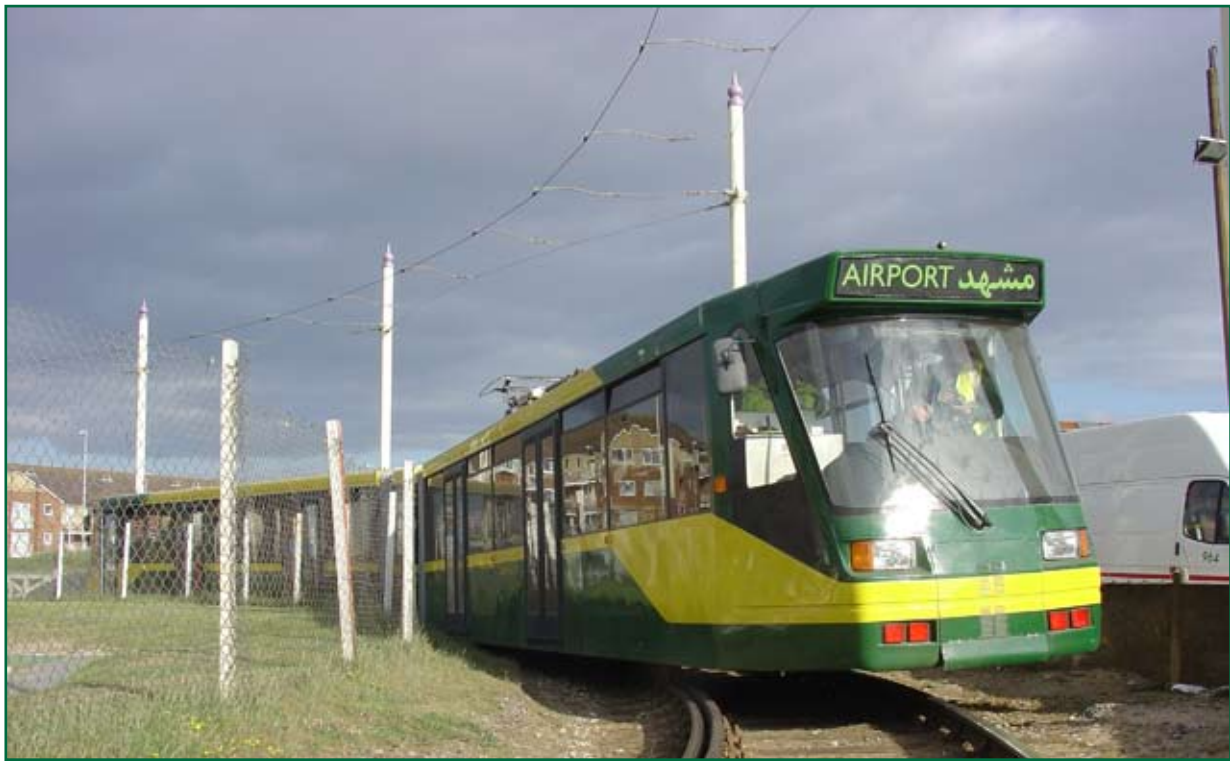
28 The tram remained upright and no other wheels were derailed; see Figure 4. There were no injuries and only minor marking of the track. There was no significant disruption to passenger service as arrangements were made to enable service trams to turn back at a *crossover* immediately north of the loop and continue running.

Figure 4: Derailed tram

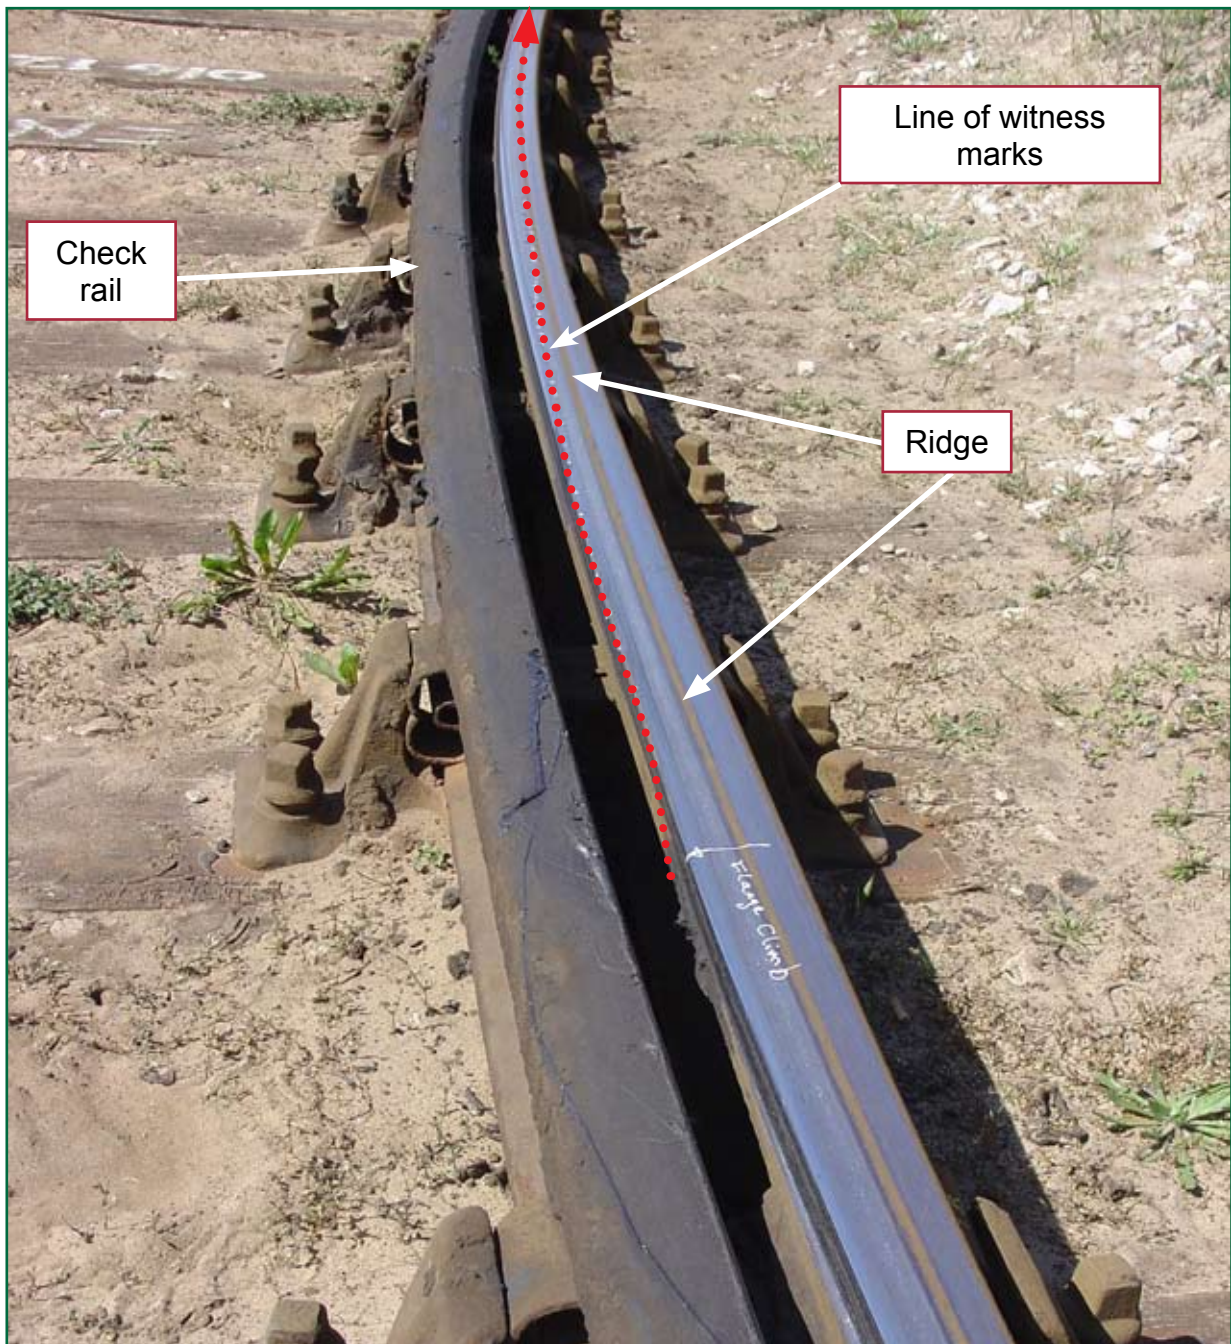
The tram

Figure 5: Witness marks on the inner rail showing the path of the wheel flange climb and its sustained running on the rail head

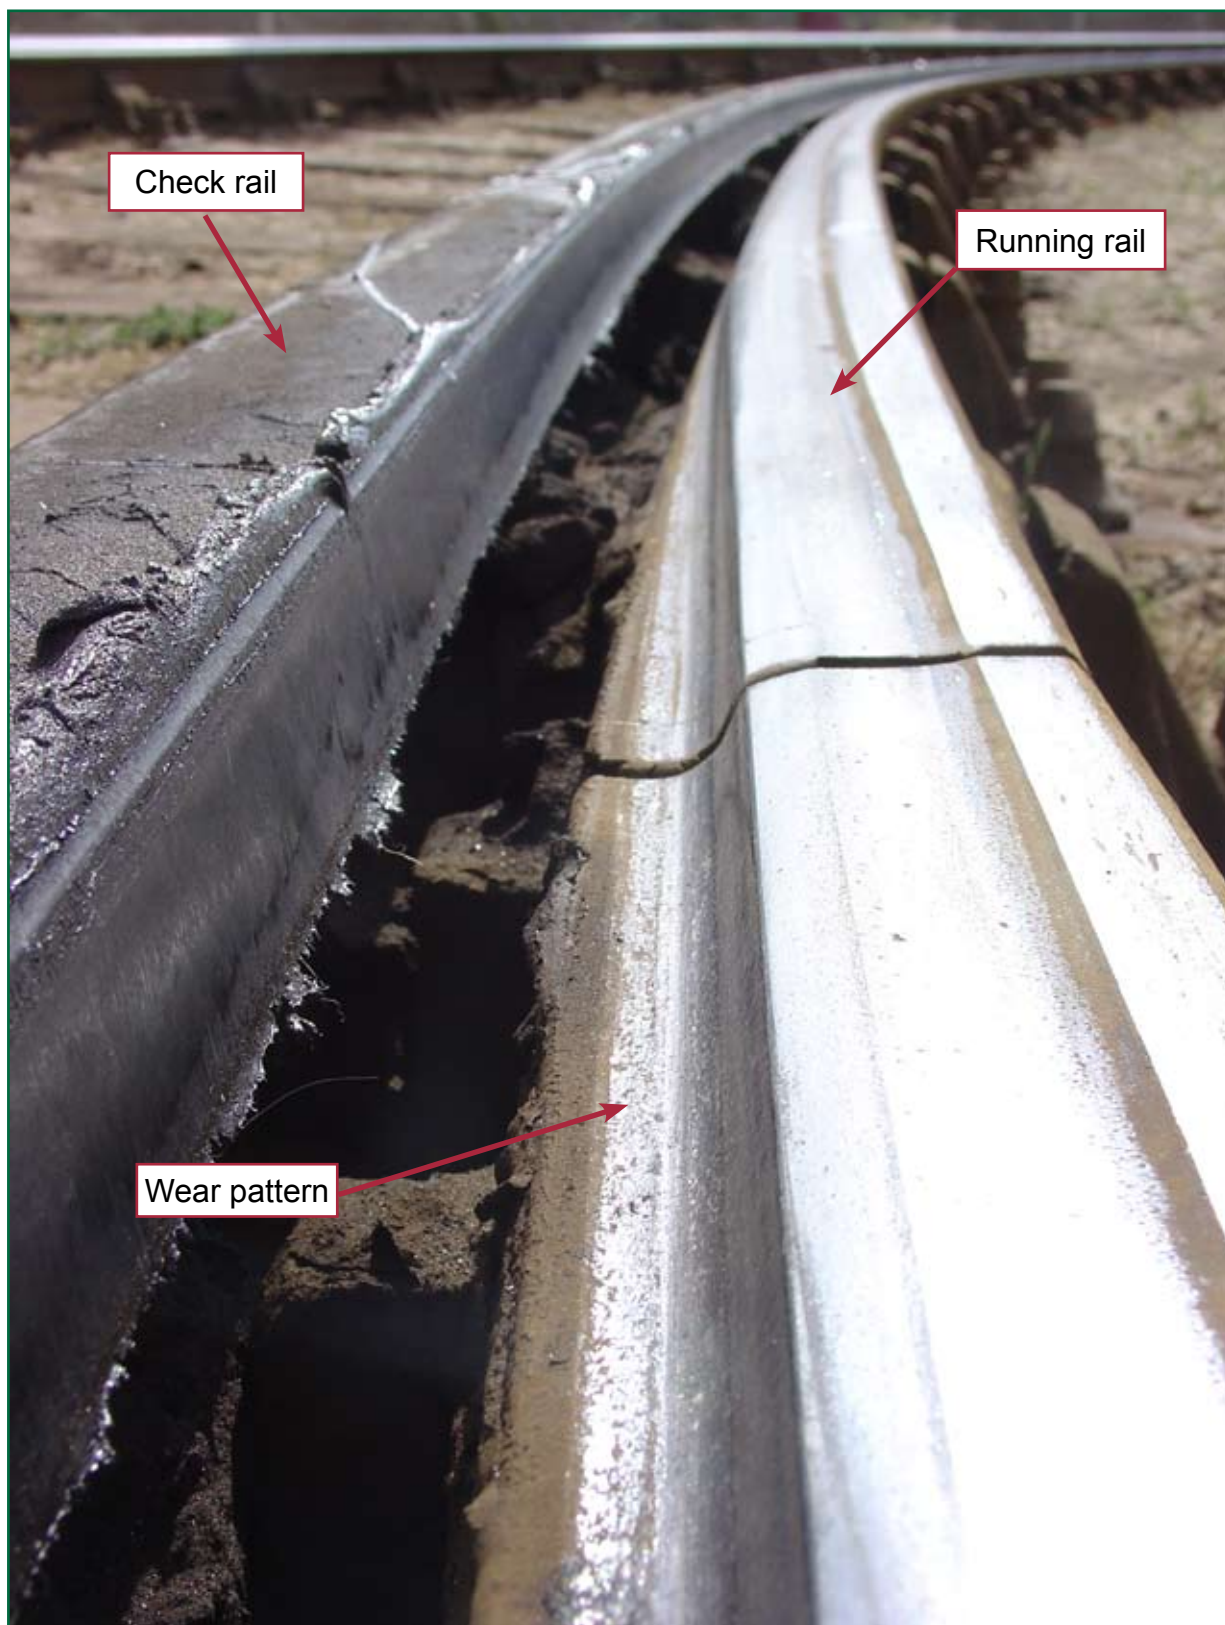
33 A *rail joint* was located immediately prior to the place where the wheel flange had started to climb the inner rail. Wear was evident on the gauge face of the rail, see Figure 6.

Figure 6: Pattern of wear observed on the gauge face of the rail

- 46 HMRI has put Tram Power in contact with a specialist consultancy having the capability and experience of analysing the dynamic behaviour of the type of running gear fitted to tram 611. Proposals for a study of the dynamic behaviour tram 611 have been discussed.
- 47 Tram Power has also been in discussion with other tram operators regarding their experience of the behaviour of independent rotating wheels.
- 48 BBC has re-profiled the rail gauge face on the loop by grinding.

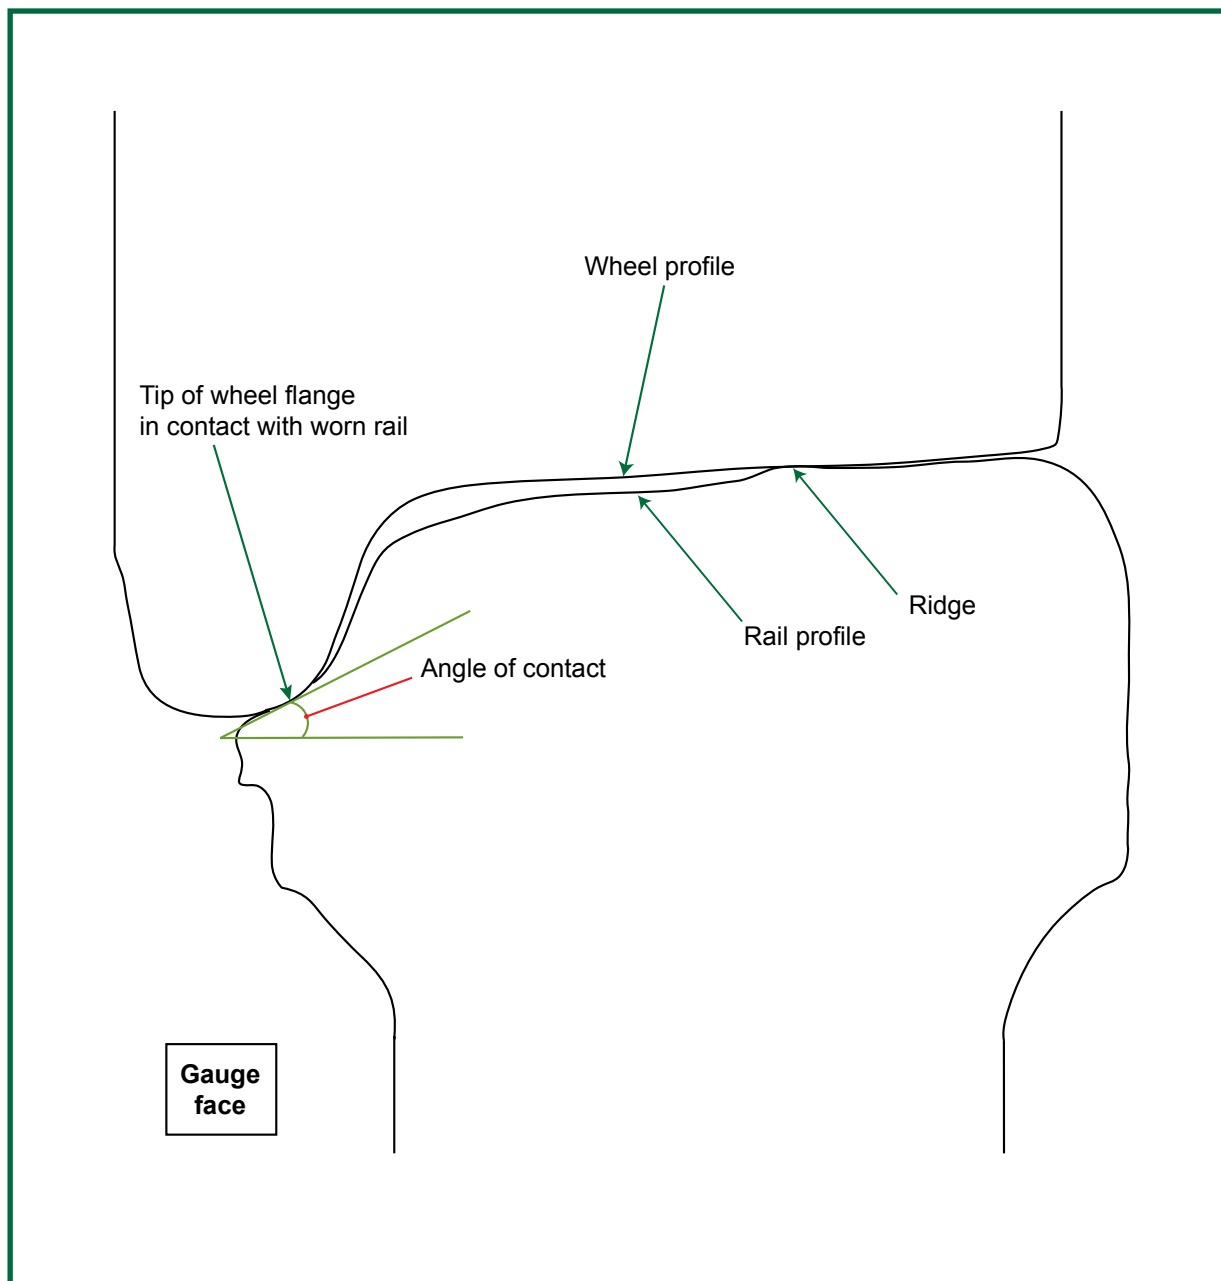
Figure 2: Principal arrangement of the tram

Figure 7: Overlay of measured rail and wheel profile showing the potential for wheel flange tip contact

35 The above shows the immediate cause of the derailment was that the tip of the wheel flange came into contact with the worn profile of the rail gauge face whilst a sufficiently high horizontal force was acting toward the centre of the curve. The check rail provides no protection for a wheel derailing in this direction.
