Rail Accident Investigation Branch

# Rail Accident Report

## **Tram collision at Soho Benson Road, Midland Metro 19 December 2006**

Report 17/2007  
June 2007

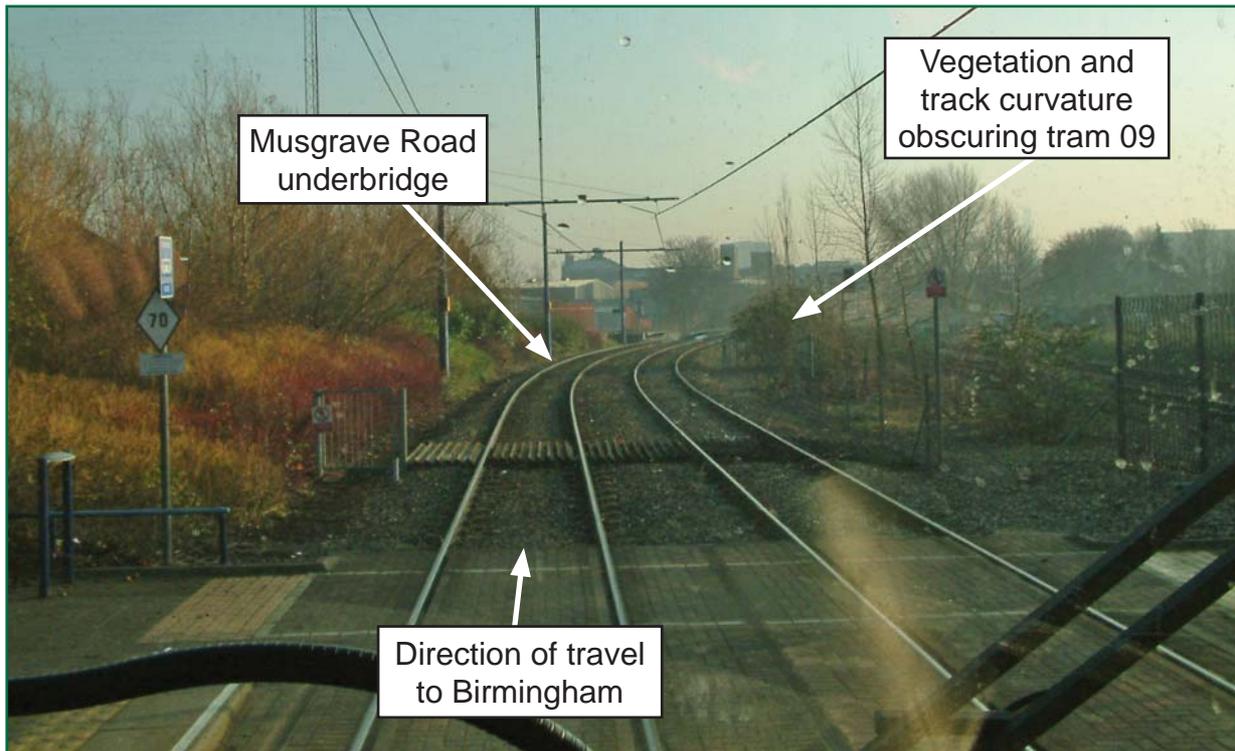
Figure 5: Tram 09 and the collision location obscured from tram at Soho

- 28 After tram 09 departed Soho nine minutes late at 11:49 hrs the original fault reoccurred and caused an automatic application of the service brake that brought the tram to a halt 62 metres north west of Norton Road overbridge. See Figure 3. At this location, tram 09 was obscured from trams departing Soho due to right hand track curvature and vegetation on Network Rail infrastructure at Musgrave Road underbridge. See Figure 5.
- 29 Tram 09's driver called the control centre using the cab mobile phone and waited for the call to be answered. The driver did not use the tram's hazard warning lights to warn other trams of the obstruction.
- 30 Up to this time tram 10's driver had not seen tram 09 ahead at any time in its journey, even when the time interval between trams reduced to one minute.

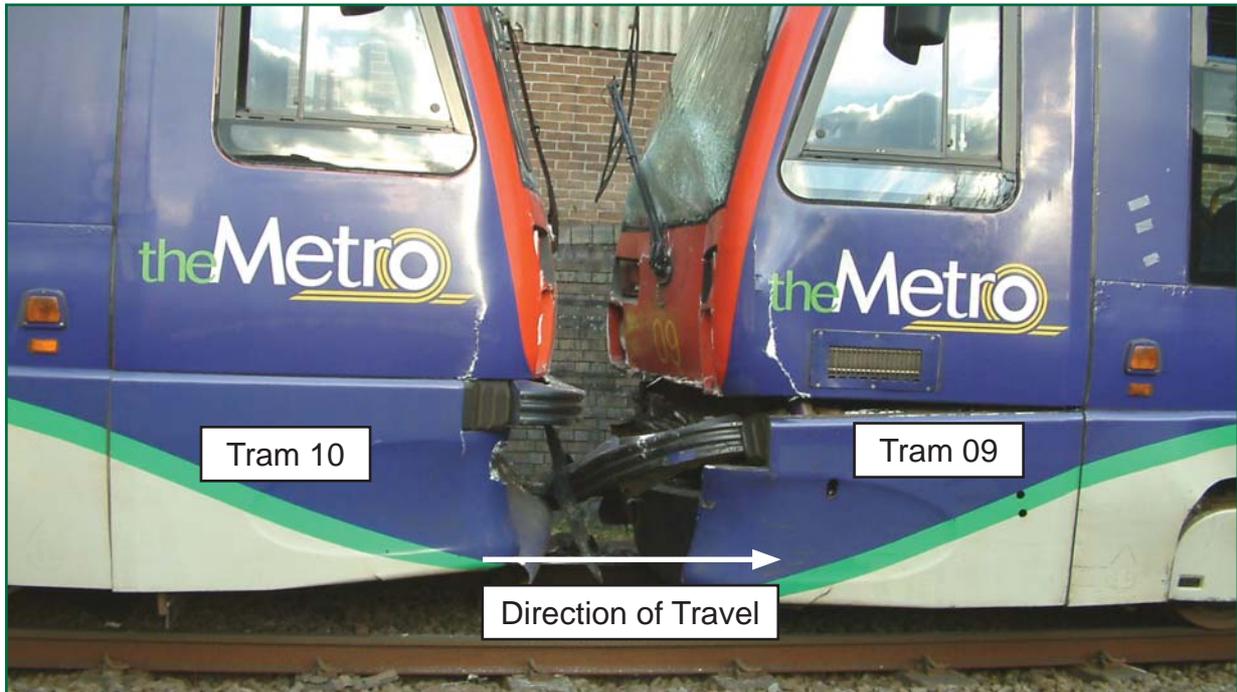
Figure 6: Trams 10 and 09 after the collision

39 Trams 09 and 10 sustained damage to their cabs. See Figures 6 - 9.

- 90 Structural damage was confined to the trams' cabs only. Neither tram 10 nor tram 09 sustained damage to any other structural element, including the passenger saloon and the articulation joints. The trams' collision damage compared favourably with the damage predicted by the computer simulation.

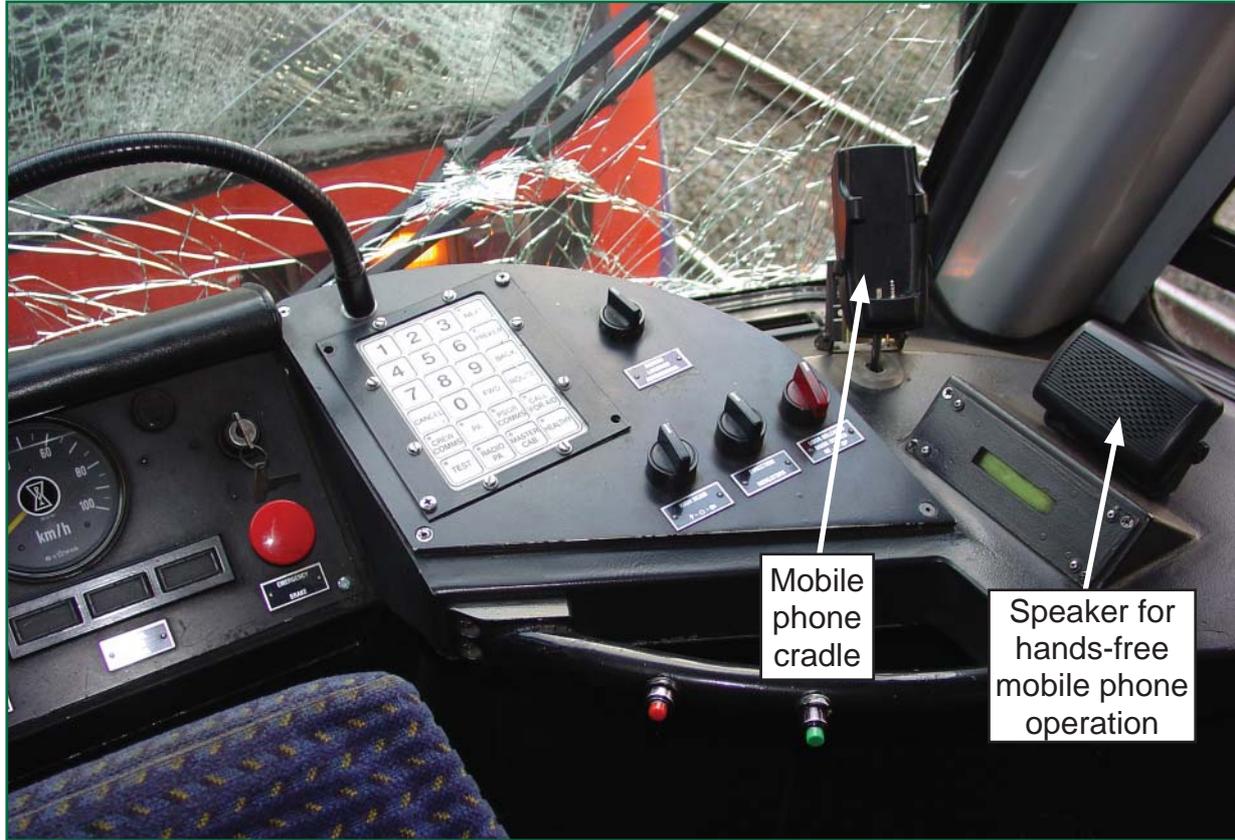
Figure 9: Inside tram 10's cab

- 75 Although TMM installed the cab mobile phone in a desk mounted cradle with a speaker for hands-free use, they did not discourage its hand-held use by retention of the phone to the cradle. See Figure 9.

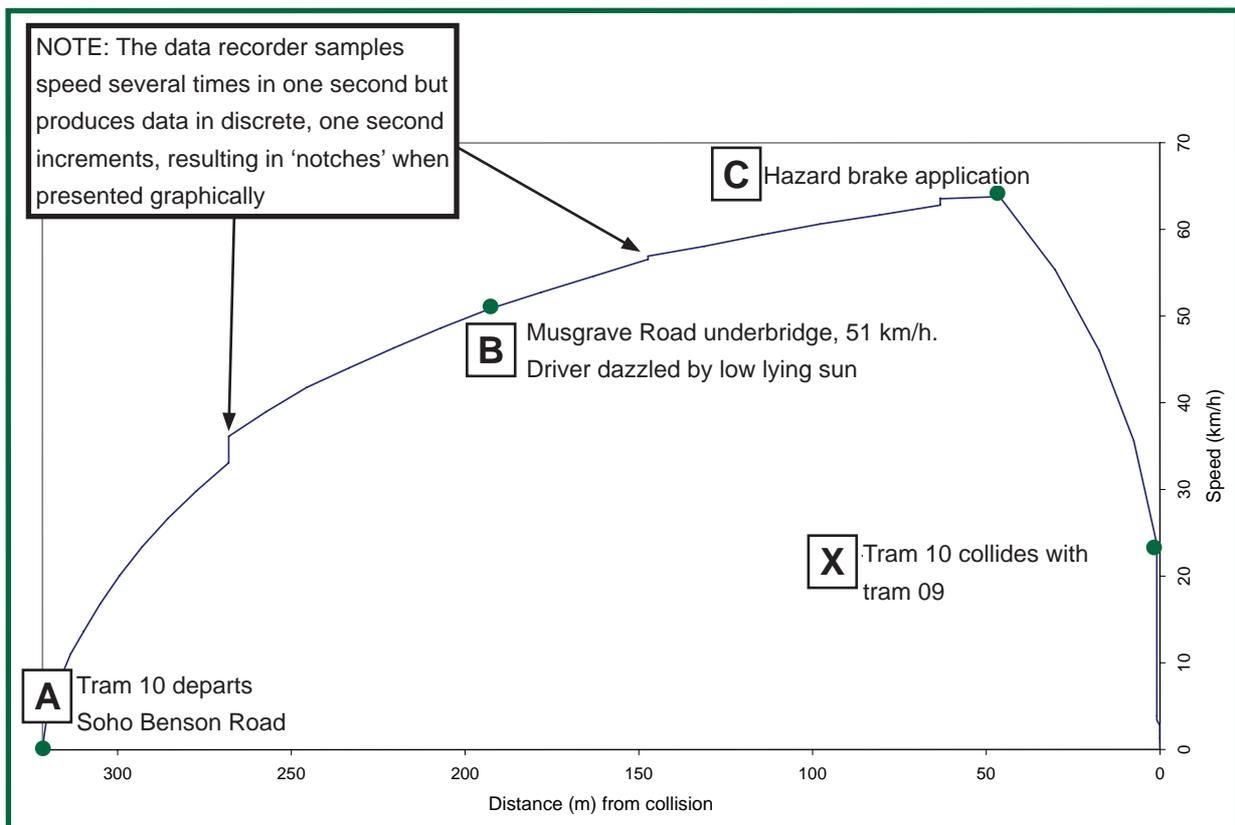
Figure 10: Tram 10 data recorder analysis from Soho Benson Road tram stop to the collision

45 Office of Rail Regulation (ORR) guidance on tramways<sup>1</sup> paragraph 353 (b) states that '[Trams] should have a hazard brake with a retardation rate of at least 2.5 m/s<sup>2</sup>'. The retardation rate of tram 10, calculated from the tram's data recorder, was 3.0 m/s<sup>2</sup> from hazard brake application until collision. See Figure 10.

46 With the exception of its sunblind mechanism tram 10 had performed satisfactorily; there was no evidence of abnormal operation prior to the collision. After the collision the tram was the subject of post-accident examination and brake testing. No faults were found. Tram braking performance did not contribute to the accident.

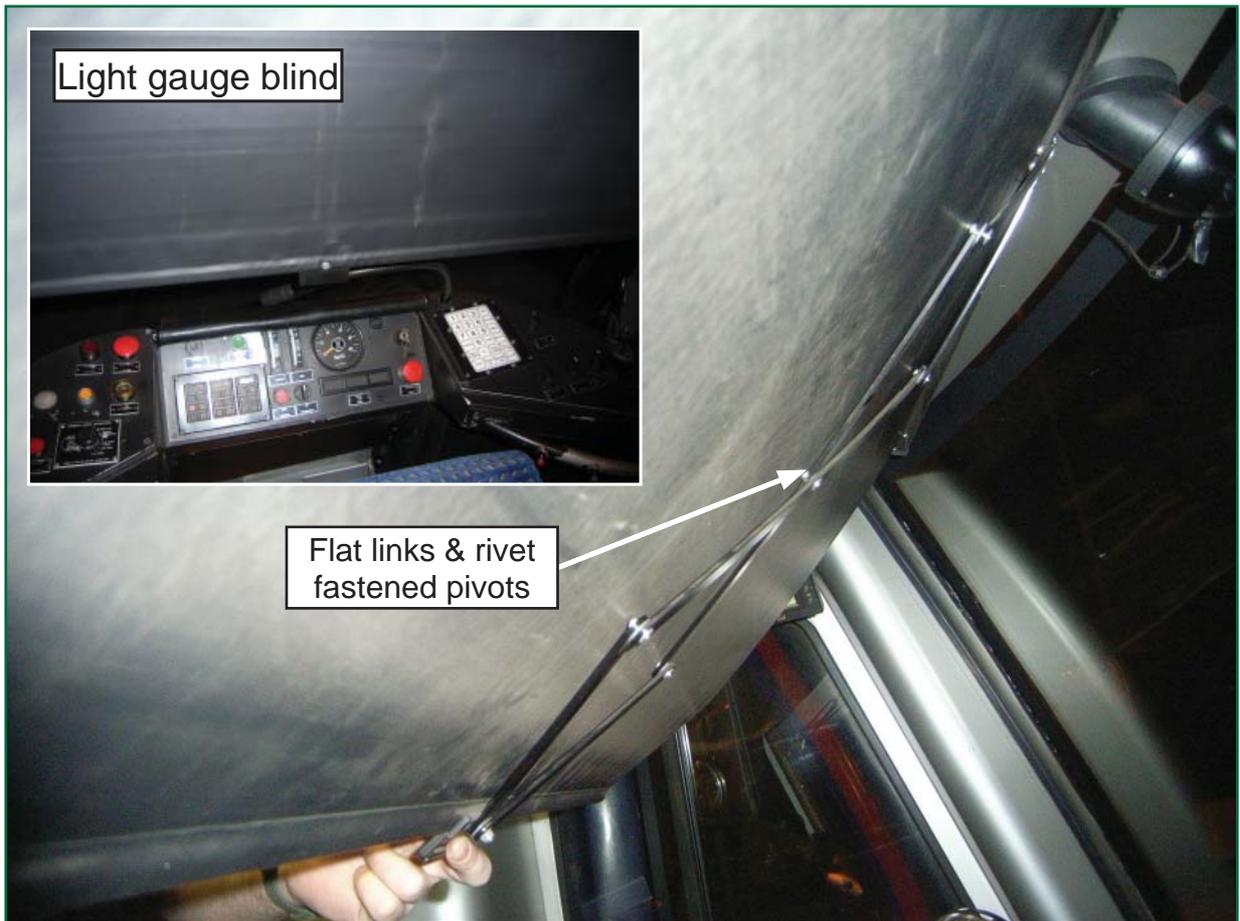
Figure 12: Sunblind mechanism - type II

61 Sunblind type II is used as a replacement for type I and has a scissor mechanism with flat links, rivet fastened pivots, a thin gauge blind and no device to adjust clamping force; the force that is required to deploy or retract the blind. See Figure 12.

- 64 When the driver attempted to deploy tram 10's type II sunblind, a 'wedge' made from ticket roll paper fell from the mechanism. The wedge had been used by an earlier driver to prevent the sunblind from involuntary retraction, a commonplace event according to TMM staff and supported by test results.
- 65 The driver released the TBC and attempted to reinsert the wedge into the mechanism with the sunblind at the required position, and stated that this activity took approximately three seconds.
- 66 A contributory factor was that tram 10's driver became occupied with adjusting a sunblind that would not remain in position.

- 1 TMM should:
  - (i) modify the design of the tram sunblinds to ensure that, when deployed, they remain in position during tram operation;
  - (ii) amend the maintenance regime to ensure that sunblind mechanisms remain fit for purpose over their working lives; and
  - (iii) amend their procedures to ensure that fleet checks are carried out to a standard sufficient to correctly identify faults (Paragraph 101b).
- 2 TMM should amend their procedure for tram failure to require the use of hazard warning lights immediately a tram is causing an obstruction (Paragraph 101c).
- 3 TMM should conduct a risk assessment into their off-street operation to identify improvements that could be made in the identification of and response to unexpected hazards, including obstructions on the tramway (Paragraph 74).

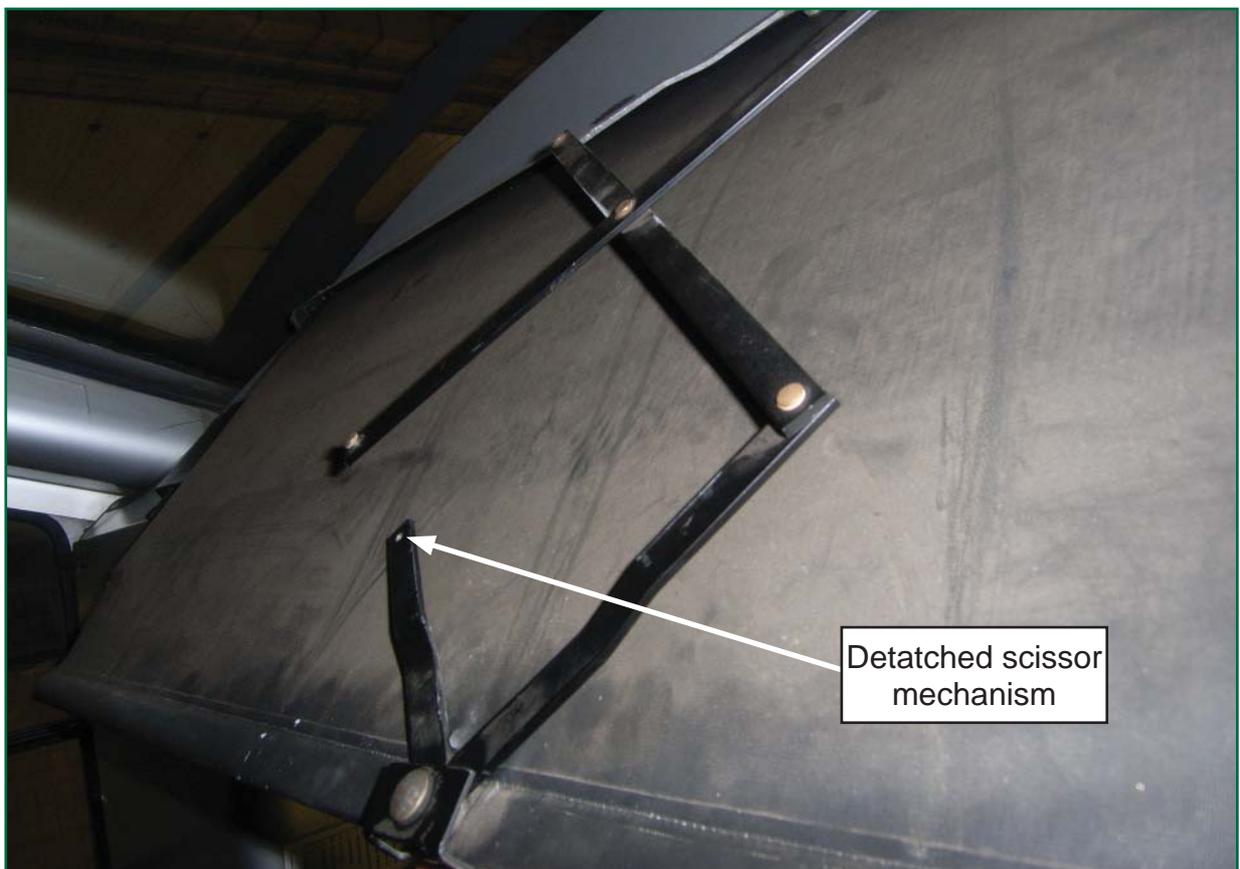
Figure 13: Sunblind mechanism - type I - not capable of operation

62 RAIB testing found 18 sunblinds of 25 that were not fit for purpose, despite the fleet being subjected to a TMM post-accident check of sunblind mechanism performance with no faults reported.

63 The sunblinds that were not fit for purpose were either prone to involuntary retraction or not capable of operation (see Figure 13 for an example of the latter). All seven of the satisfactory sunblinds were type I, original equipment. The sunblind test results are summarised in Figure 14.
