Rail Accident Investigation Branch

# Rail Accident Report

## Fire on HGV shuttle in the Channel Tunnel 21 August 2006

## 21 August 2006

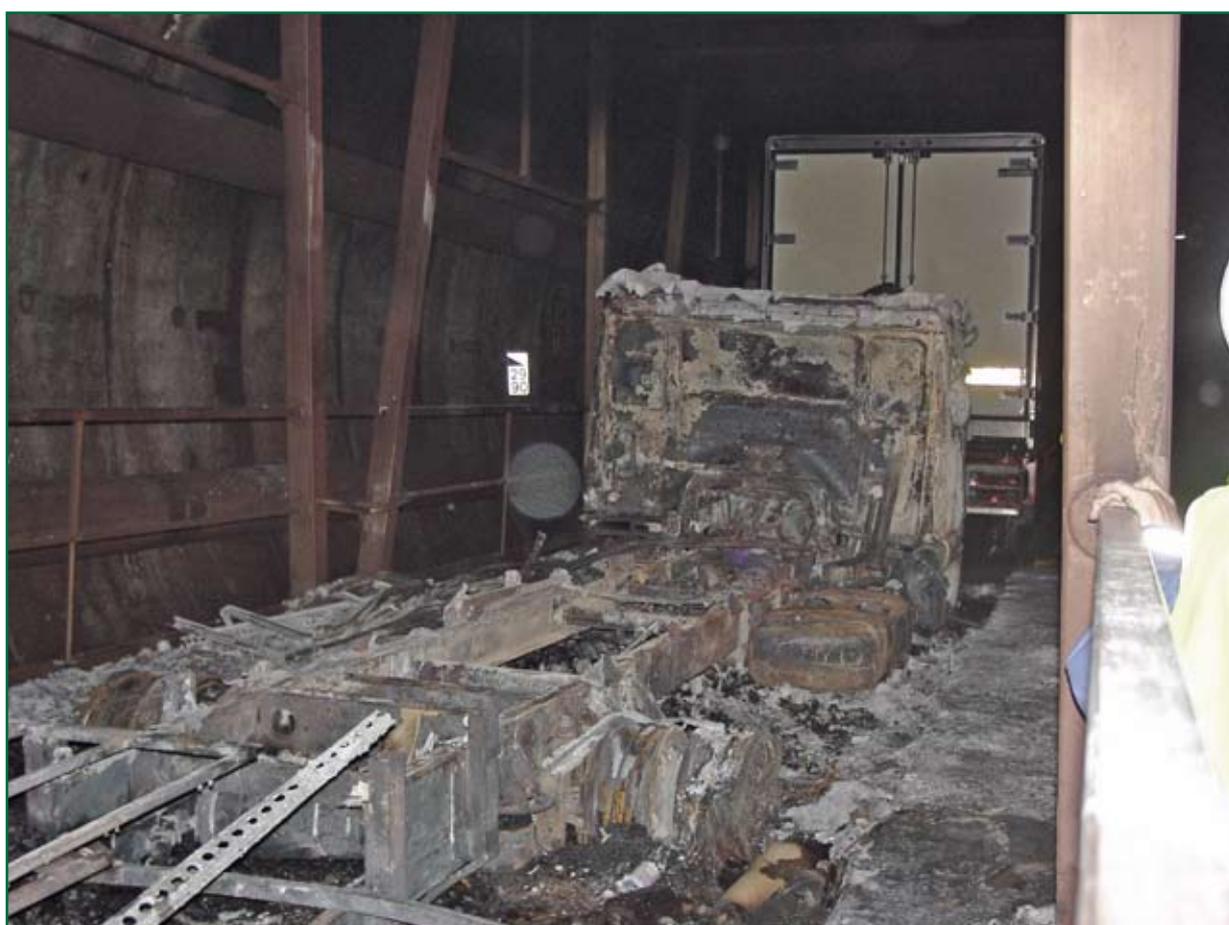
- 22 The UK Second Line of Response (SLOR) started fire fighting at 15:45 hrs and confirmed the fire extinguished at 16:05 hrs.
- 23 The fire was close to the rear of the train on the penultimate carrier wagon, destroyed the lorry on which it occurred, and damaged the adjacent ones. The carrier wagon was structurally damaged, but able to be moved from the tunnel after inspection and without receiving any repairs at the site of the incident. The overhead catenary became parted and the tunnel lining was damaged to a depth of about 30 mm at the crown of the tunnel in the proximity of the fire over a length of 10 m.

- 46 No passengers or staff were injured during the incident.
- 47 Damage to the tunnel infrastructure was confined to the immediate area of the fire over a length of approximately 12 metres. Cables running along the tunnel wall were damaged. The overhead catenary sustained damage as the copper *contact wire* parted. The tunnel lining immediately above the fire was penetrated to a depth of 30 mm, which was just sufficient to expose the steel reinforcements, but did not cause the dislodgement of large concrete sections.
- 48 The lorry concerned was destroyed by the fire (Figure 4). The lorry immediately behind it suffered destructive damage to the plastic covering over the refrigeration unit (Figure 5); the lorry ahead sustained light damage to the rear involving distortion to the registration plate, rear lights and mud flap (Figure 6).

Figure 4: Burnt out HGV (at original site)

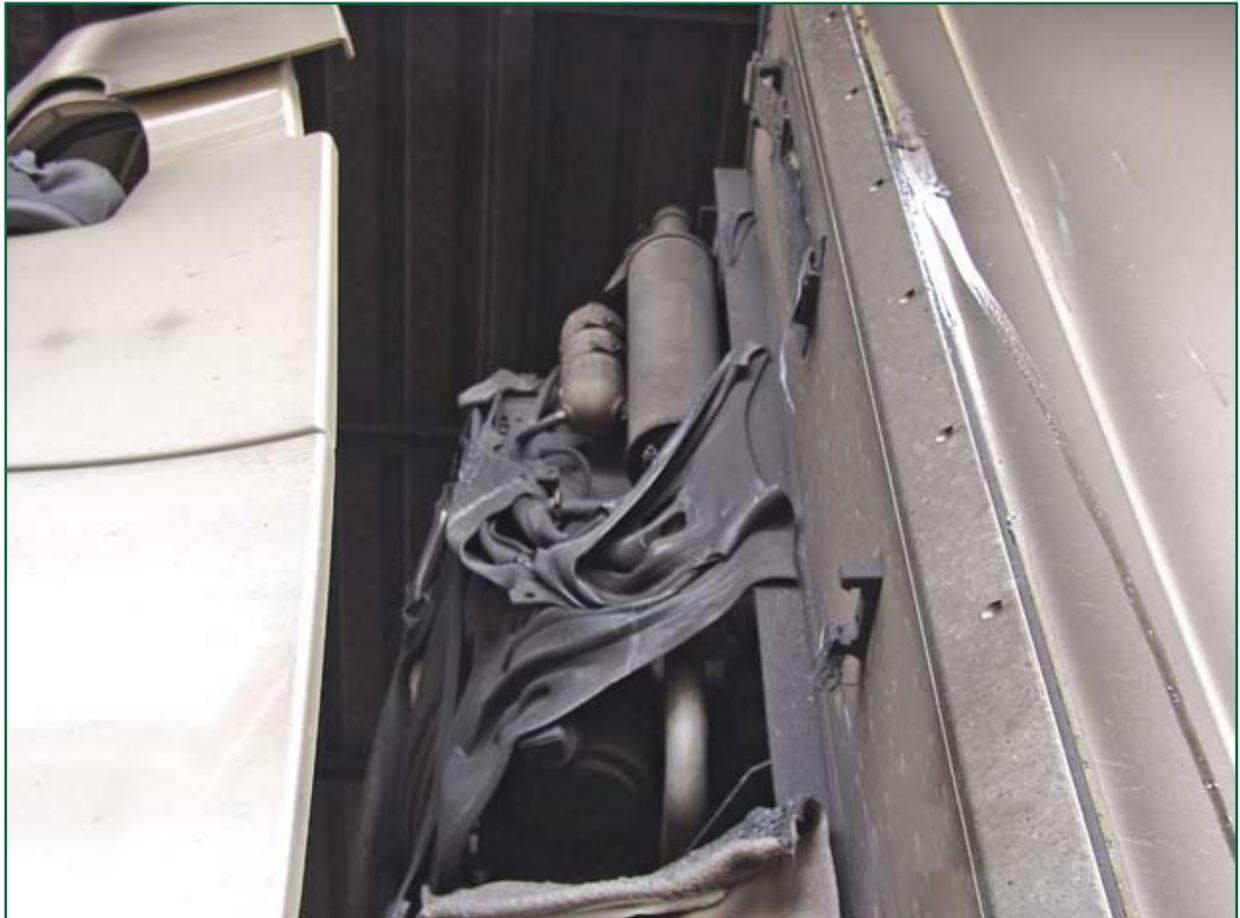
*Figure 5: Damage to refrigeration unit of HGV behind incident wagon*

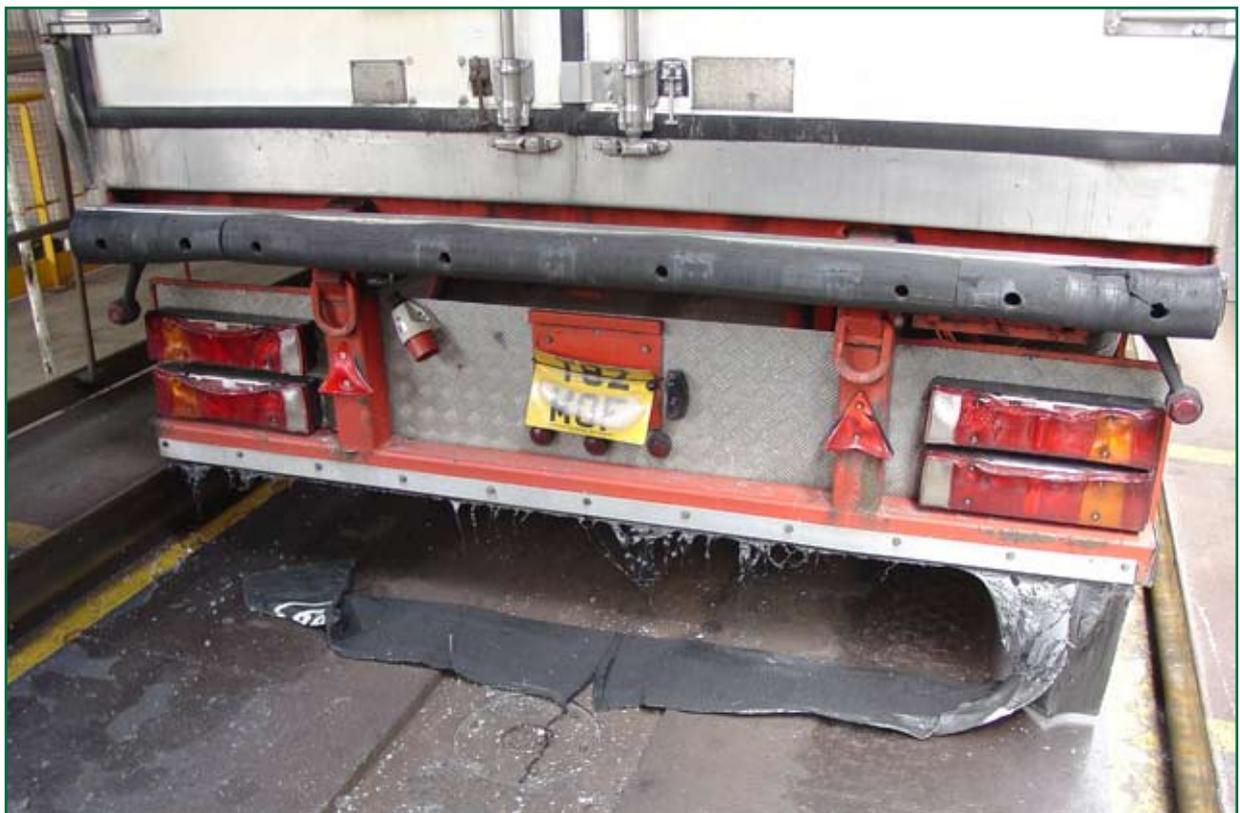
*Figure 6: Damage to rear of HGV ahead of incident wagon*

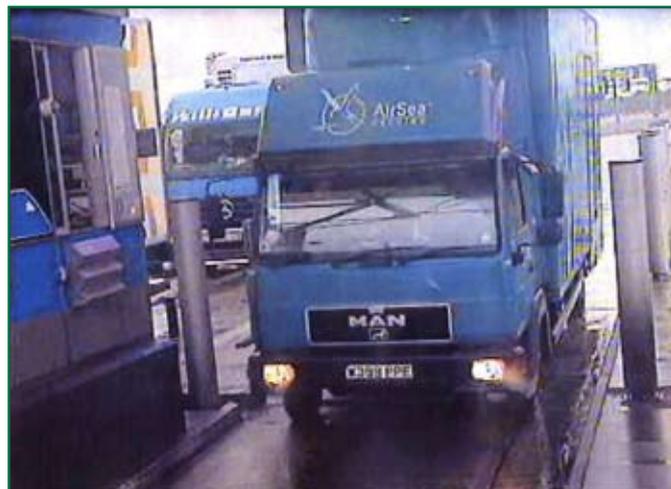
121 The lorry involved in the fire was owned and operated by AirSea Packing Group Ltd of Twickenham, Middlesex (Figure 9). It was a rigid chassis vehicle with separate cab and load compartment. The latter comprised an alloy and steel frame to which was attached the aluminium side panels and the roof. A side door to the rear of the near side and a full height rear tailgate gave access to the interior.

*Figure 9: Incident HGV before the fire (photograph courtesy of Kent Police)*

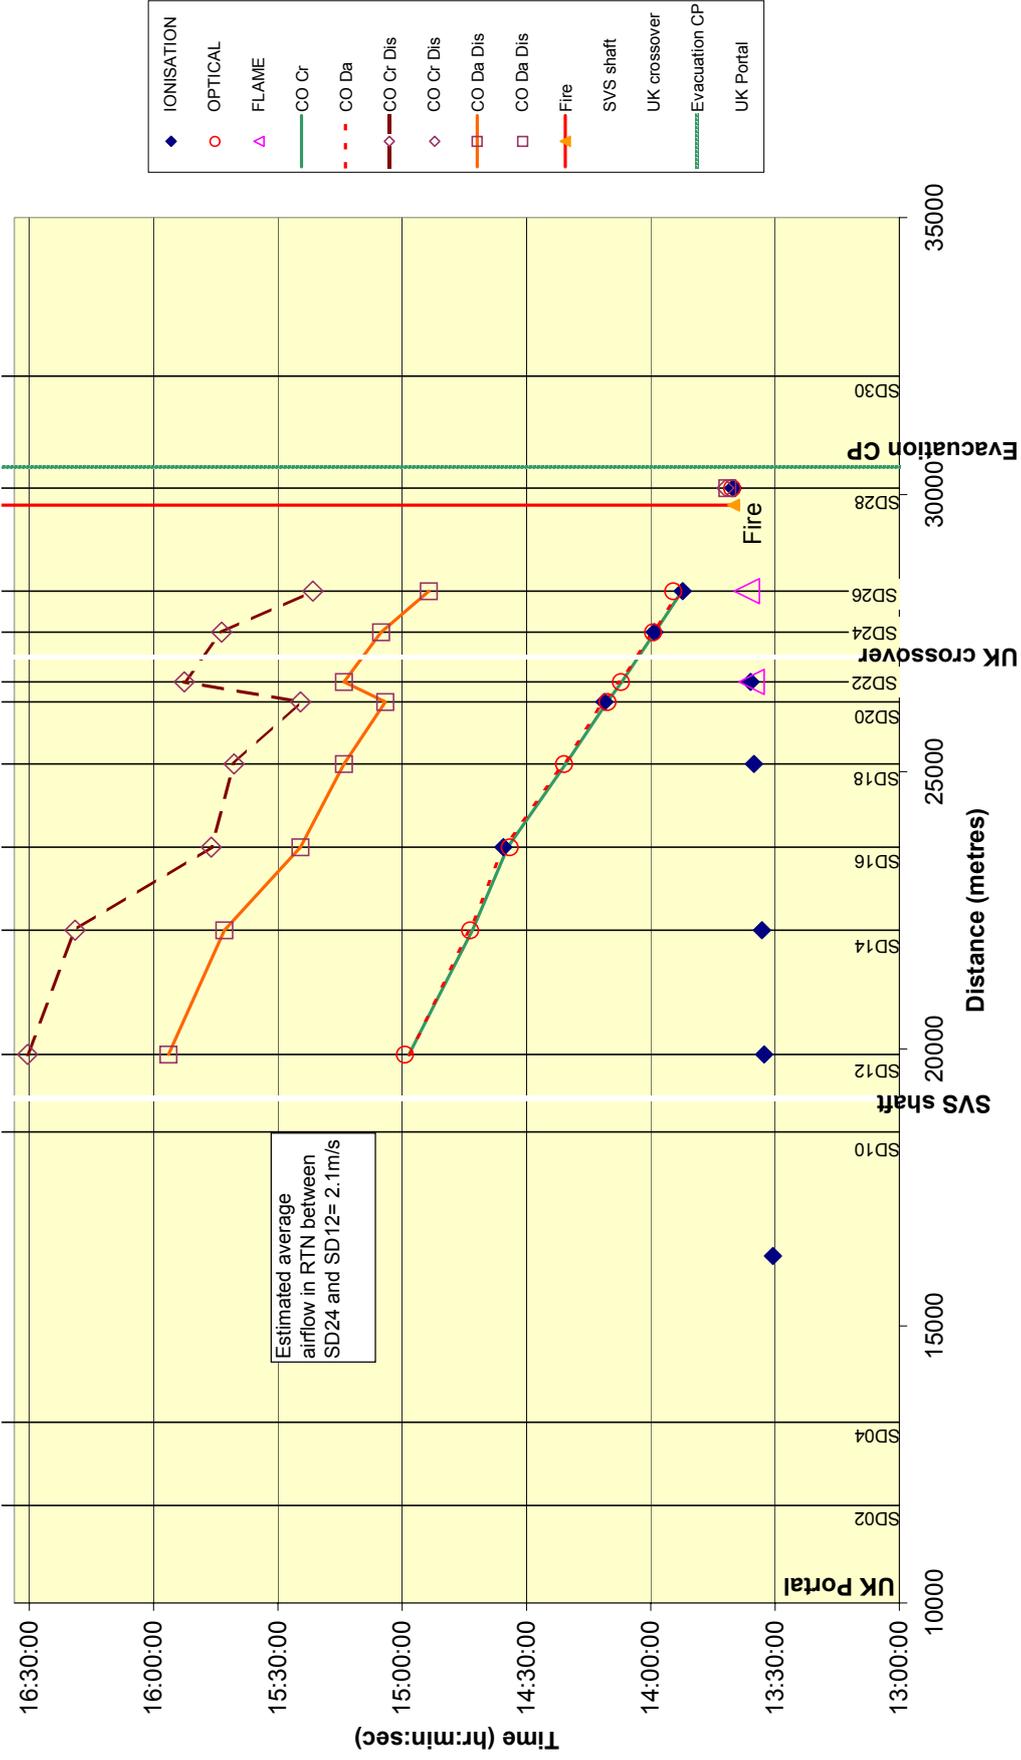
134 The first indication to the RCC that an incident was developing occurred when the ionisation smoke detectors in the fire detector station SD08, 6.2 km from the UK portal, registered an alarm. This detection caused the RCC to impose a verbal speed restriction of 100 km/h on all shuttles at 13:31 hrs.

140 The recorded activation of detectors thus corresponds with the movement of the shuttle and the associated tunnel airflows.

Figure 10: Graph showing sequence of activation of fire detectors
