Rail Accident Investigation Branch

Rail Accident Report

Collision near Burton on Trent 1 August 2007

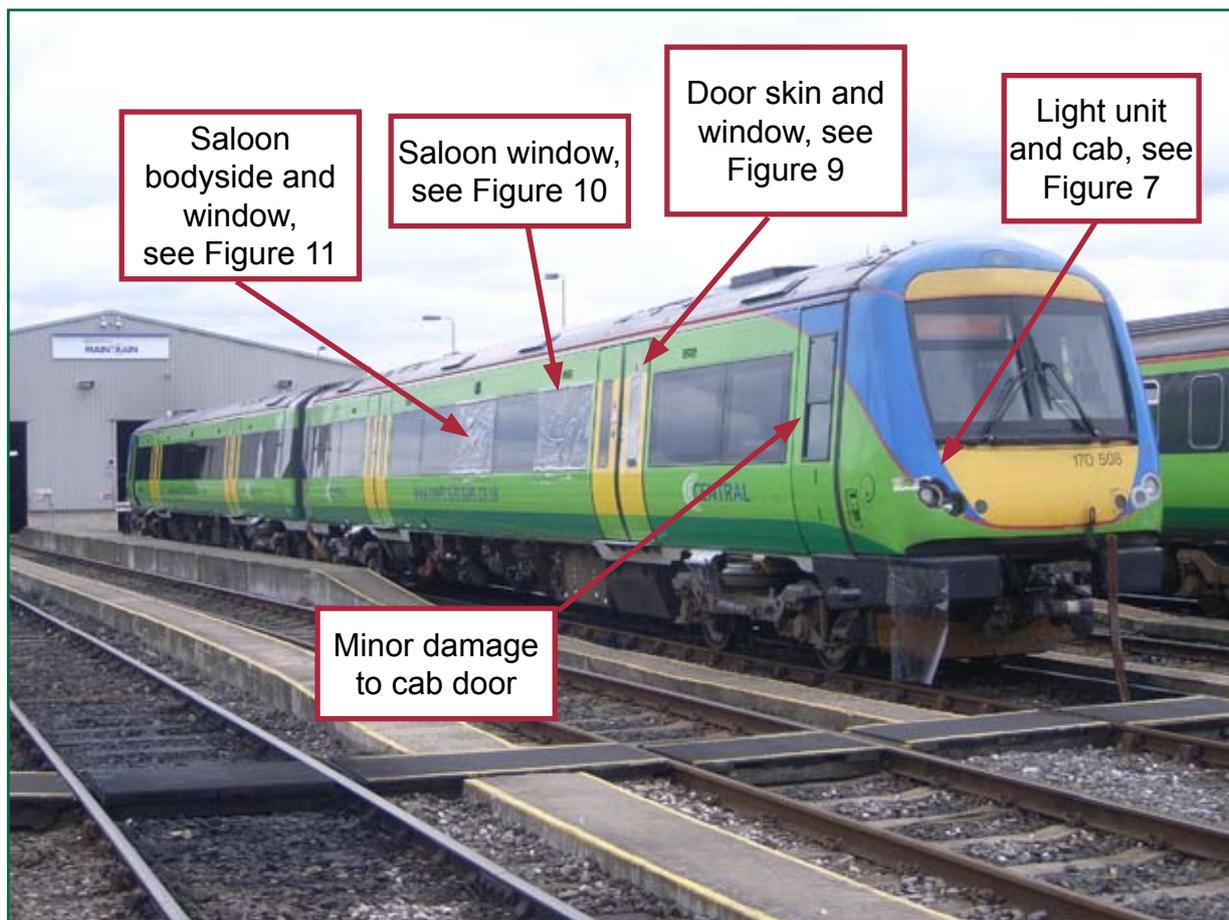
- 11 DMU number 170508 comprised vehicles numbered 79508 and 50508. Vehicle number 79508 was leading in the direction of travel at the time of the collision and was the only vehicle to sustain damage (Figure 3).

Figure 3: Collision damage to 170508 (broken windows covered with protective sheeting)

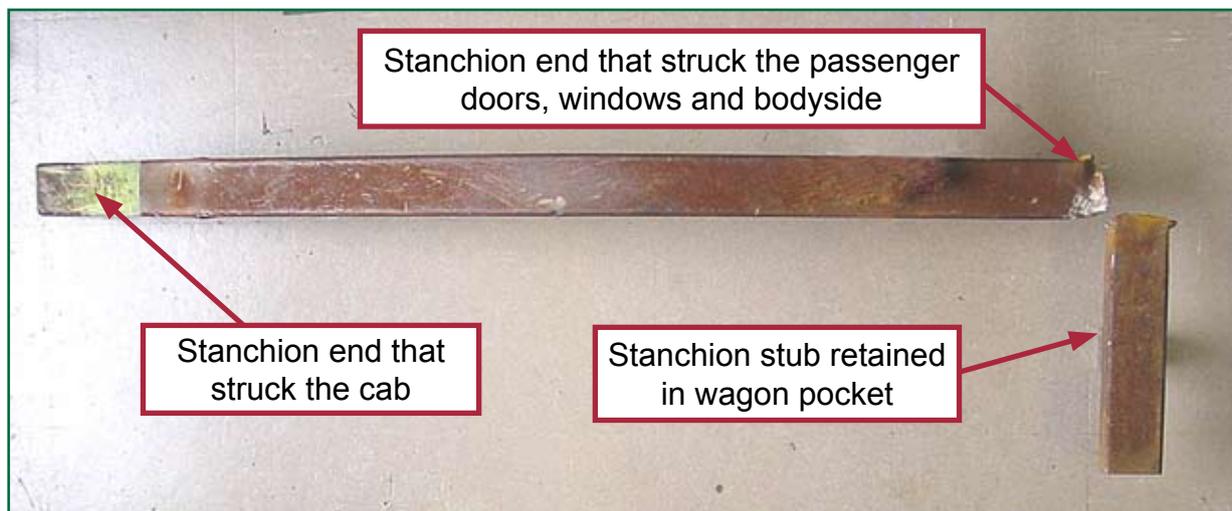
Figure 5: Stanchion position as it struck the cab of the DMU

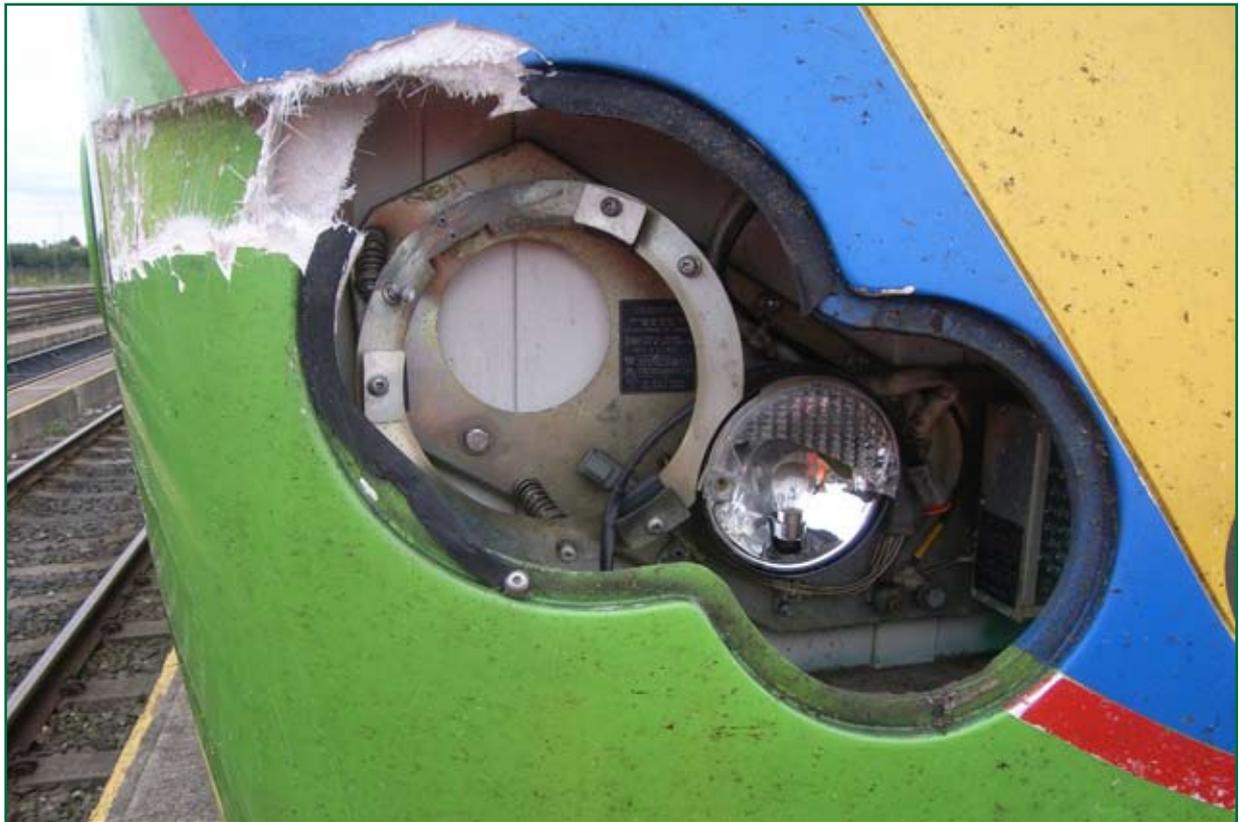
21 The stanchion struck the DMU cab as the freight train was travelling at 55 mph (89 km/h) and the DMU was travelling at 90 mph (145 km/h) (Figures 6 and 7).

Figure 7: Damage to the cab and light unit

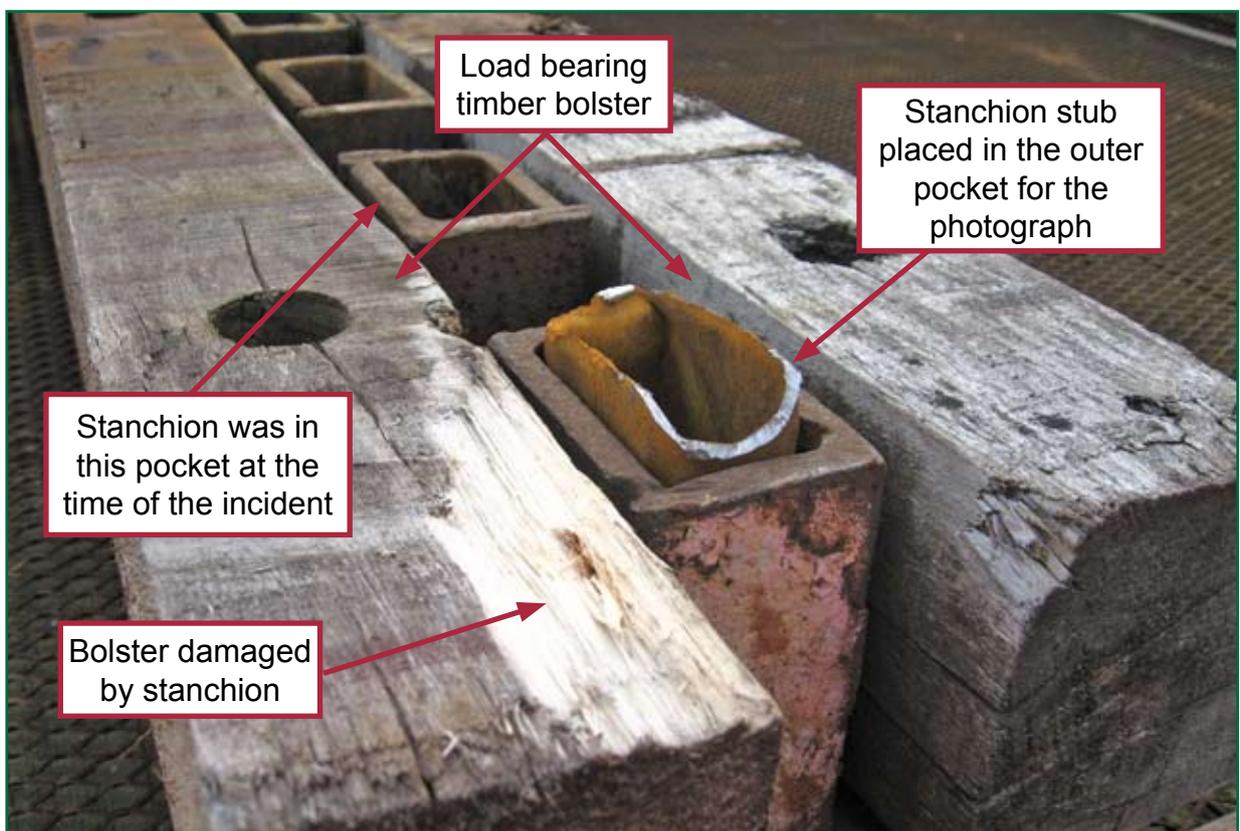
Figure 8: BEA Wagon 951198

22 The collision caused the stanchion to break away, leaving the stub in the wagon pocket. The detached stanchion then struck the adjacent timber bolster (Figure 8) and the DMU cab door, causing minor damage to the wagon bolster and the frame of the cab door window unit.

- 38 On examination of the stanchion and stub it was found that the stanchion had fractured at a position that corresponded with the height of the bolster pockets that locate the stanchions on the wagons (Figure 8).

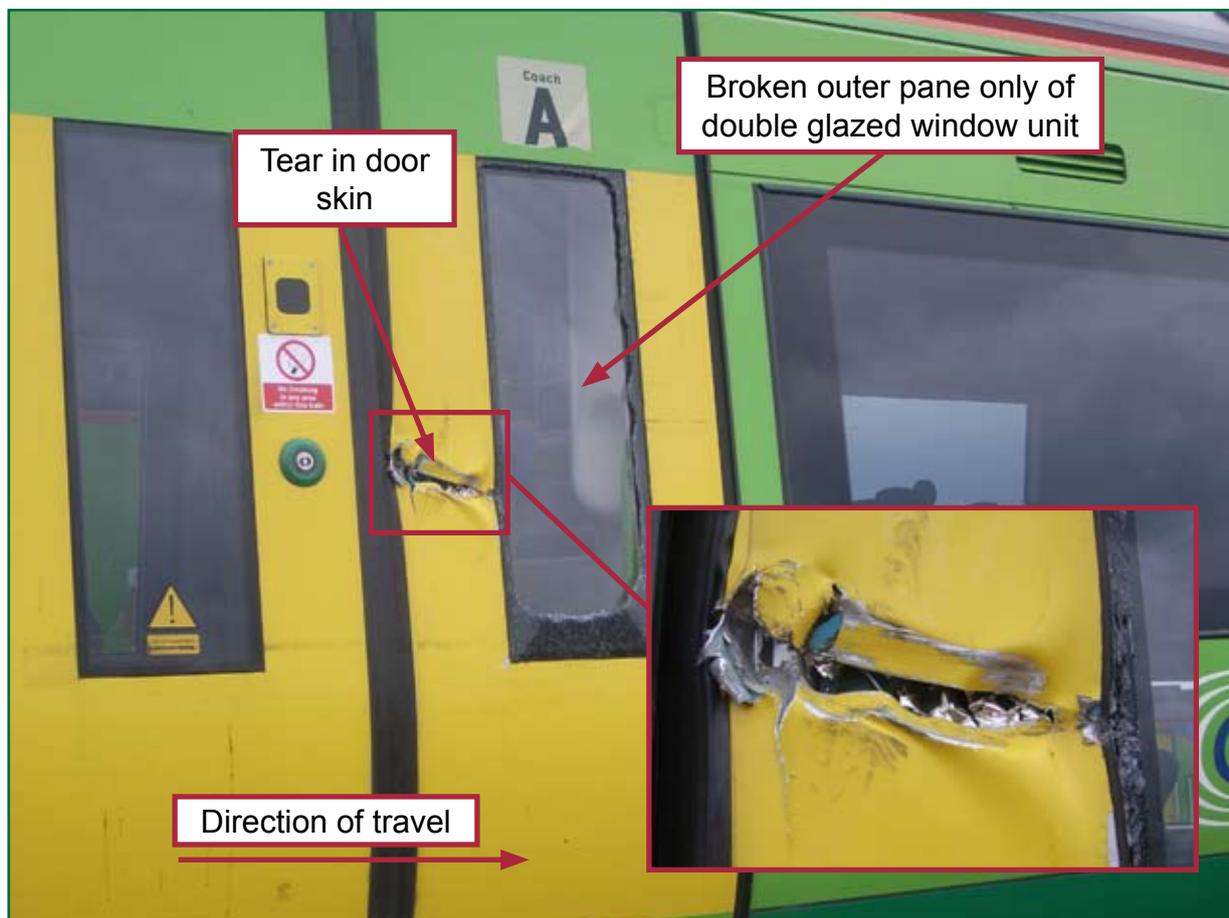
- 23 As the freight train and the DMU continued to pass one another, the detached stanchion impaled itself into the vertical face of the next timber bolster back from the wagon's direction of travel. Timber from the bolster was later found compacted into the end of the stanchion.
- 24 The stanchion then struck the first set of passenger doors, breaking the outer pane of a double glazed window unit, tearing the door skin and deforming the door leaf (Figure 9).

Figure 9: Damage to door skin and window

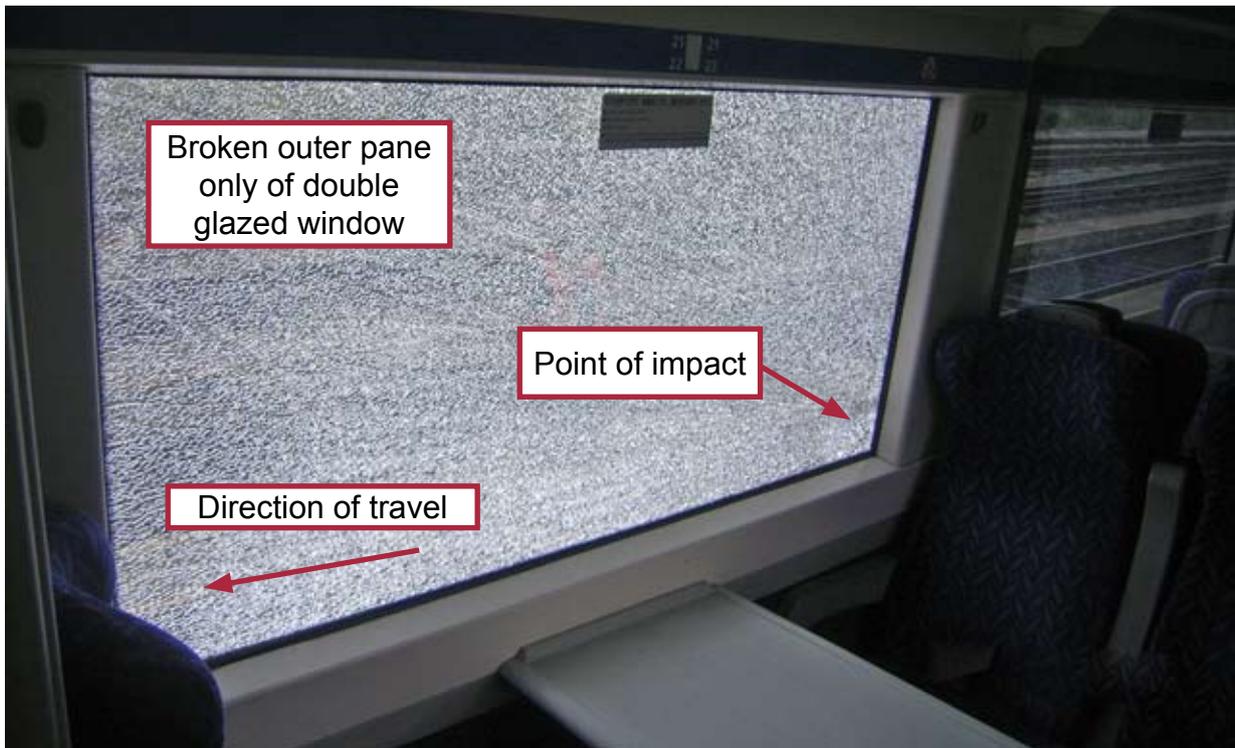
- 25 The stanchion next struck the bottom left corner of the adjacent double glazed and laminated window unit, breaking the outer pane (Figure 10).

Figure 10: Saloon window viewed from inside

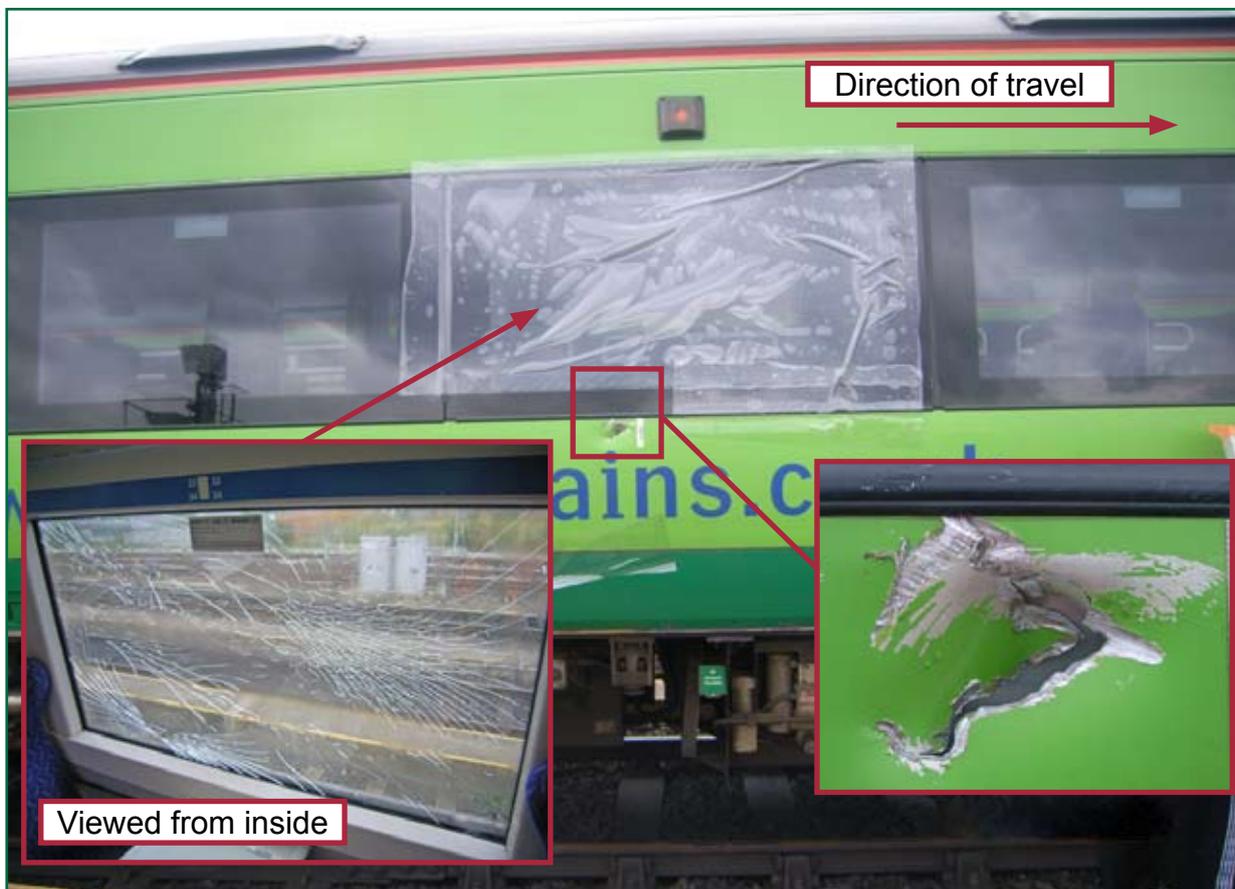
26 Finally the stanchion struck the vehicle, denting and tearing the bodyside outer skin; the tear in the skin corresponded with the stanchion end in size and shape. The stanchion deflected the vehicle bodyside as it struck, breaking the inner pane of a double glazed and laminated window unit and the adjacent table (Figure 11).

Figure 11: Damage to saloon bodyside and window (broken window covered by protective sheeting)

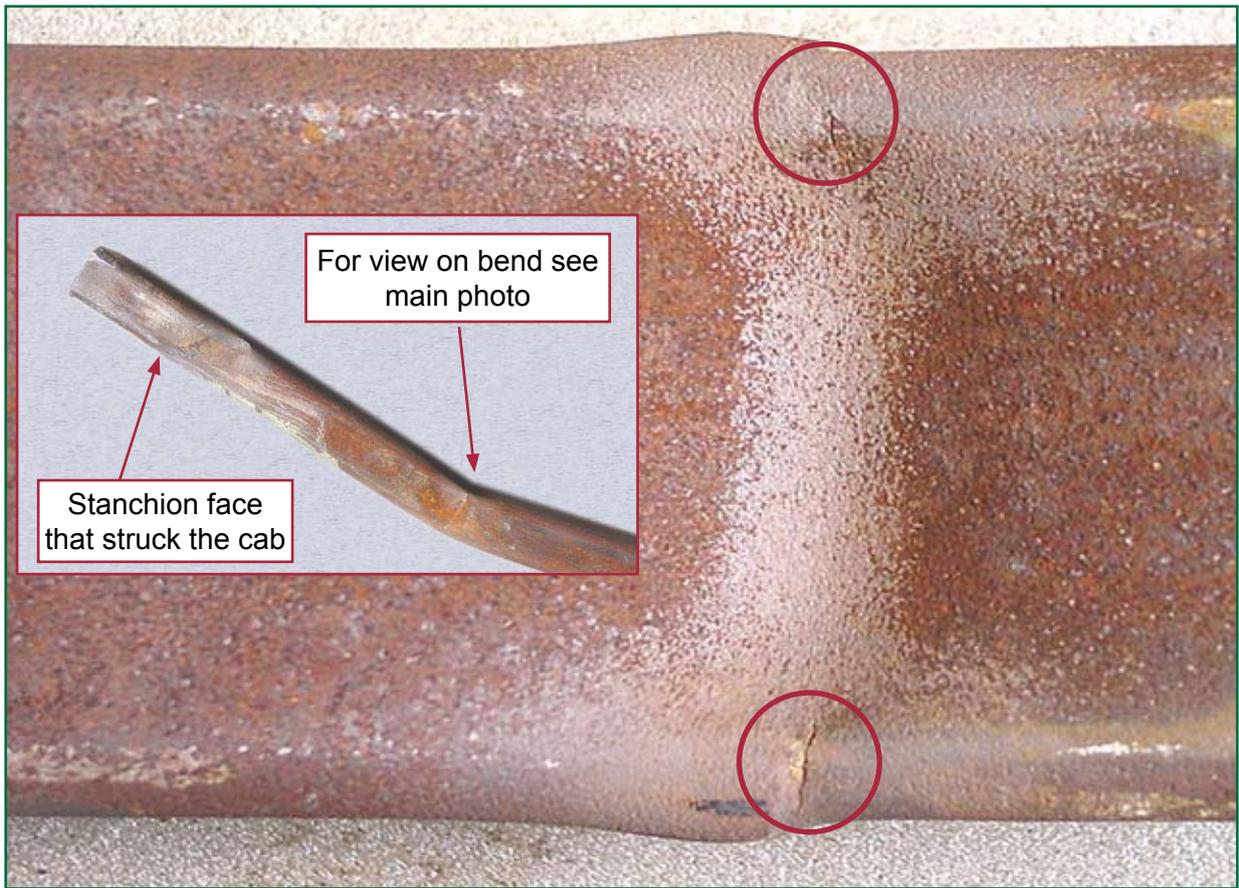
- 40 The other end of the stanchion was also bent at a position corresponding to the height of a bolster pocket. This confirmed that the stanchion had previously been turned on its end after being bent. The box section material on the inside of the bend had distorted and created 'folds' (Figure 12).

Figure 12: The inside of the bend. The material at the corners had distorted and created folds (circled) (photograph courtesy of Serco Technical & Assurance Services, Derby)

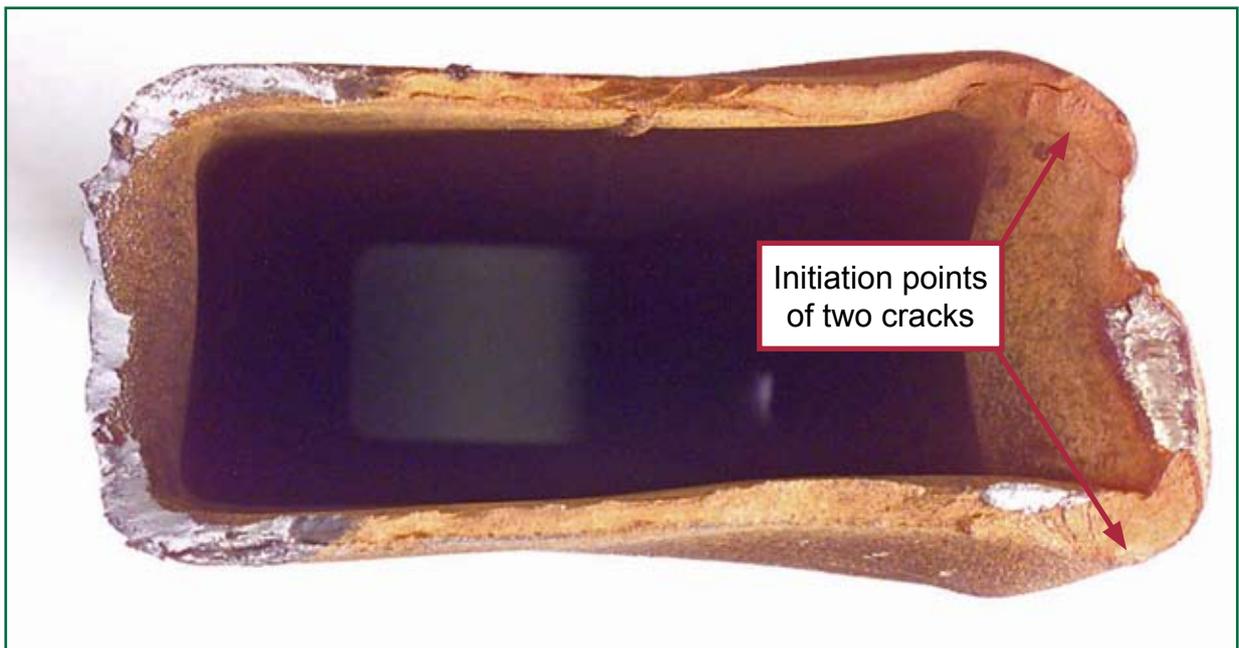
41 The stub fracture face was corroded continuously across one end and both sides, confirming that three sides of the box section had been fractured prior to the incident. The remainder of the fracture face was not corroded and was where the final fracture had occurred (Figure 13).

Figure 13: The stanchion stub end fracture face (photograph courtesy of Serco Technical & Assurance Services, Derby)

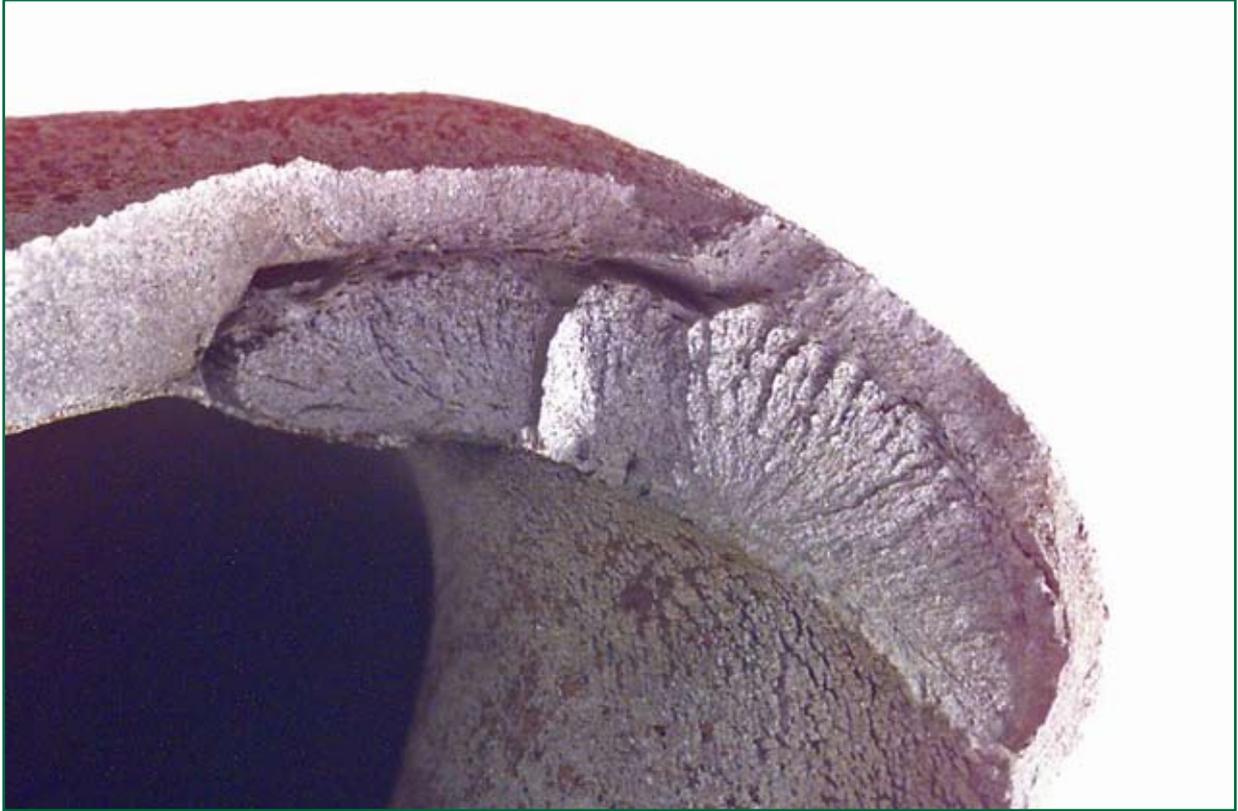
42 The stub fracture face was chemically cleaned to show two cracks that began from the material 'folds'. Three sides of the box section fractured rapidly from these cracks when the stanchion was bent back to near straight. There was no evidence of material *fatigue* (Figures 14 and 15). The fracture of the remaining material was due to the collision with the DMU.

Figure 14: Cracking from the inside of one corner after corrosion removal (photograph courtesy of Serco Technical & Assurance Services, Derby)

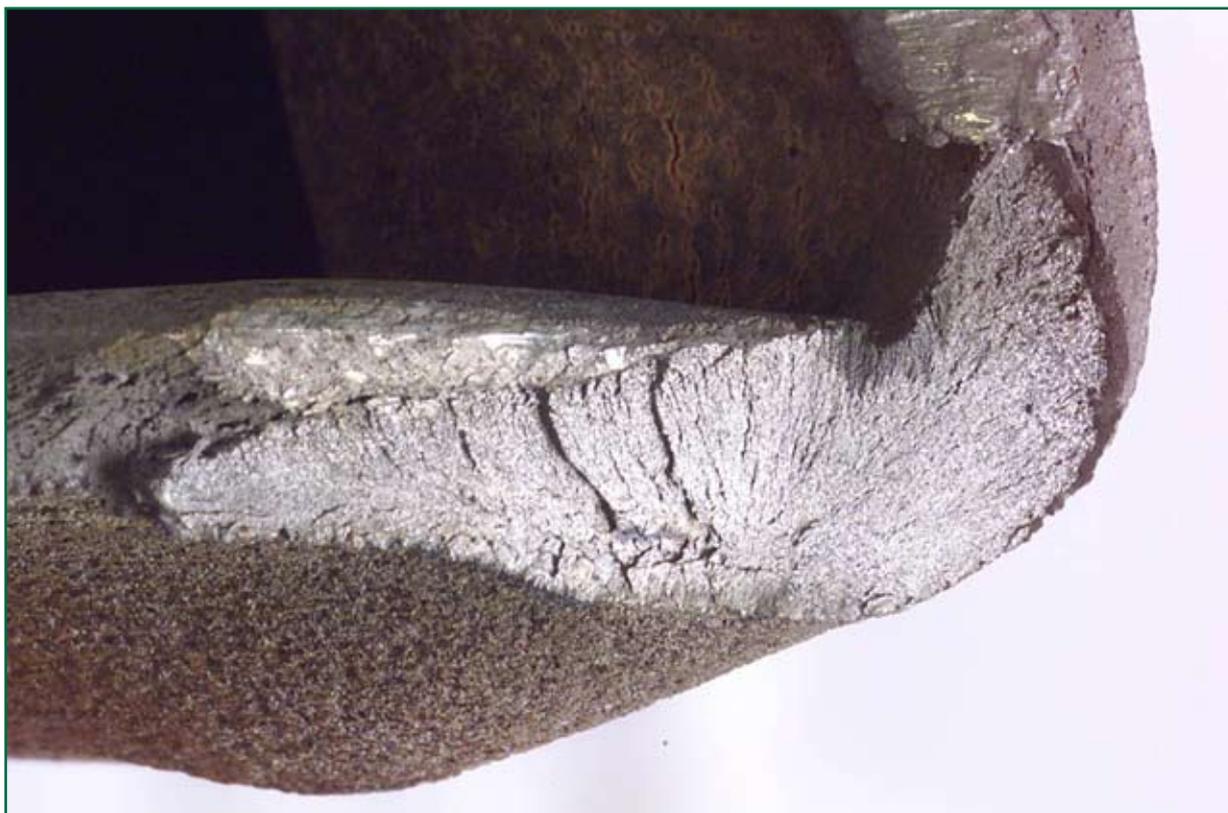
Figure 15: Cracking from the outside of one corner after corrosion removal (photograph courtesy of Serco Technical & Assurance Services, Derby)
