Rail Accident Investigation Branch

Rail Accident Report

The derailment of a freight train at King Edward Bridge, Newcastle 10 May 2007

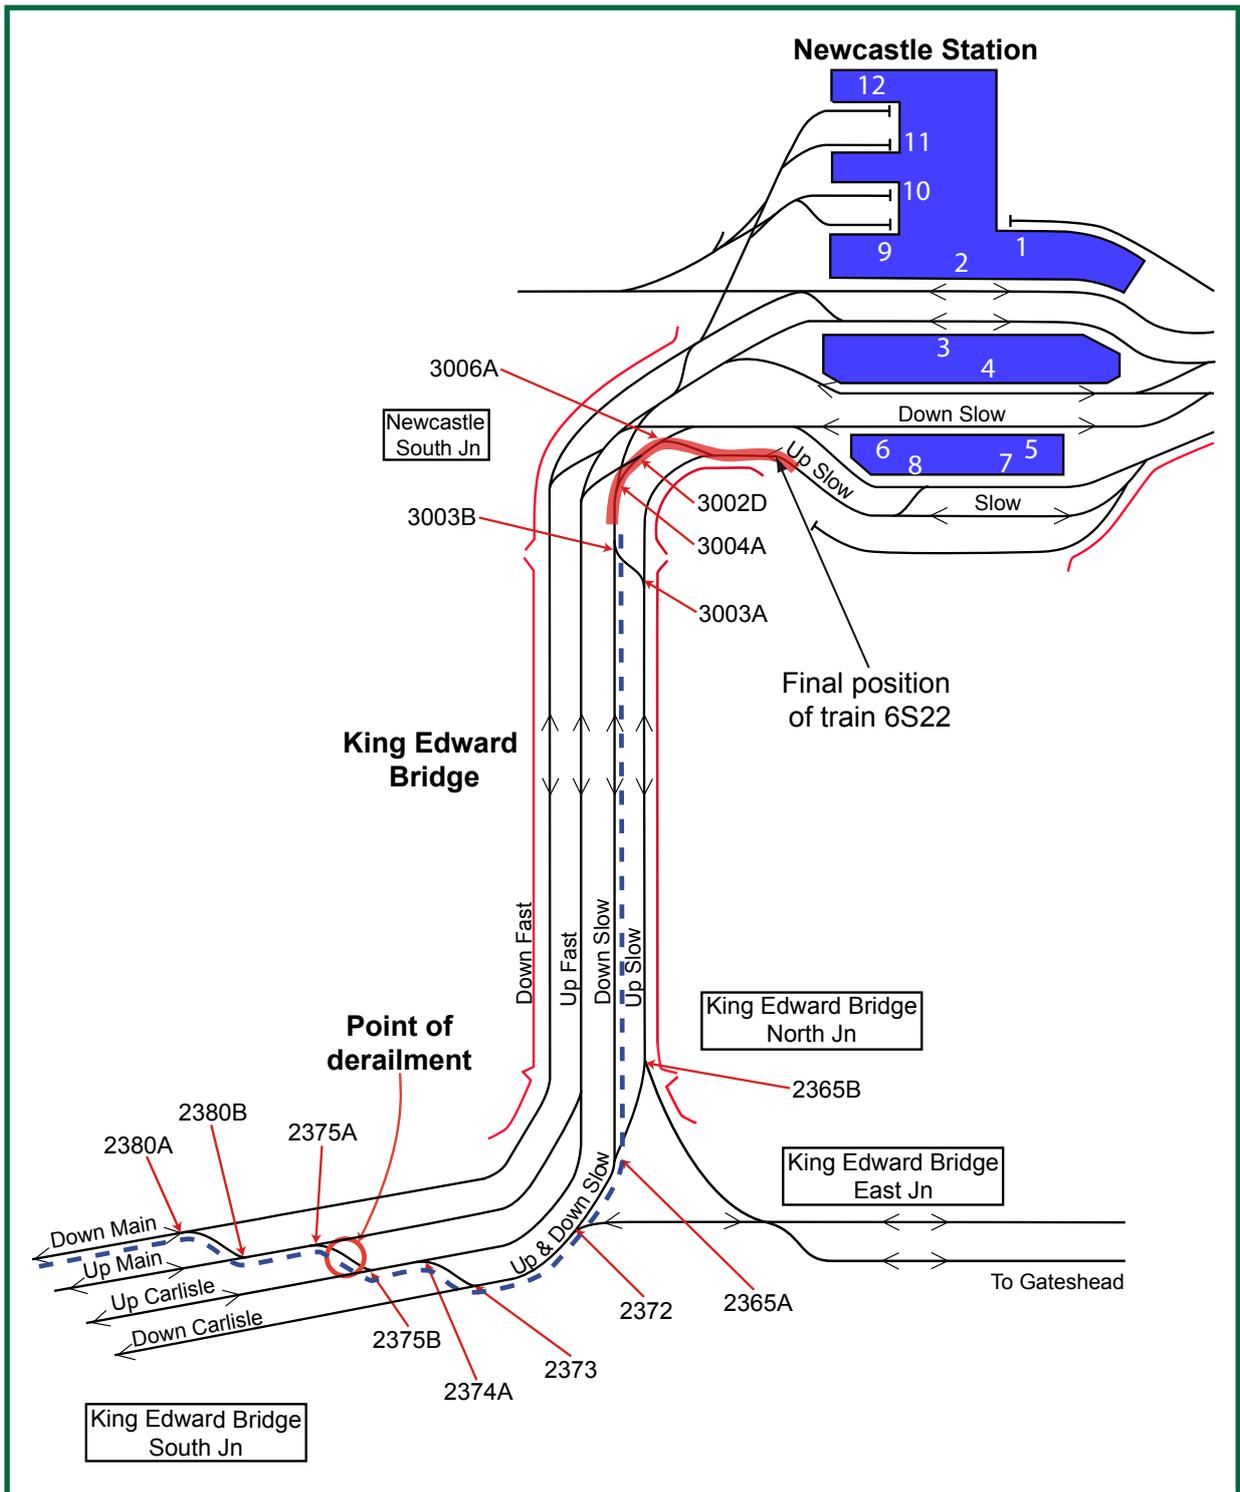
Figure 2: Schematic track diagram in the vicinity of the derailment

- 22 King Edward Bridge South Junction is located 1.1 km south of Newcastle station. At this location the East Coast Main Line converges with the lines from Carlisle. Crossovers permit moves between down main line and up Carlisle line. Lines to Gateshead head eastwards via a triangular junction with the down Carlisle line. Two main and two slow lines cross the river Tyne at a high level via the King Edward Bridge. A diagram of the track layout is shown in Figure 2.
- 23 At the north end of the King Edward Bridge, Newcastle South Junction permits moves between all of the running lines on the approach to Newcastle Station platforms.
- 24 The initial *point of derailment* (POD) was identified as being within the crossover between the up main line (2375A points) and up Carlisle line (2375B points).

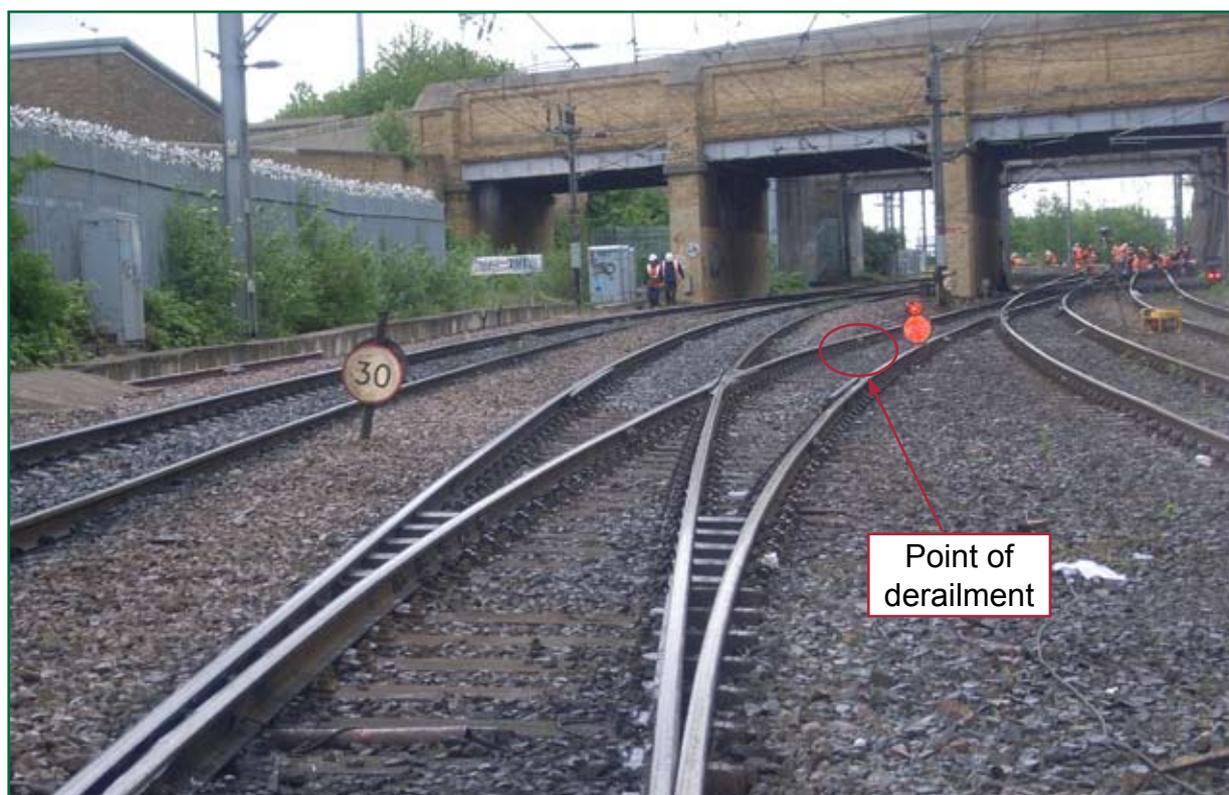
Figure 6: 2375 crossover

- 43 As the trailing vehicles passed through 2375 crossover the left leading wheel of the 23rd wagon, HAA 352421, mounted the head of the left rail immediately following a *six-hole insulated rail joint*. The wheel flange rode along the rail head for 13 m before dropping outside the rail. At 2375B, the trailing points of the crossover, the trailing axle of 352421 also became derailed to the left (Figure 6).

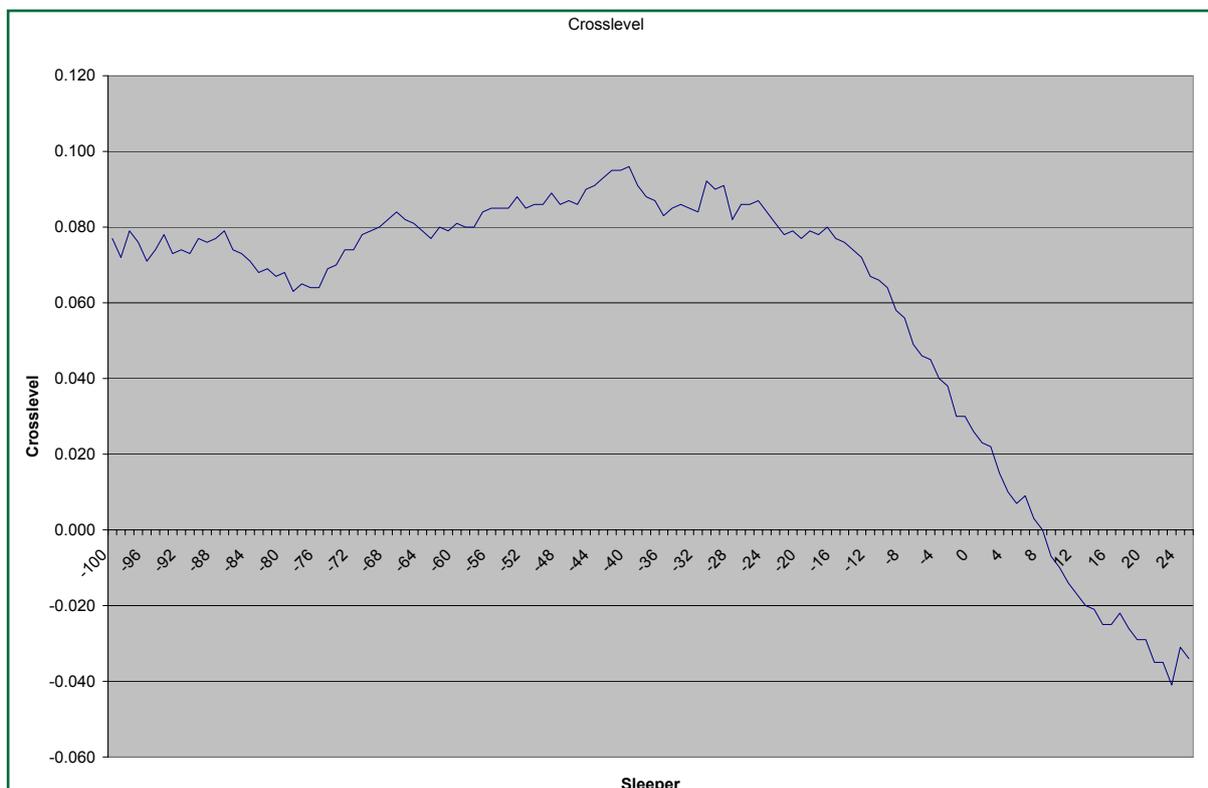
Figure 7: Cross-level through the site

- 84 At the crossing of 2375A points, 24 sleepers prior to the POD, the cross-level is +90 mm. This is required to match the cross-level on the up main line. The crossing of 2375B points, 19 sleepers beyond the POD, has a cross-level of -29 mm to match the geometry of the up Carlisle line. An overall change in cross-level of 119 mm in 43 sleepers, approximately 30 m, is an average twist of 1 in 254. The cross-level is shown in Figure 7.

- 85 A critical parameter in rail vehicle operation is suspension behaviour and the ability to maintain adequate vertical wheel loads whilst traversing irregular track geometry. For a four wheeled vehicle the relevant Group Standard, GM/RT2141, stipulates that the most unloaded wheel must retain at least 40 per cent of its nominal wheel load when subjected to a 1 in 150 twist over the wheelbase of the vehicle. Although HAA vehicles predate the current acceptance regime, they are compliant with the suspension performance requirements when maintained to specification.
- 86 HAA wagons have a wheelbase of 5662 mm and a twist of 1 in 150 equates to a 37 mm difference in cross-level between the two axle locations.

- 4 Network Rail should include guidance in NR/SP/TRK/001 Section 11.4.2 to ensure that additional consideration is given to the geometry monitoring frequency and methodology for locations where the dynamic track geometry is likely to deteriorate and exceed the maintenance limit without otherwise being detected. This may occur because of the proximity of the design geometry to the maintenance limit, where there is difficulty identifying the geometry or loaded parameters or where geometry deterioration rates are high (paragraph 147).

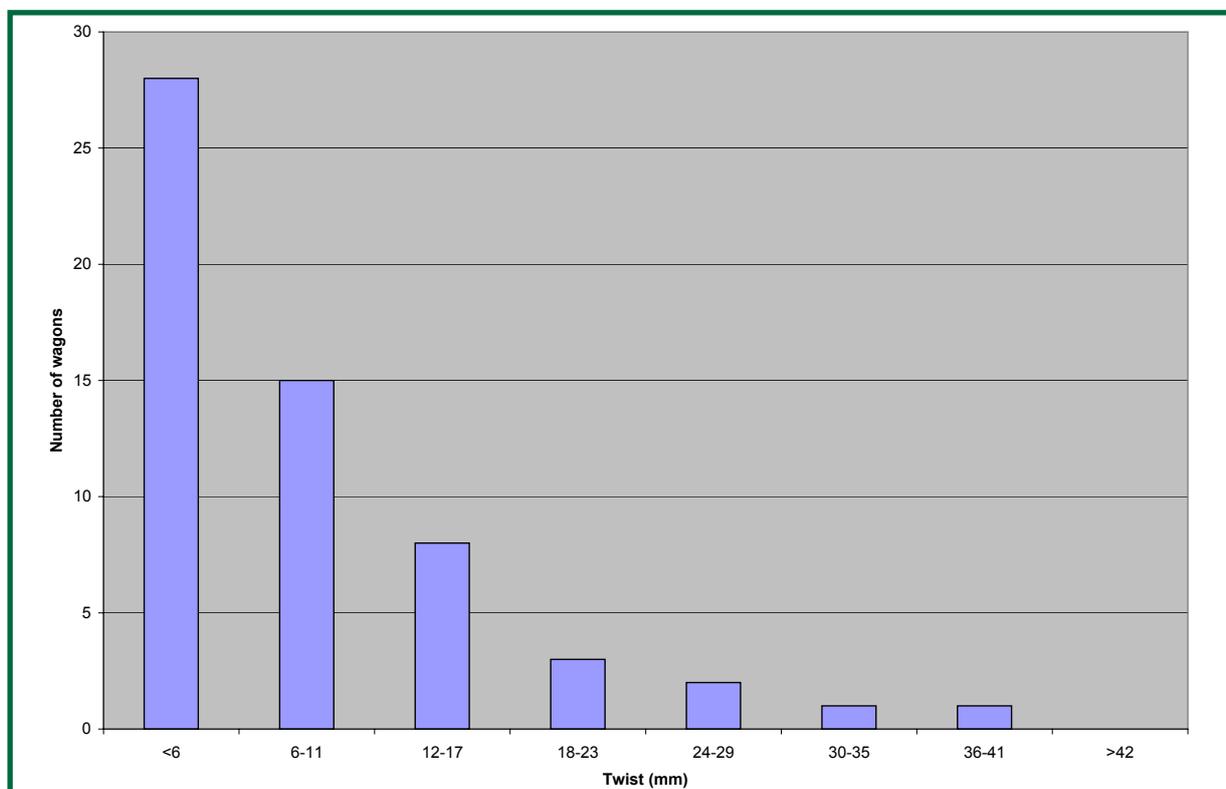
Figure 8: Results of the wagon frame twist survey

107 To assess the fleet condition a frame twist survey was carried out on a random sample of 58 serviceable MGR wagons, approximately 7 per cent of the current operating fleet. Of this sample 50 per cent had frame twist which exceeded the 6 mm maximum specified in WF/81 (paragraph 90). The greatest value of uncompensated twist was 31 mm.

108 One wagon had a twist which was measured at 40 mm. The wagon was plated, identifying the twist as 12 mm. This was partially compensated for by a 10 mm packing.

110 A feature of the detected twists was a predominance of twist in one direction; that is the left leading and right trailing corners were generally high.

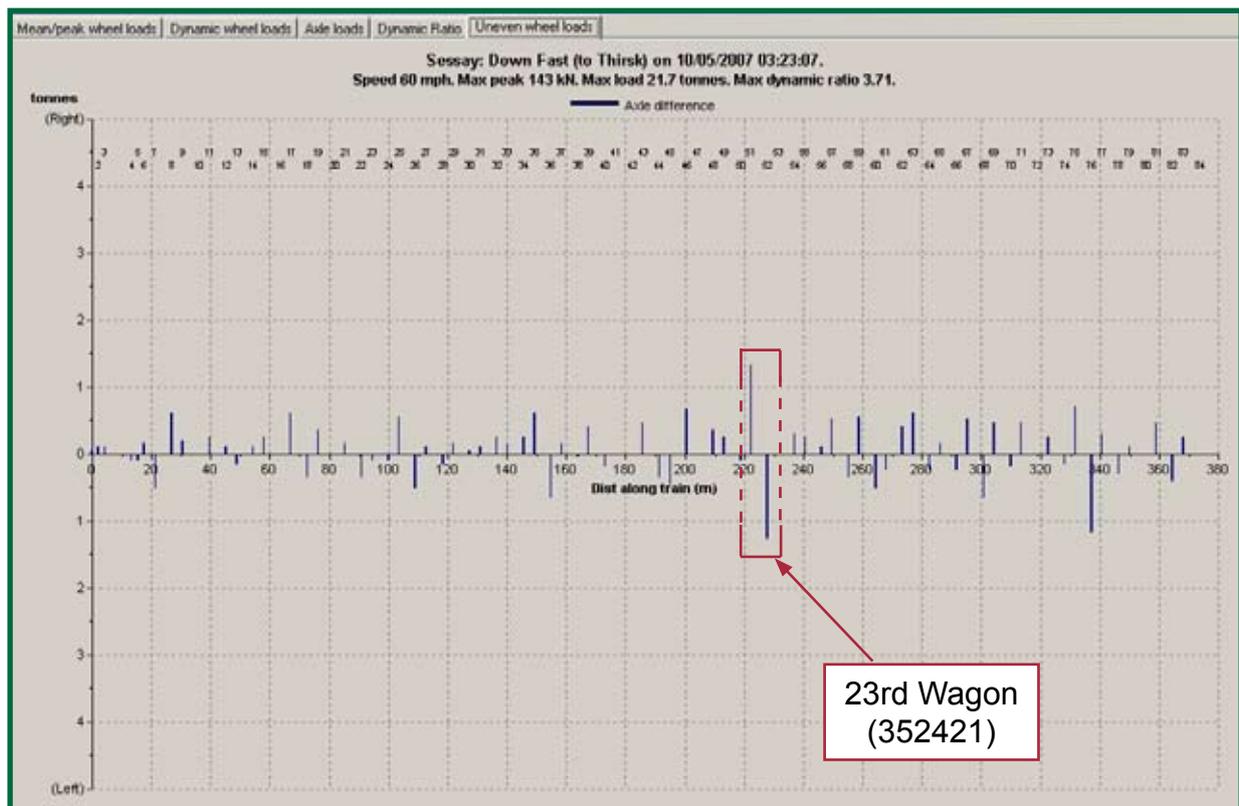
Figure 9: Uneven Wheel Load report for train 6S22

111 At 03:23 hrs on the morning of 10 May train 6S22 passed through and was detected by the Wheelchex system equipment at Sessay. Although Wheelchex is operated primarily as an alarm system which identifies excessive dynamic loads generated by flat or out-of-round wheels, and initiates a real-time response by Network Rail operations staff and freight operators' rolling stock inspectors. Other reports are available, but are not routinely produced. One of these is an uneven wheel loads report.

113 The front of the train is to the left of the graph. Vertical bars below the central axis represent the left-hand side of the train, and those above the axis the right.
