Rail Accident Investigation Branch

Rail Accident Report

Accident at Leatherhead 29 August 2007

Report 19/2008
October 2008

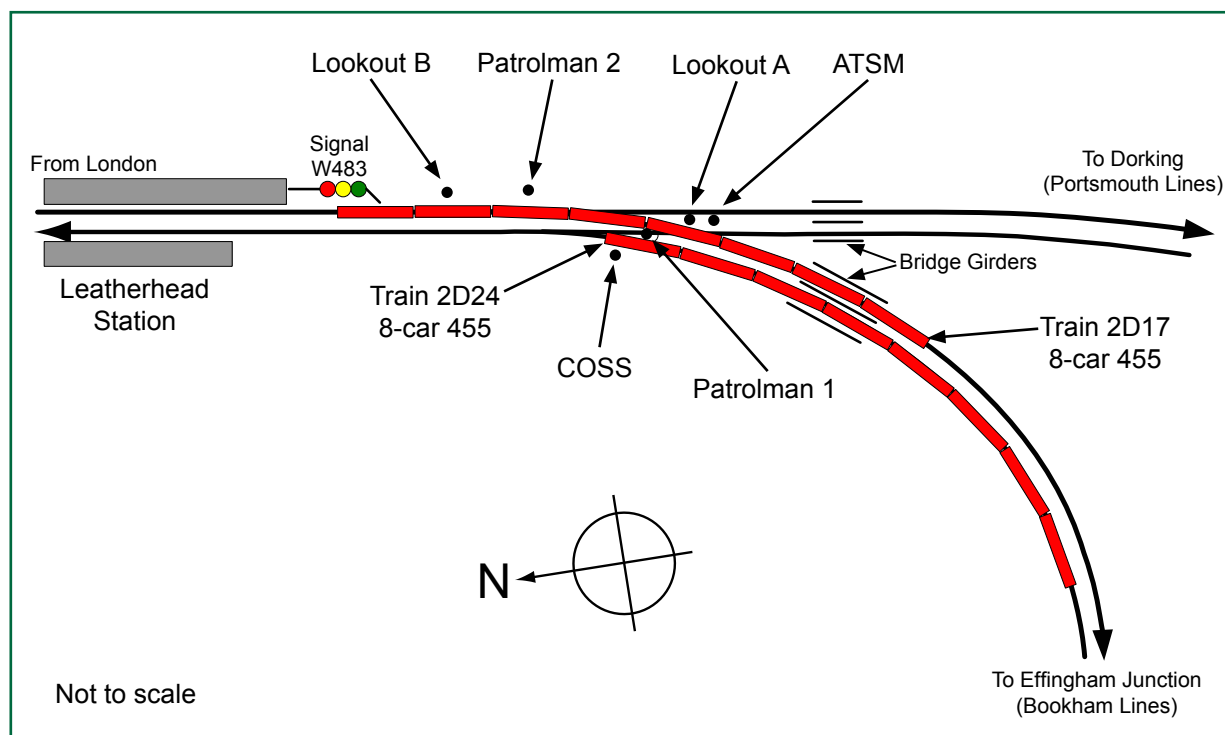
34 Patrolman 1 had received injuries to his head, back and legs. He was unconscious and was lying between the up and down Bookham lines, trapped under the current collection equipment of the train which had struck him. No-one else was injured, but the other members of the gang were severely shocked by what had happened.

Figure 3: Diagram showing the positions of people and trains immediately after the accident

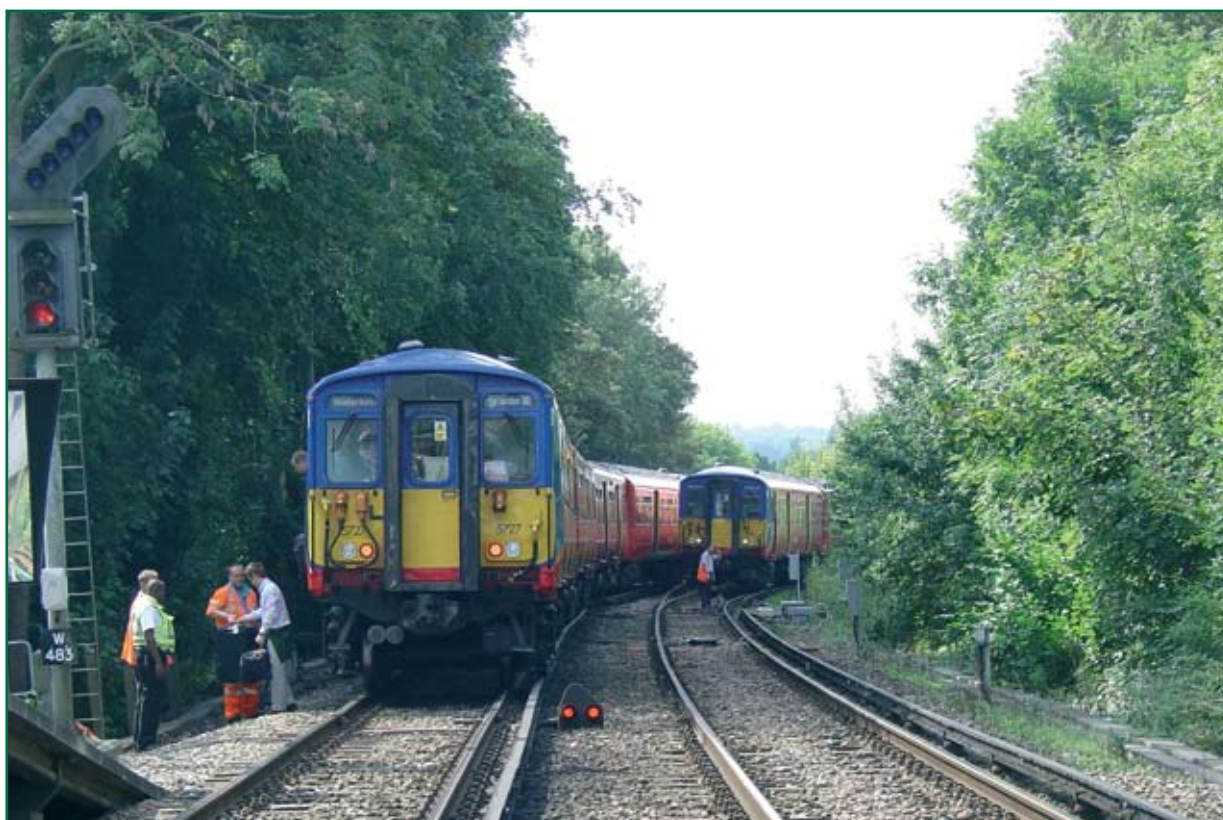
Figure 4: The scene following the accident, showing trains 2D17 (left) and 2D24. Passengers are being escorted off 2D17
