Rail Accident Investigation Branch

Rail Accident Report

Derailment at Ely Dock junction 22 June 2007

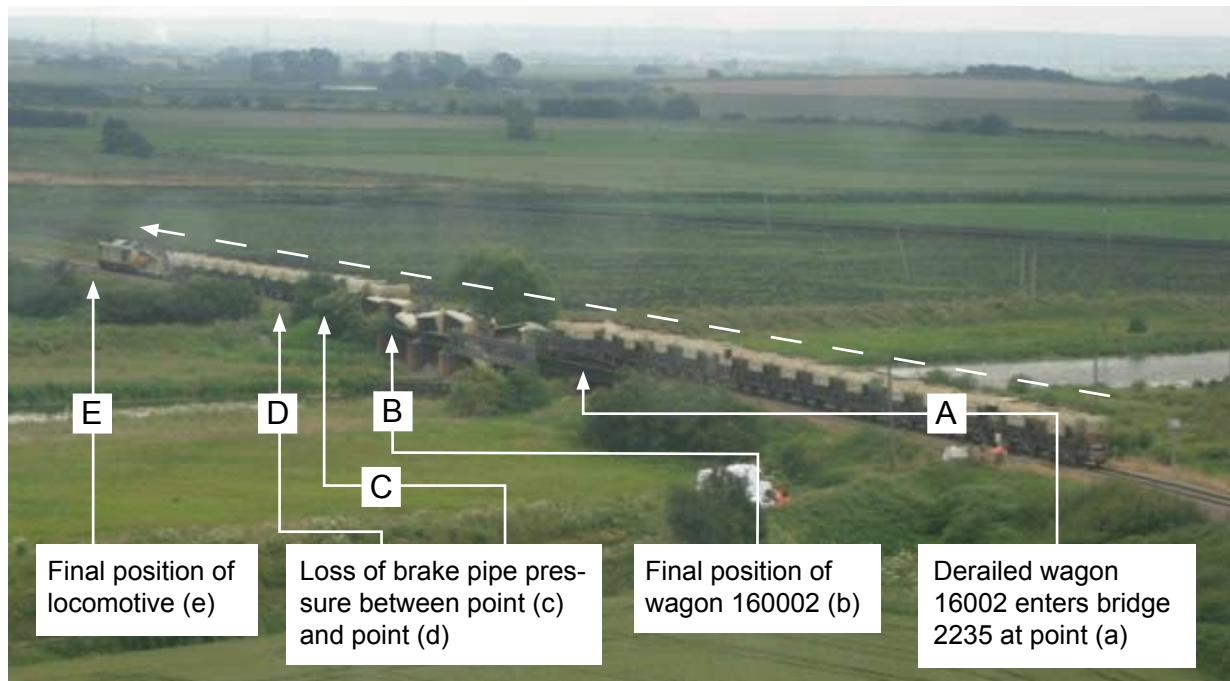
- 57 The weight of the 15th wagon running derailed caused the 14th wagon, REDA 16001, to topple onto its left side and the 13th wagon to derail its trailing wheel set. The 16th to 21st wagons also toppled over onto their left side in the same direction as wagon REDA 16002 as they reached the damaged bridge. They continued to slide, losing their payload, wheel sets and suspension components in the process. The derailment and wagon trajectories resulted in the bridge being catastrophically damaged.

Figure 10: Image showing final position of train 6L58 on bridge 2235 (aerial images are shown at appendix E)

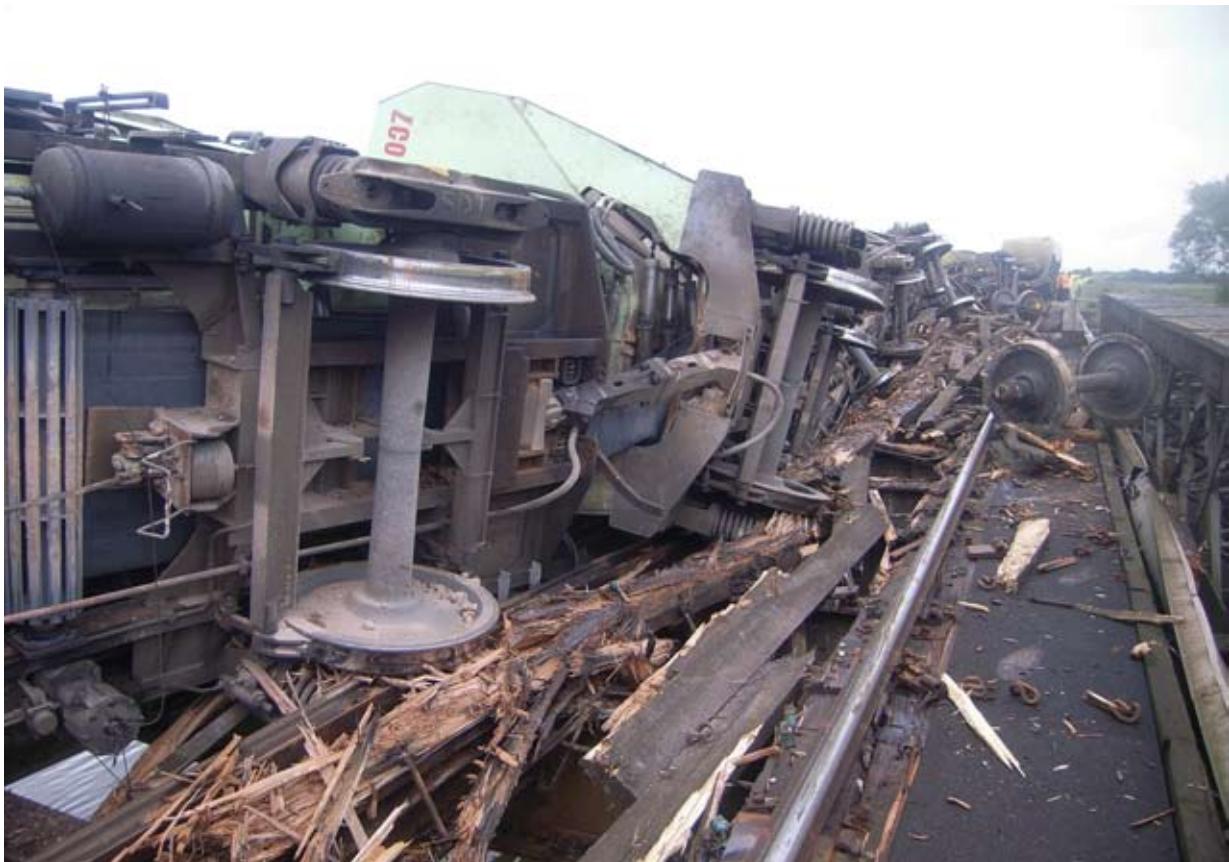
Figure 13: View of 6L58 on bridge 2235. Leading wheelset of 16002 can be seen on right with wagon REDA 16002 in background

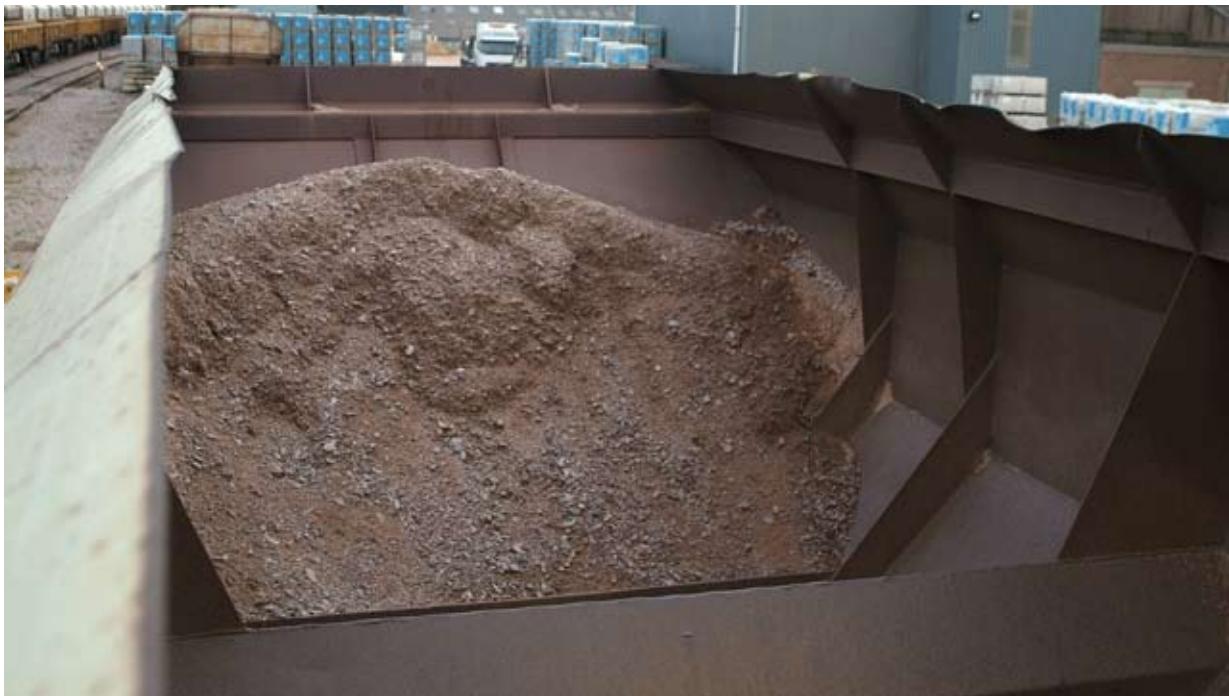
- 81 During the investigation, the RAIB observed a wagon being sent for loading despite a residual load of 2 - 3 tonnes which was adhering to the rear wall of the wagon (Figure 19). This had not been checked before loading.
- 82 There was a weighbridge at the depot but it was not in use when train 6L58 was being prepared for departure on 21 June 2007.

Figure 19: Residual ballast in wagon REDA 16021

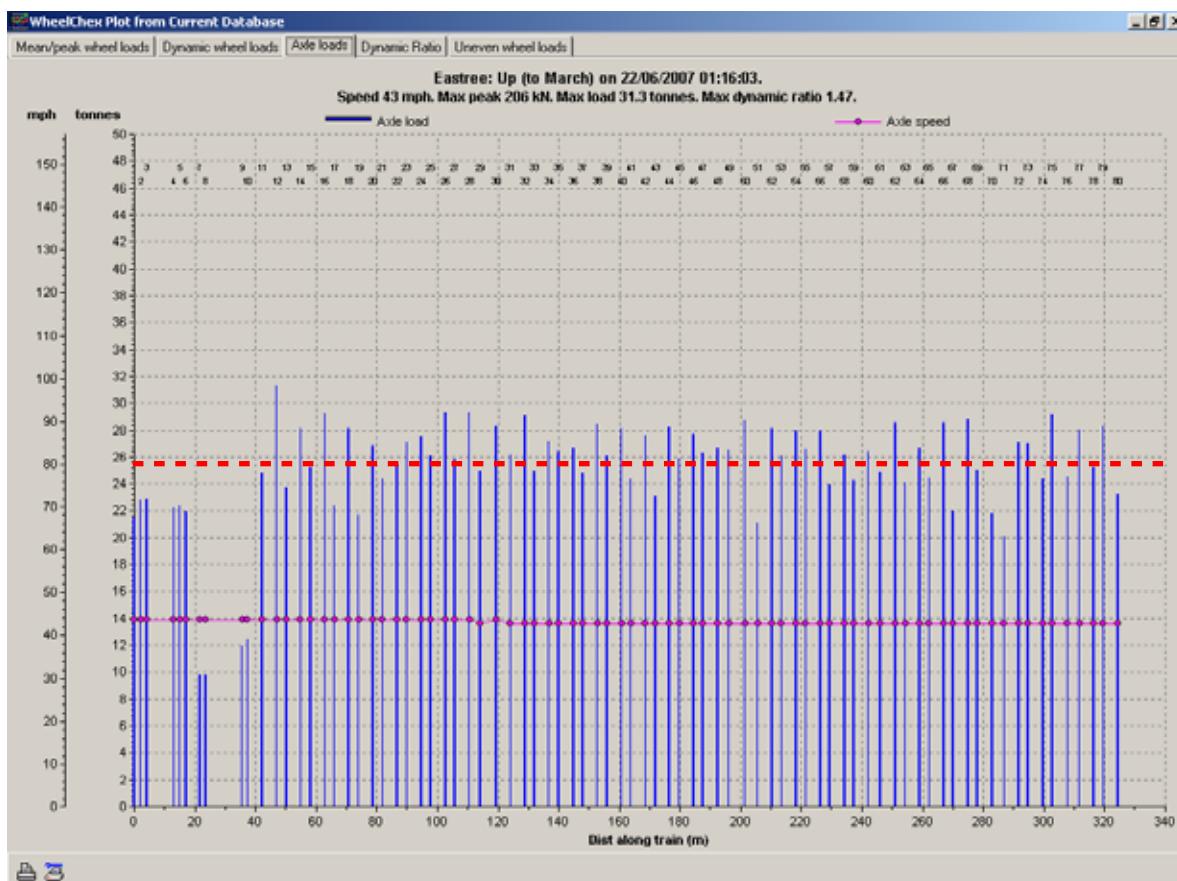
- 87 The total weight of wagon REDA 16056 was 51.4 tonnes; there were 29.7 tonnes on the rear axle and 21.7 tonnes on the front, a difference of 8.0 tonnes. The total weight initially recorded by the Lafarge operator on the order to move slip was 48.4 tonnes; this was amended to what was thought to be a correct 50.4 tonnes. Other wagons showed a similar pattern of load distribution.
- 88 Wagons that had been damaged and lost their payload could not be weighed. Details of known axle weights from the locomotive and KJA discharge vehicle were used as a reference to calculate the weights and axle loads of the whole train and to analyse the data from the Eastrea wheelchex site (paragraphs 128 to 133).

Figure 20: Data from Eastrea Wheelchex site showing axle load of 6L58. Data shows axle loads against datum line of maximum permitted tonnage on each axle (25.5 tonnes)

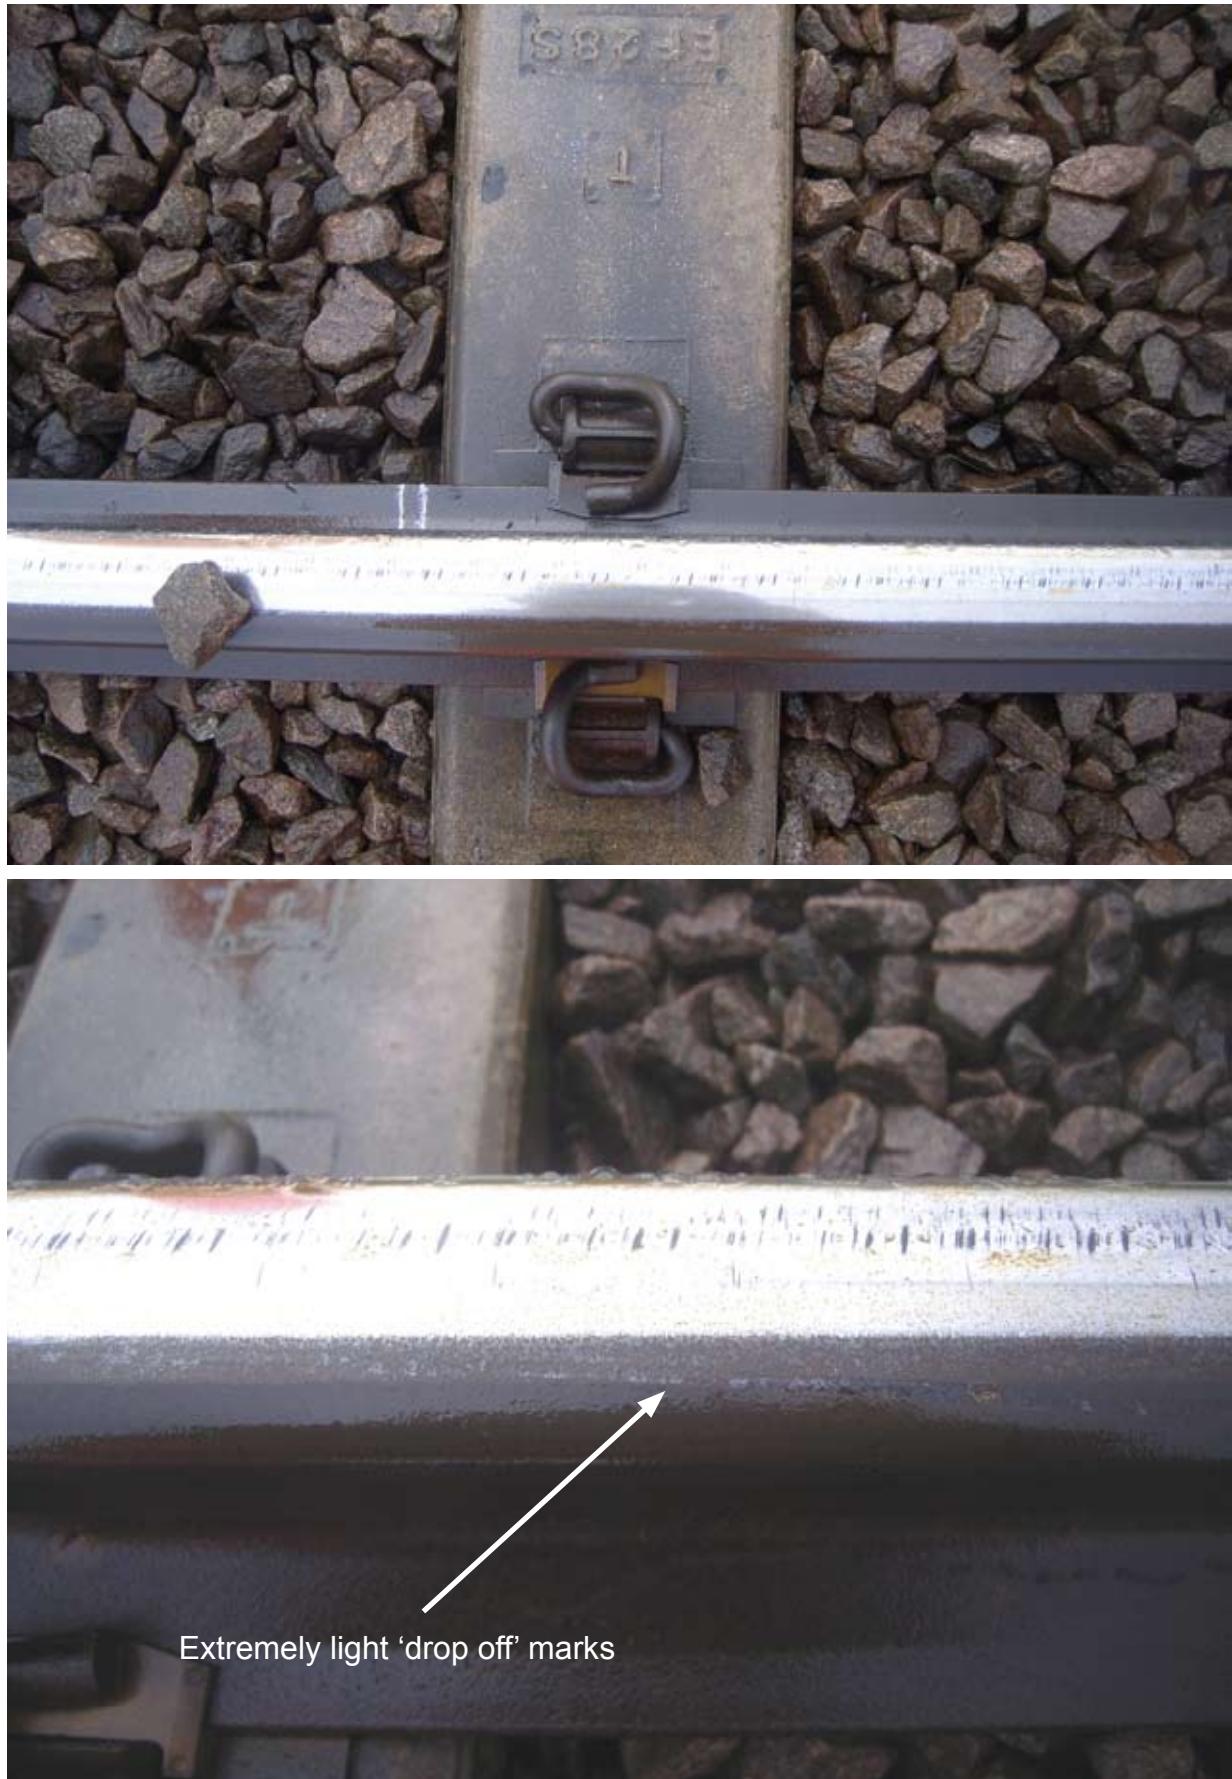
- 105 The leading right hand wheel of wagon REDA 16002 made contact with the surface of the sleepers causing them to fracture. Impact marks on the foot of the rail, damaged *Pandrol clips* and base plates started at the point of derailment and continued to Hawks UWC. Damage to the longitudinal timbers at Hawks UWC indicated that the derailed wagon moved to the right and that the wheelset ran parallel to the rails.

Figure 21a & b: Derailment drop-off mark on high right-hand rail

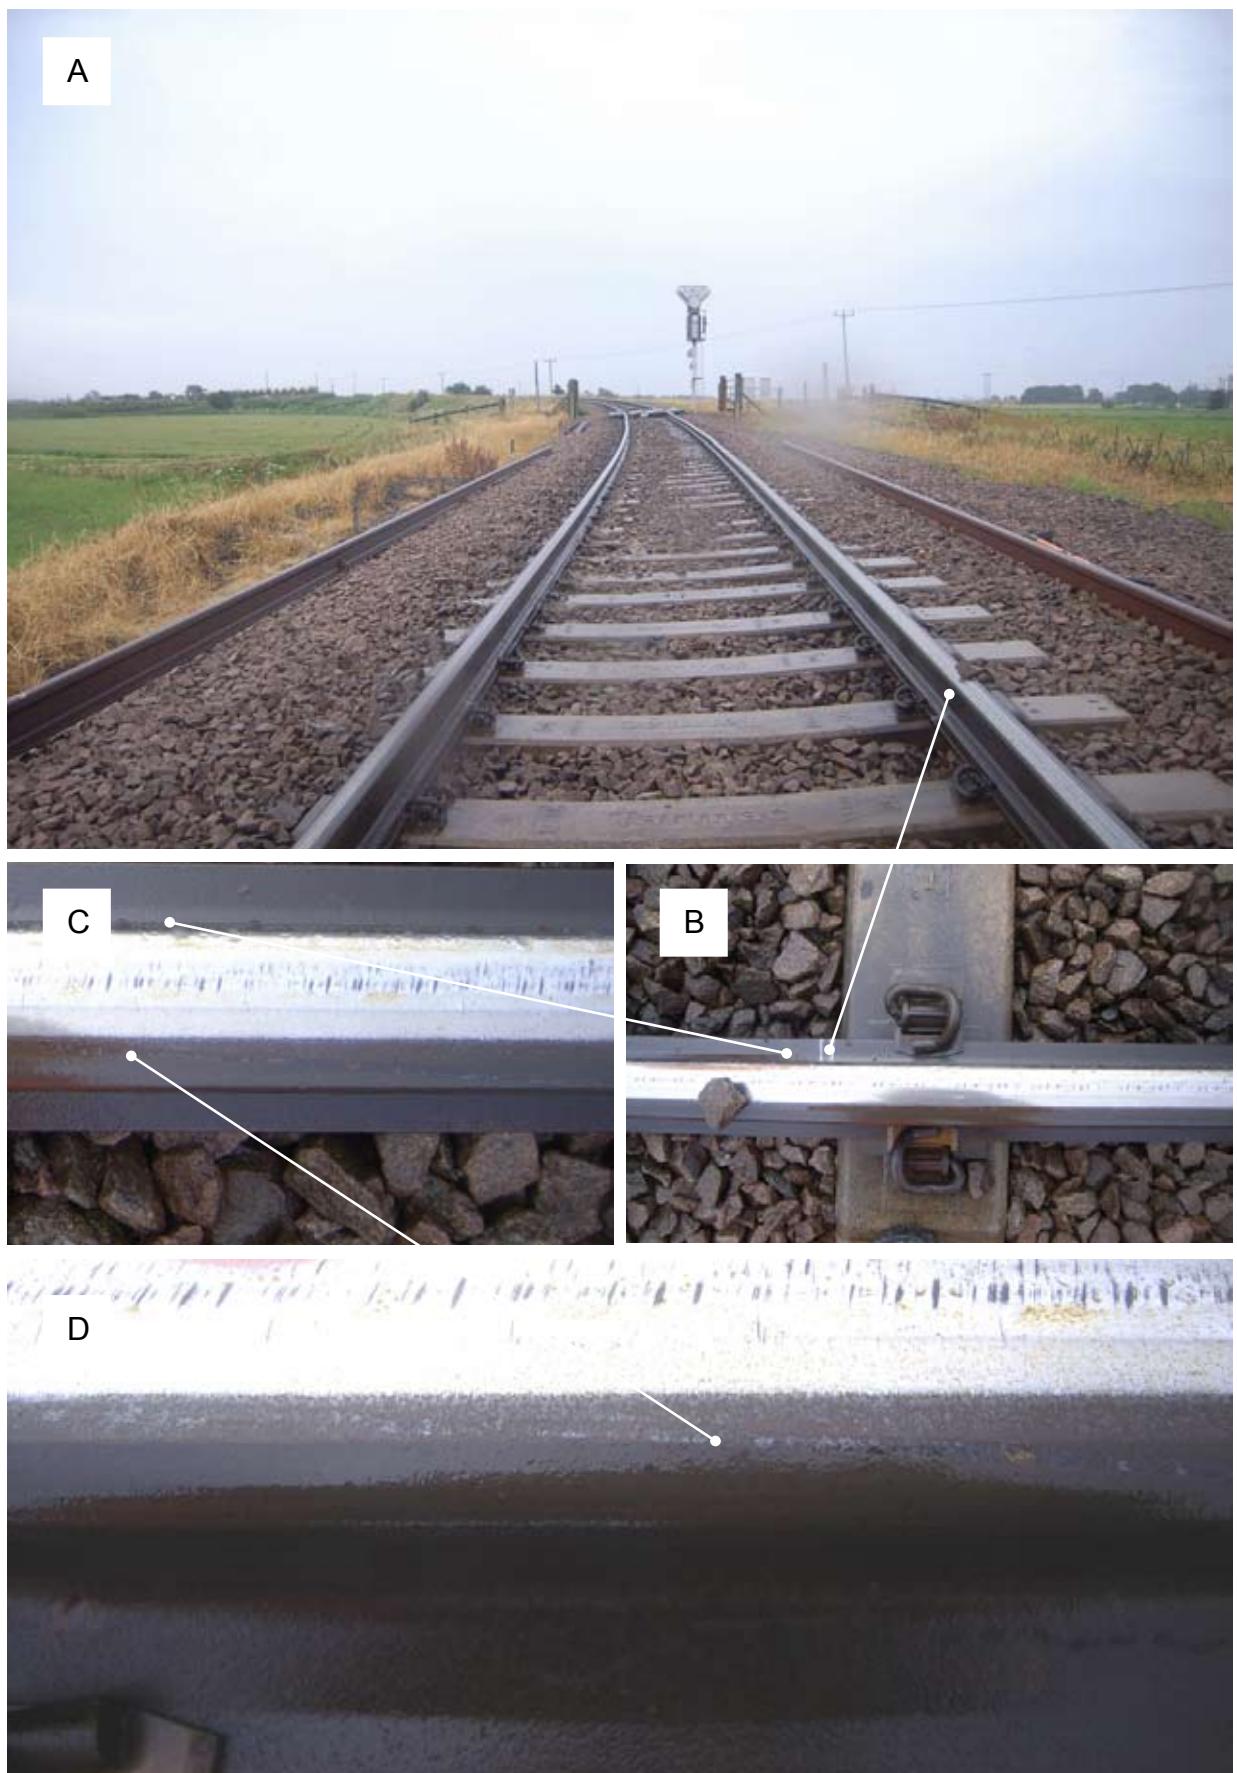
Figure 22: Sequence of images showing the area of flange climb (a), from the gauge corner onto the crown of the high right-hand rail (b & c) and the drop off mark (d)

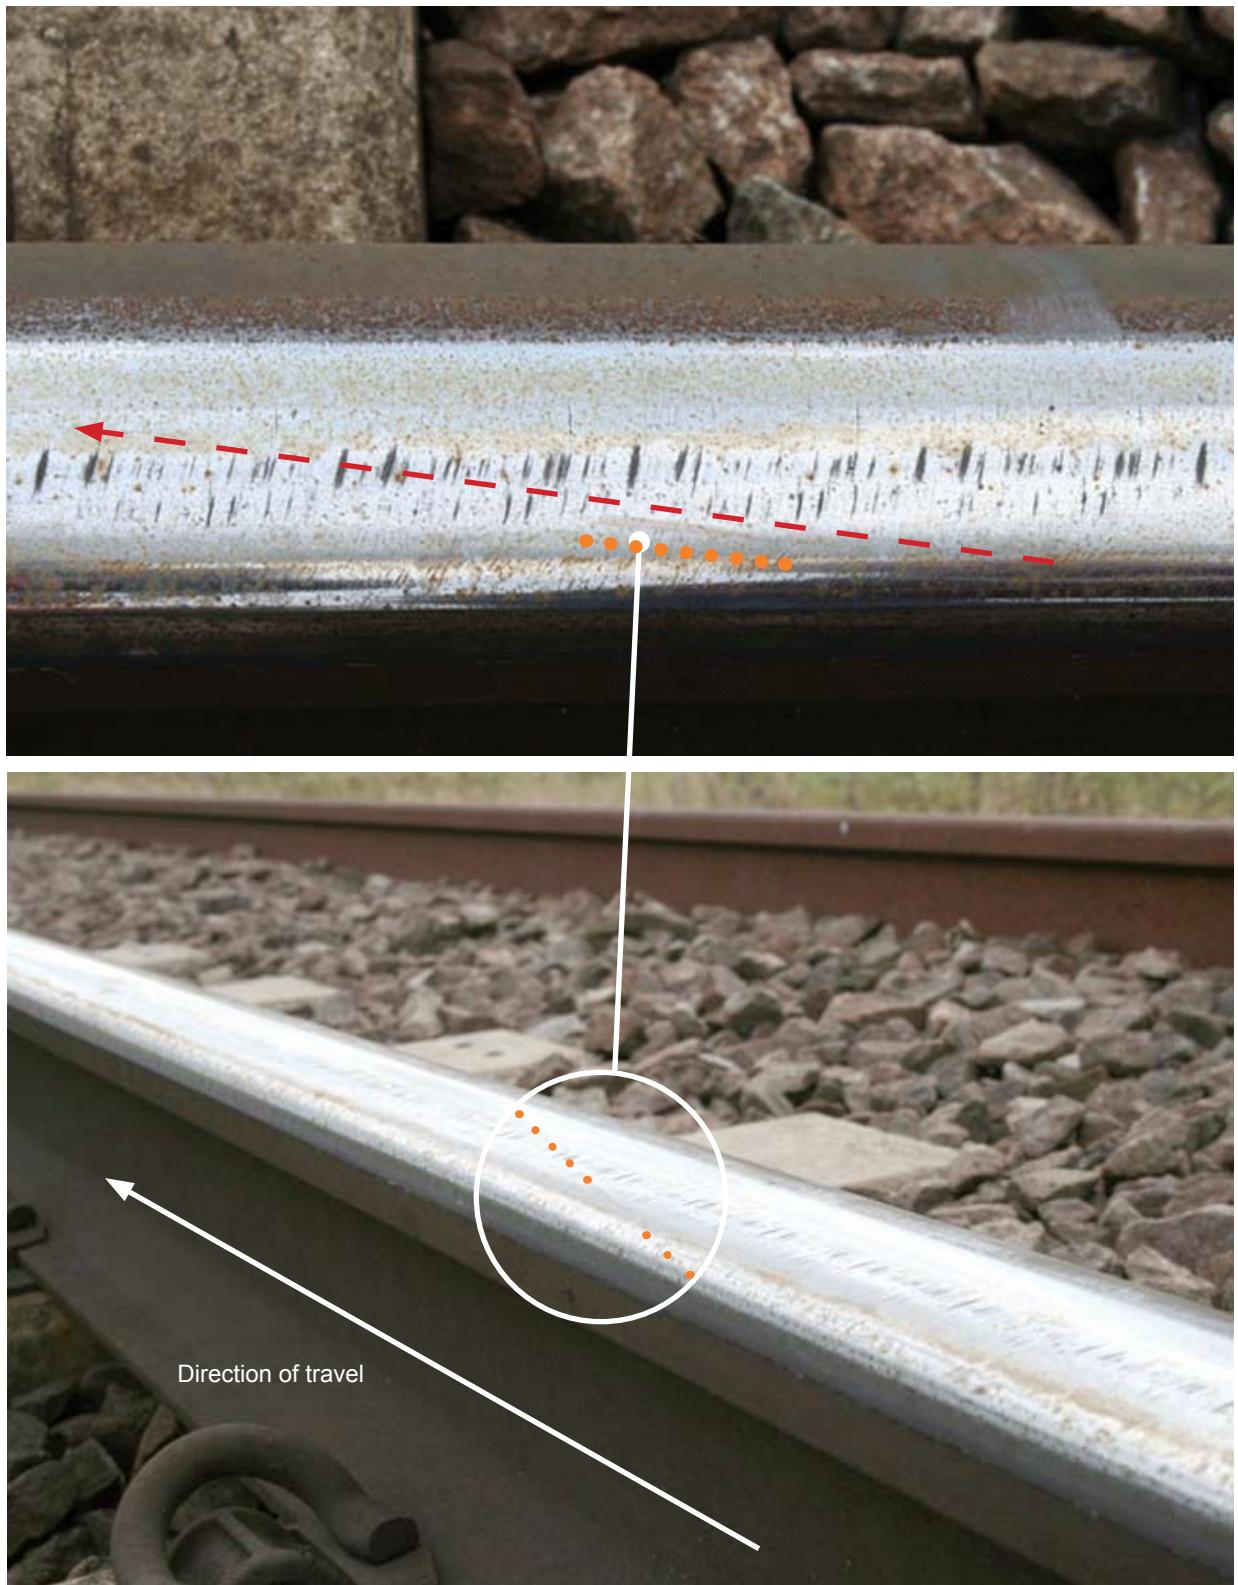
Figure 23a (top) and b (bottom): High right-hand rail showing view of derailment mark on railhead from the four-foot in direction of travel

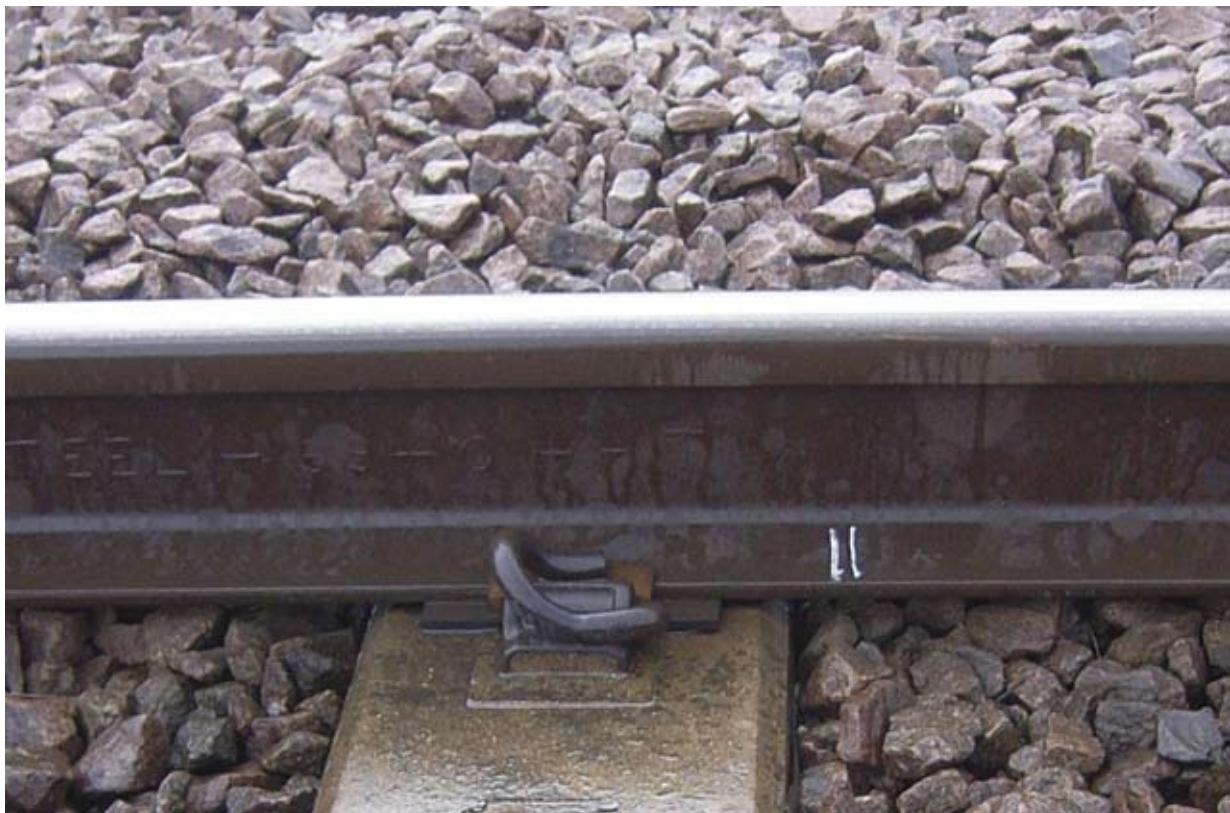
Figure 24a: Lower left-hand rail (drop off)

- 106 The leading left wheel rode heavily in the *four-foot* on the ballast and concrete sleepers next to the low (left) rail and cut through some of the steel reinforcing strands in the sleepers.
- 107 The leading right hand wheel of the leading right hand suspension generated slight impact marks on the sleepers on the high (right) side of the track. The right wheel only skimmed the top of some concrete sleepers with visible damage from the wheel flange of 1 - 2 mm in depth. The depth of the impact marks from the right hand wheel increased with time and distance from the point of derailment. There was no evidence of the suspension breakout from sleeper number (0) to bridge 2235.

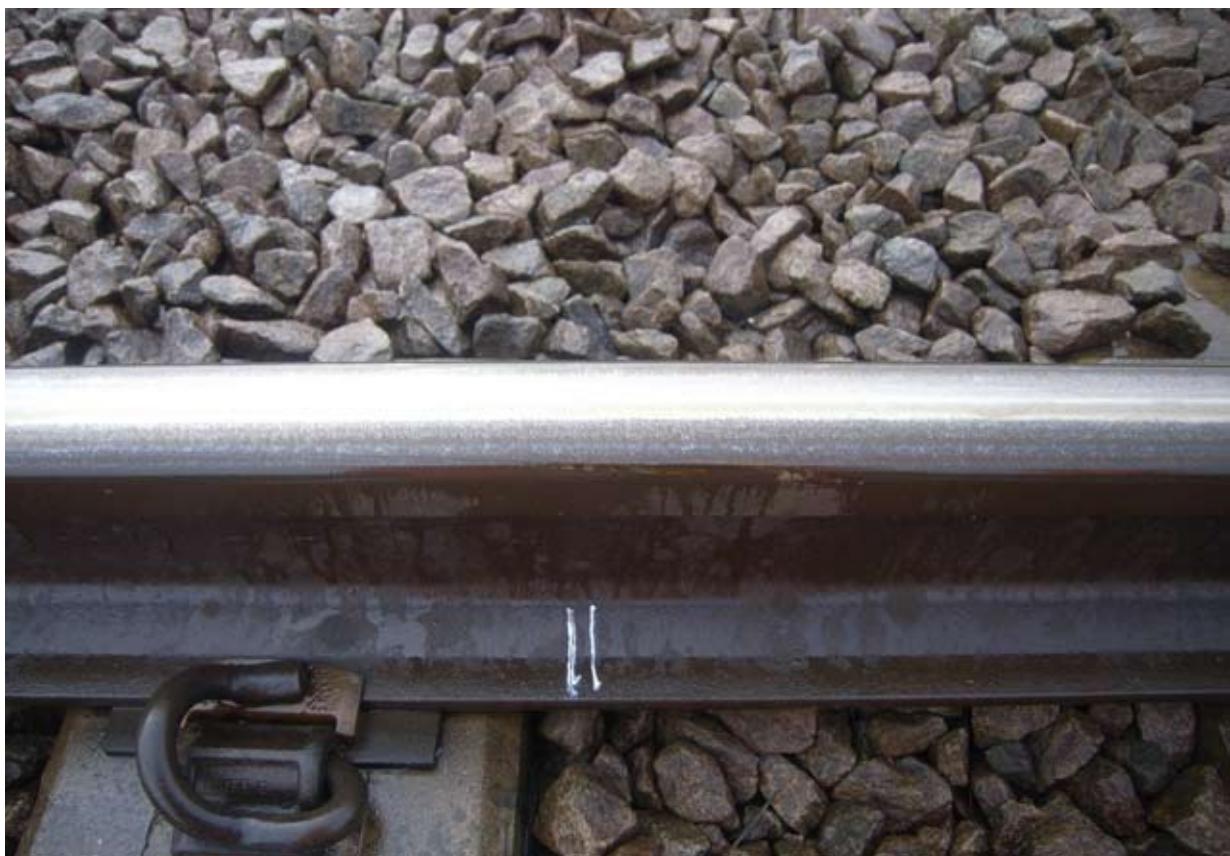
Figure 24b: Close-up image of lower left-hand rail (drop off)

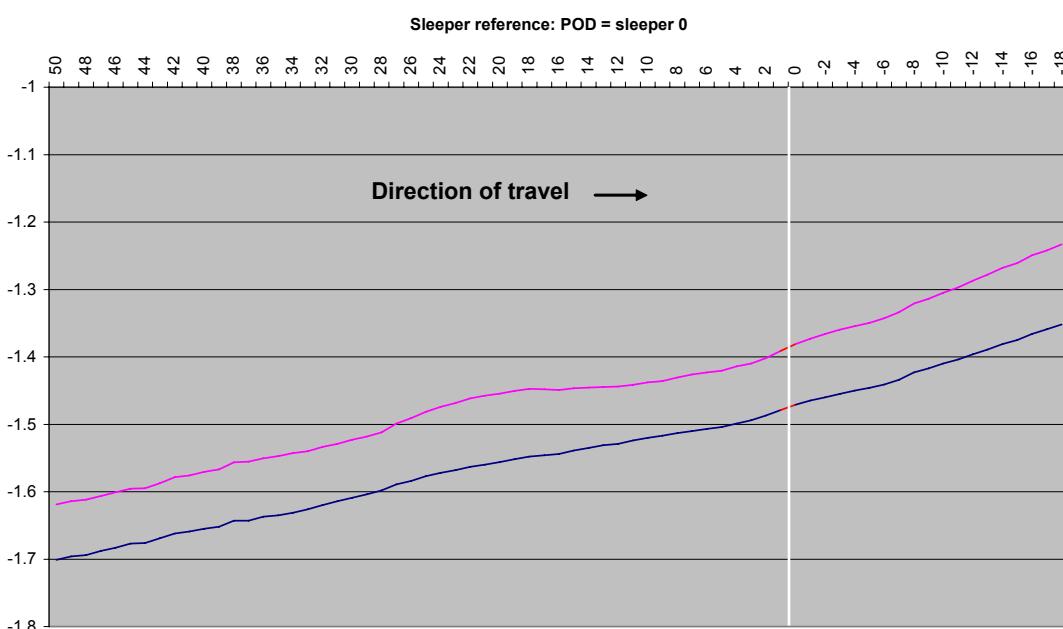
- 109 The change in cant over 3 metres was 13.5 mm at sleeper +28 to +24, giving it a track twist of 1 in 222. This is worse than the 1 in 300 maintenance limit and requires the Track Maintenance Engineer to monitor the track conditions to prevent deterioration to the point where the track reaches intervention limits mandated by NR/SP/TRK/001. Those intervention limits include the requirement for action within 14 days of detection for twists below 1 in 200 and on a curve radius of 400 metres (paragraph 114). There was also an opposing track twist of 1 in 236 over 3 metres at sleeper +13. Calculated over 5 metres (225 mm more than the wagon wheelbase of 4775 mm), the greatest track twists occurred at sleeper +22 (1 in 268), and at sleeper +12 (1 in 250) (Figure 25).

Figure 25: Diagram showing the twist features in track geometry from +50 sleepers to -19. High right-hand rail (magenta) and low left-hand rail (blue). Point of derailment marked at zero (paragraph 277)

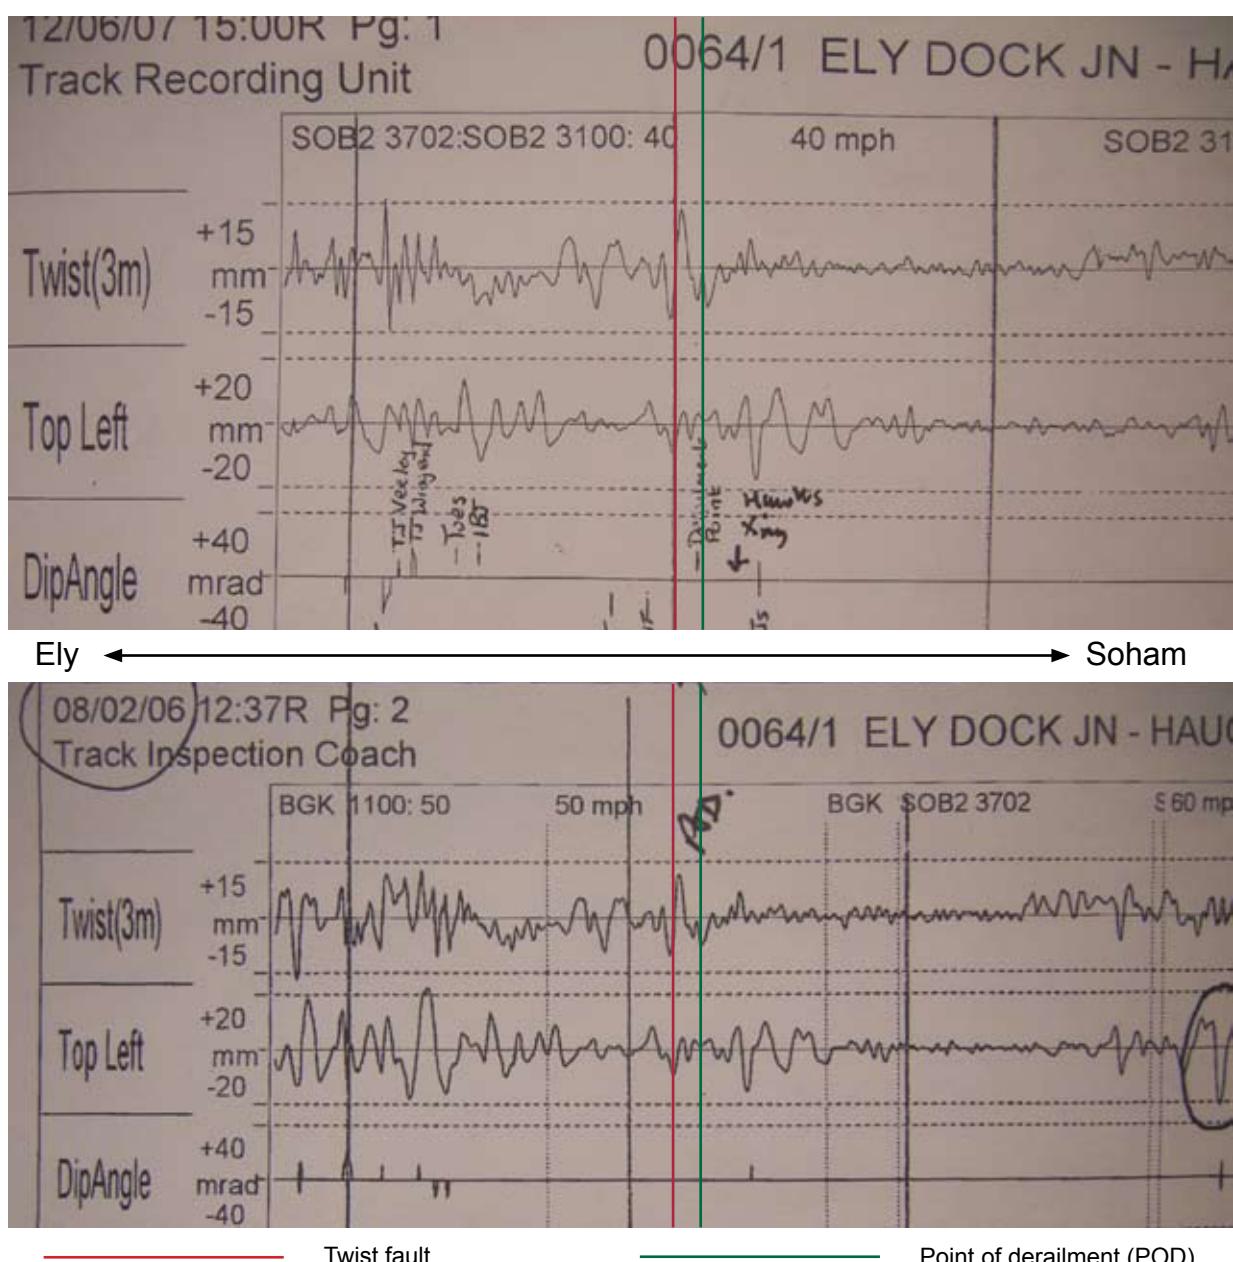
- 114 Network Rail's *track recording vehicle* (TRV) was scheduled to run over the track every six months and ran over the Soham branch on 12 June 2007, ten days before the derailment. The Track Maintenance Engineer (TME) considered the track to be in satisfactory condition based upon his evaluation of inspection records, and the propagation of faults was in line with his preventative maintenance plan.
- 115 The TRV recorded a twist fault of 1 in 222 within the curve leading to bridge 2235 in February 2006, but it was not highlighted until after 12 June 2007 when the new TRV trace was reviewed and the fault fell within the maintenance limits of NR/SP/TRK/001 (Figure 27).
- 116 Tamping is carried out on an as required basis normally in response to the output from the track recording; however the section of track at the point of derailment had not been tamped since 2004.

Figure 27: Track recording vehicle data trace from 8 February 2006 (bottom) and 12 June 2007 (top). The horizontal dotted line indicates the intervention limit. The track twist and POD are also shown

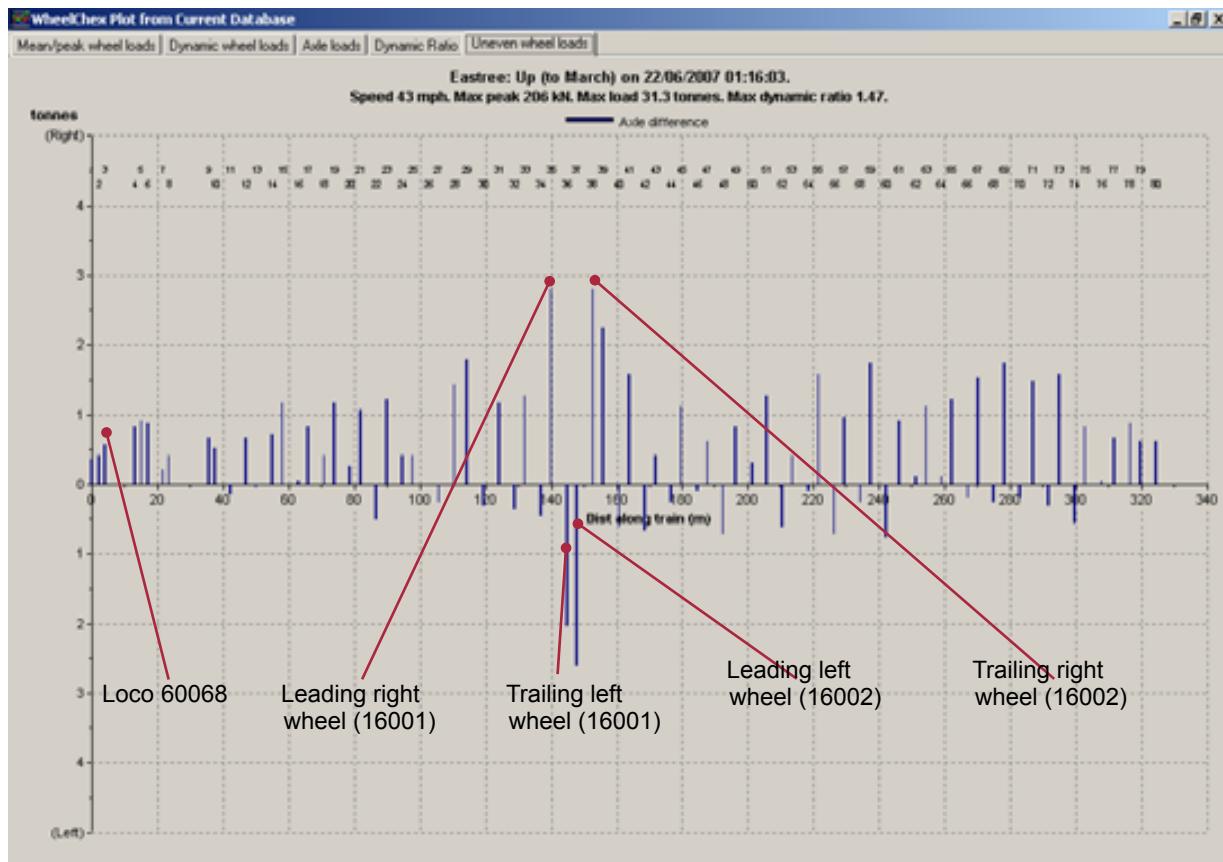
Figure 28: Wheelchex graphs showing uneven wheel loads REDA 16001 and REDA 16002

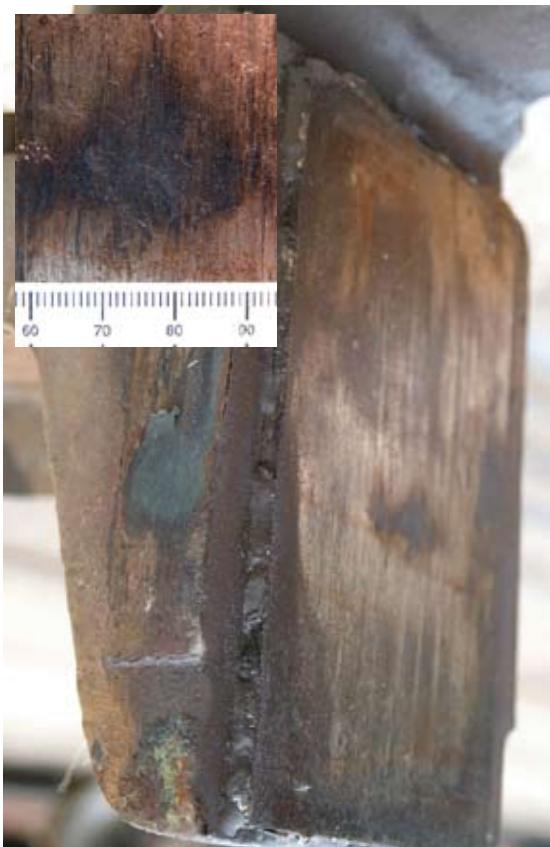
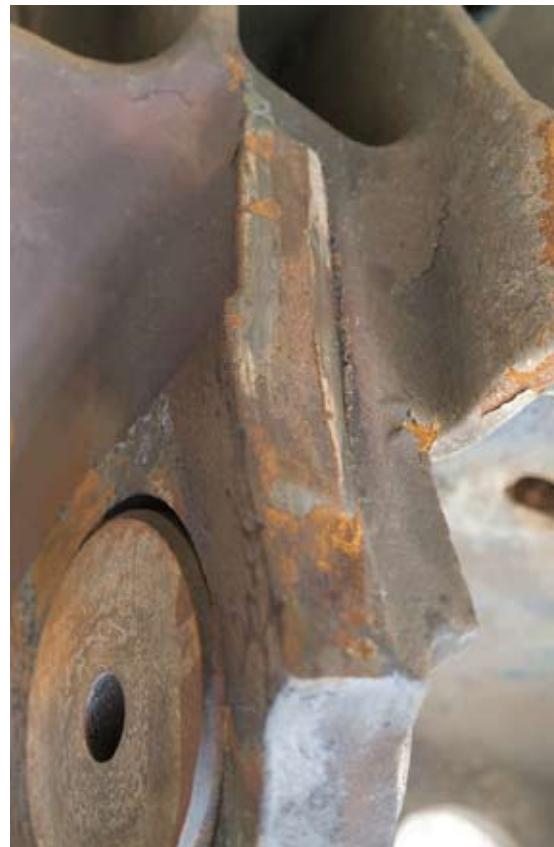
Figures 32 (left) with inset. Front portion of inner aspect of the right-hand pedestal showing heat damage. Figure 33 (right). Heat damage to rear portion of inner aspect of pedestal guide.

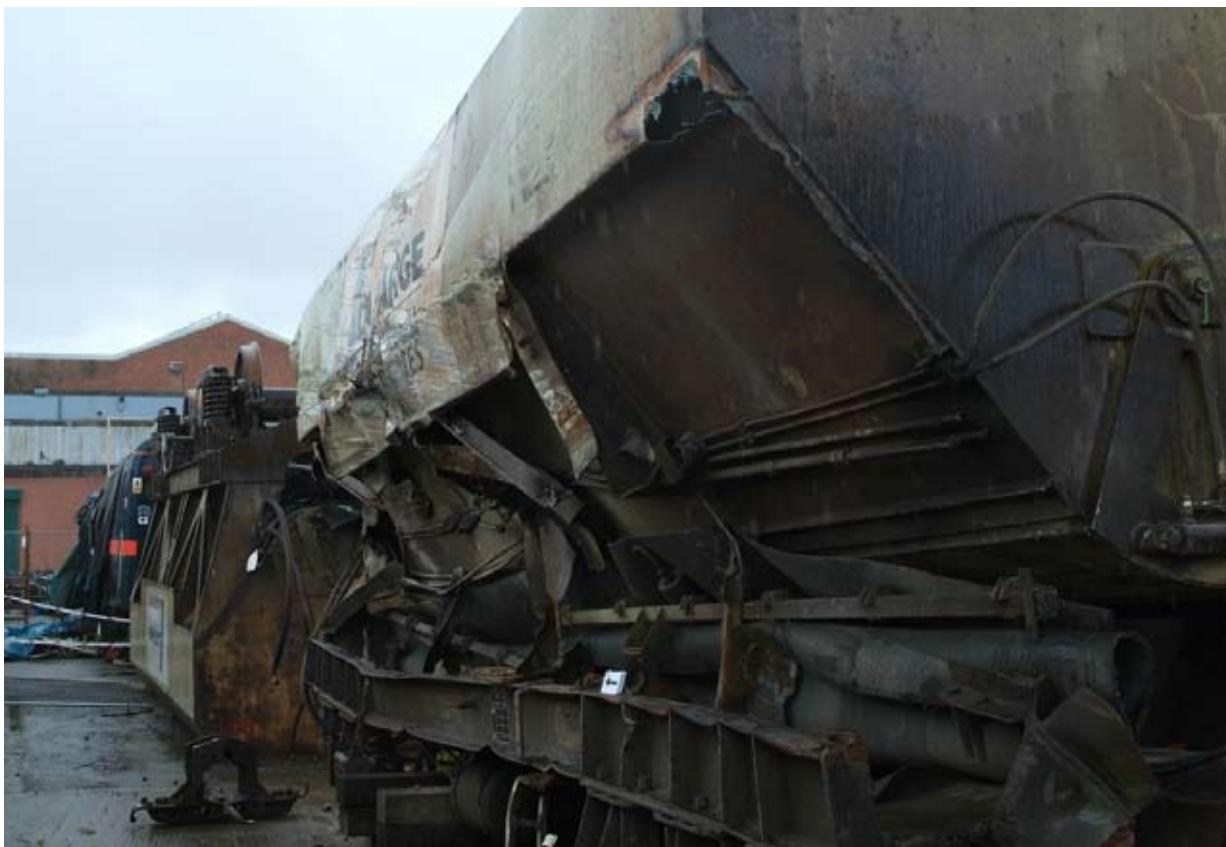
150 The bolts and fastenings between the shims and the pedestal / frame on corners 2 and 4 were of a different type and visually different to the un-shimmed corners 1 and 3 which may indicate that the shims were fitted post manufacture or at different times. The damage sustained as a result of the incident prevented any accurate physical frame twist examination being completed on wagon REDA 16002 (Figure 34).

Figure 34: Left side of wagon REDA 16002 showing severe damage and frame twist caused by incident

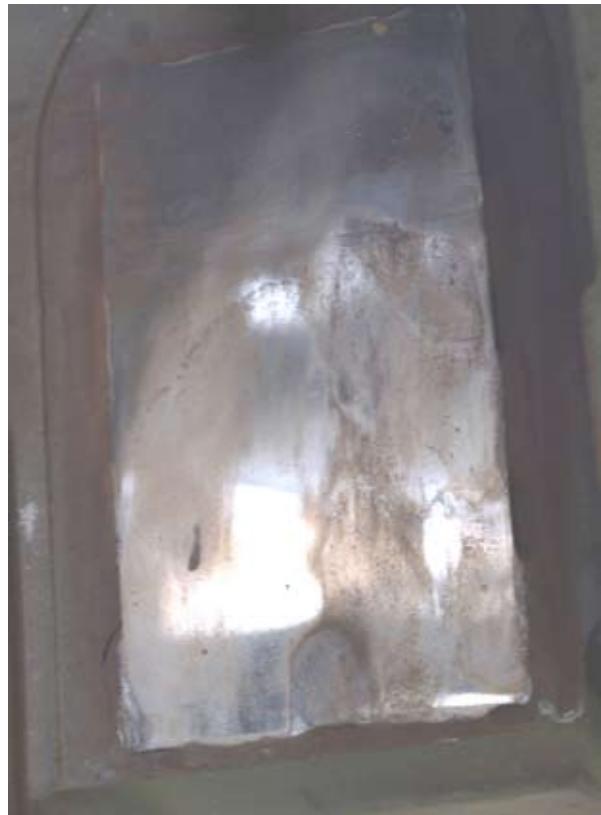
Fig 38: Wear to leading right pedestal guide on REDA 16011 showing polished surfaces but no evidence of heat damage

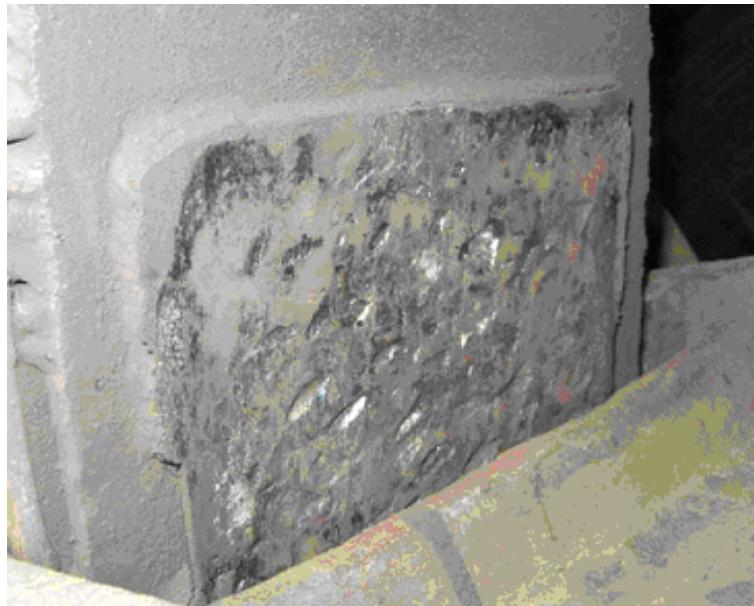
Figure 41: Abnormal wear pattern on friction liner of wagon 14503 identified during Network Rail's audit of Lafarge vehicles in May 2007

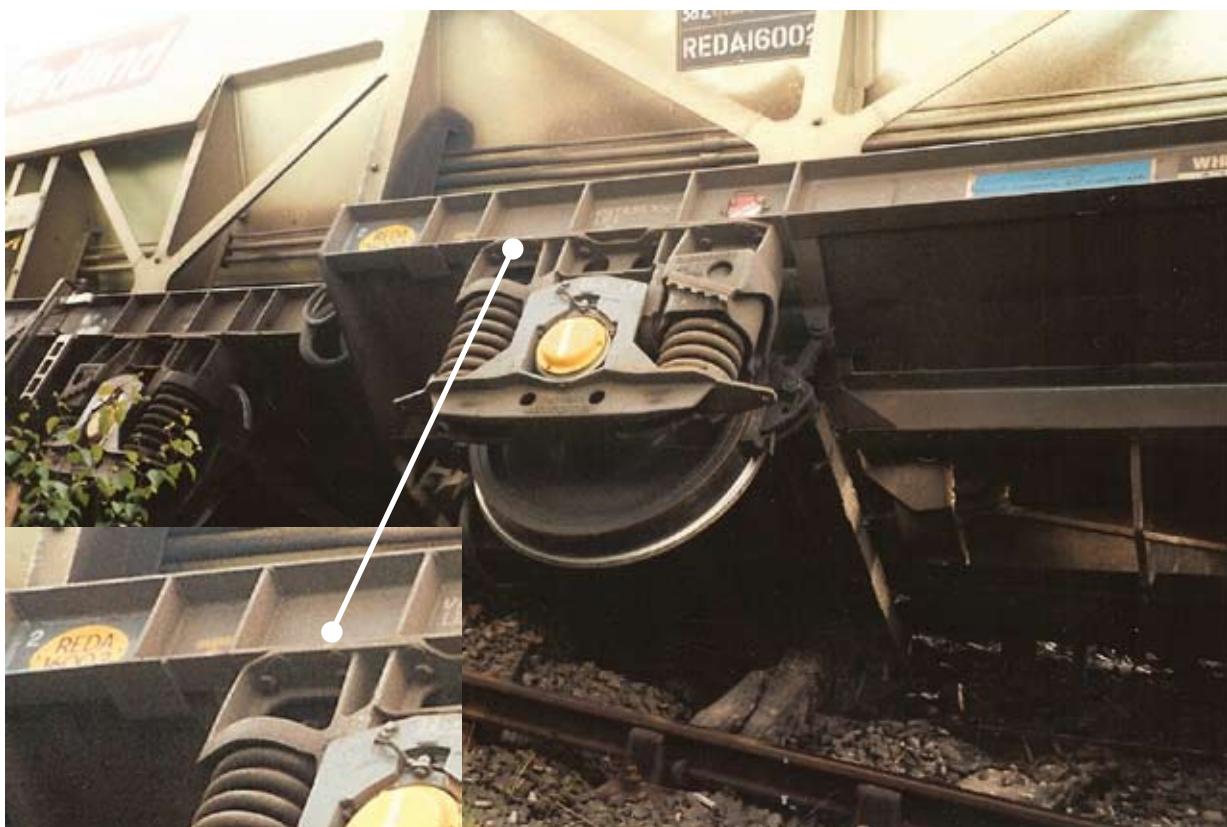
Figure 42: Detail of damage to vehicle REDA 16002 following Baguley Fold junction derailment. Inset shows no visible packing and no evidence of welding work

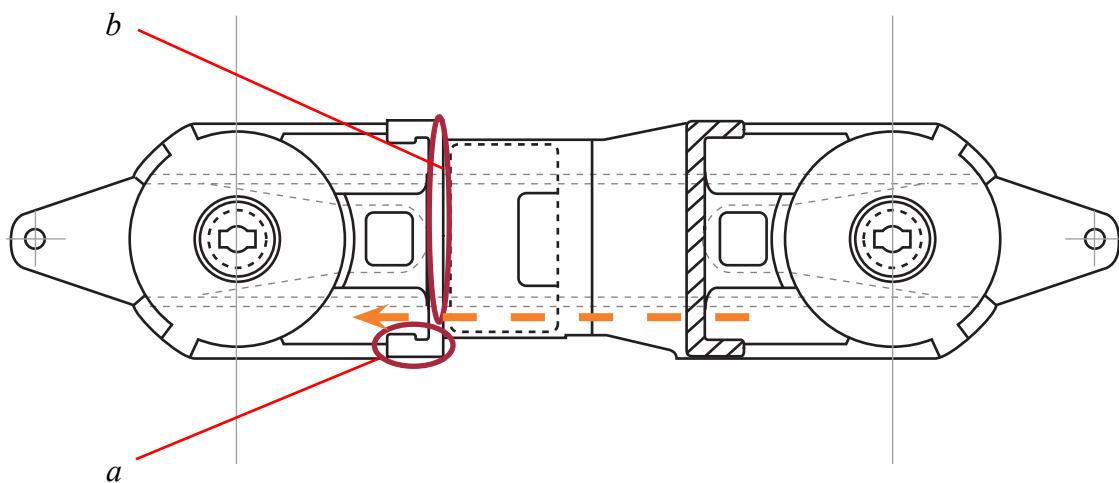
Figure 50: Plan view of Leading RHS pedestal and saddle showing area of frictional heat generation at (a) lateral guide and (b) friction liner
